RAPIDS LANDING LIFESTYLE COMMUNITY STRUCTURE PLAN

**Lot 9014 John Archibald Drive, Margaret
River**

Project Contact: Glenn Ahola
Project Job Code: 00100
Identification No: AUGU/2021/____ - 1
Date: 30 January 2024

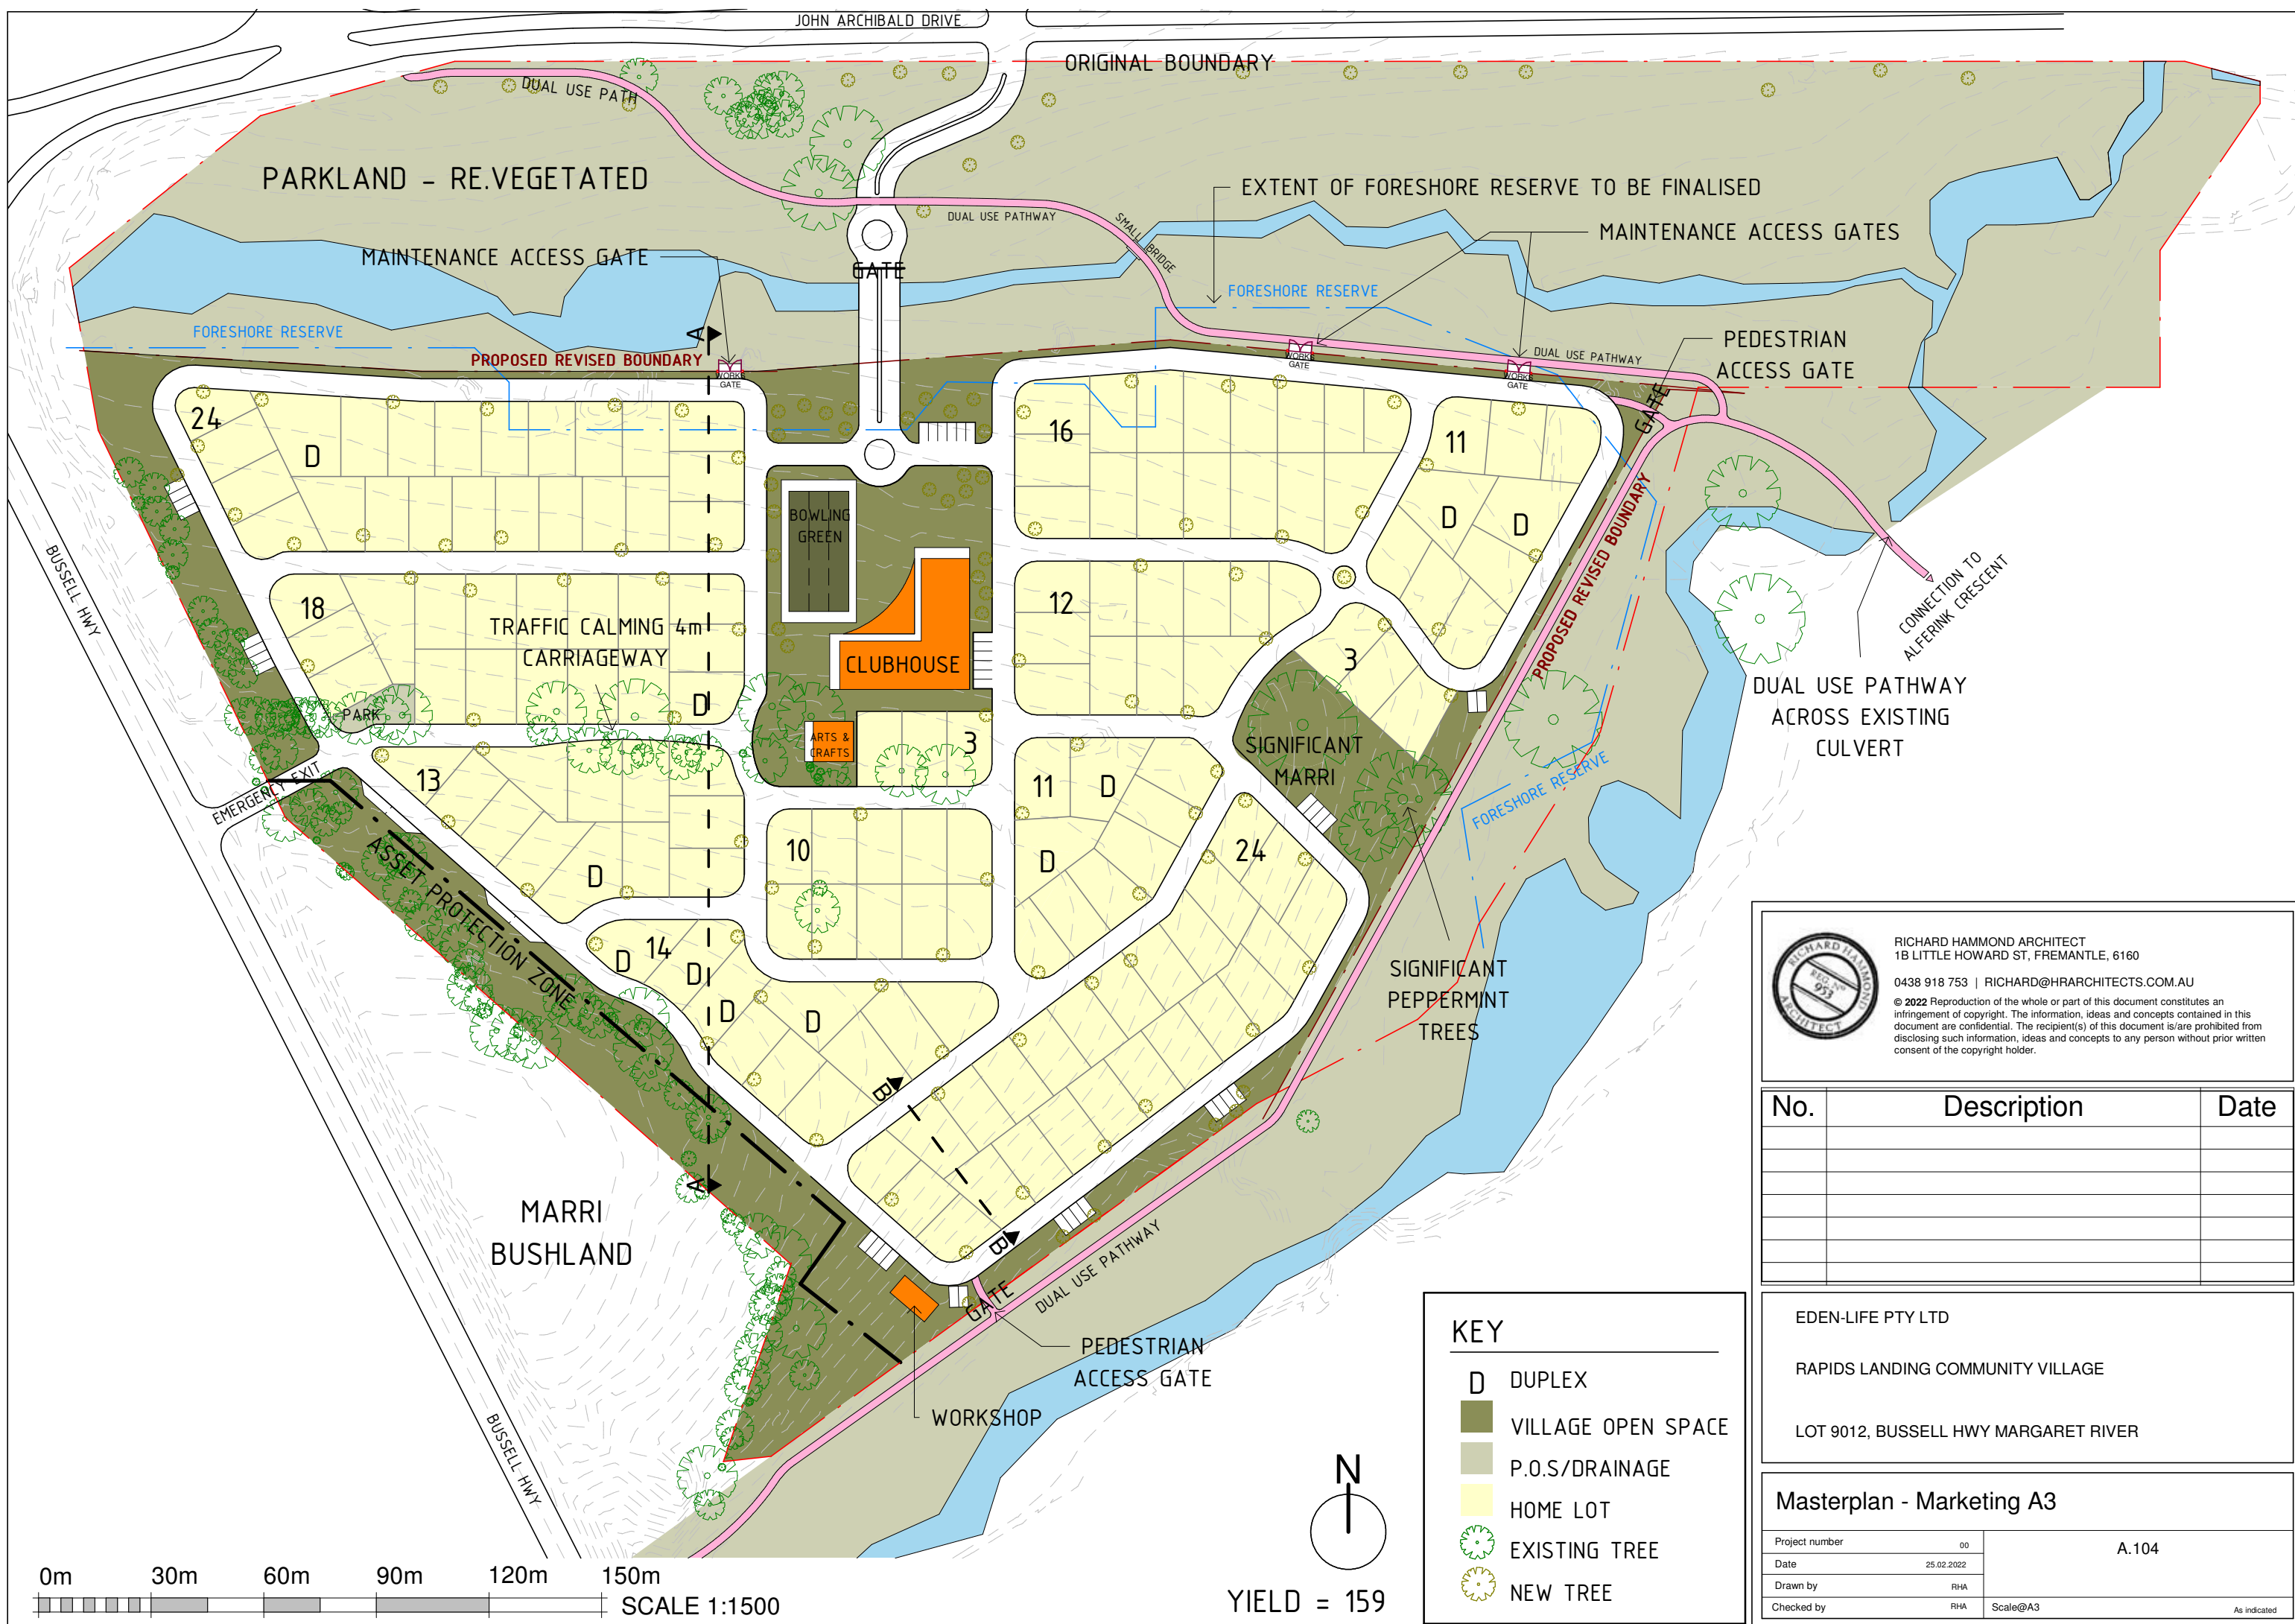
Project number	00	A.104
Date	25.02.2022	
Drawn by	RHA	
Checked by	RHA	Scale@A3

YIELD = 159

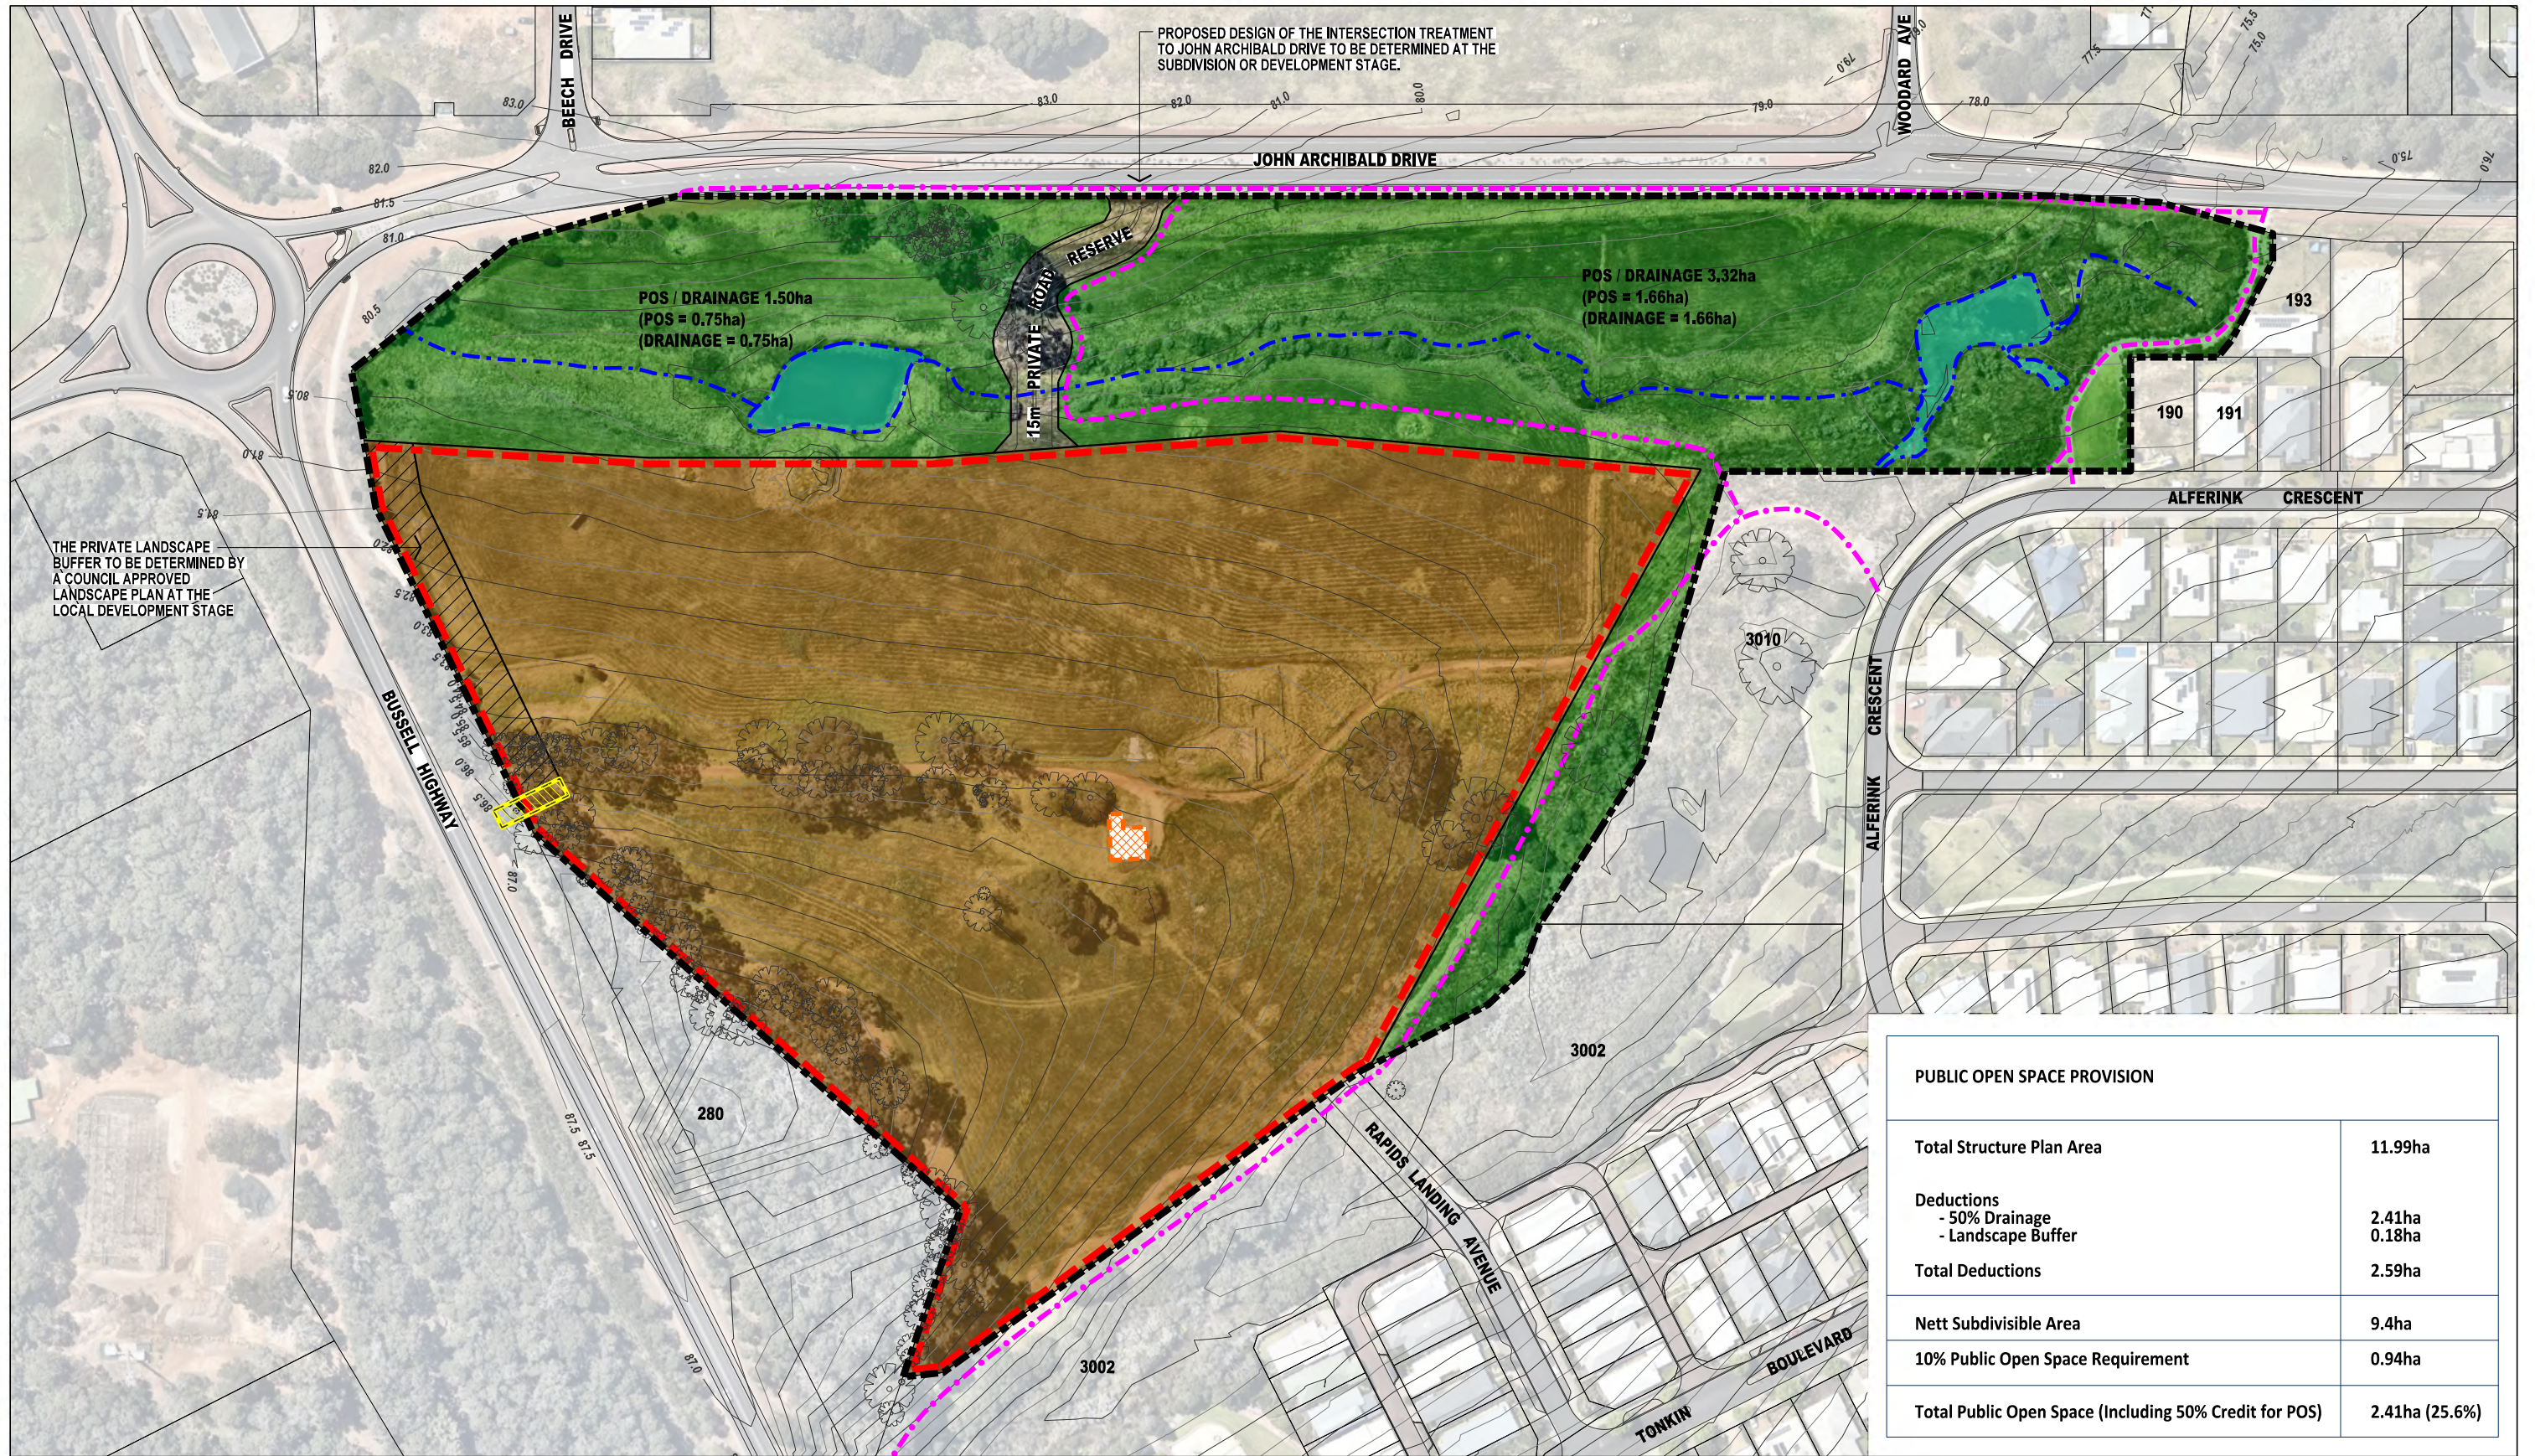
PROPOSED DESIGN OF THE INTERSECTION TREATMENT TO JOHN ARCHIBALD DRIVE TO BE DETERMINED AT THE SUBDIVISION OR DEVELOPMENT STAGE.

THE PRIVATE LANDSCAPE BUFFER TO BE DETERMINED BY A COUNCIL APPROVED LANDSCAPE PLAN AT THE LOCAL DEVELOPMENT STAGE

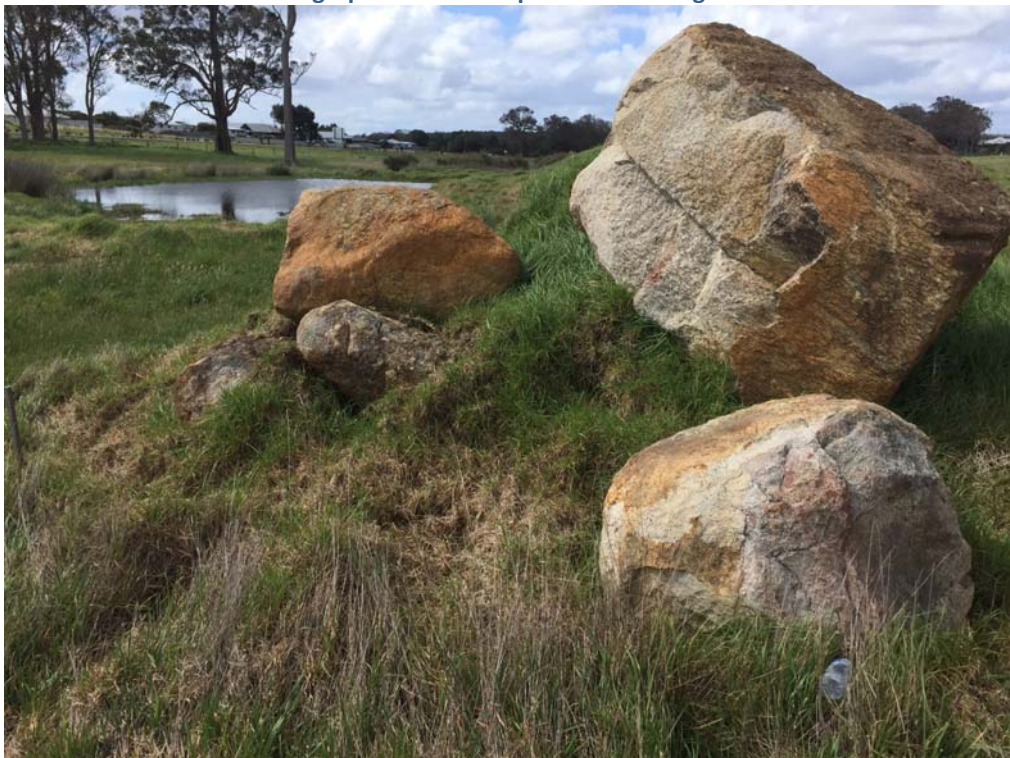
Photograph 8: Typical rock stockpiles on southern side of creek

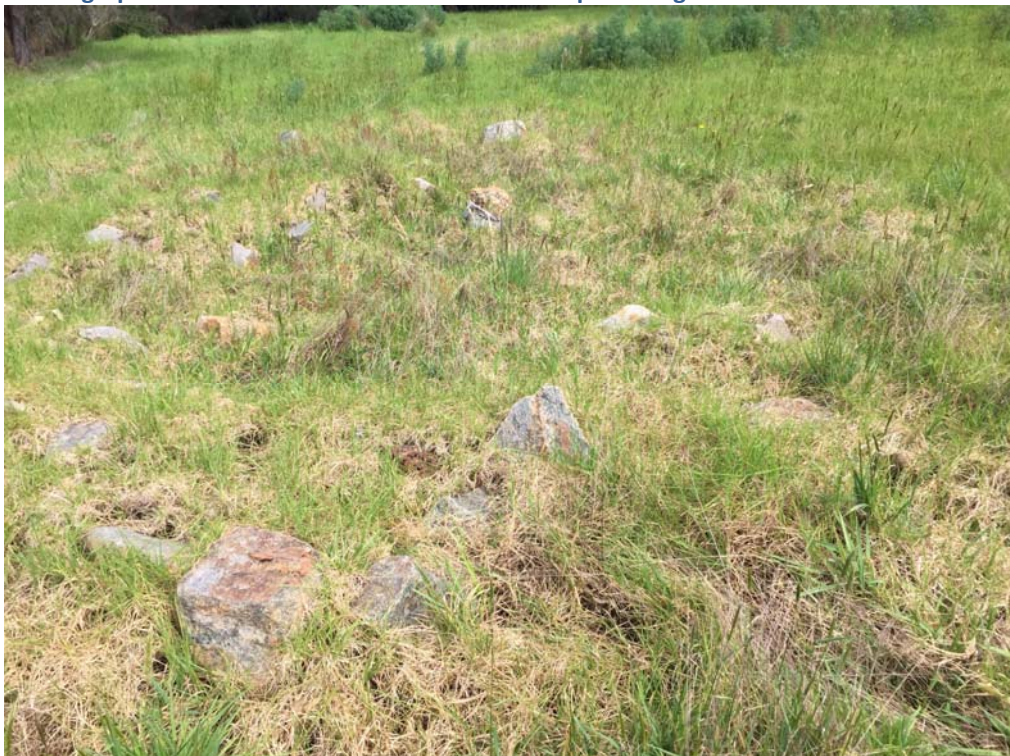
Photograph 9: Soft surface conditions and shallow perched groundwater in middle of site

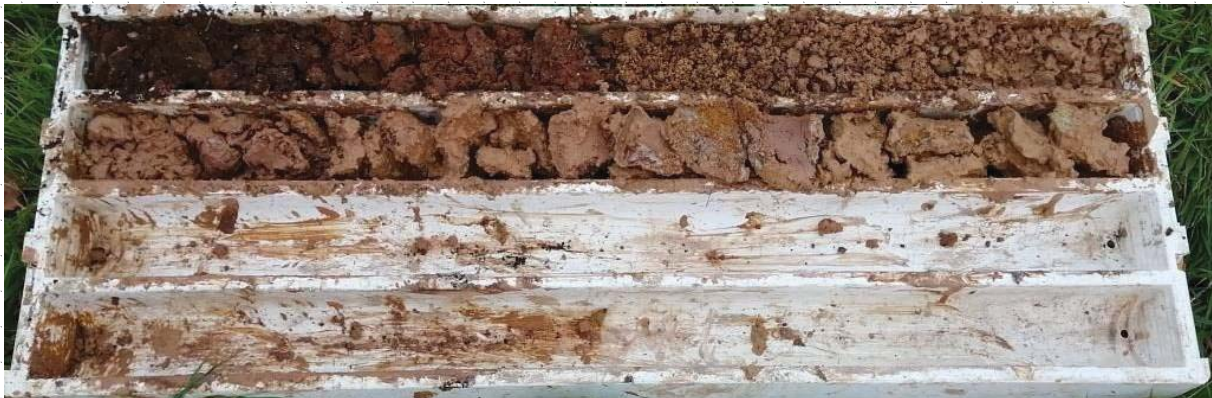
Drilling				Sampling		Field Material Description				
METHOD	PENETRATION RESISTANCE	WATER	DEPTH (metres)	SAMPLE OR FIELD TEST	RECOVERED GRAPHIC LOG	SOIL CLASS	SOIL/ROCK MATERIAL DESCRIPTION	MOISTURE CONDITION	CONSISTENCY DENSITY	STRUCTURE AND ADDITIONAL OBSERVATIONS
			0.0			SM	TOPSOIL: Silty SAND, fine to coarse grained, dark brown, 10-20% non-plastic fines, trace organics			Perched groundwater
	E					SC	Clayey SAND: fine to coarse grained, orange-brown, 25-35% medium plasticity fines	M	L - MD	
			0.5			SP	Gravelly SAND: fine to coarse grained, orange-brown, 30-40% fine to coarse grained gravel, with fines	W	D - VD	
			1.0			CI	Sandy CLAY: medium to high plasticity, grey mottled brown, 40-60% fine to coarse grained sand, trace gravel		D - M	
			2.0				Hole terminated at 2.00 m Target depth Groundwater encountered at 0.9 m

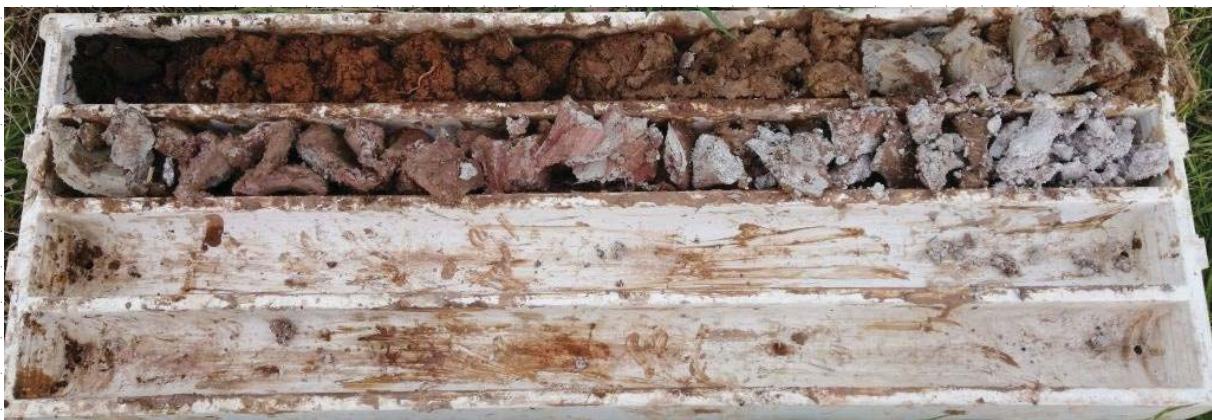
Drilling			Sampling		Field Material Description							
METHOD	PENETRATION RESISTANCE	WATER	DEPTH (metres)	DEPTH RL	SAMPLE OR FIELD TEST	RECOVERED GRAPHIC LOG	SOIL CLASS	SOIL/ROCK MATERIAL DESCRIPTION	MOISTURE CONDITION	CONSISTENCY	DENSITY	STRUCTURE AND ADDITIONAL OBSERVATIONS
ADV	E	▲	0.0		B(BH04-1)	[SM]	SM	TOPSOIL: Silty SAND, fine to coarse grained, dark brown, 10-20% non-plastic fines, with organics	M	VL - L		Perched groundwater
			0.5			[SC]	SC	Clayey SAND: fine to coarse grained, orange-brown, 15-30% medium plasticity fines, trace gravel With gravel				
F			1.0			[CH]	CH	Sandy CLAY: high plasticity, grey mottled red, 40-50% fine to coarse grained sand	D - M			
			1.5					Becoming medium plasticity, grey, with silt fines				
			2.0					Hole terminated at 2.00 m Target depth Groundwater encountered at 0.5 m

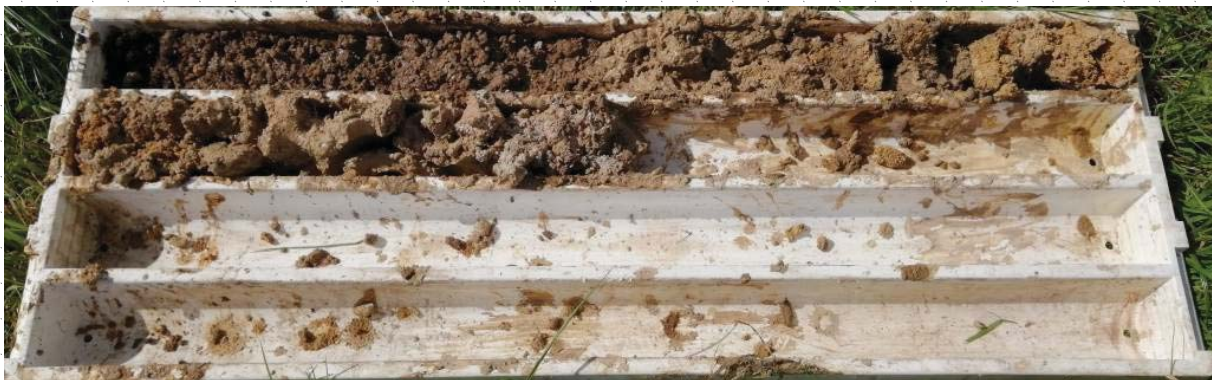
2.0				Hole terminated at 1.50 m Refusal on stiff clay Groundwater encountered at 0.3 m

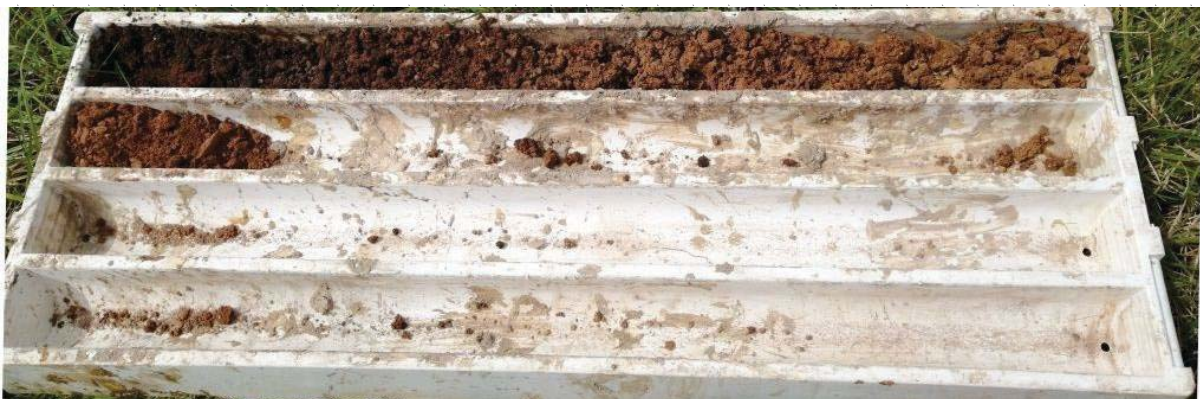
Drilling				Sampling		Field Material Description				
METHOD	PENETRATION RESISTANCE	WATER	DEPTH (metres)	SAMPLE OR FIELD TEST	RECOVERED GRAPHIC LOG	SOIL CLASS	SOIL/ROCK MATERIAL DESCRIPTION	MOISTURE CONDITION	CONSISTENCY DENSITY	STRUCTURE AND ADDITIONAL OBSERVATIONS
ADV	E		0.0			SC	TOPSOIL: Clayey SAND, fine to coarse grained, dark brown, 10-15% low plasticity fines, with organics	D-M	L	
			0.5		SC	Clayey SAND: fine to coarse grained, orange brown, 15-25% low to medium plasticity fines, with gravel				
			1.0		CI	Sandy CLAY: medium plasticity, orange-brown, 50-60% fine to coarse grained sand, trace gravel	D	VSt		
			1.5				Hole terminated at 1.10 m Refusal on very stiff clay Groundwater not encountered

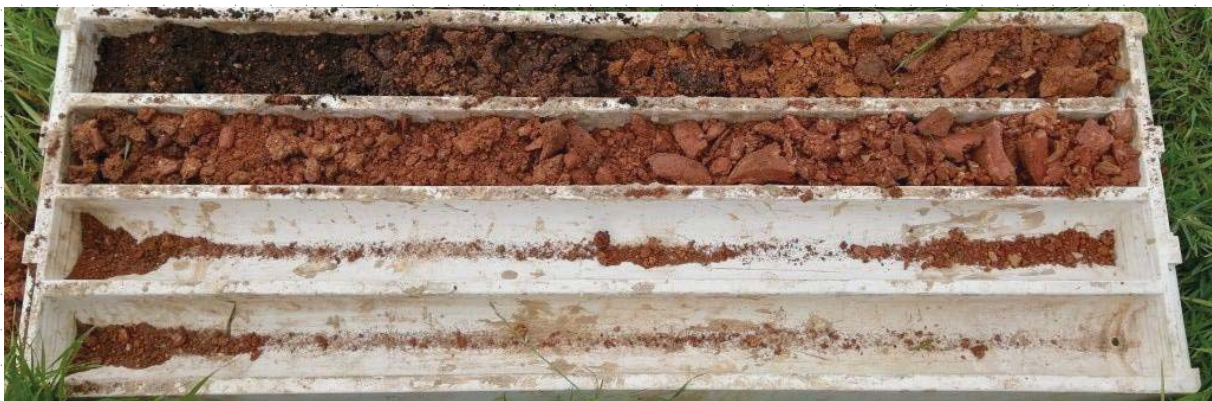
Drilling				Sampling		Field Material Description				
METHOD	PENETRATION RESISTANCE	WATER	DEPTH (metres)	SAMPLE OR FIELD TEST	RECOVERED GRAPHIC LOG	SOIL CLASS	SOIL/ROCK MATERIAL DESCRIPTION	MOISTURE CONDITION	CONSISTENCY DENSITY	STRUCTURE AND ADDITIONAL OBSERVATIONS
ADV	E		0.0		[SM Symbol]	SM	TOPSOIL: Silty SAND, fine to coarse grained, dark brown, 10-20% non-plastic fines, with organics	D - M	L	
			0.5			SP	Gravelly SAND: fine to coarse grained, orange brown, 30-40% fine to medium grained, lateritic gravel, with fines		MD	
	1.0	F		CI	Sandy CLAY: medium to high plasticity, orange brown, 40-50% fine to coarse grained sand	VSt				
	1.5	F-H		CH	High plasticity	D				
			2.0				Hole terminated at 2.00 m Target depth Groundwater not encountered

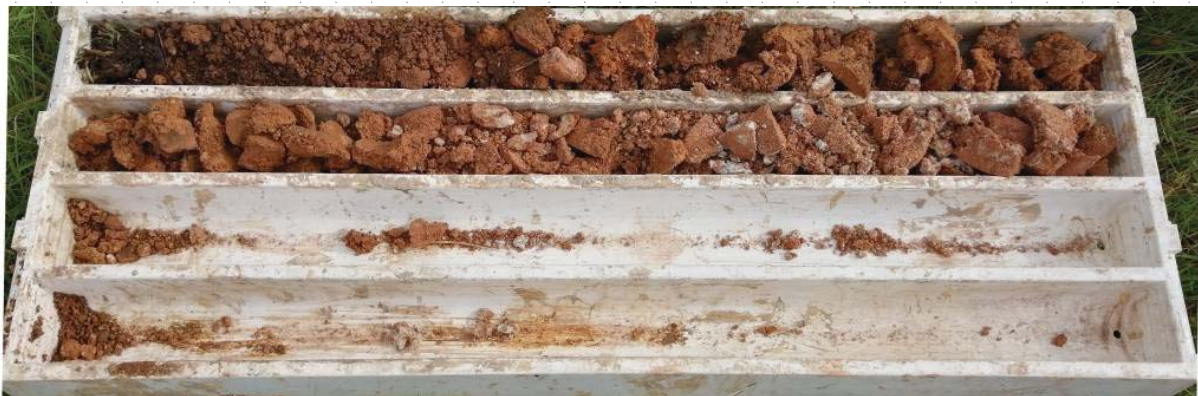
CH	High plasticity, grey mottled red				
			2.0				Hole terminated at 2.00 m Target depth Groundwater not encountered

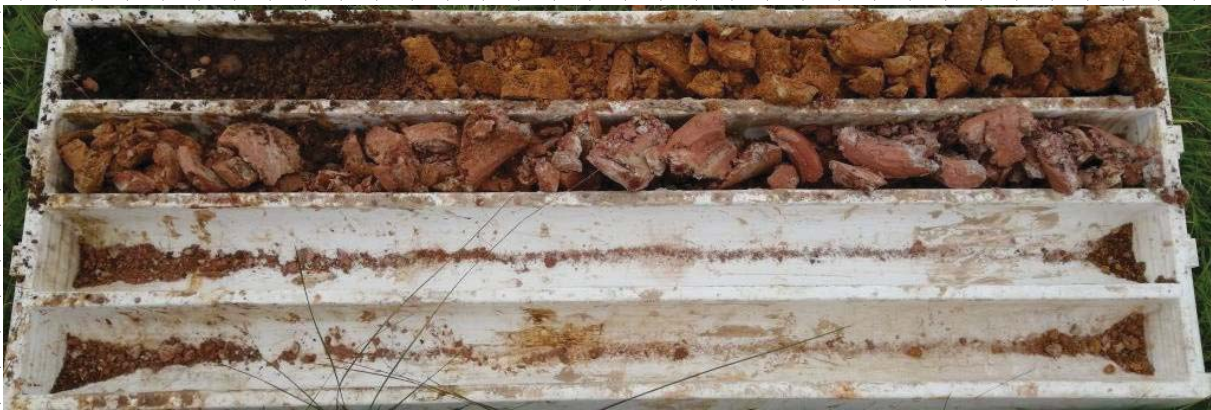
Drilling				Sampling		Field Material Description				
METHOD	PENETRATION RESISTANCE	WATER	DEPTH (metres)	SAMPLE OR FIELD TEST	RECOVERED GRAPHIC LOG	SOIL CLASS	SOIL/ROCK MATERIAL DESCRIPTION	MOISTURE CONDITION	CONSISTENCY DENSITY	STRUCTURE AND ADDITIONAL OBSERVATIONS
ADV	E		0.0		SM	TOPSOIL: Silty SAND, fine to coarse grained, dark brown, 10-15% non-plastic fines, with organics	D - M	L - MD		
					SP	Gravelly SAND: fine to coarse grained, brown, 35-45% fine to medium grained, lateritic gravel, with fines				
	0.5		B(BH09-01)	CI	Sandy CLAY: medium plasticity, orange brown, 40-50% fine to coarse grained sand	St				
						VSt				
F-H		1.0			CLAY: high plasticity, red mottled grey, with sand	D				
		1.5	B(BH09-02)	CH						
		2.0			Hole terminated at 2.00 m Target depth Groundwater not encountered

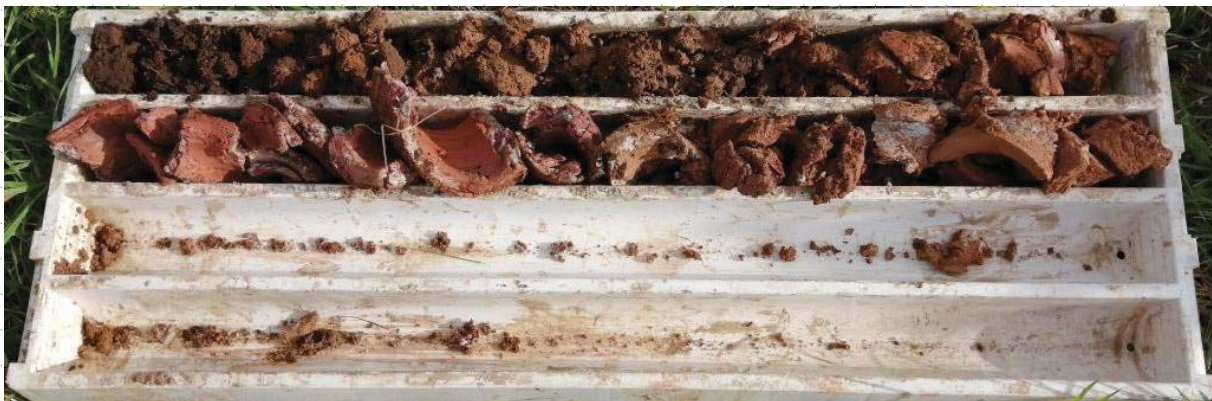
Drilling				Sampling		Field Material Description				
METHOD	PENETRATION RESISTANCE	WATER	DEPTH (metres)	SAMPLE OR FIELD TEST	RECOVERED GRAPHIC LOG	SOIL CLASS	SOIL/ROCK MATERIAL DESCRIPTION	MOISTURE CONDITION	CONSISTENCY DENSITY	STRUCTURE AND ADDITIONAL OBSERVATIONS
ADV	F		0.0		[SM Symbol]	SM	TOPSOIL: Silty SAND, fine to coarse grained, dark brown, 10-20% non-plastic fines, with organics	D - M	VL	
			0.5			SM	Silty SAND: fine to coarse grained, orange-brown, 10-20% non-plastic to low plasticity fines, trace gravel		L - MD	
	1.0			[CI Symbol]	CI	Sandy CLAY: medium plasticity, orange, 40-50% fine to coarse grained sand	F - St			
	1.5				CH	CLAY: high plasticity, red mottled grey, with sand	D			
F-H		2.0				Hole terminated at 2.00 m Target depth Groundwater not encountered

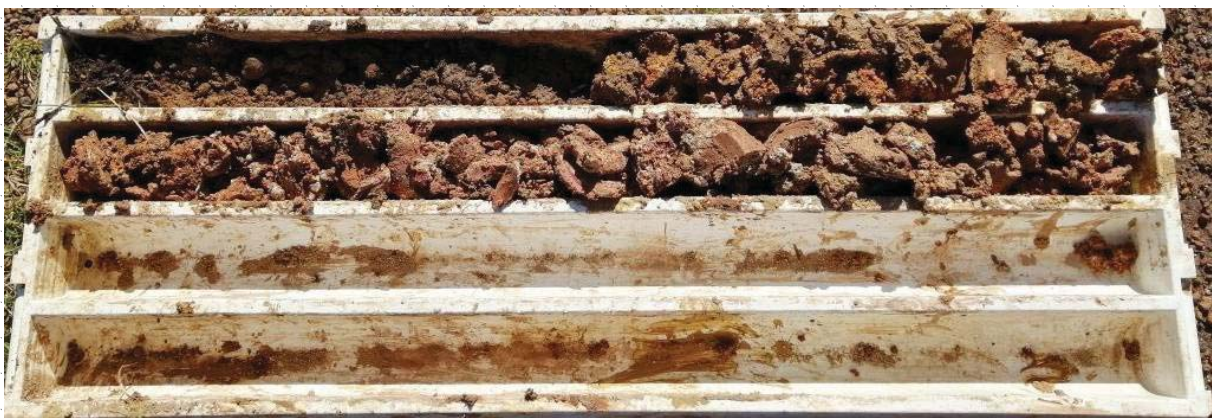
Drilling				Sampling		Field Material Description				
METHOD	PENETRATION RESISTANCE	WATER	DEPTH (metres)	SAMPLE OR FIELD TEST	RECOVERED GRAPHIC LOG	SOIL CLASS	SOIL/ROCK MATERIAL DESCRIPTION	MOISTURE CONDITION	CONSISTENCY DENSITY	STRUCTURE AND ADDITIONAL OBSERVATIONS
ADV	E	▲	0.0			SM	TOPSOIL: SAND, fine to coarse grained, sub-angular to sub-rounded, black, with organics, with fines			Perched groundwater
				B(BH11-01)		GP	Sandy GRAVEL: fine to coarse grained lateritic gravel, sub-angular to sub-rounded, brown, 30-40% fine to coarse grained sand, with fines	W	MD	
			0.5		B(BH11-02)		CI	Sandy CLAY: high plasticity, orange-brown, 50-60% fine to coarse grained sand, trace gravel		F - St
			1.0		B(BH11-03)		CH	High plasticity, 30-40% fine to coarse grained sand, trace gravel		M
			2.0				Hole terminated at 2.00 m Target depth Groundwater encountered at 0.5 m

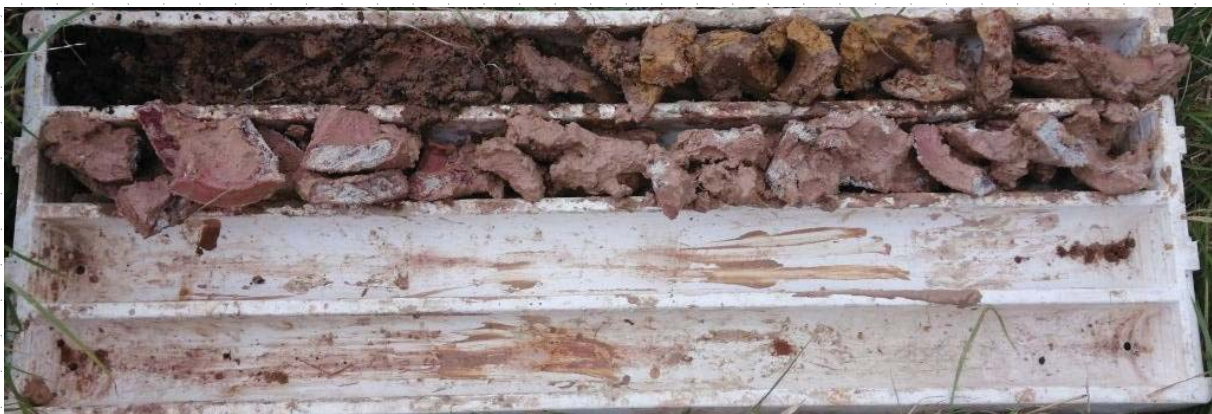
Drilling				Sampling		Field Material Description				
METHOD	PENETRATION RESISTANCE	WATER	DEPTH (metres)	SAMPLE OR FIELD TEST	RECOVERED GRAPHIC LOG	SOIL CLASS	SOIL/ROCK MATERIAL DESCRIPTION	MOISTURE CONDITION	CONSISTENCY DENSITY	STRUCTURE AND ADDITIONAL OBSERVATIONS
ADV	E	▲	0.0		[Symbol]	SP-SM	TOPSOIL: Silty SAND/SAND, fine to coarse grained, dark brown, 5-15% non-plastic to low plasticity fines, with organics	M	VL-L	Perched groundwater
			0.2			SP-SM	Silty SAND/SAND: fine to coarse grained, orange brown, 5-15% non-plastic to low plasticity fines	M-W		
	0.5		[Symbol]	CI	Sandy CLAY: medium to high plasticity, orange brown, 40-50% fine to coarse grained sand	Vst				
	1.0			CH	High plasticity, grey mottled red		D-M			
F		2.0								
Hole terminated at 2.00 m Target depth Groundwater encountered at 0.4 m

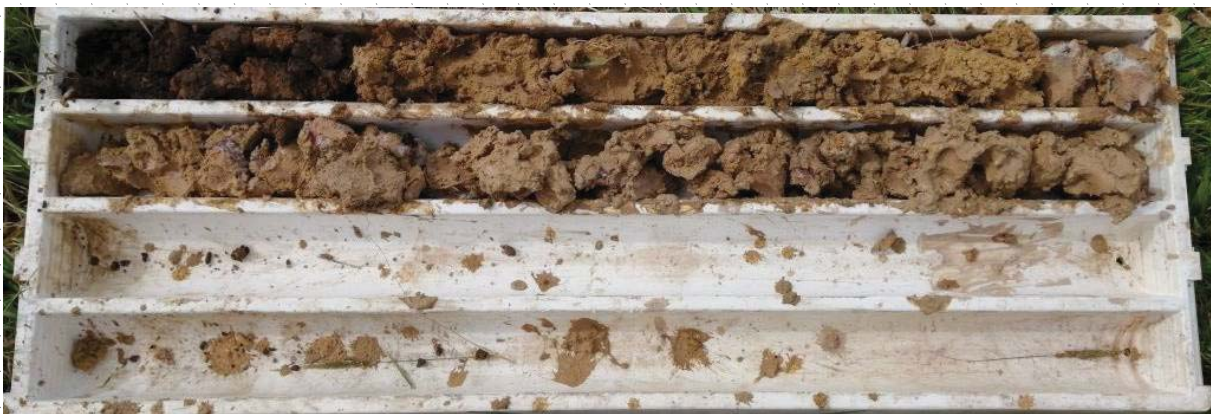
CH	Sandy CLAY: high plasticity, grey mottled red, 45-55% fine to coarse grained sand	M				
	1.5										
			2.0				Hole terminated at 2.00 m Target depth Groundwater encountered at 1 m

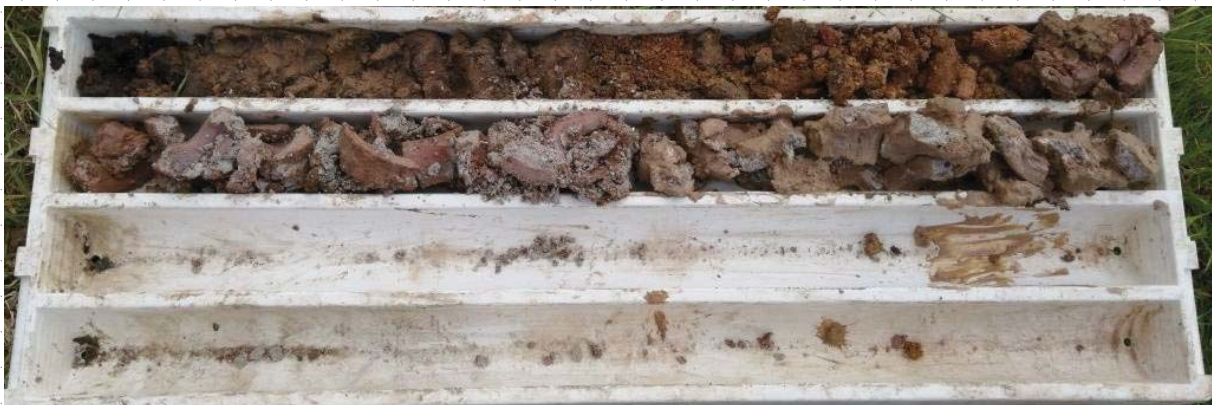
Drilling			Sampling		Field Material Description							
METHOD	PENETRATION RESISTANCE	WATER	DEPTH (metres)	DEPTH RL	SAMPLE OR FIELD TEST	RECOVERED GRAPHIC LOG	SOIL CLASS	SOIL/ROCK MATERIAL DESCRIPTION	MOISTURE CONDITION	CONSISTENCY	DENSITY	STRUCTURE AND ADDITIONAL OBSERVATIONS
ADV	E	▲	0.0				SP	TOPSOIL: SAND, fine to coarse grained, dark brown, with fines, with organics	M	L		Perched groundwater
						SP	SAND: fine to coarse grained, brown, with fines	W				
	E-F	0.5				SC	Clayey SAND: fine to coarse grained, orange brown mottled red, 15-30% medium plasticity fines		D			
		1.0		B(BH14-01)		CH	Sandy CLAY: high plasticity, grey mottled red, 40% fine to coarse grained sand, trace gravel		St			
F			1.5							D - M		
			2.0					Hole terminated at 2.00 m Target depth Groundwater encountered at 0.2 m

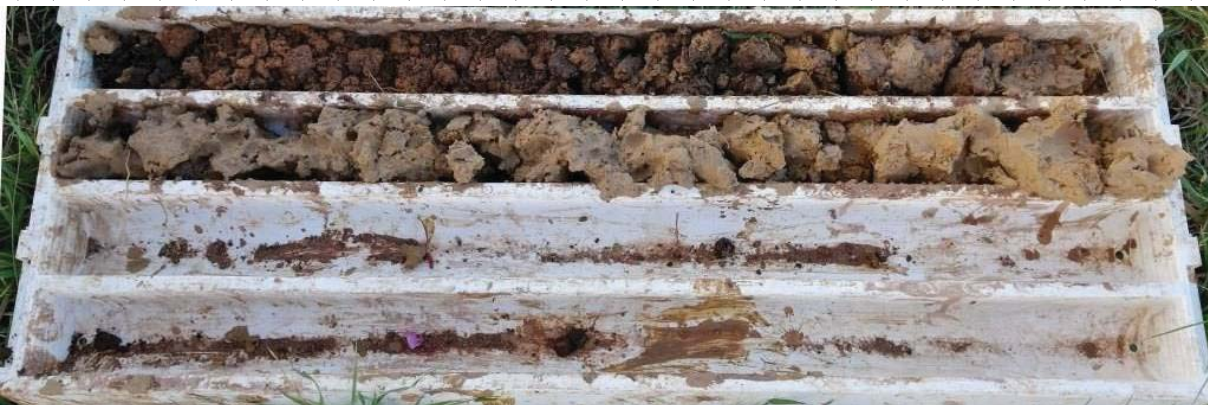
Drilling				Sampling		Field Material Description					
METHOD	PENETRATION RESISTANCE	WATER	DEPTH (metres)	SAMPLE OR FIELD TEST	RECOVERED GRAPHIC LOG	SOIL CLASS	SOIL/ROCK MATERIAL DESCRIPTION	MOISTURE CONDITION	CONSISTENCY	DENSITY	STRUCTURE AND ADDITIONAL OBSERVATIONS
			0.0			SM	TOPSOIL: Silty SAND, fine to coarse grained, pale brown, 10-15% non-plastic fines, with organics				
			0.5			SC	Clayey SAND: fine to coarse grained, orange brown, 15-30% low plasticity fines		M	L	
			1.0				Medium plasticity fines				
			1.5			CI	Sandy CLAY: high plasticity, orange brown, 50% fine to coarse grained sand, trace gravel			W	
			2.0				Hole terminated at 2.00 m Target depth Groundwater encountered at 0.9 m

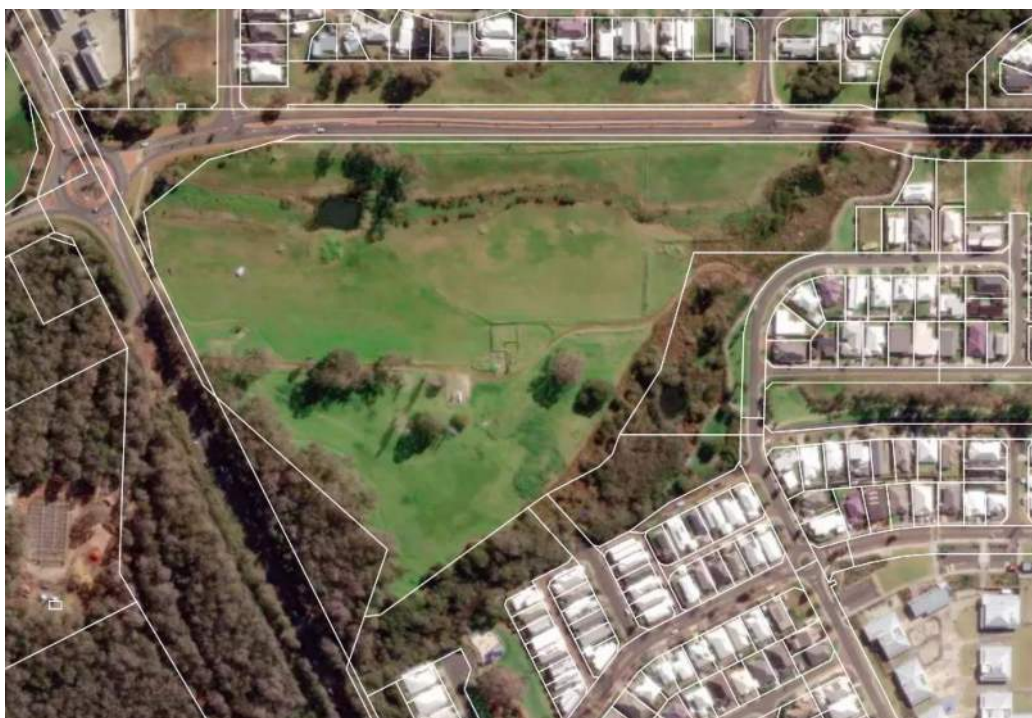
Figure 1- MetroMap Aerial Image Capture

A drainage channel also exists within the northern portion of the site which accepts flows from a culvert at the intersection of the Bussell Hwy and John Archibald Drive and flows to the east to join the drainage channel to the south of the site before.

There is a large gas storage tank (Kleenheat Gas) located approximately in the centre of the site and associated buried pipelines to Rapids Landing Avenue.

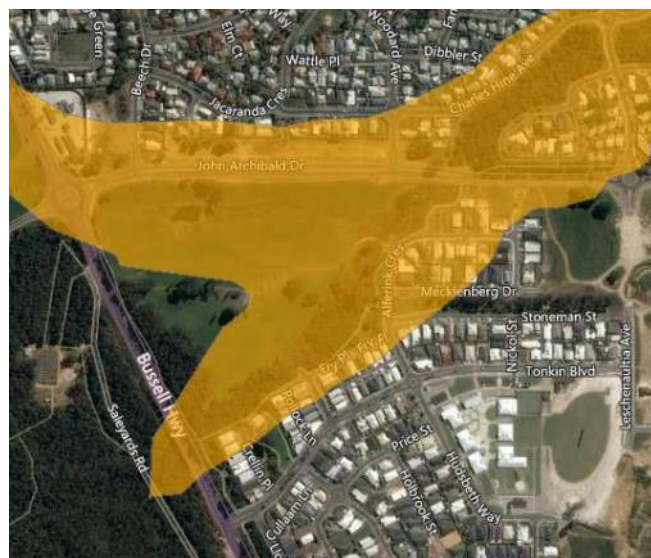
Figure 2- Slip Locate Acid Sulphate Soil Risk (Low to Medium)

A review of the available information from Landgate's SLIP Portal indicates that the subject Site has a low to medium risk (class 2) of acid sulphate soils associated with the Darch Brook to the south of the site and Darch Brook tributary within the north of the site (Figure 2)

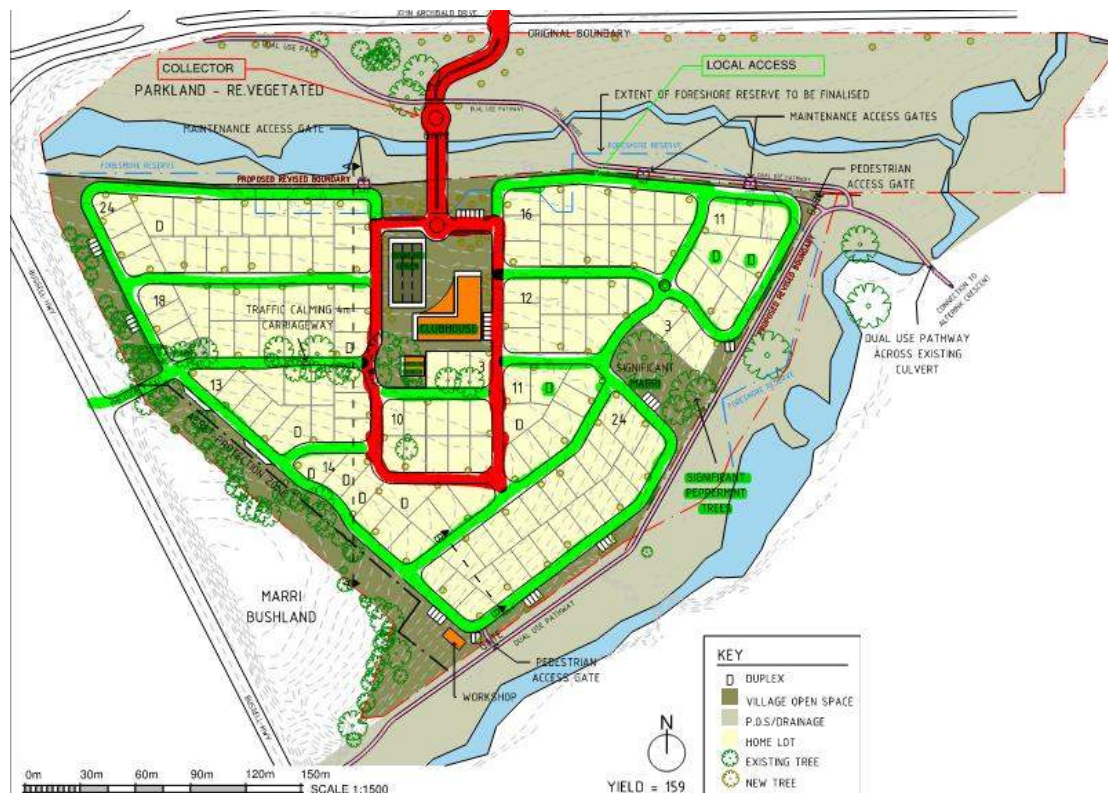
Figure 4- Road Classification

It is expected all road pavements will typically be a minimum 5.5- 6m wide sealed pavement surface for two-way roads in private developments. The speed limit is expected to be 8 km/hr. Figure 4 shows a preliminary road hierarchy based on expected traffic volumes. Table 1 details the required pavement thicknesses based on a subgrade CBR of 5%. Reductions of pavement layer thicknesses are possible where the in-situ subgrade is lime stabilised to a minimum of 300mm depth. Refer to Appendix 2 for further details.
