RAPIDS LANDING LIFESTYLE COMMUNITY STRUCTURE PLAN

**Lot 9014 John Archibald Drive, Margaret
River**

Project Contact: Glenn Ahola
Project Job Code: 00100
Identification No: AUGU/2021/____ - 1
Date: 30 January 2024

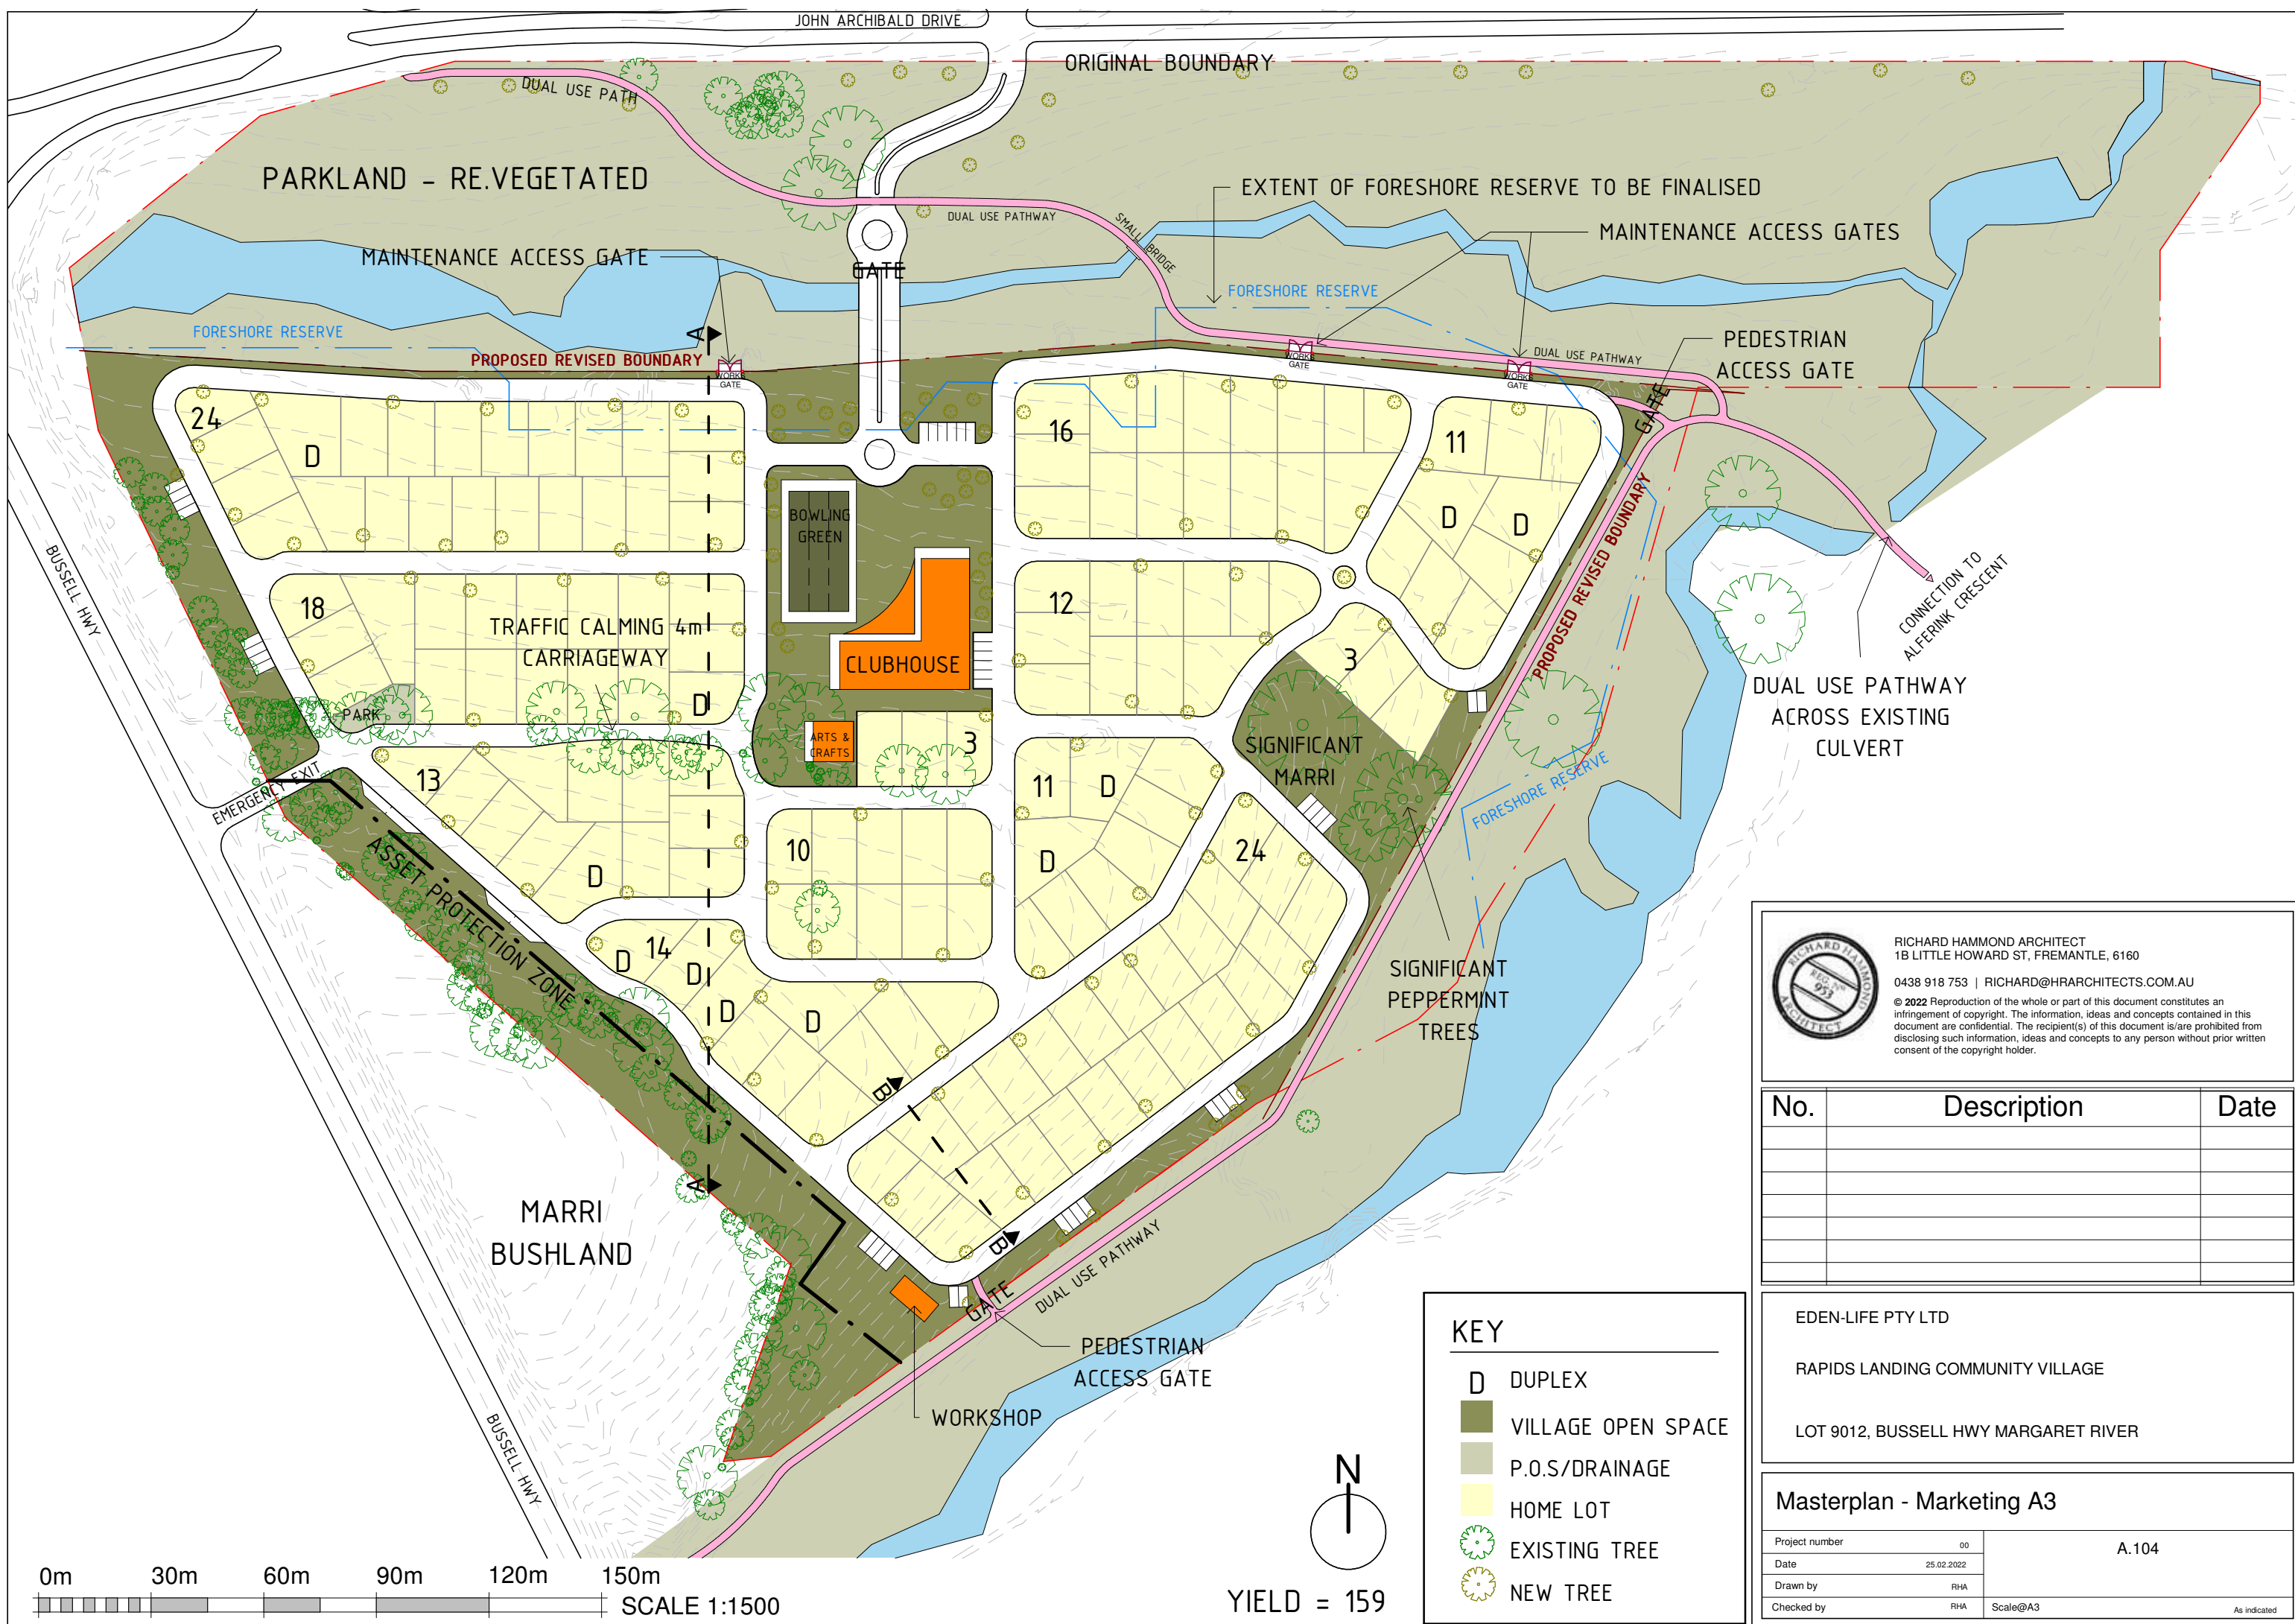
11. APPENDIX 1 – MASTER PLAN AND TYPICAL SECTIONS

YIELD = 159

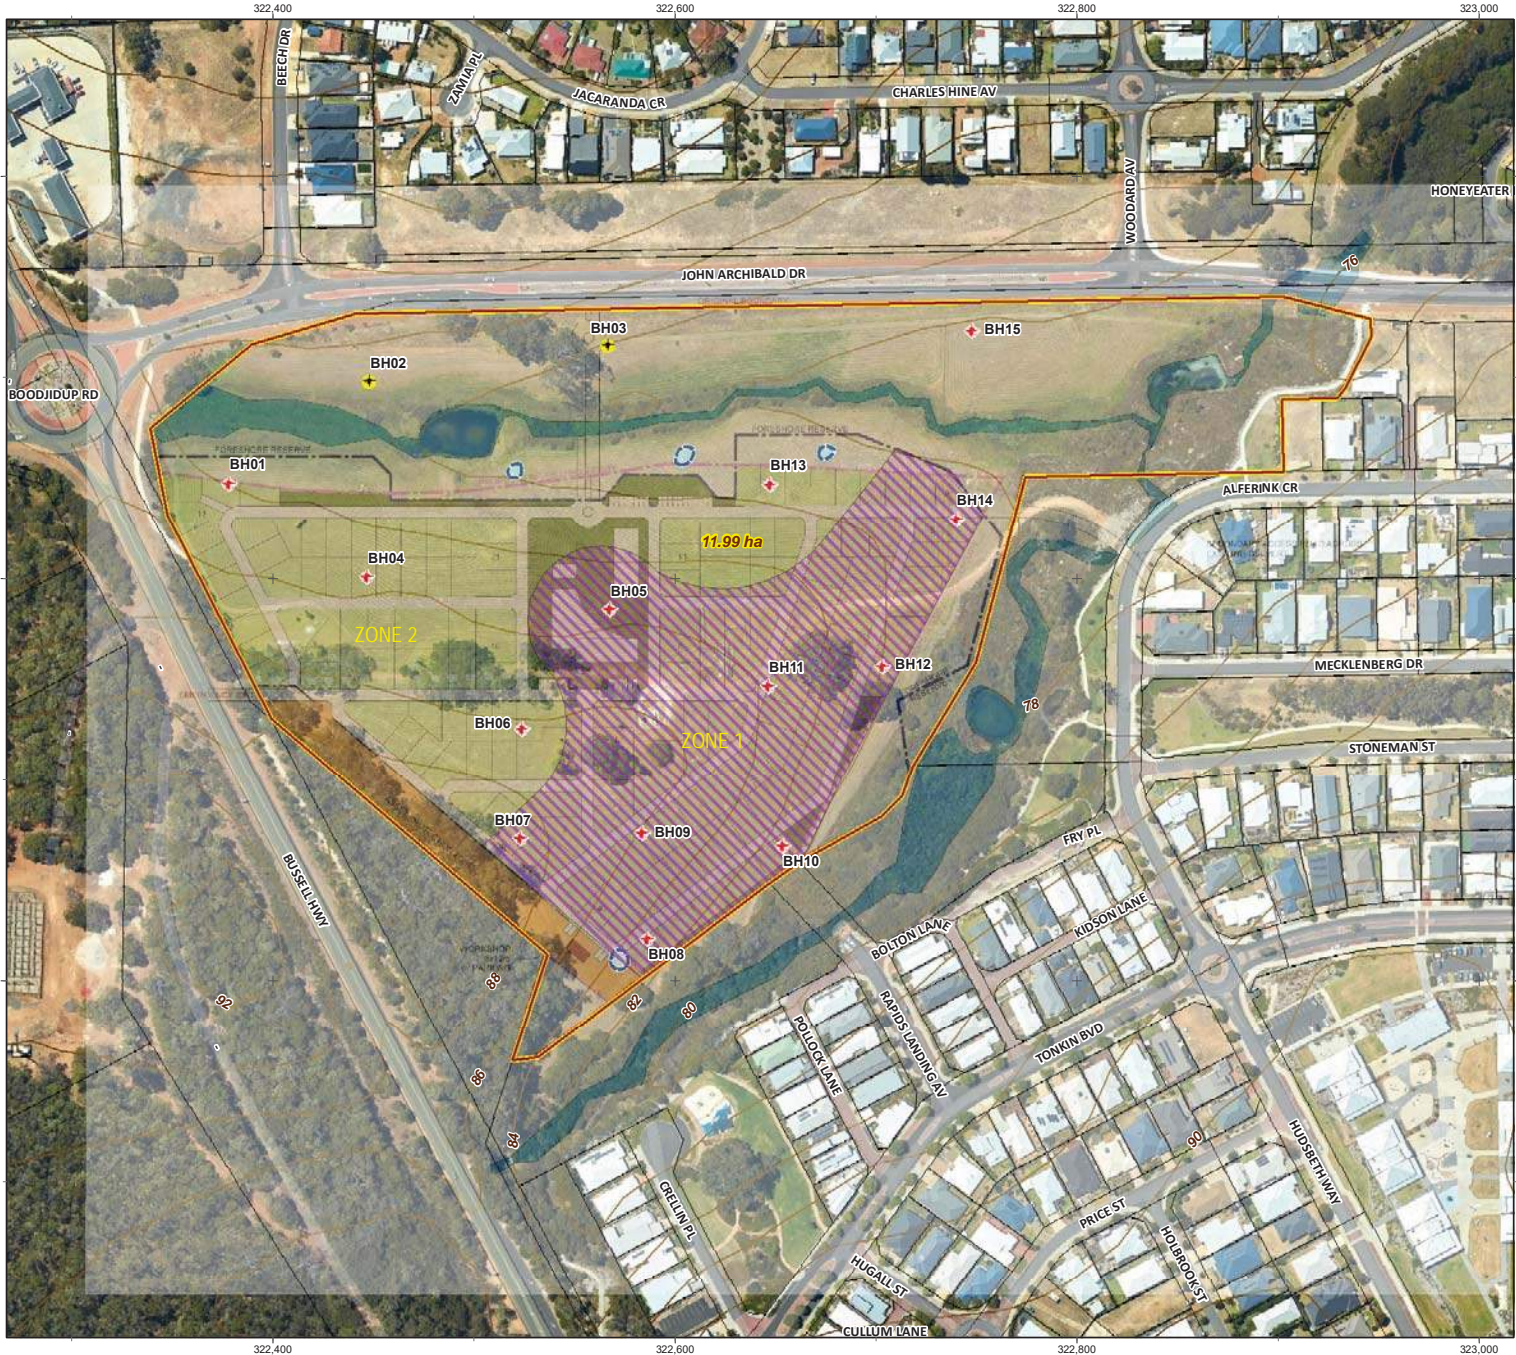
Figures

- Legend**
- Site Boundary
 - Stockpiles of loose rock boulders
 - 0.4 - 0.7m SAND/GRAVEL overlying clayey strata
 - + Borehole
 - + Borehole not augered due to access constraints

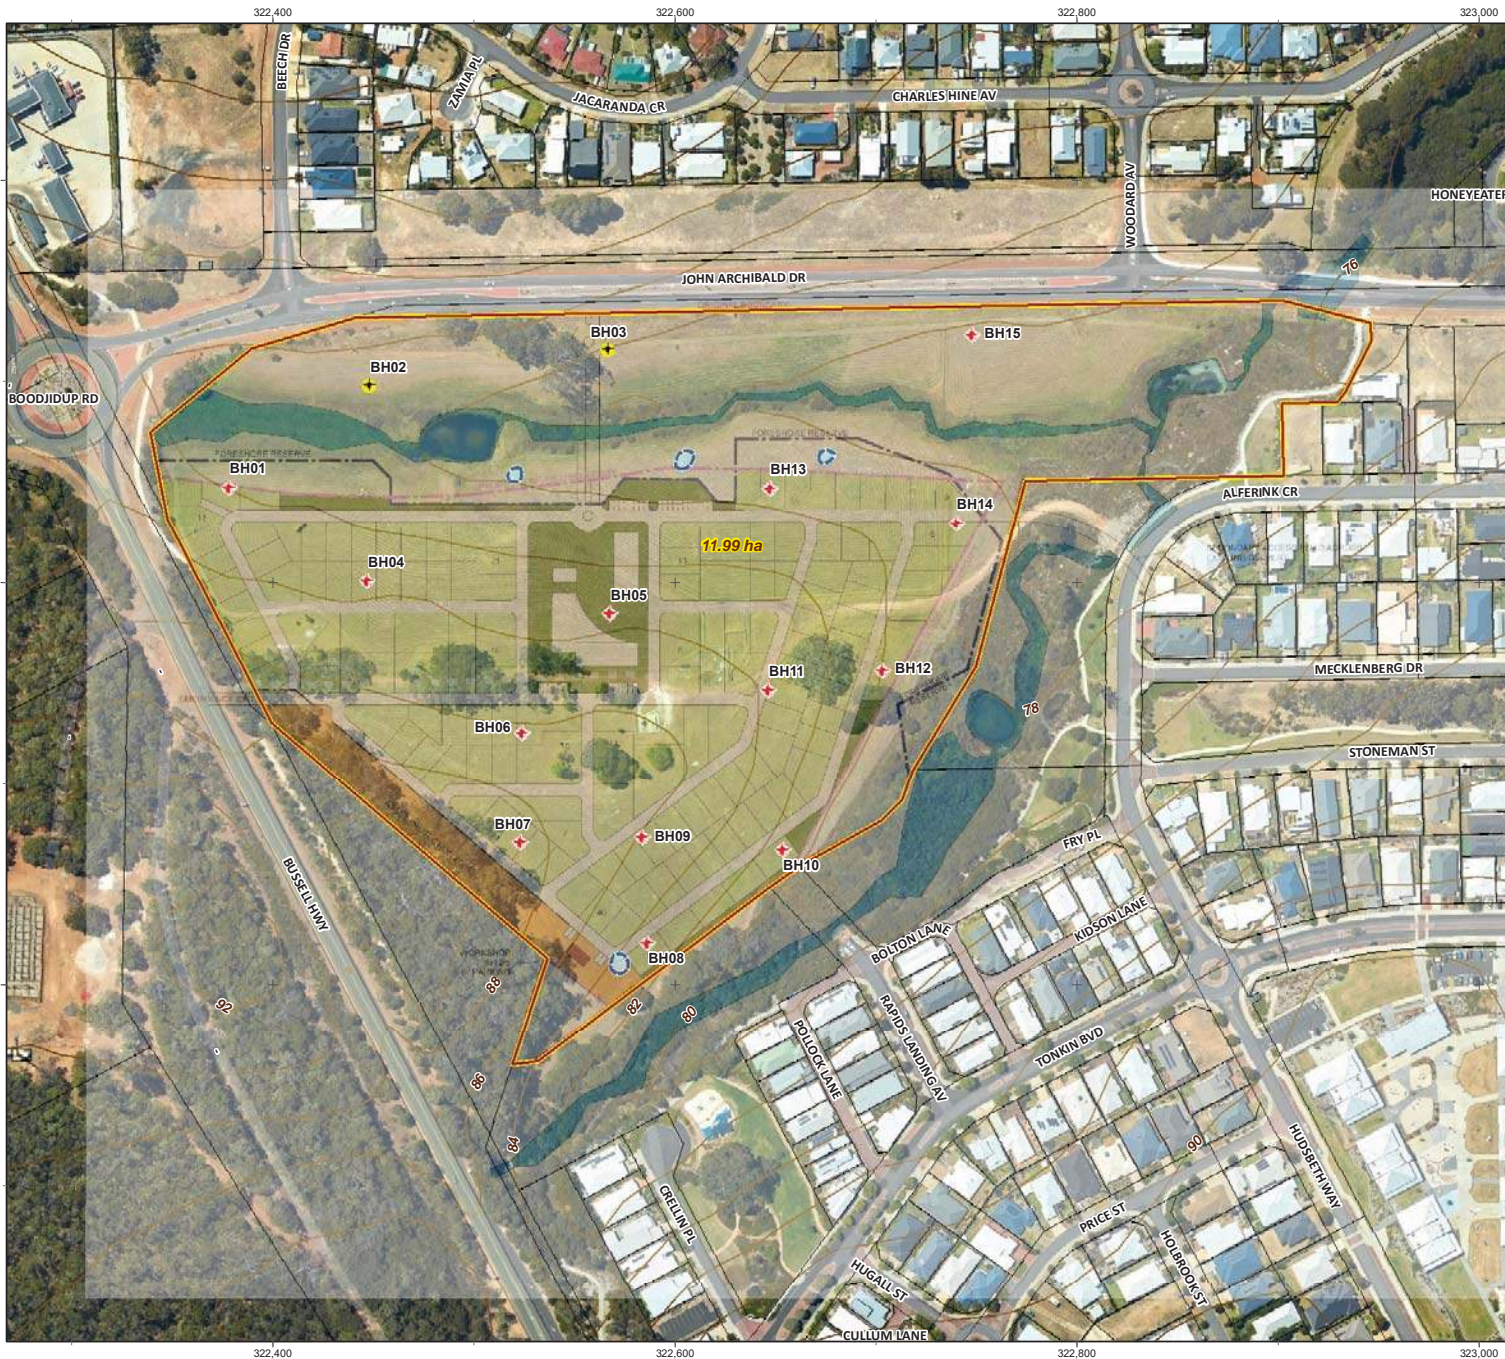
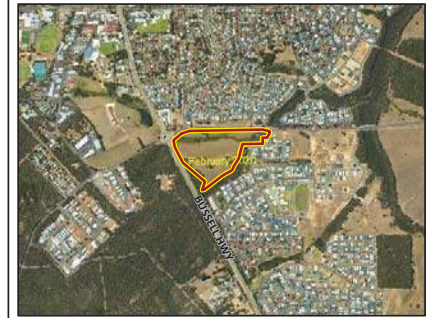
CLIENT	MCDOWALL AFFLECK PTY LTD		
PROJECT	EDENLIFE - MARGARET VILLAGE		
LOCATION	LOTS 280, 3002 & 3010 BUSSELL HIGHWAY MARGARET RIVER		
TITLE	INDICATIVE SOIL ZONES		
Job No	J2001180	Fig No	FIGURE 2
Rev			A

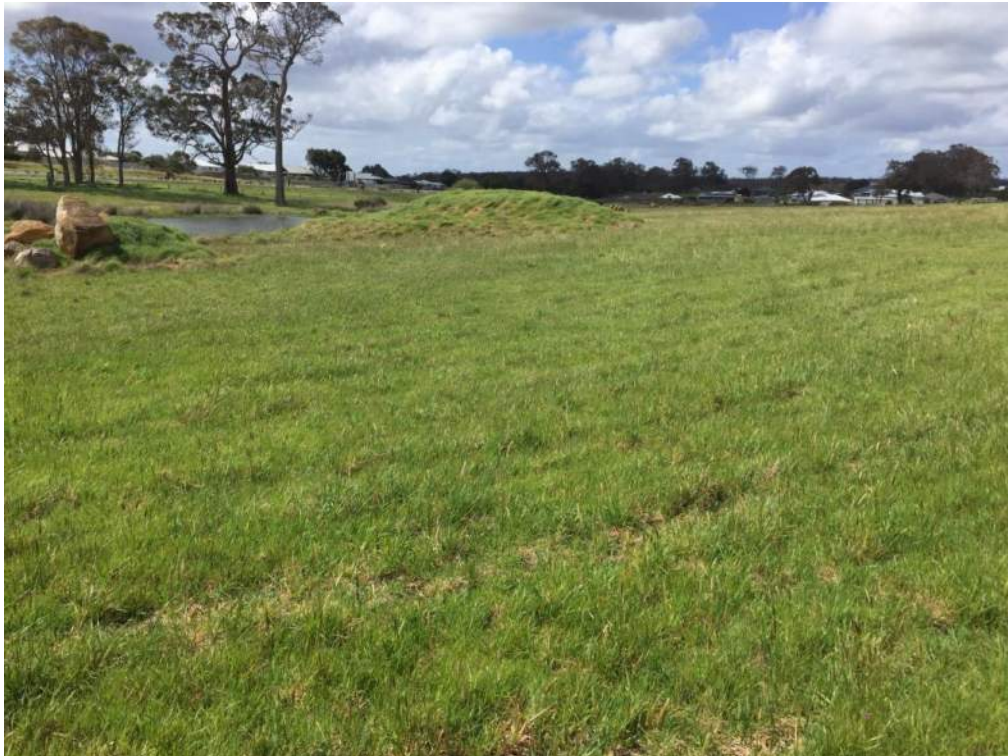
Photograph 7: Northern part of site along creek

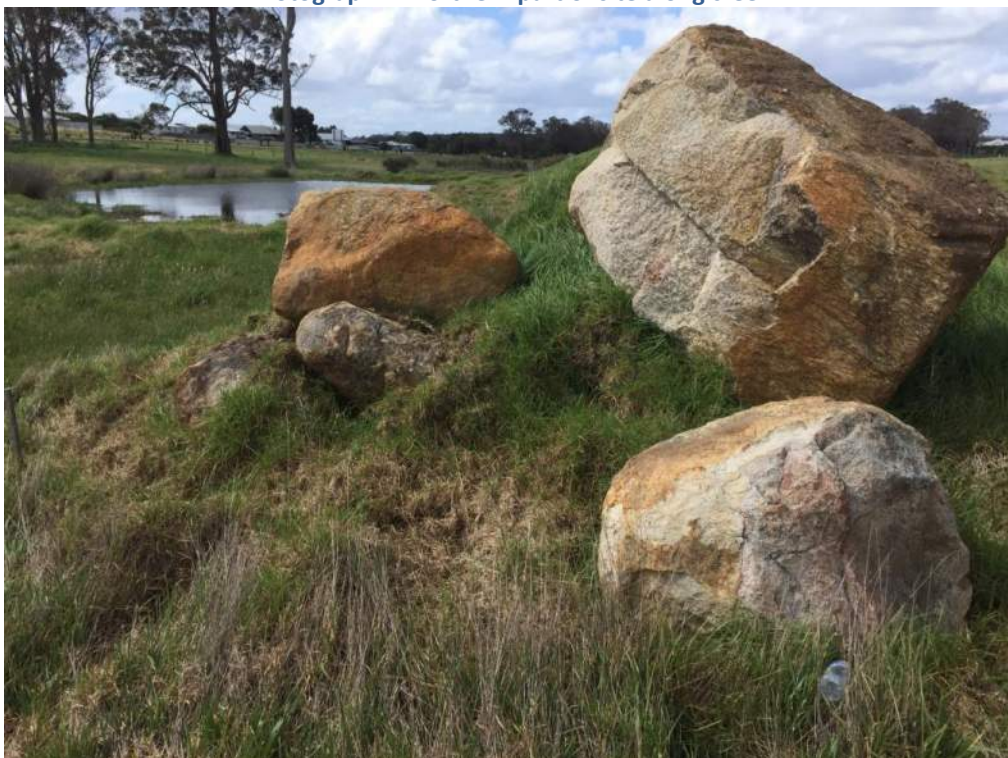
Photograph 8: Typical rock stockpiles on southern side of creek

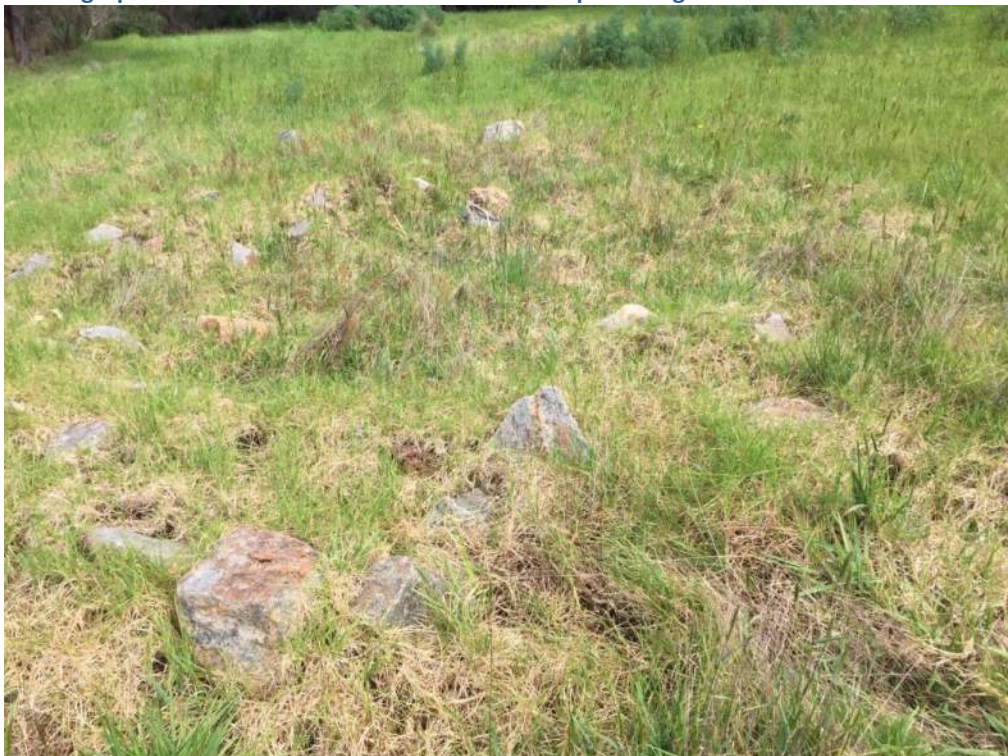
Photograph 9: Soft surface conditions and shallow perched groundwater in middle of site

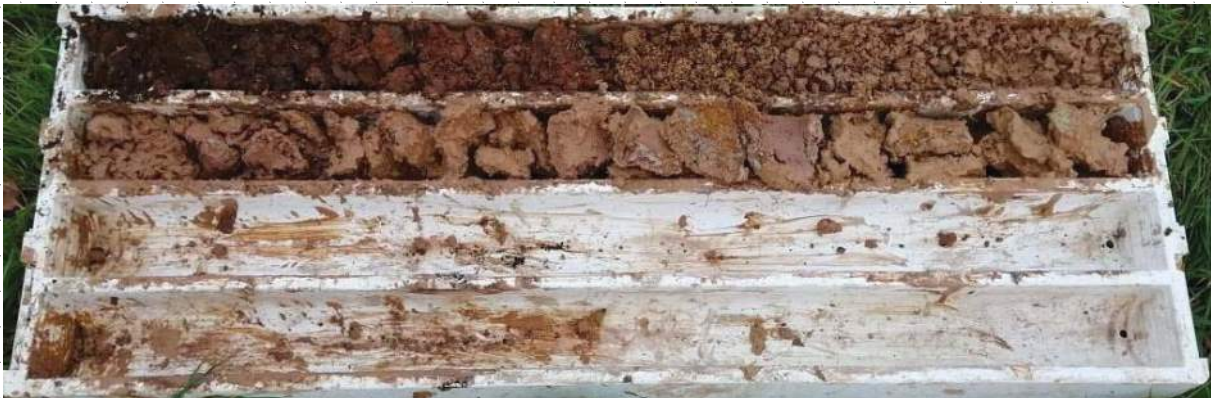
Drilling				Sampling		Field Material Description				
METHOD	PENETRATION RESISTANCE	WATER	DEPTH (metres)	SAMPLE OR FIELD TEST	RECOVERED GRAPHIC LOG	SOIL CLASS	SOIL/ROCK MATERIAL DESCRIPTION	MOISTURE CONDITION	CONSISTENCY DENSITY	STRUCTURE AND ADDITIONAL OBSERVATIONS
			0.0			SM	TOPSOIL: Silty SAND, fine to coarse grained, dark brown, 10-20% non-plastic fines, trace organics			Perched groundwater
	E					SC	Clayey SAND: fine to coarse grained, orange-brown, 25-35% medium plasticity fines	M	L - MD	
			0.5			SP	Gravelly SAND: fine to coarse grained, orange-brown, 30-40% fine to coarse grained gravel, with fines	W	D - VD	
			1.0			CI	Sandy CLAY: medium to high plasticity, grey mottled brown, 40-60% fine to coarse grained sand, trace gravel		D - M	
			2.0				Hole terminated at 2.00 m Target depth Groundwater encountered at 0.9 m

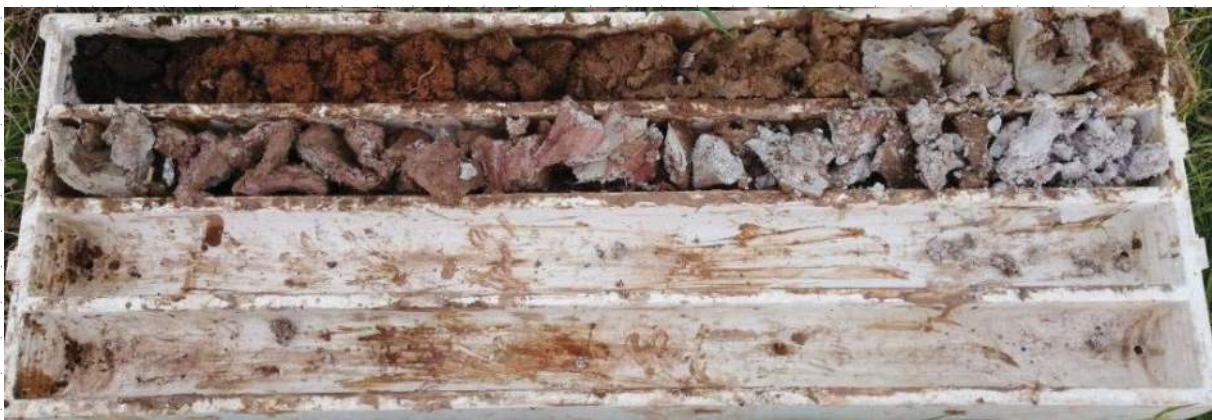
Drilling				Sampling		Field Material Description					
METHOD	PENETRATION RESISTANCE	WATER	DEPTH (metres)	SAMPLE OR FIELD TEST	RECOVERED GRAPHIC LOG	SOIL CLASS	SOIL/ROCK MATERIAL DESCRIPTION	MOISTURE CONDITION	CONSISTENCY	DENSITY	STRUCTURE AND ADDITIONAL OBSERVATIONS
			0.0			SM	TOPSOIL: Silty SAND, fine to coarse grained, dark brown, 10-20% non-plastic fines, with organics				Perched groundwater
				B(BH04-1)		SC	Clayey SAND: fine to coarse grained, orange-brown, 15-30% medium plasticity fines, trace gravel	M	VL - L		
			0.5				With gravel	W	D		
			1.0				Sandy CLAY: high plasticity, grey mottled red, 40-50% fine to coarse grained sand		St		
			1.5			CH	Becoming medium plasticity, grey, with silt fines				
			2.0				Hole terminated at 2.00 m Target depth Groundwater encountered at 0.5 m

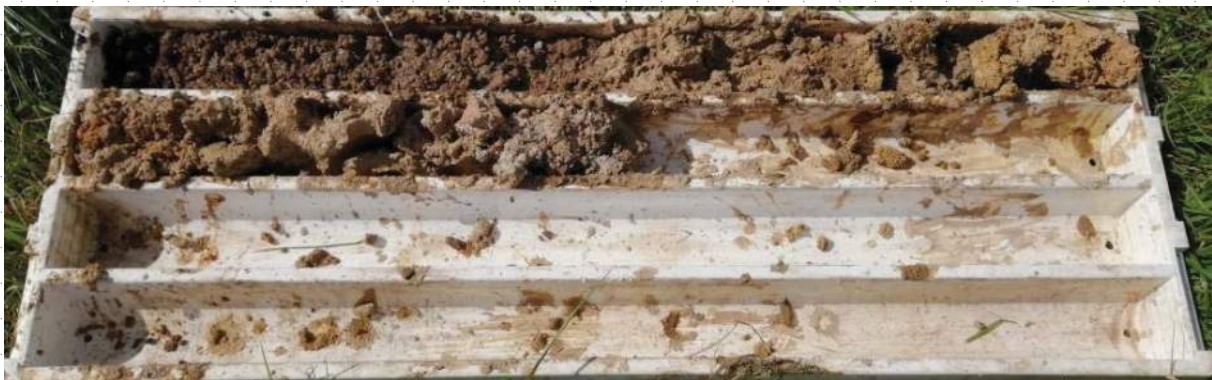
2.0				Hole terminated at 1.50 m Refusal on stiff clay Groundwater encountered at 0.3 m

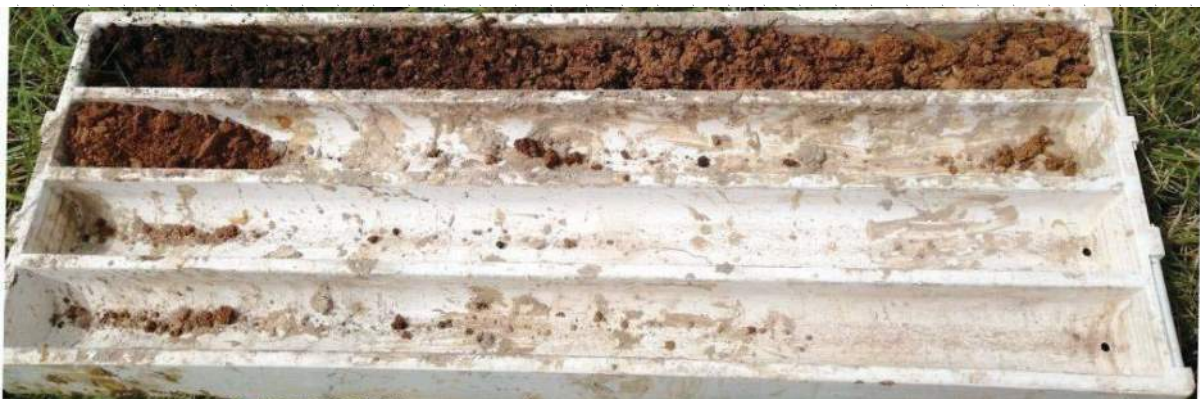
Drilling				Sampling		Field Material Description					
METHOD	PENETRATION RESISTANCE	WATER	DEPTH (metres)	SAMPLE OR FIELD TEST	RECOVERED GRAPHIC LOG	SOIL CLASS	SOIL/ROCK MATERIAL DESCRIPTION	MOISTURE CONDITION	CONSISTENCY	DENSITY	STRUCTURE AND ADDITIONAL OBSERVATIONS
ADV	E		0.0			SC	TOPSOIL: Clayey SAND, fine to coarse grained, dark brown, 10-15% low plasticity fines, with organics	D-M	L		
			0.5		SC	Clayey SAND: fine to coarse grained, orange brown, 15-25% low to medium plasticity fines, with gravel					
			1.0		F-H		CI	Sandy CLAY: medium plasticity, orange-brown, 50-60% fine to coarse grained sand, trace gravel	D	VSt	
			1.5				Hole terminated at 1.10 m Refusal on very stiff clay Groundwater not encountered				
			2.0

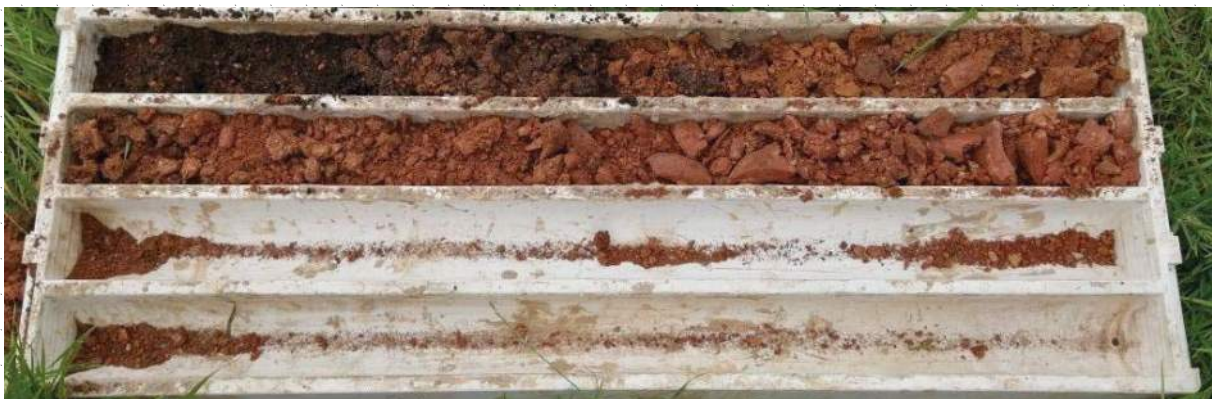
Drilling				Sampling		Field Material Description				
METHOD	PENETRATION RESISTANCE	WATER	DEPTH (metres)	SAMPLE OR FIELD TEST	RECOVERED GRAPHIC LOG	SOIL CLASS	SOIL/ROCK MATERIAL DESCRIPTION	MOISTURE CONDITION	CONSISTENCY DENSITY	STRUCTURE AND ADDITIONAL OBSERVATIONS
			0.0			SM	TOPSOIL: Silty SAND, fine to coarse grained, dark brown, 10-20% non-plastic fines, with organics		L	
	E					SP	Gravelly SAND: fine to coarse grained, orange brown, 30-40% fine to medium grained, lateritic gravel, with fines	D - M	MD	
	F		0.5			CI	Sandy CLAY: medium to high plasticity, orange brown, 40-50% fine to coarse grained sand		VSt	
ADV			1.0			CH	High plasticity		D	
	F-H		1.5							
			2.0				Hole terminated at 2.00 m Target depth Groundwater not encountered

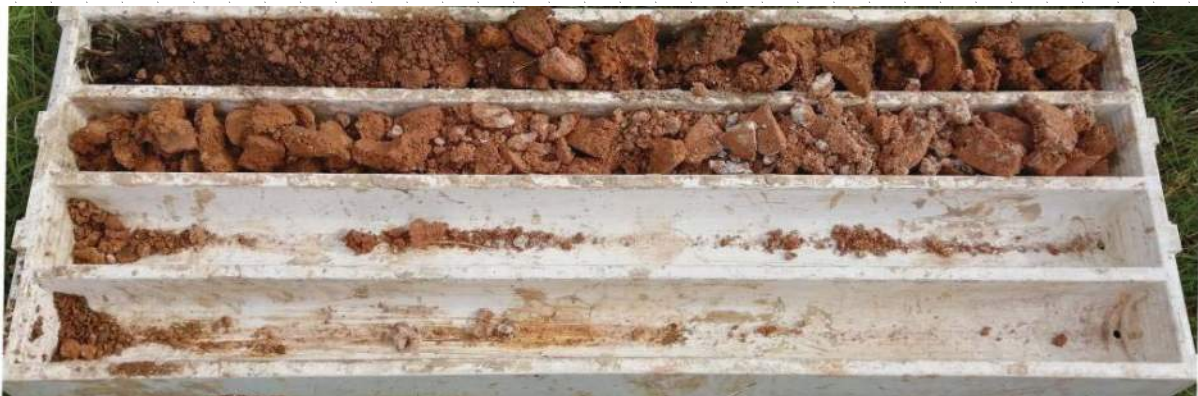
CH	High plasticity, grey mottled red				
		2.0					Hole terminated at 2.00 m Target depth Groundwater not encountered

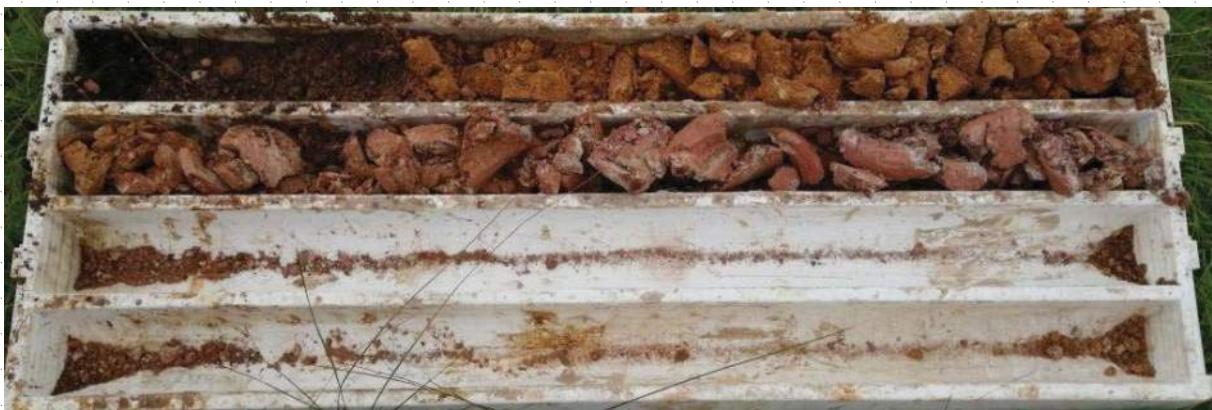
Drilling				Sampling		Field Material Description				
METHOD	PENETRATION RESISTANCE	WATER	DEPTH (metres)	SAMPLE OR FIELD TEST	RECOVERED GRAPHIC LOG	SOIL CLASS	SOIL/ROCK MATERIAL DESCRIPTION	MOISTURE CONDITION	CONSISTENCY DENSITY	STRUCTURE AND ADDITIONAL OBSERVATIONS
ADV	E		0.0		SM	TOPSOIL: Silty SAND, fine to coarse grained, dark brown, 10-15% non-plastic fines, with organics	D - M	L - MD		
					SP	Gravelly SAND: fine to coarse grained, brown, 35-45% fine to medium grained, lateritic gravel, with fines				
	0.5		B(BH09-01)	CI	Sandy CLAY: medium plasticity, orange brown, 40-50% fine to coarse grained sand	St				
					CLAY: high plasticity, red mottled grey, with sand	VSt	D			
	F		1.0							
	F-H		1.5	B(BH09-02)	CH					
			2.0				Hole terminated at 2.00 m Target depth Groundwater not encountered

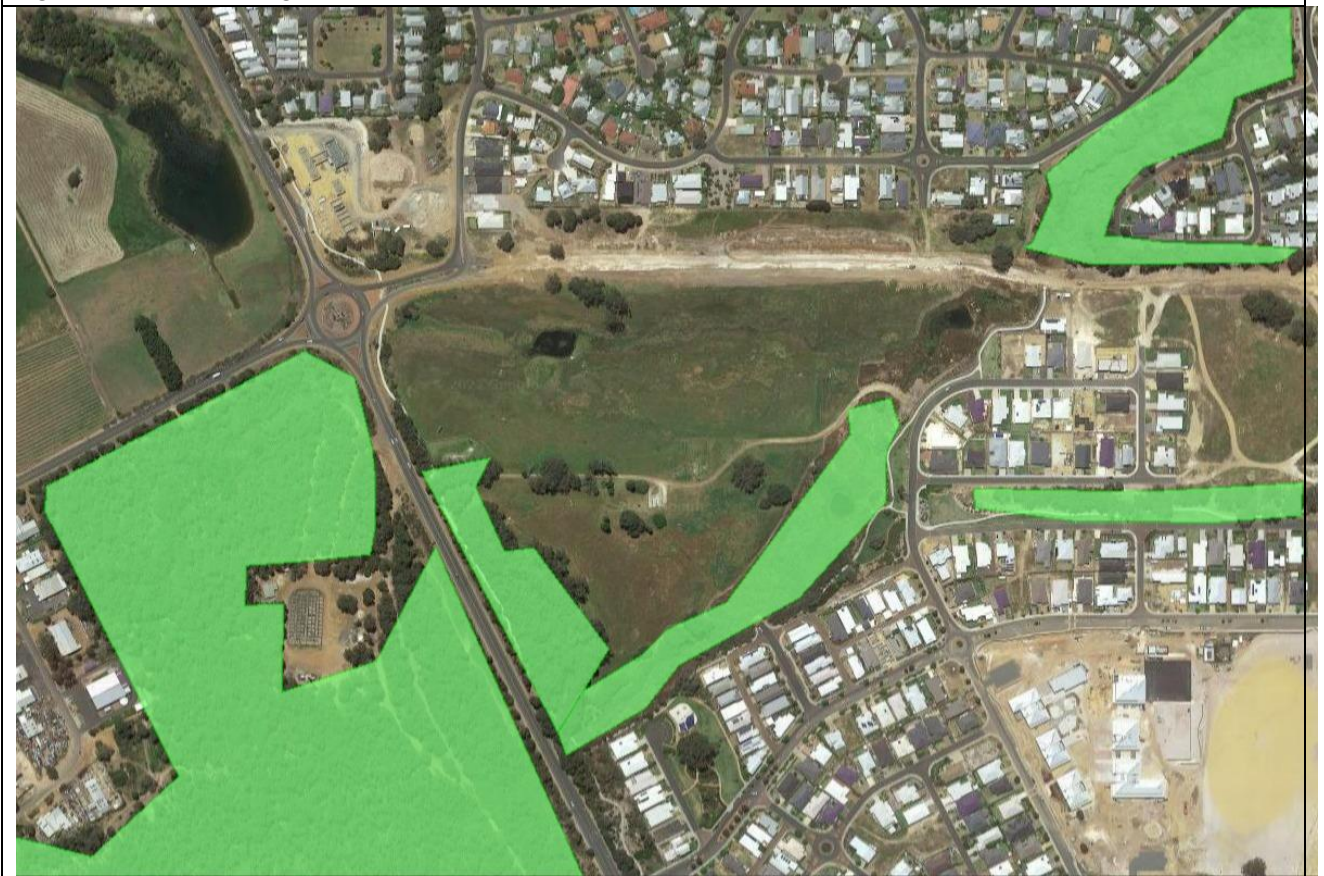
Figure 3A: Native Vegetation Extent (DPIRD-005)

The site is within an area designated as Native Vegetation Extent. The data used to undertake this map is been progressively updated by the Department of Agriculture post-NLWRA with assistance the Department of conservation and Land Management.

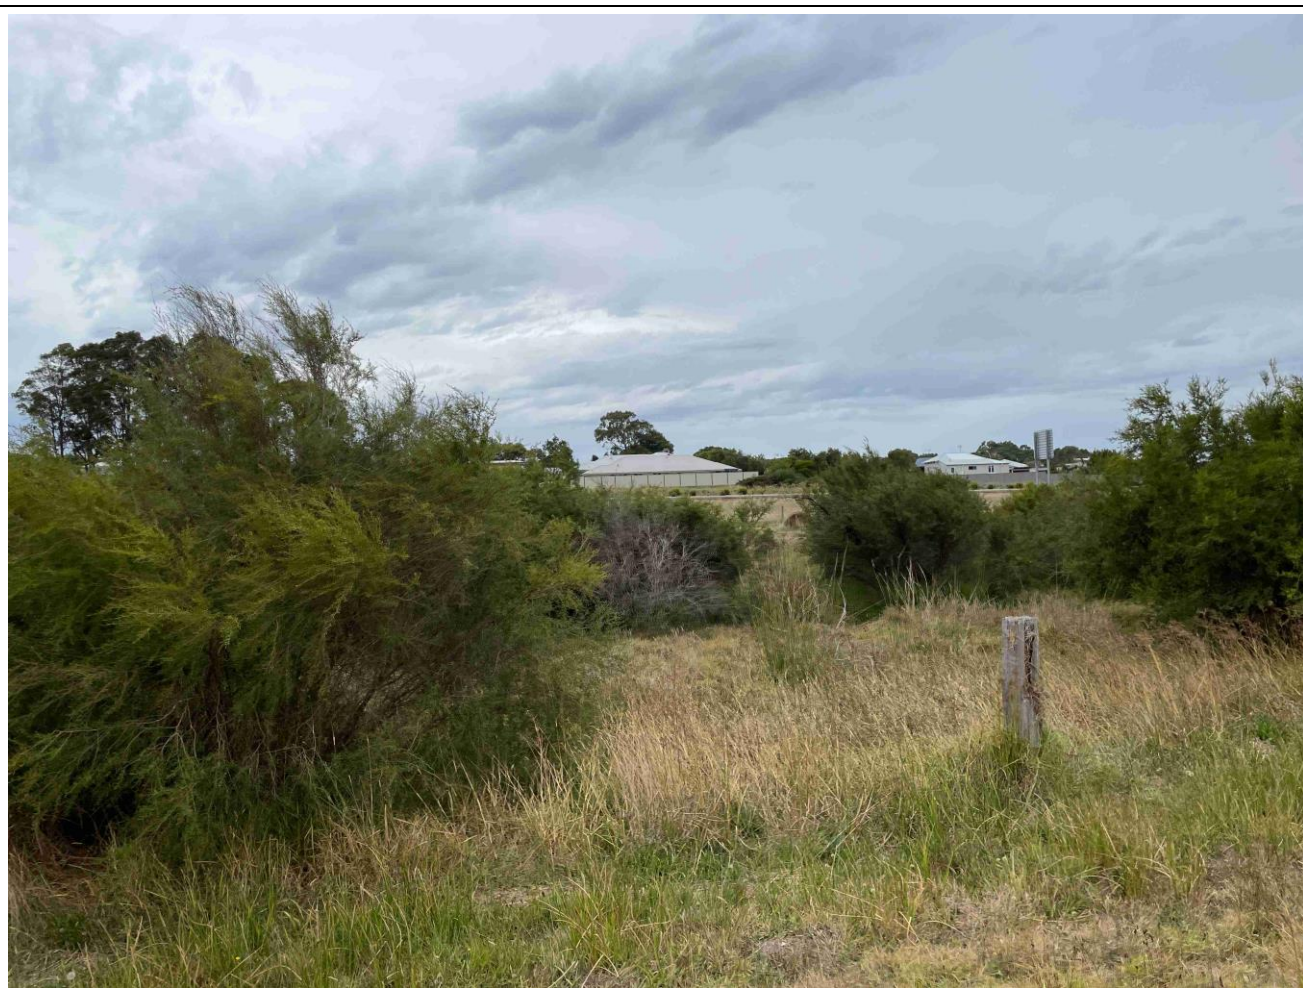
Existing	Class G Grassland
Post Development	Class C Shrubland
Effective Slope	Upslope/0
Photo ID	1a

Class C Shrubland – area to be revegetated to Waterway Revegetation Plan (Nicole Siemon & Associates Pty Ltd) and Landscape Guide Plan (Bill James Landscape Architect)

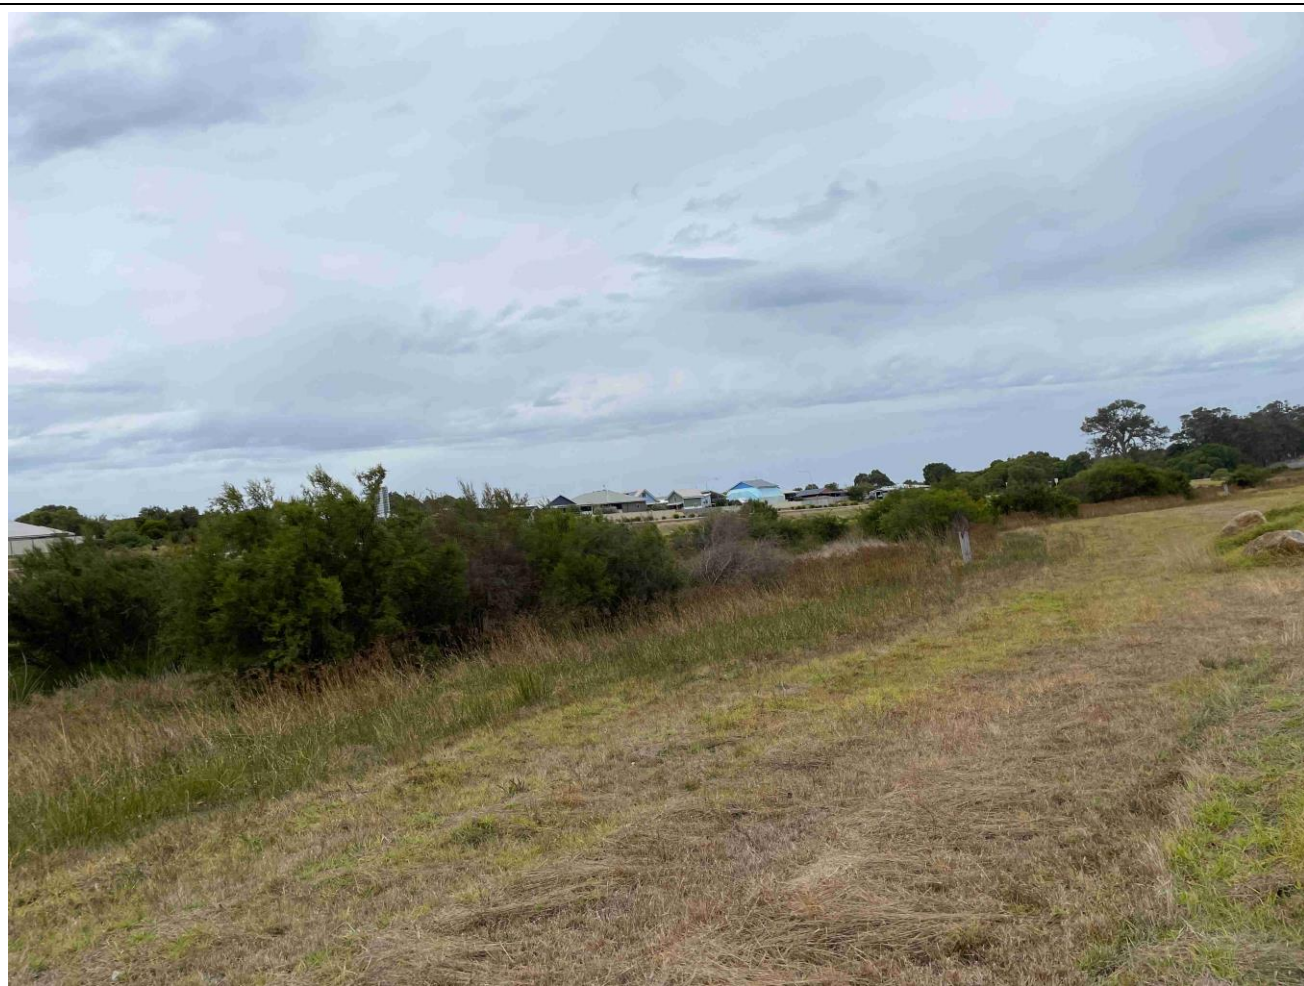
Existing	Class G Grassland
Post Development	Class C Shrubland
Effective Slope	Upslope/0
Photo ID	1b

Class C Shrubland – area to be revegetated to Waterway Revegetation Plan (Nicole Siemon & Associates Pty Ltd) and Landscape Guide Plan (Bill James Landscape Architect)

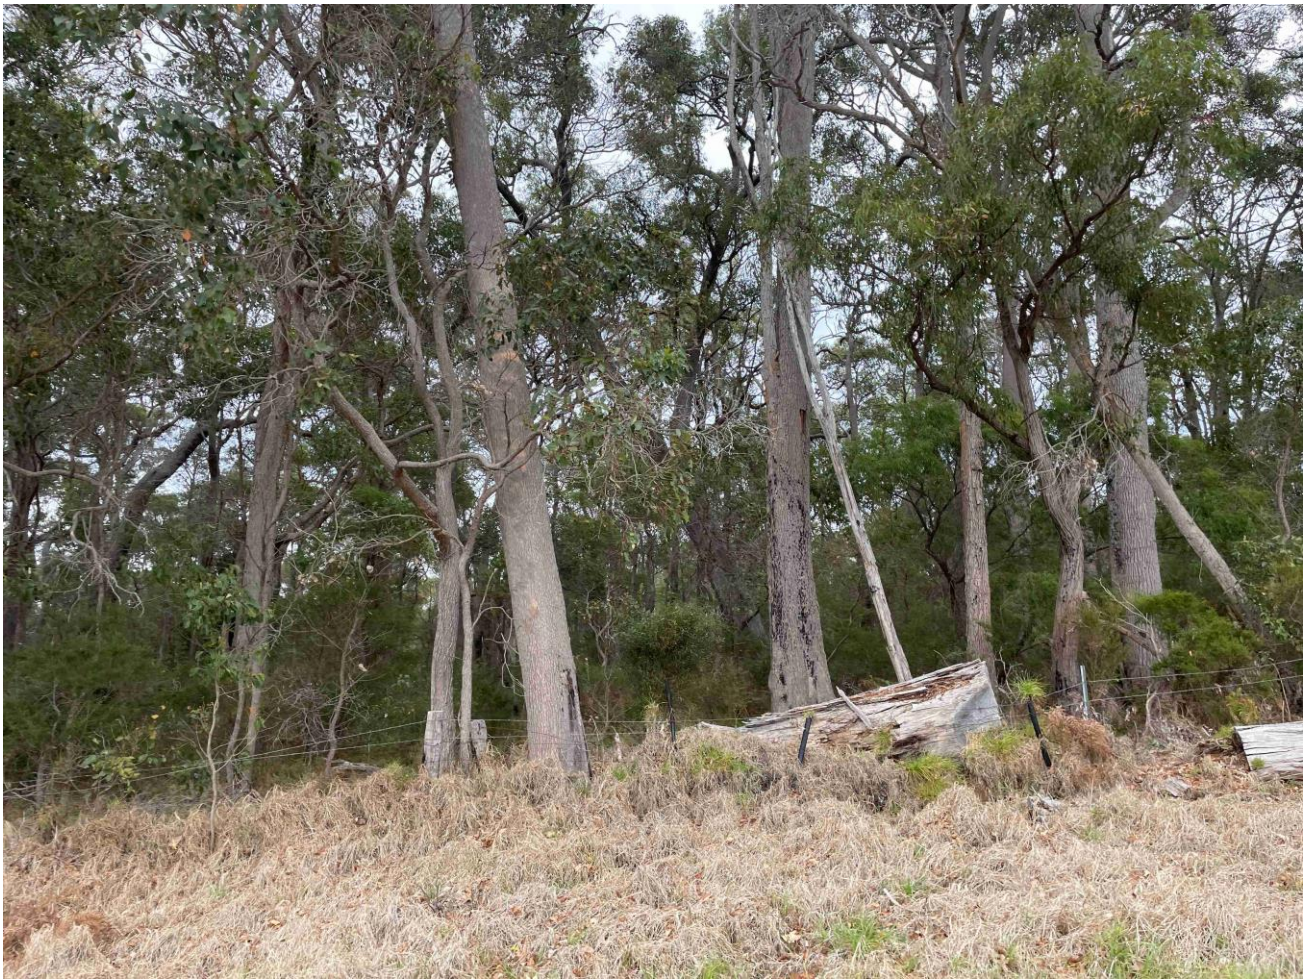
Existing	Class A Forest
Post Development	Class A Forest
Effective Slope	Upslope/0
Photo ID	2a

Trees 10-30 m high; 30-70% foliage cover (may include understorey of sclerophyllous low trees and tall scrubs or grass). Typically dominated by eucalypts.

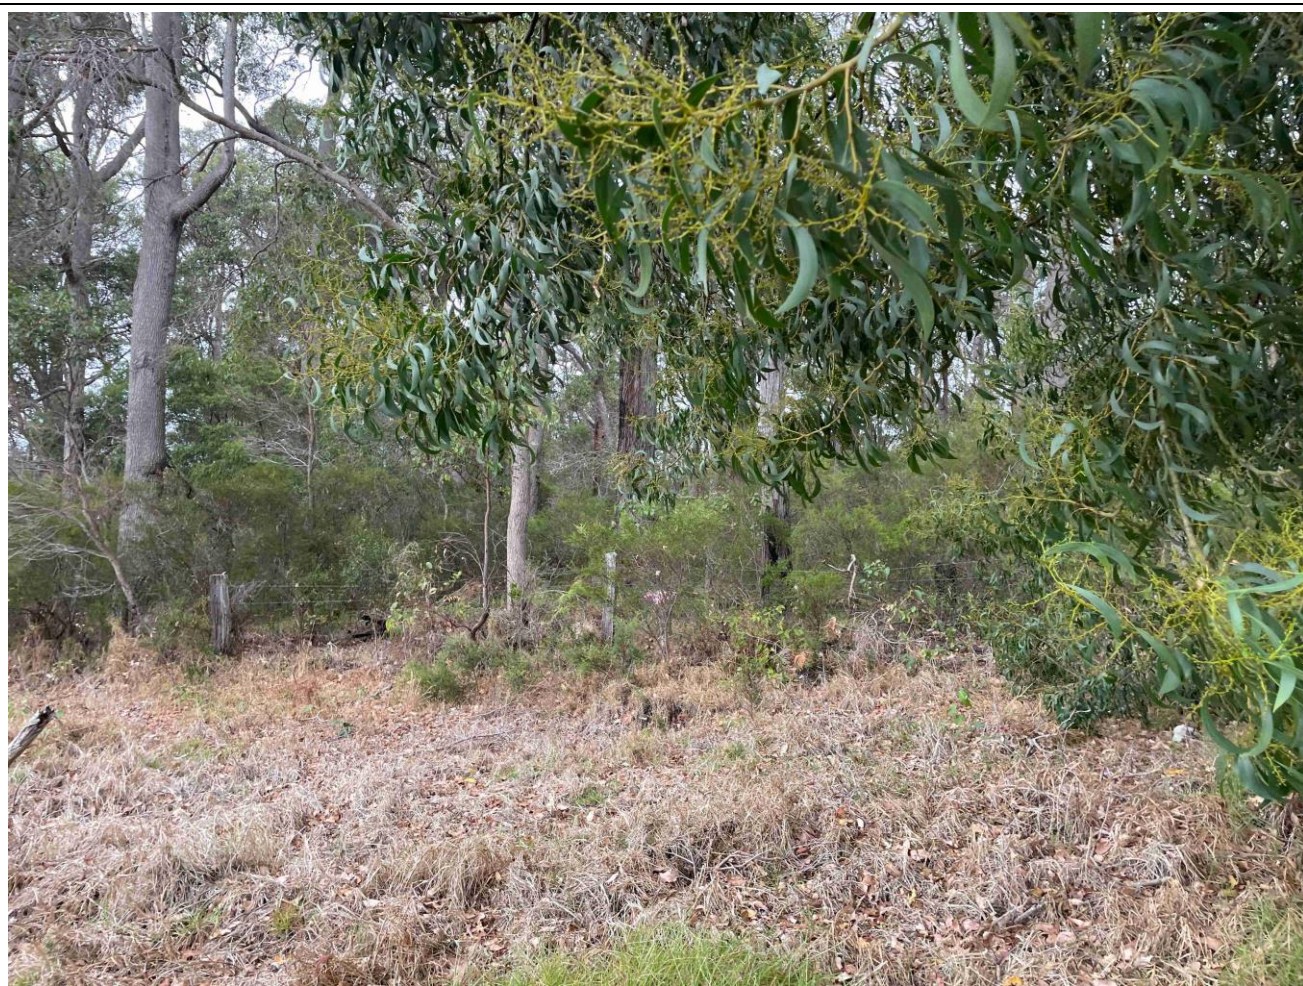
Existing	Class A Forest
Post Development	Class A Forest
Effective Slope	Downslope/4
Photo ID	3a

Trees 10-30 m high; 30-70% foliage cover (may include understorey of sclerophyllous low trees and tall scrubs or grass). Typically dominated by eucalypts.

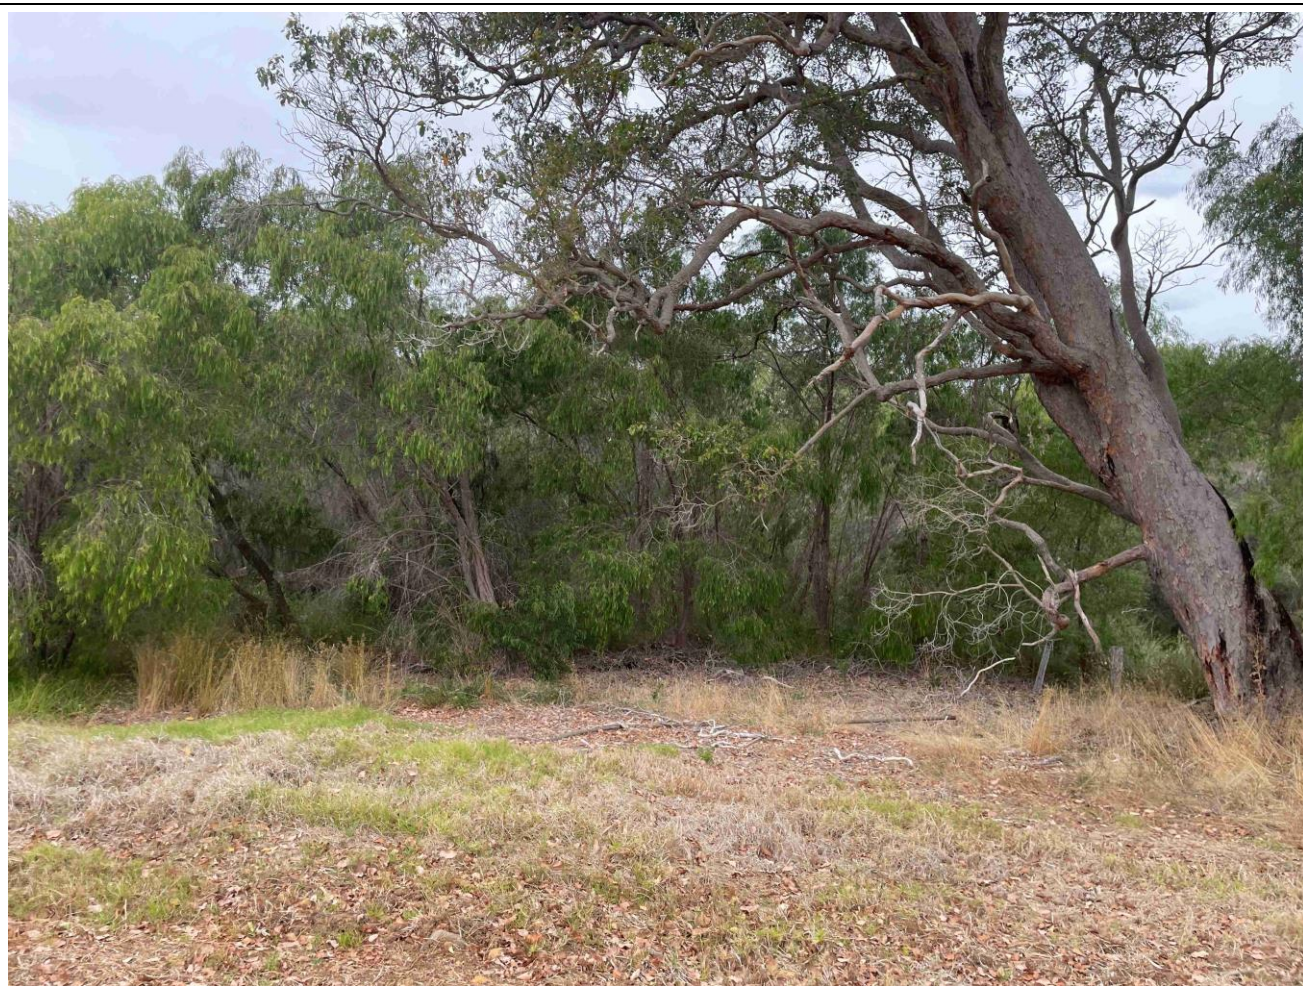
Existing	Class D Scrub
Post Development	Class D Scrub
Effective Slope	Upslope/0
Photo ID	4a

Scrub vegetation typically with continuous horizontal and vertical vegetation structures, greater than 2 metres high.
