RAPIDS LANDING LIFESTYLE COMMUNITY STRUCTURE PLAN

**Lot 9014 John Archibald Drive, Margaret
River**

Project Contact: Glenn Ahola
Project Job Code: 00100
Identification No: AUGU/2021/____ - 1
Date: 30 January 2024

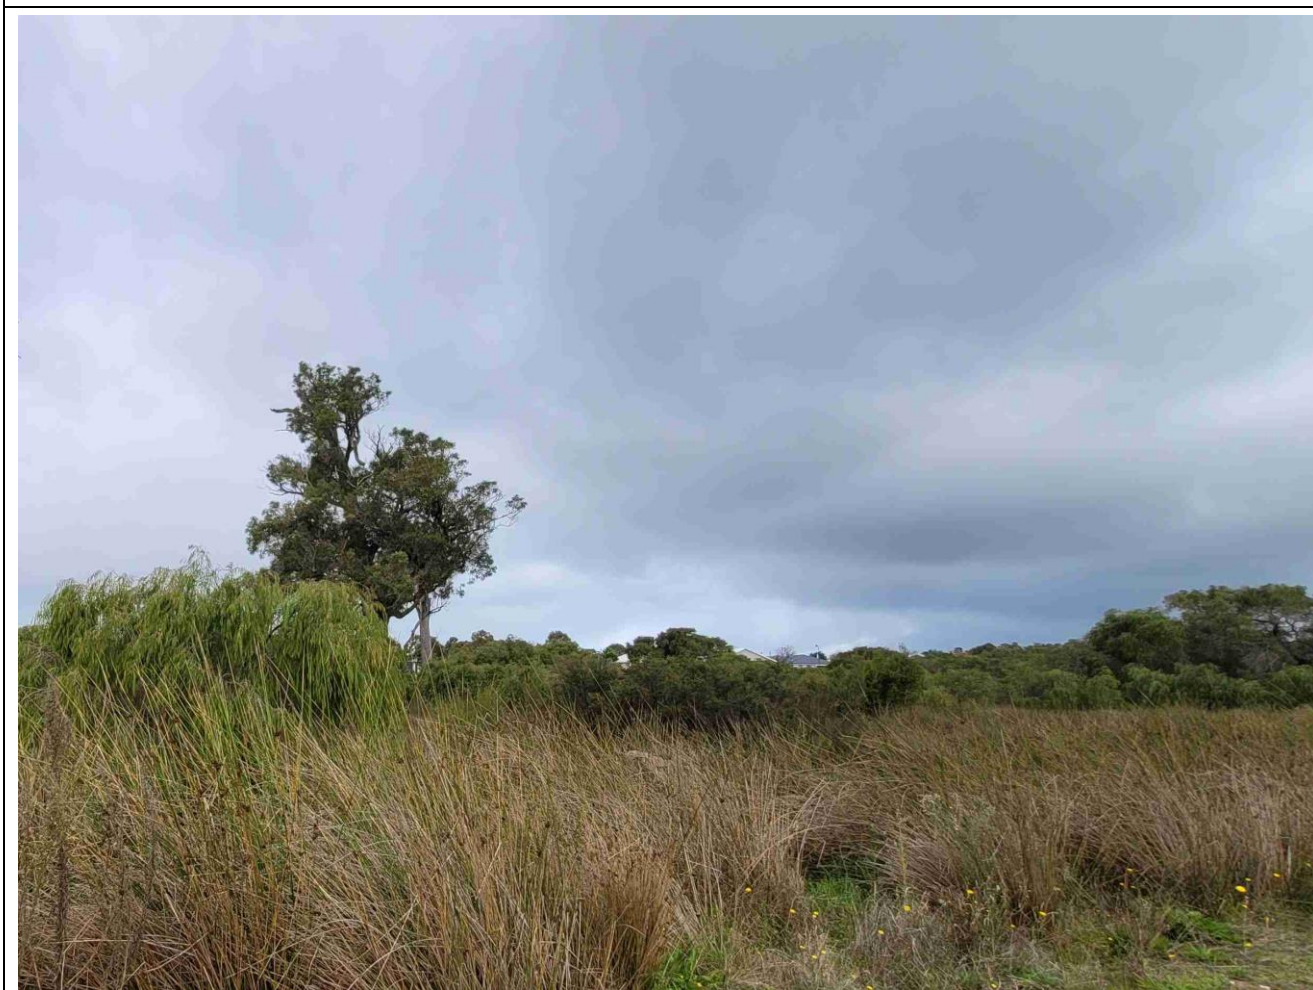
Existing	Class C Shrubland
Post Development	Class C Shrubland
Effective Slope	Upslope/0
Photo ID	5a

Shrubs <2 m high; greater than 30% foliage cover with overstorey tree coverage less than 10%.

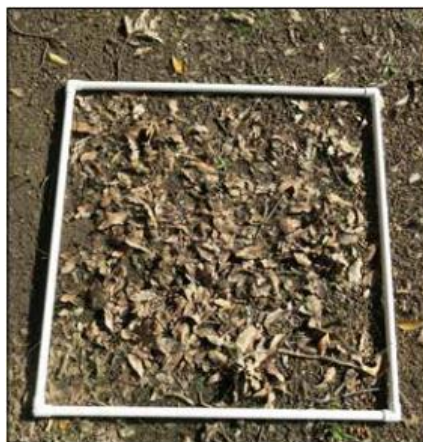
Fine Fuel Load: Should be managed and removed on a regular basis to maintain a low threat state. Should be maintained at <2 tonnes per hectare (on average). Mulches should be non-combustible such as stone, gravel or crushed mineral earth

or wood mulch >6 millimetres in thickness.

Trees (> 6 metres in height): Trunks at maturity should be a minimum distance of six metres from all elevations of the building. Branches at maturity should not touch or overhang a building or powerline. Lower branches and loose bark should be removed to a height of two metres above the ground and/or surface vegetation. Canopy cover within the APZ should be <15 per cent of the total APZ area. Tree canopies at maturity should be at least five metres apart to avoid forming a continuous canopy. Stands of existing mature trees with interlocking canopies may be treated as an individual canopy provided that the total canopy cover within the APZ will not exceed 15 per cent and are not connected to the tree canopy outside the APZ.

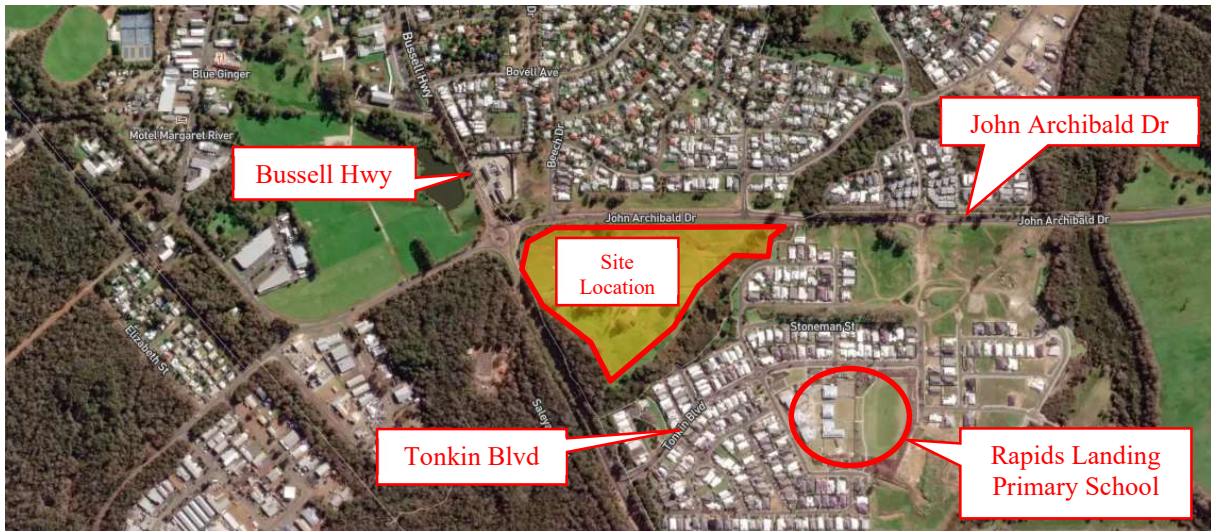
Figure 2.1: General Locality Plan *Source: MetroMap*

The development site is located east of Bussell Highway, just south of John Archibald Drive, in Margaret River. The general locality is shown in **Figure 2.1**, with the site location shown in more detail in **Figure 2.2**.

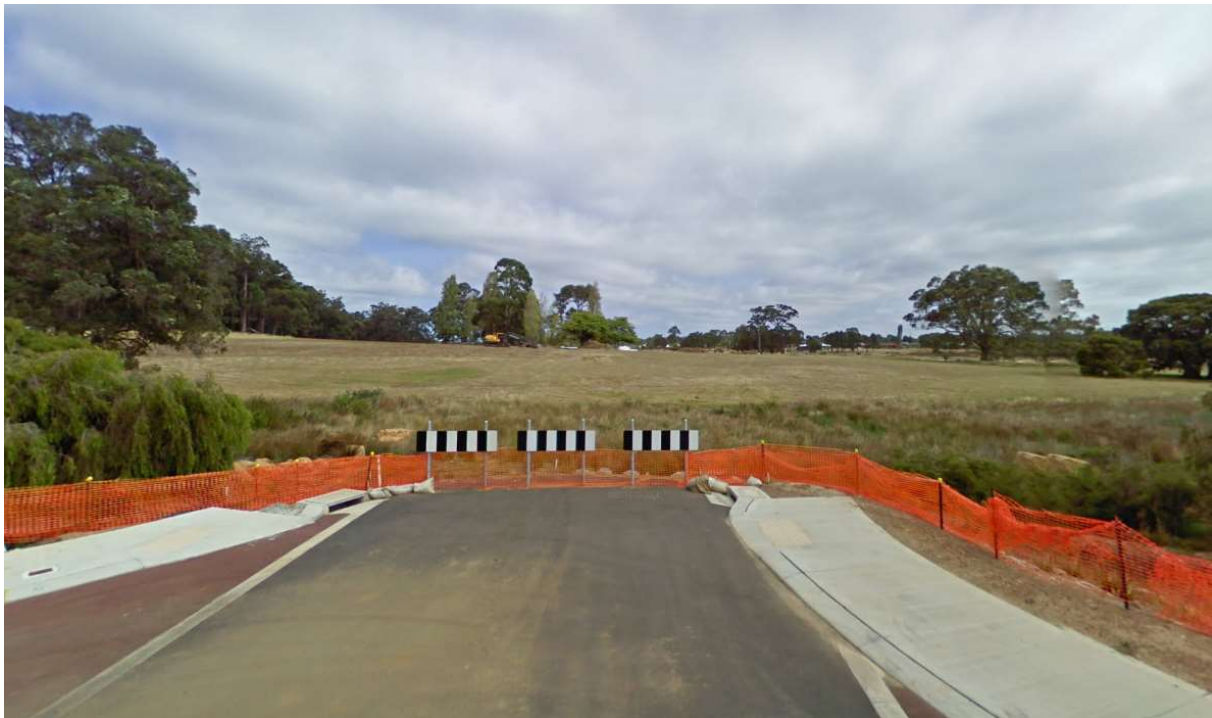
Figure 2.4: Access link prepared off Rapids Landing Avenue *Source: Streetview*

The site has one existing formal access onto Bussell Highway to the west. Provision has been made for an additional access connection to the south onto Rapids Landing Avenue as shown in **Figure 2.4**.

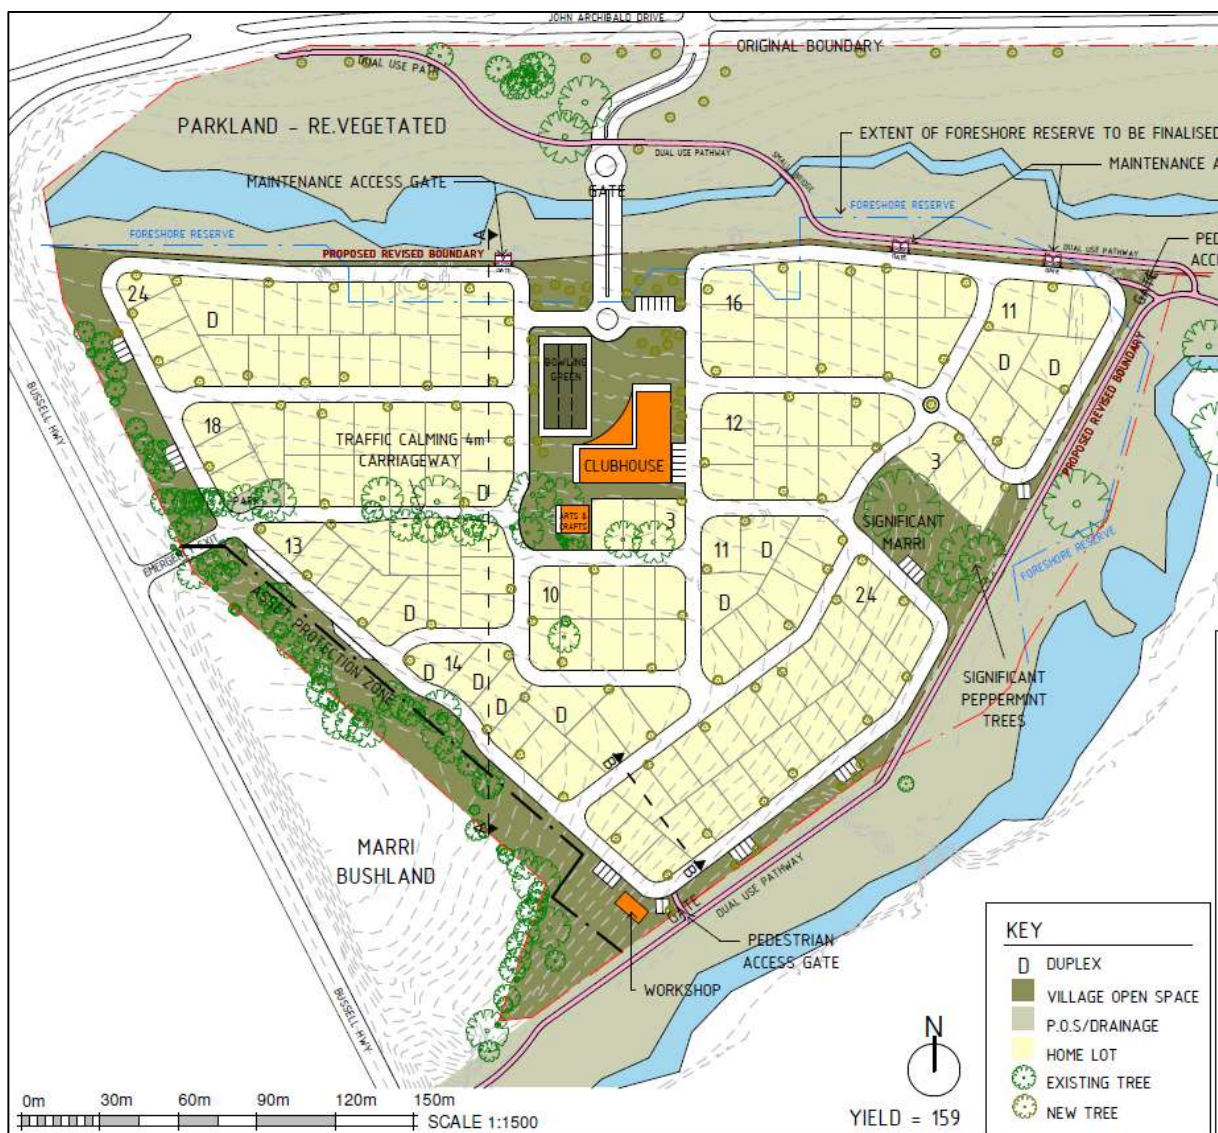
Figure 3.1: Rapids Landing Community Lifestyle Village Concept Plan

Figure 3.1 shows the finalised Rapids Landing Community Lifestyle Village Concept Plan.

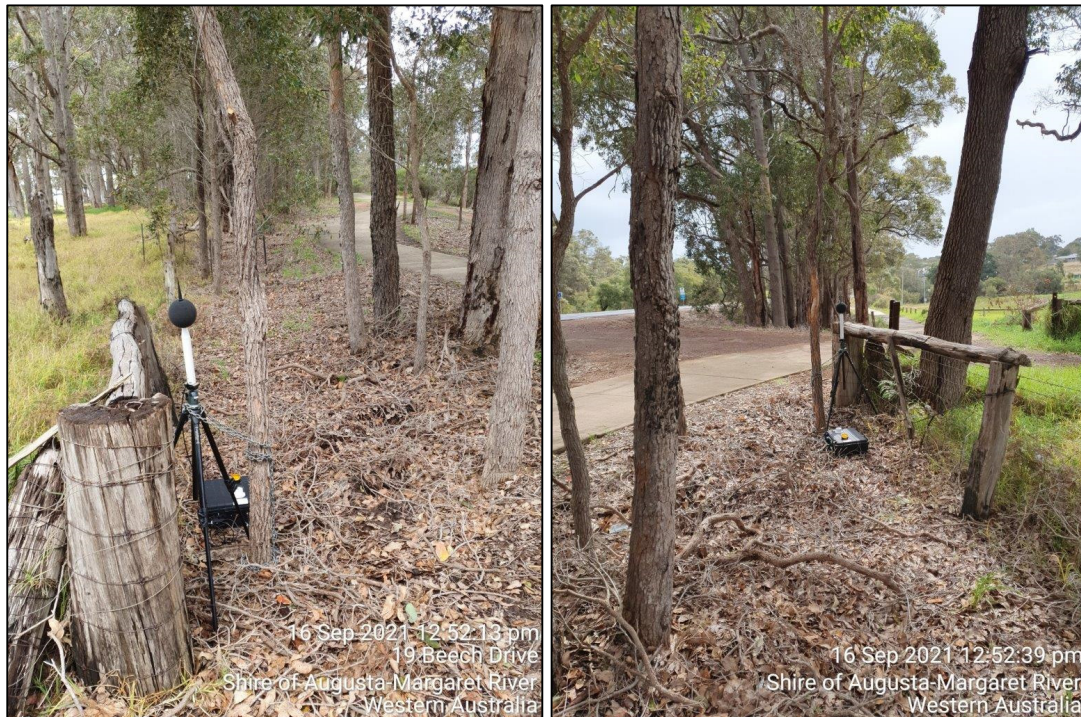
FIGURE 3.2 NOISE MONITOR INSITU

For information, the results of the monitoring are shown graphically in Appendix E, with Figure 3.1 showing the location map, Figure 3.2 showing the monitor insitu and Figure 3.3 showing the road surface.

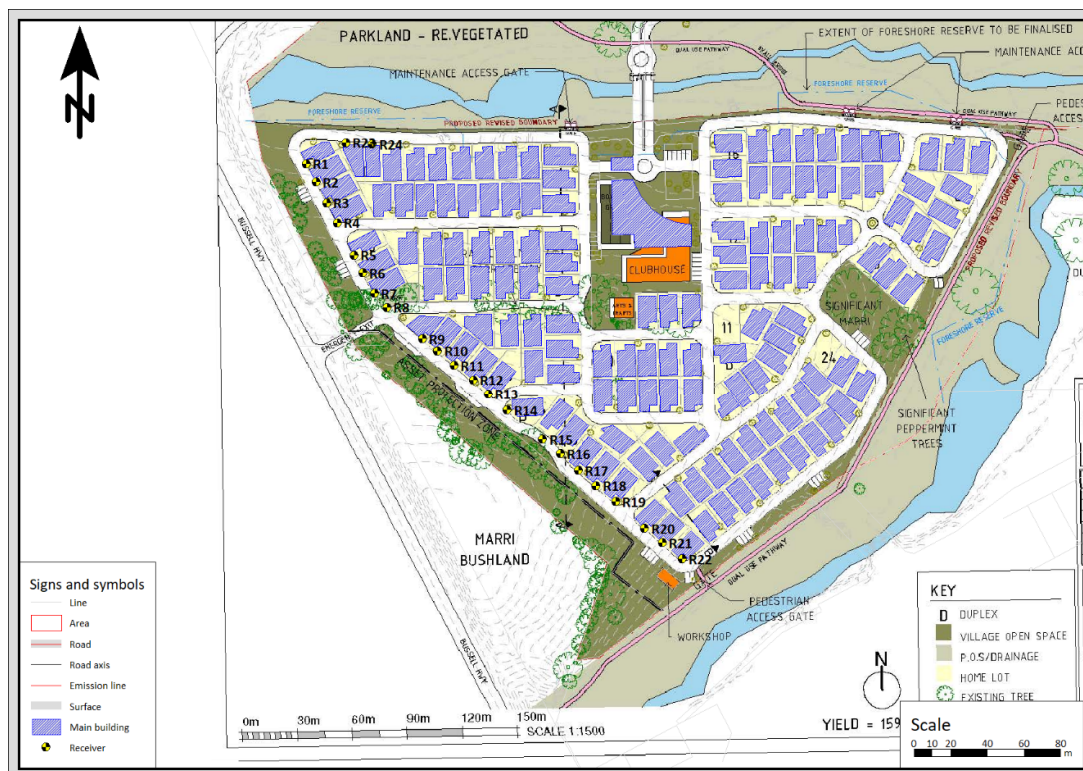
FIGURE 4.1 - RECEIVER LOCATION PLAN

The results of the acoustic assessment indicate that noise received at the ground floor level of residences located adjacent to Bussell Highway, could exceed the above Noise Target acoustic criteria. In the worst-case location, the level of exceedance would be approximately 9 dB(A). Table 4.1 details the noise level at the building envelop for each proposed development Lot and the “Quiet House” design package required to achieve compliance. Figure 4.1 showing the location map of the receivers.

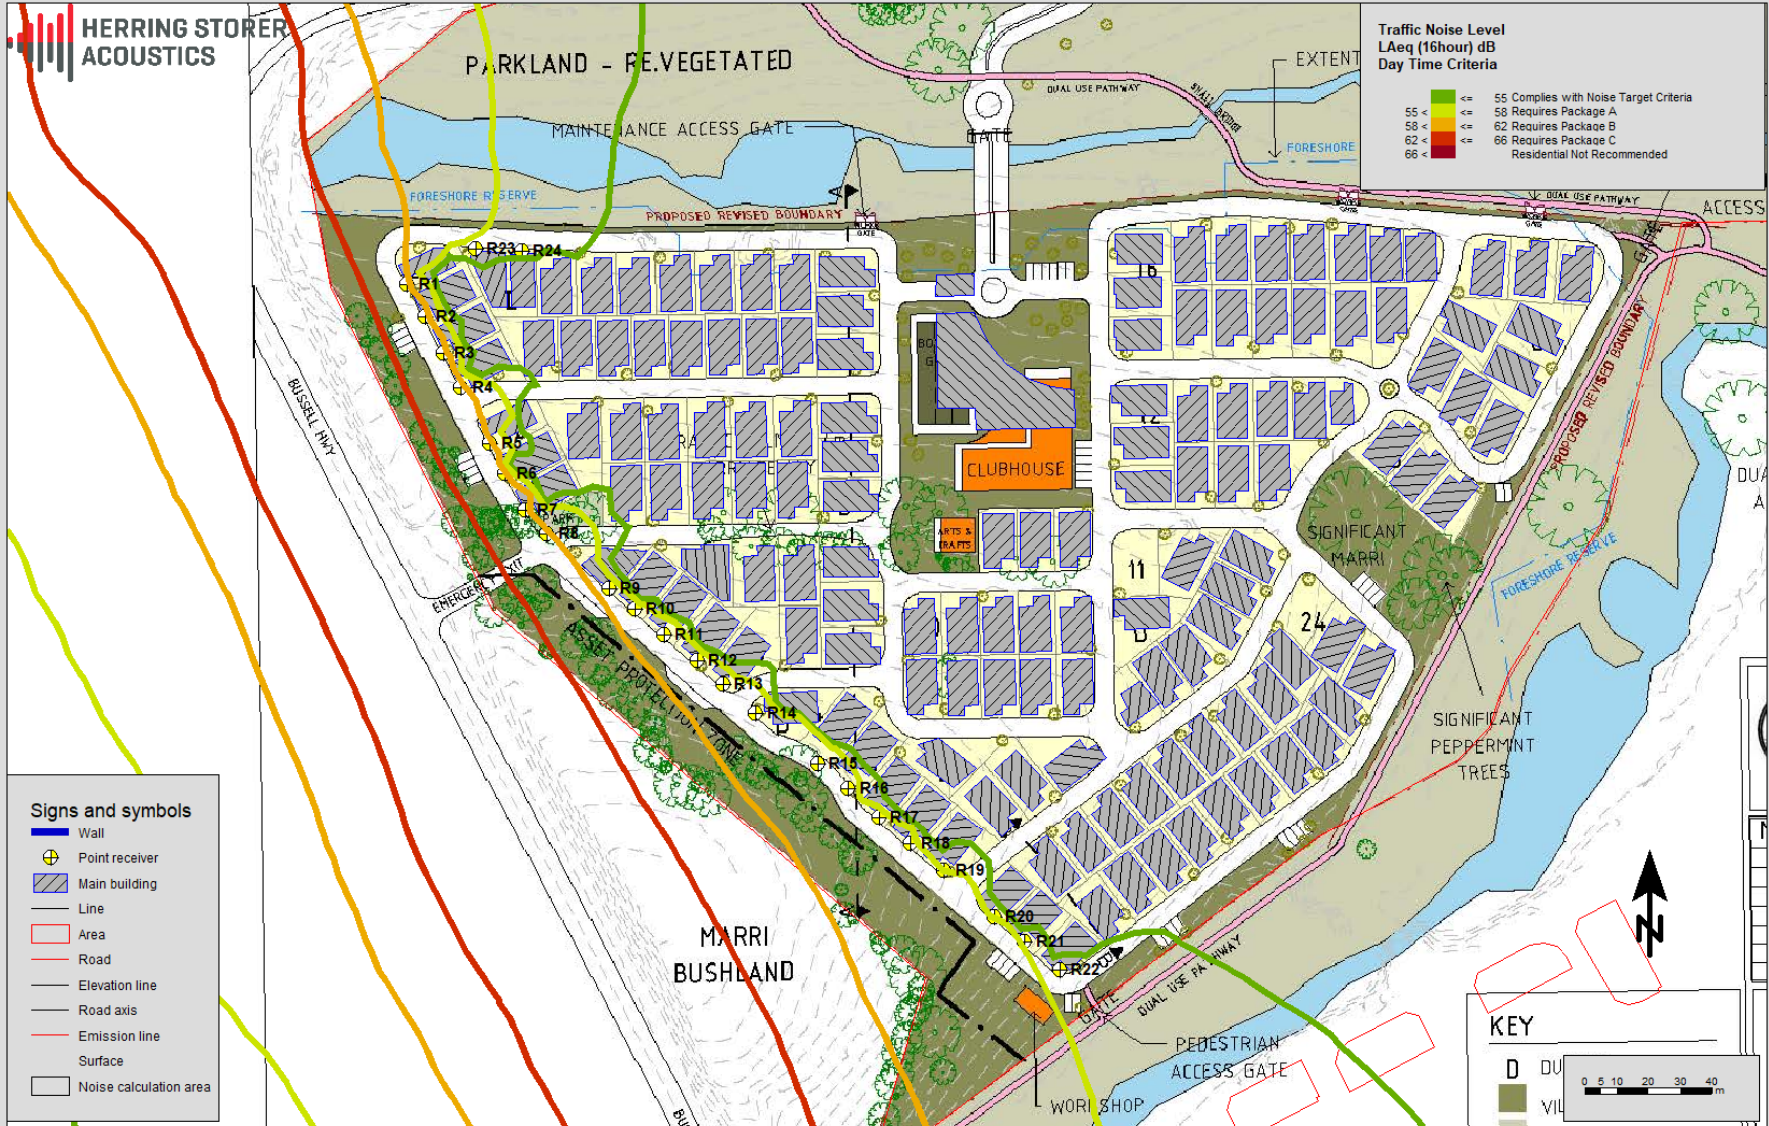
NOISE CONTOUR PLOTS

Traffic Noise Level LAeq (16hour) dB Day Time Criteria

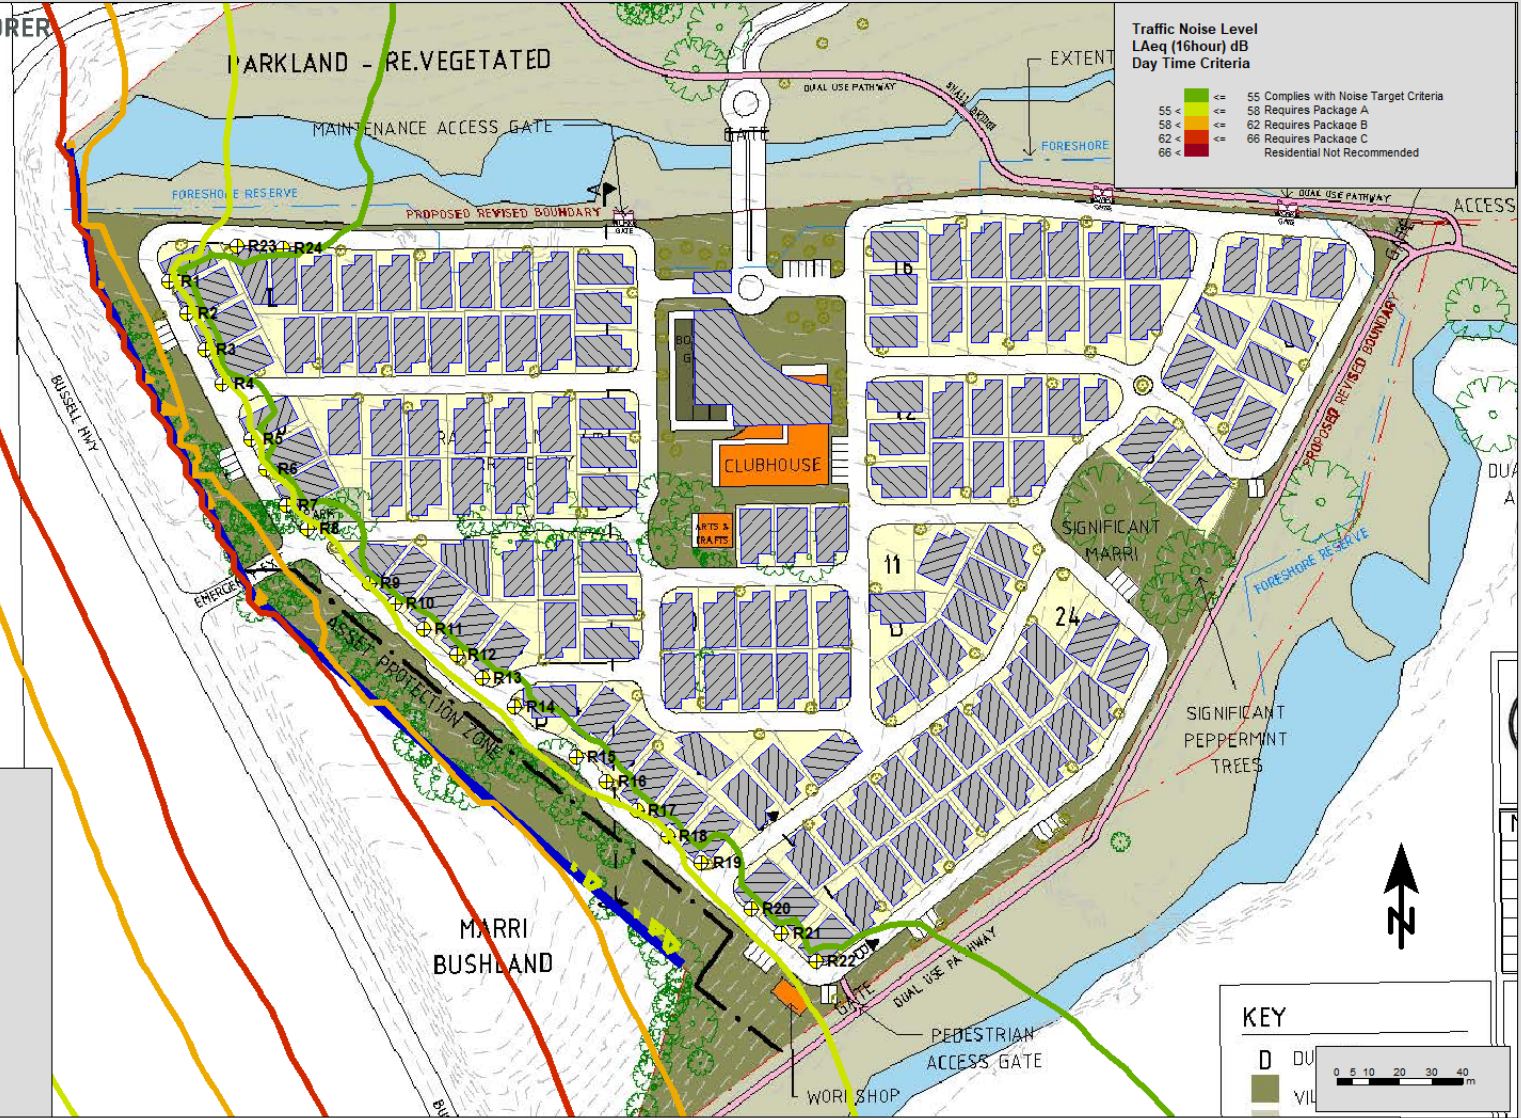
Figure 02
Ref # 006

Lot 9012 Bussell Highway Margaret River
Future Traffic Volumes - With 1.8m Wall
LAeq (16hour) Day Noise Level Contour

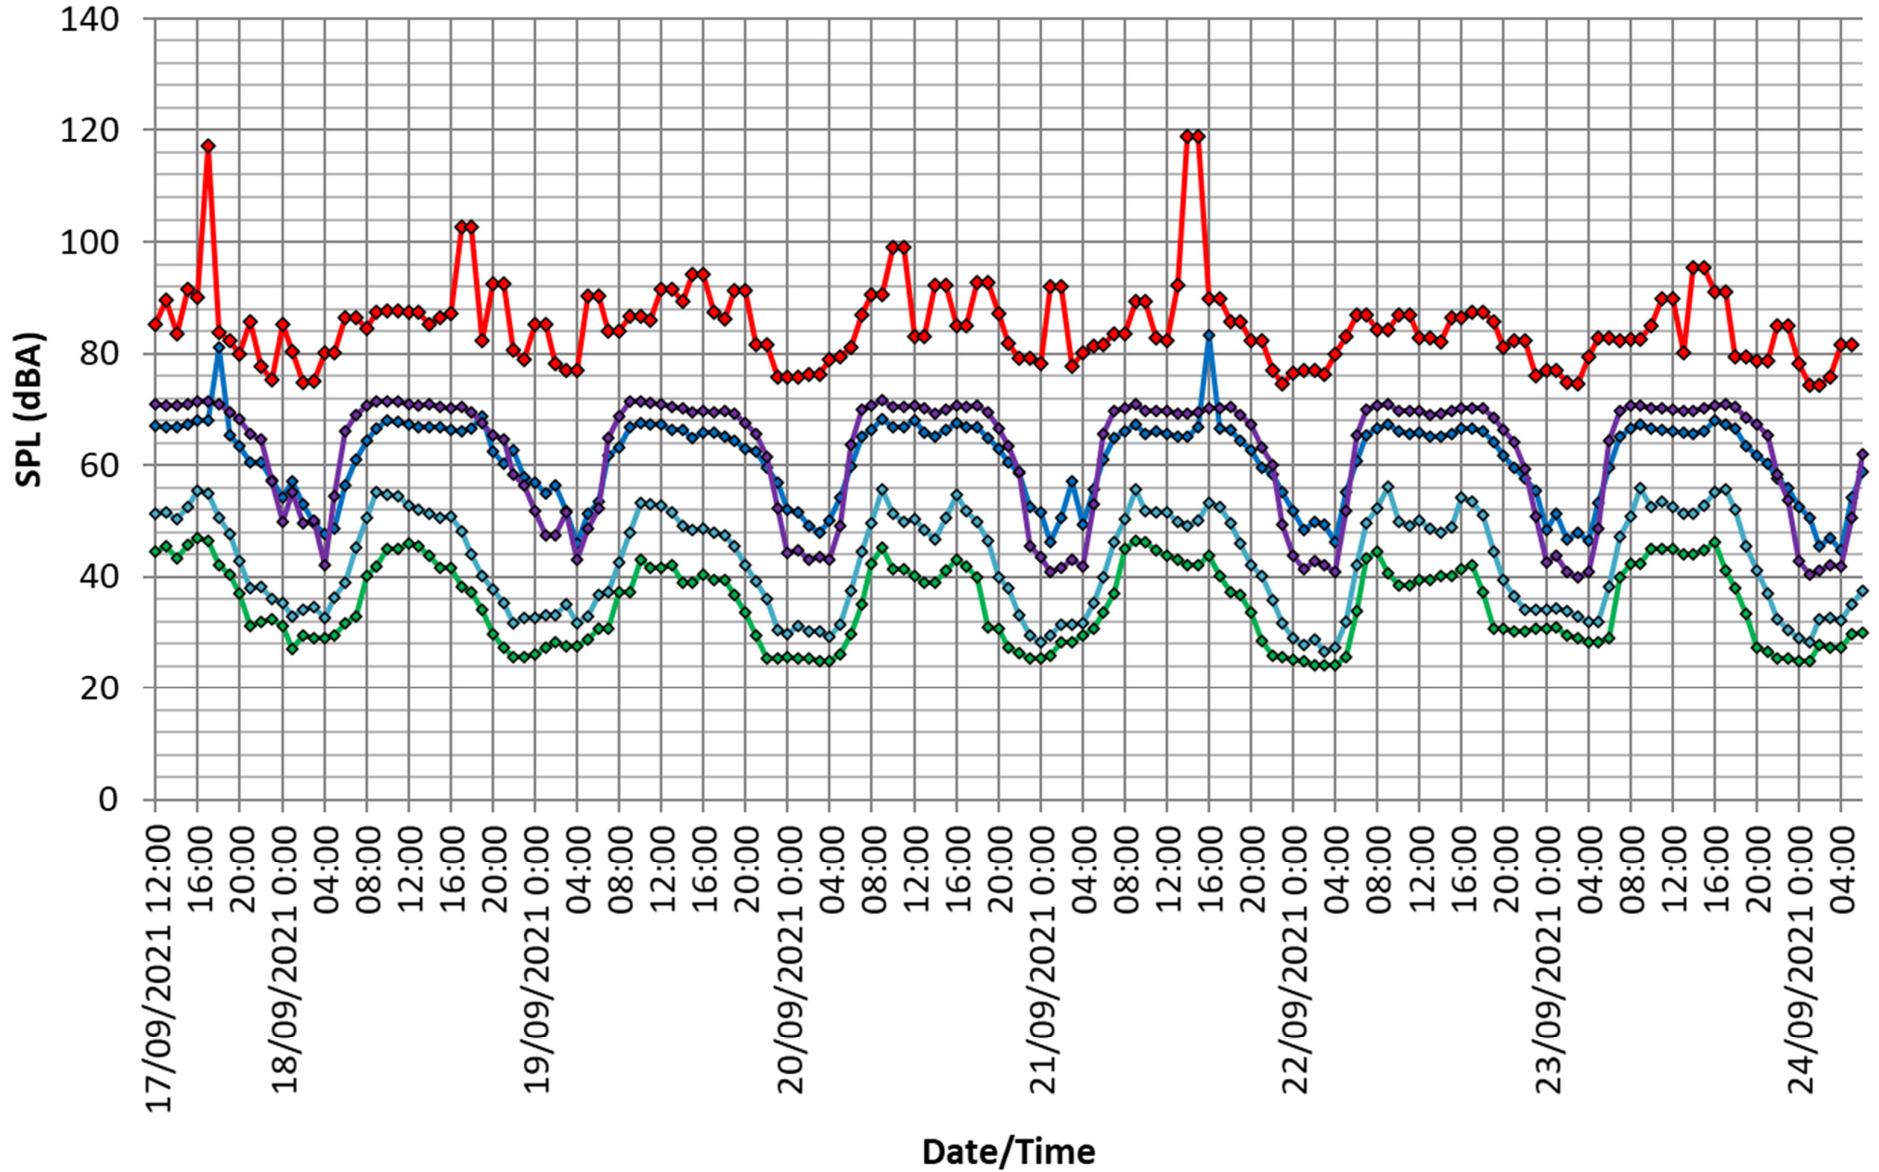
Noise Logging - Lot 9014 Bussell Hwy, Margaret River

—◆— LAeq —◆— LAmin —◆— LA10 —◆— LA90 —◆— LAmax
