## DEVELOPMENT PLAN

LOT 331 HAMILTON ROAD, SOUTH HEDLAND

711-340  
MAY 2012

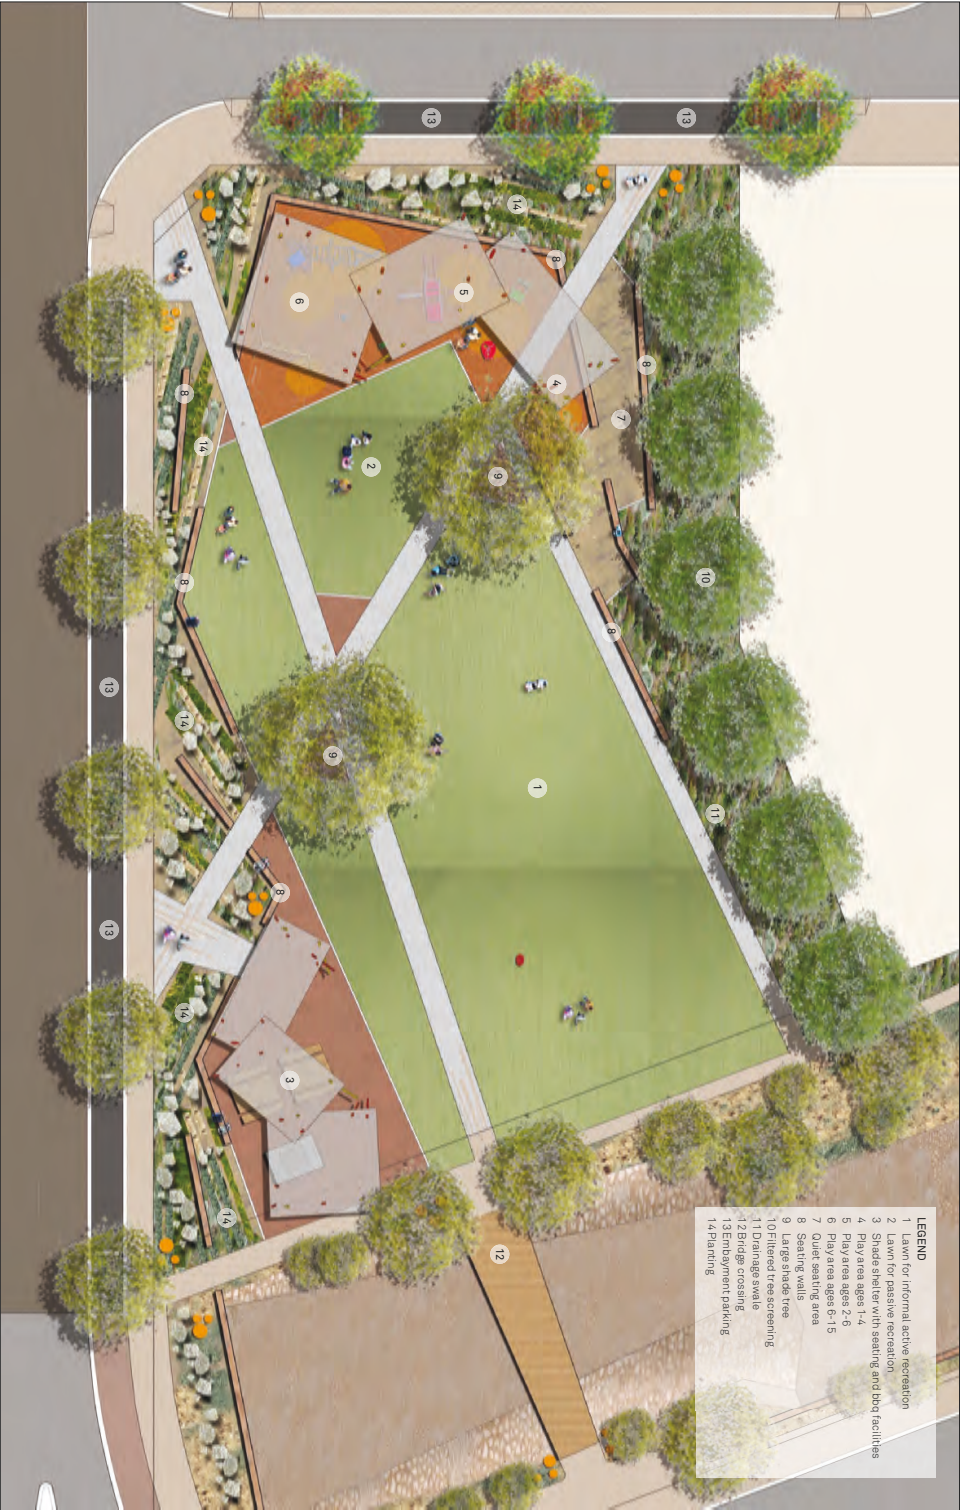
Hamilton Development\_South Hedland  
Detail POS Plan Scale 1:200 at A2  
24 May 2012

REFER TO FIGURE 14 - CENTRAL PUBLIC OPEN SPACE AREA

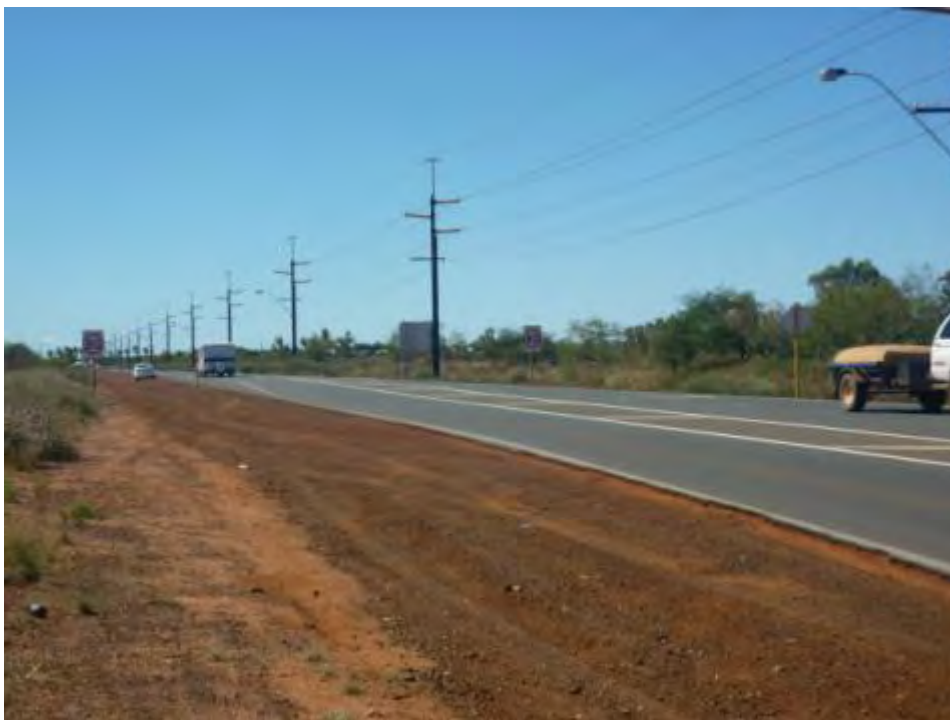
Figure 2 North Circular Road, facing northeast (taken adjacent to the site)

According to a traffic study conducted in 2010 by Porter Consulting Engineers, North Circular Road east of Hamilton Road carried in the range of 3,000-7,000 vehicles per day (more specific recent traffic count data is not available). This volume range is commensurate with a classification of Local Distributor, all else being equal. The road is a single, undivided carriageway with a posted speed limit of 80 kilometres per hour adjacent to the site. North Circular Road provides access to Wallwork Road to the east via a roundabout-controlled intersection, which in turn provides access northwards to Great Northern Highway and Port Hedland. North Circular Road facing northeast can be seen in Figure 2.

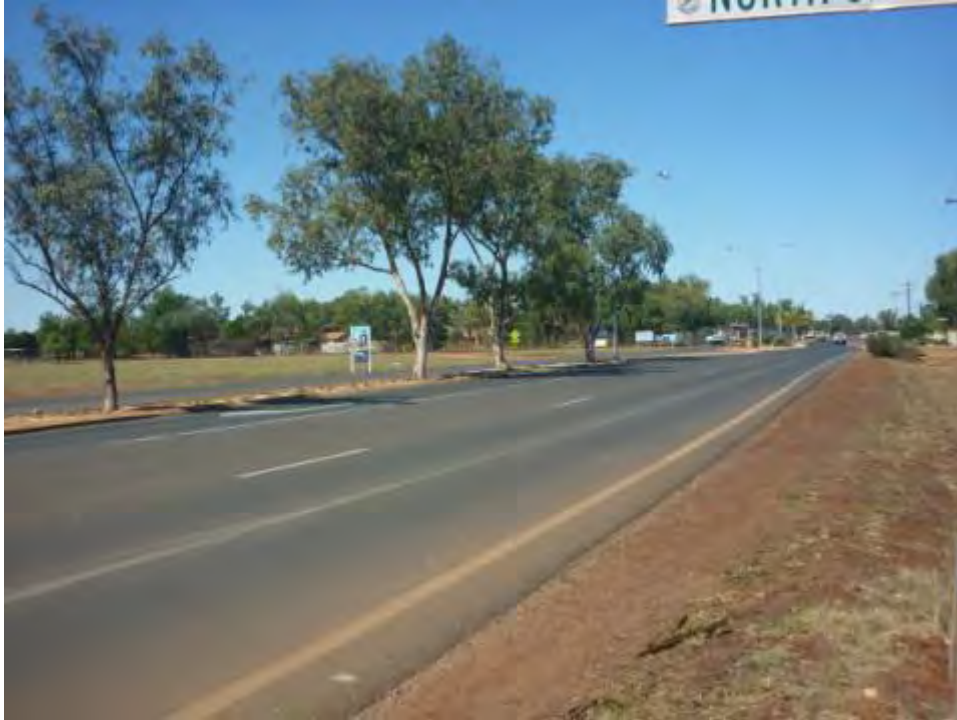
Figure 3 Hamilton Road, facing southeast (taken from its intersection with North Circular Road)

Hamilton Road is classified by the ToPH as a Primary Distributor north of North Circular Road and District Distributor to the south. It is classed as a Local Distributor in MWRA's FRH. The road has single, undivided carriageway excepting where a limited stretch of median (about 440 metres long) has been constructed from the TAFE site to the south to a point about 125 metres north of the intersection with North Circular Road. This has been constructed to facilitate turning movements and queuing.

The posted speed limit is 60 kilometres per hour to the south of the site, increasing to 80 kilometres per hour approximately 250 metres north of North Circular Road. Based on 2011 traffic count data, Hamilton Road south of North Circular Road carries about 10,000 vehicles per day. This reduces to about 4,580 vehicles per day north of North Circular Road (according to 2010 traffic count data). Hamilton Road can be seen in Figure 3.

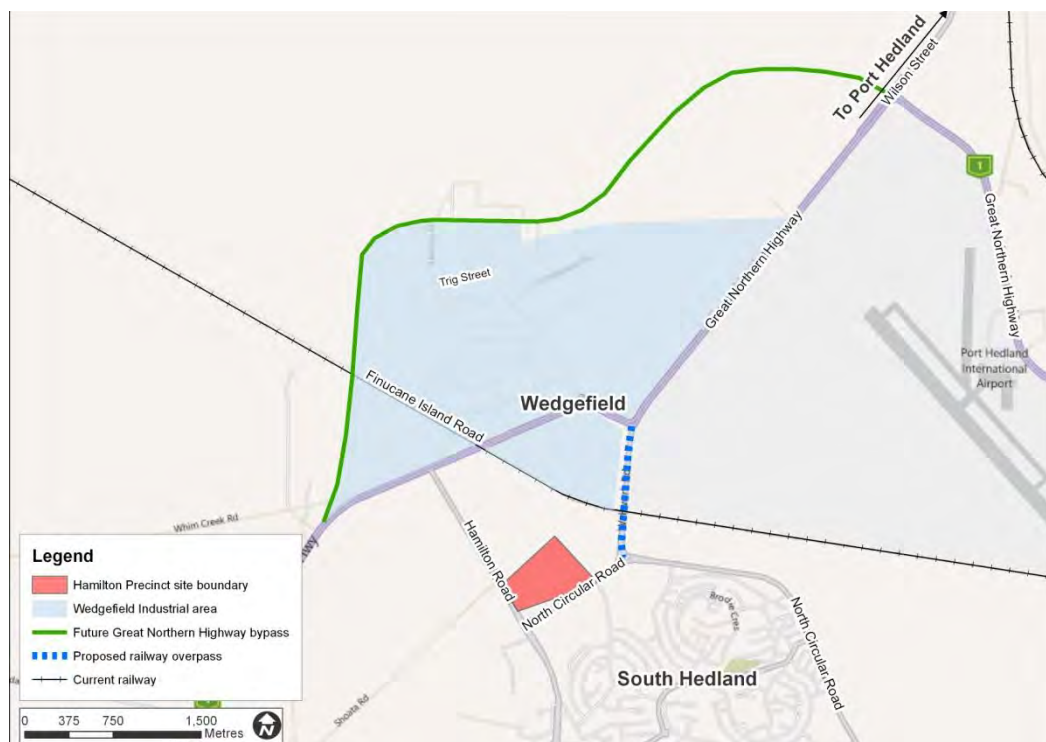
Figure 8 Major transport infrastructure (planned and committed)

Major infrastructure projects are shown on Figure 8.

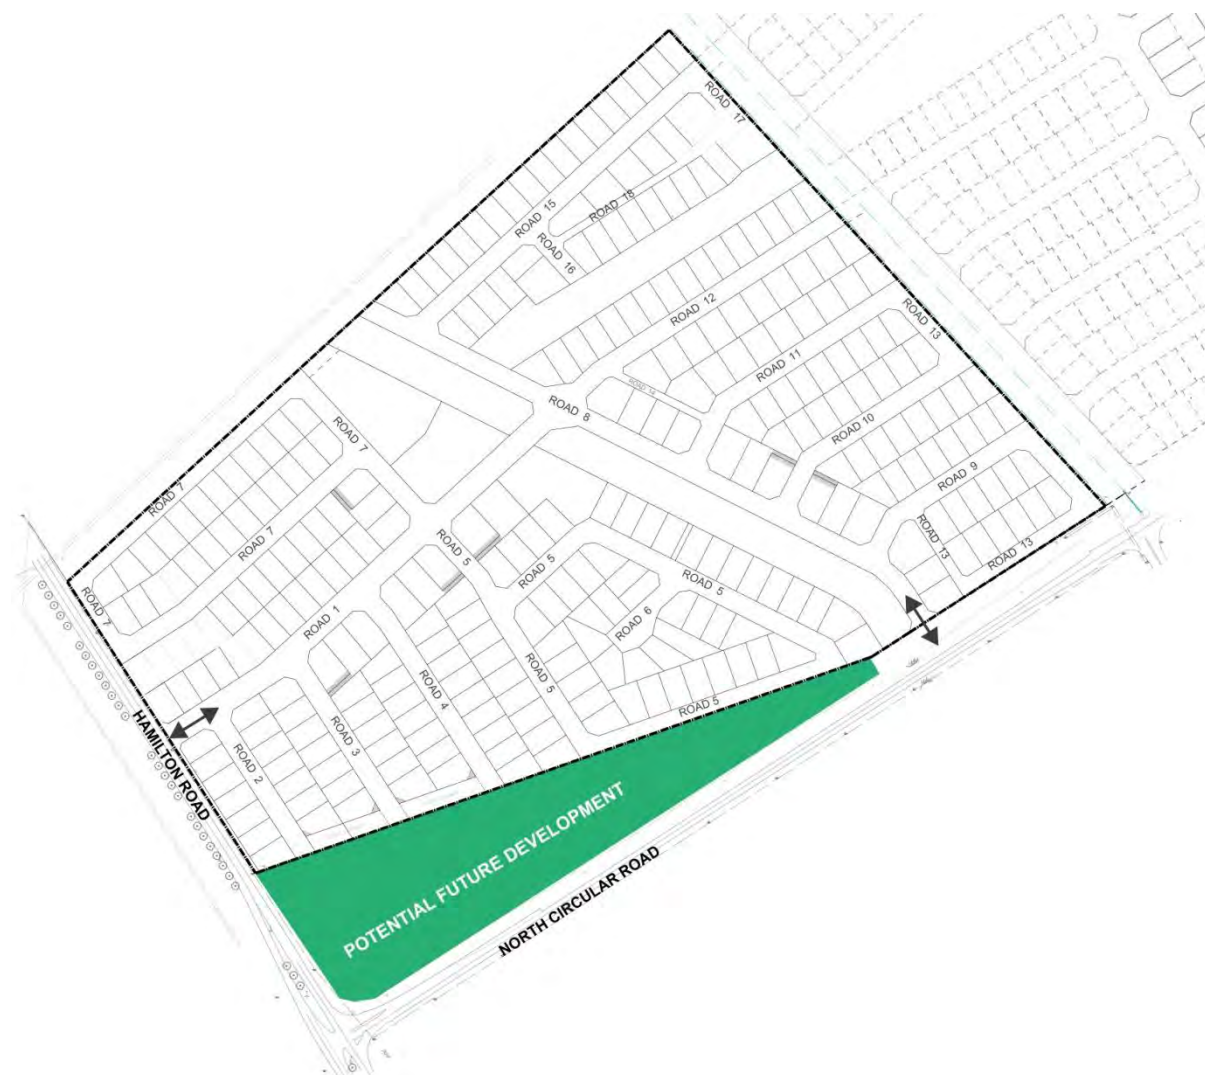
Figure 9 Proposed subdivision plan  
(Source: TPG/ Arup, March 2012)

The proposed internal street network is shown on the following Subdivision Plan (Figure 9). Proposed external connections are indicated. All streets are intended to function as local access streets. However, in future, when the development is connected to new adjacent subdivisions, the internal spine routes (Roads 1 and 8) have sufficient carriageway width to function, if required, both as Neighbourhood Connectors and bus routes.

Road 5 may be connected to North Circular Road and northwards into new adjoining development sometime in the future. However, it is envisaged to be a high order access street rather than a Neighbourhood Connector and has been designed appropriately (see below).

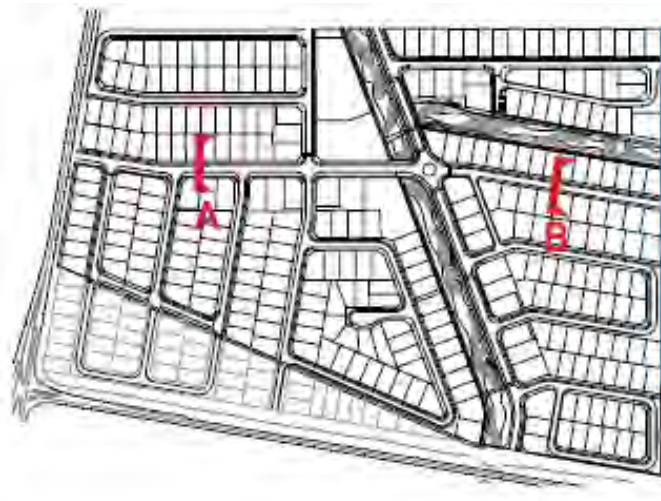
Figure 10 Key map [sections (A)-(B)]

The project team has developed indicative cross sections for the streets within the development. Key (location) maps are shown in Figures 10 and 11 and the cross sections themselves in Figures 12 to 17. All sections have been reviewed by the project team's civil engineers and landscape architects to make sure that appropriate provisions for services and landscaping have been incorporated.

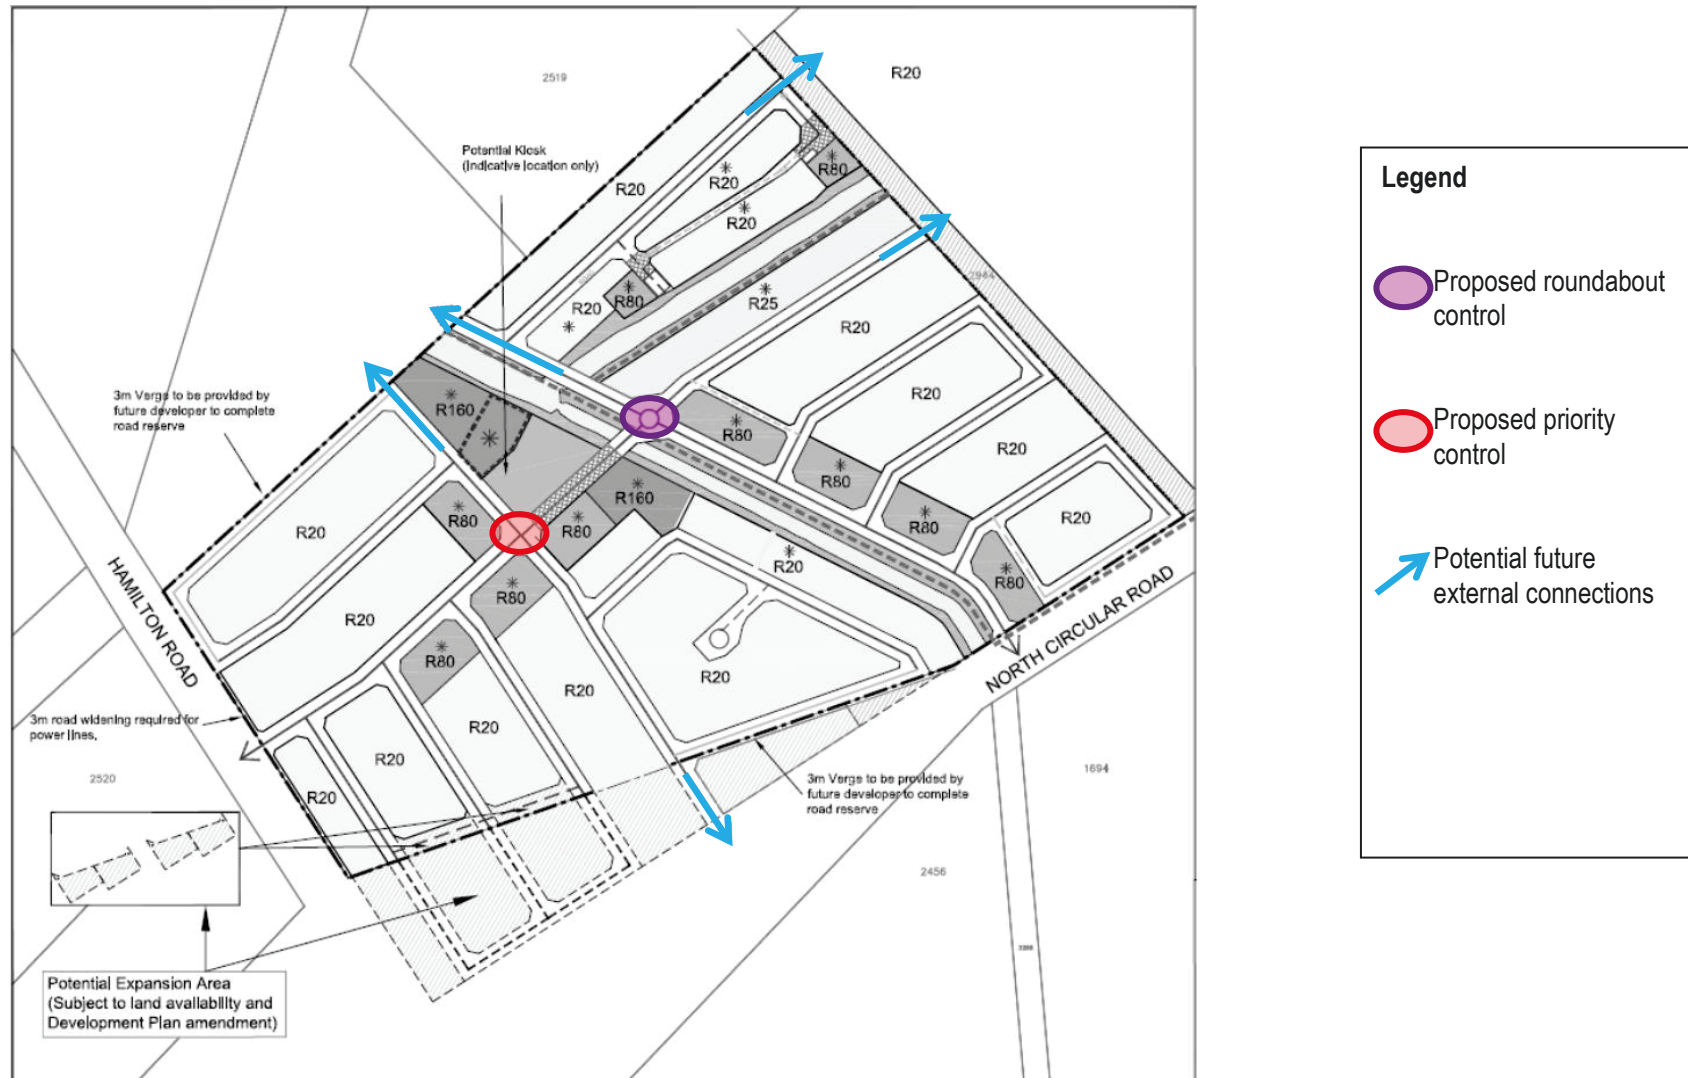
The development plan makes provision for future connections with adjacent development to the northwest and northeast. These are shown in Figure 18.

Figure 18 Potential future external connections and key internal intersection control  
(Source: TPG, March 2012)

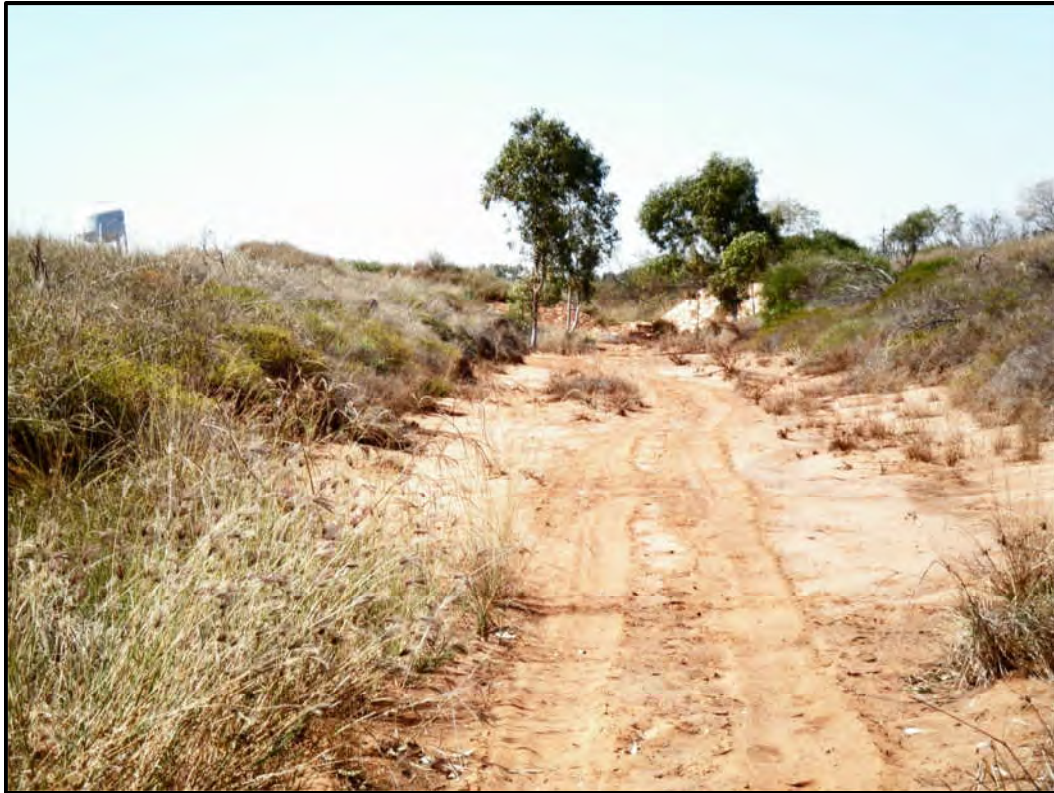
**Plate 2:**  
**Lot 330 Existing Drainage Channel**

The subject site is generally flat, with the exception of two drainage channels that intersect on the property. The site levels range from approximately 8.6m Australian Height Datum in the north of the site to 9.6m AHD in the south. Field observations suggest the drainage channels are approximately 2m to 3m deep (Plate 2).

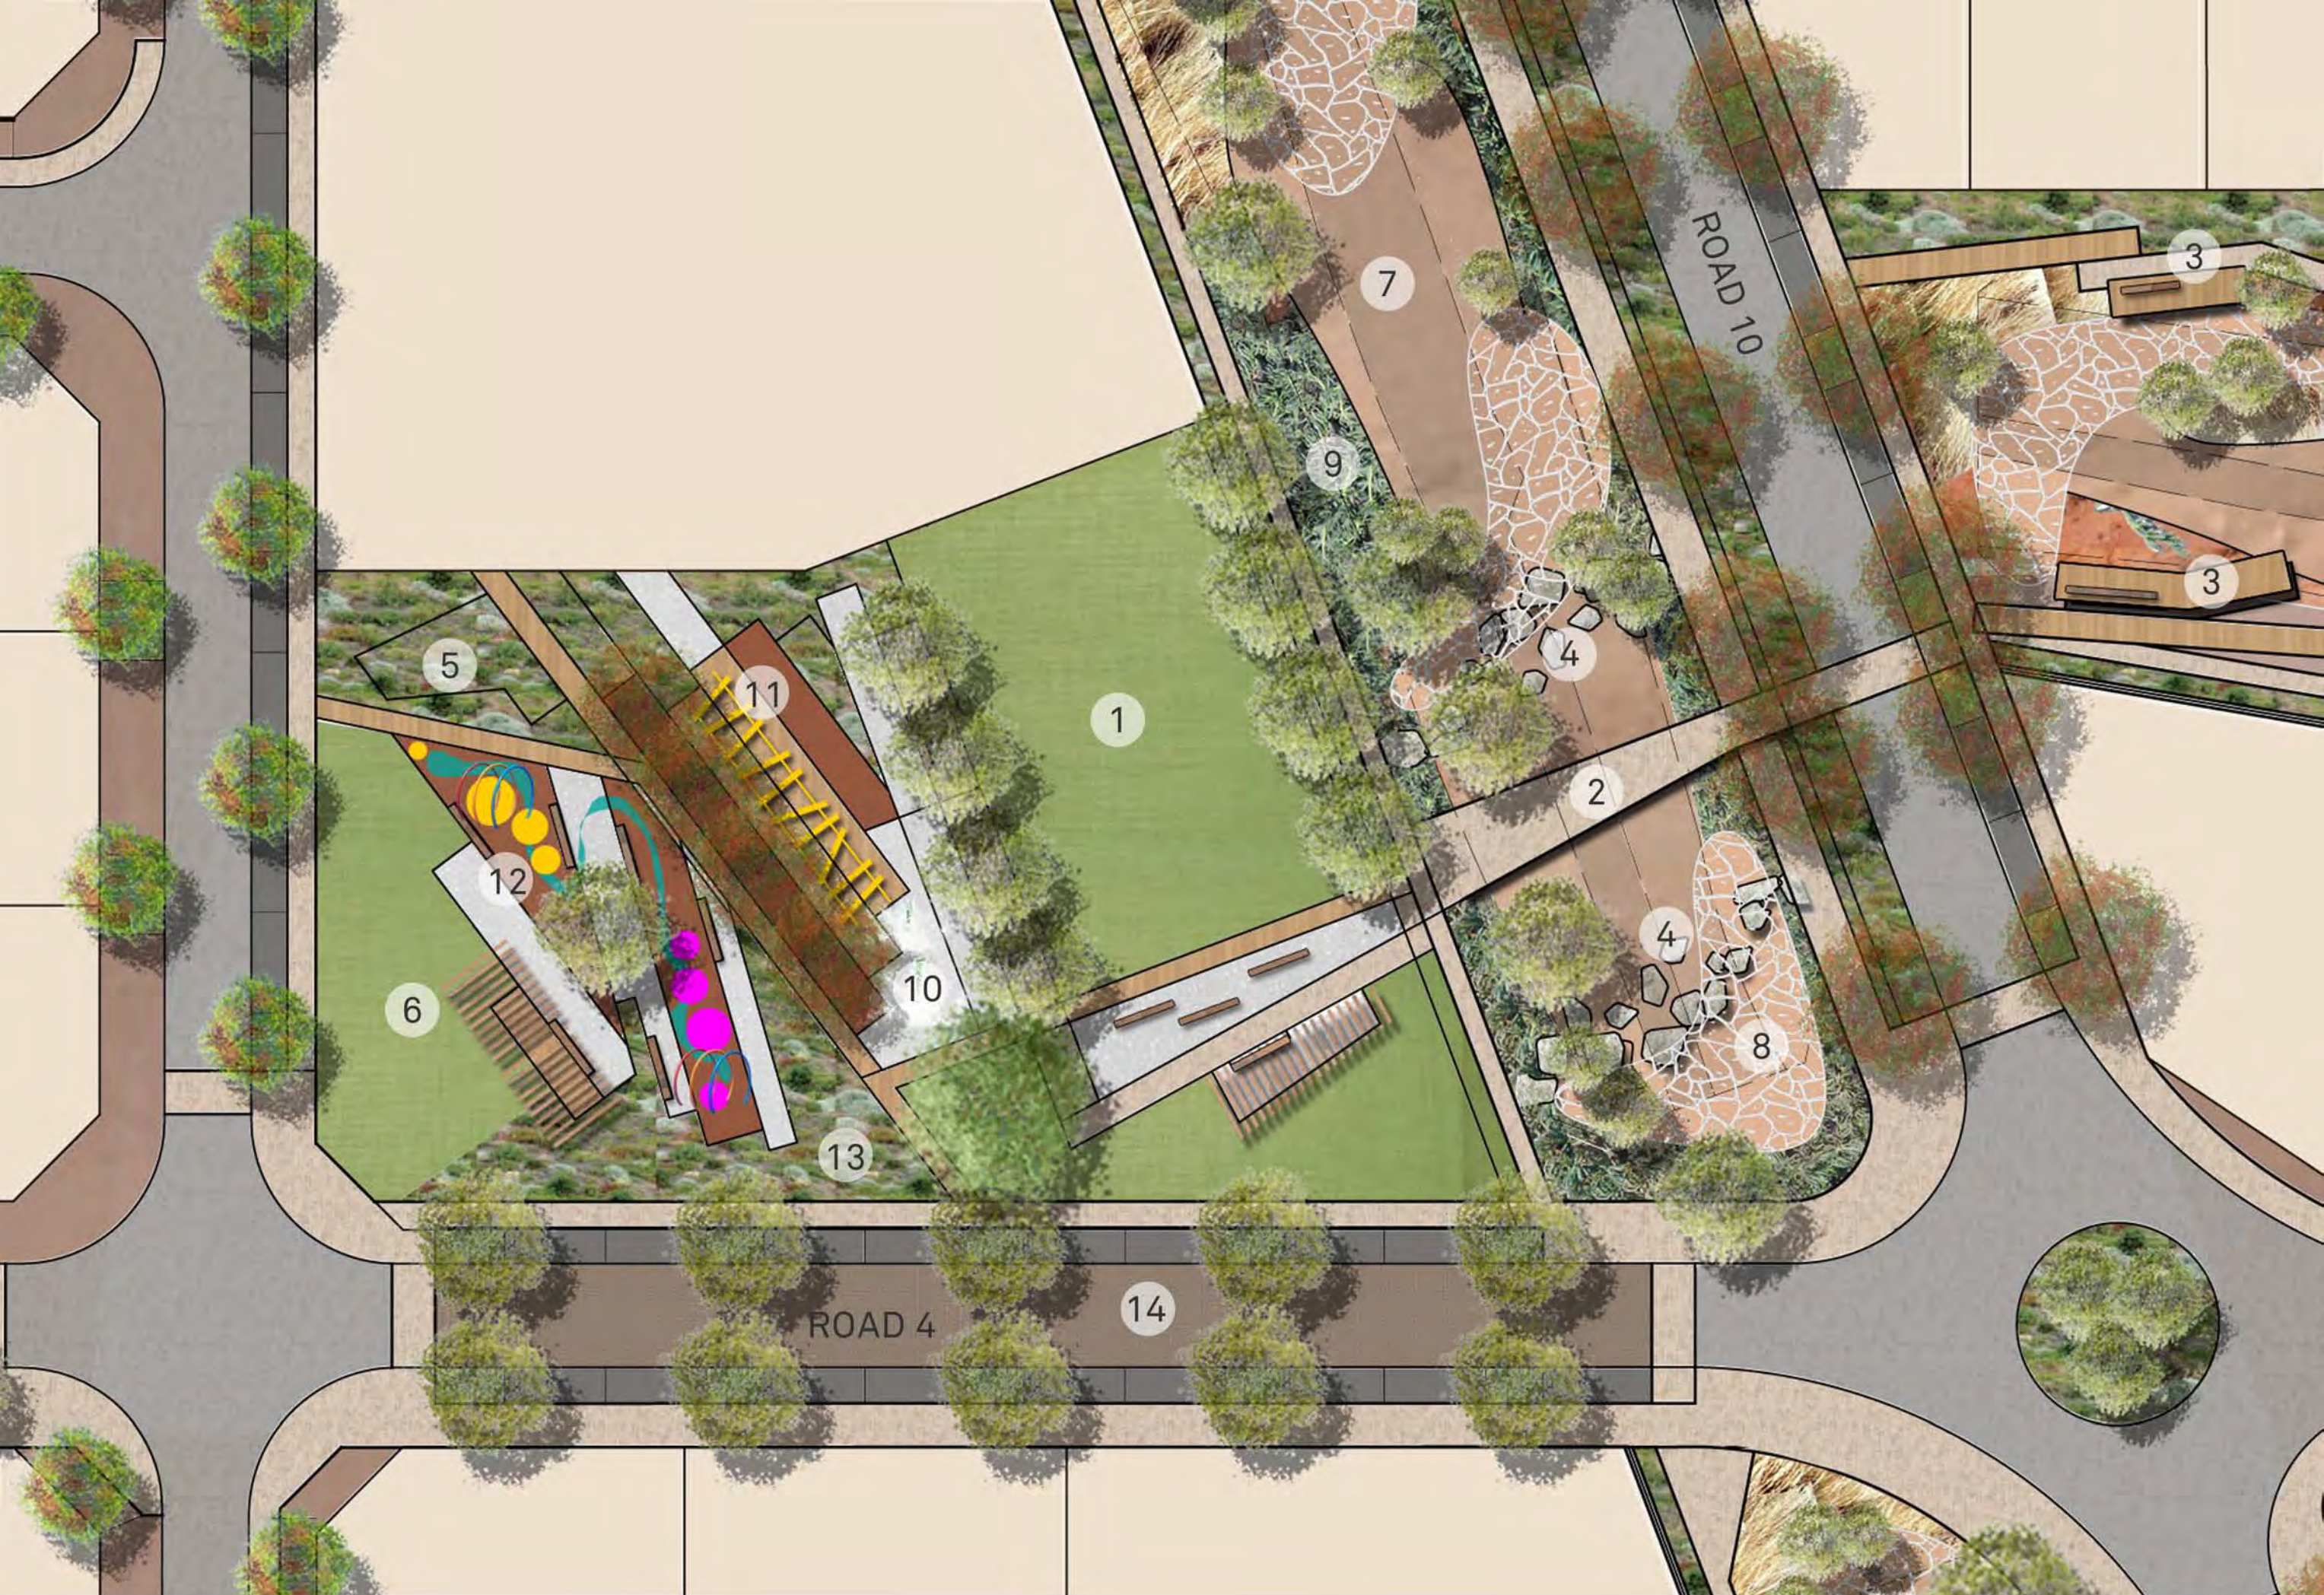
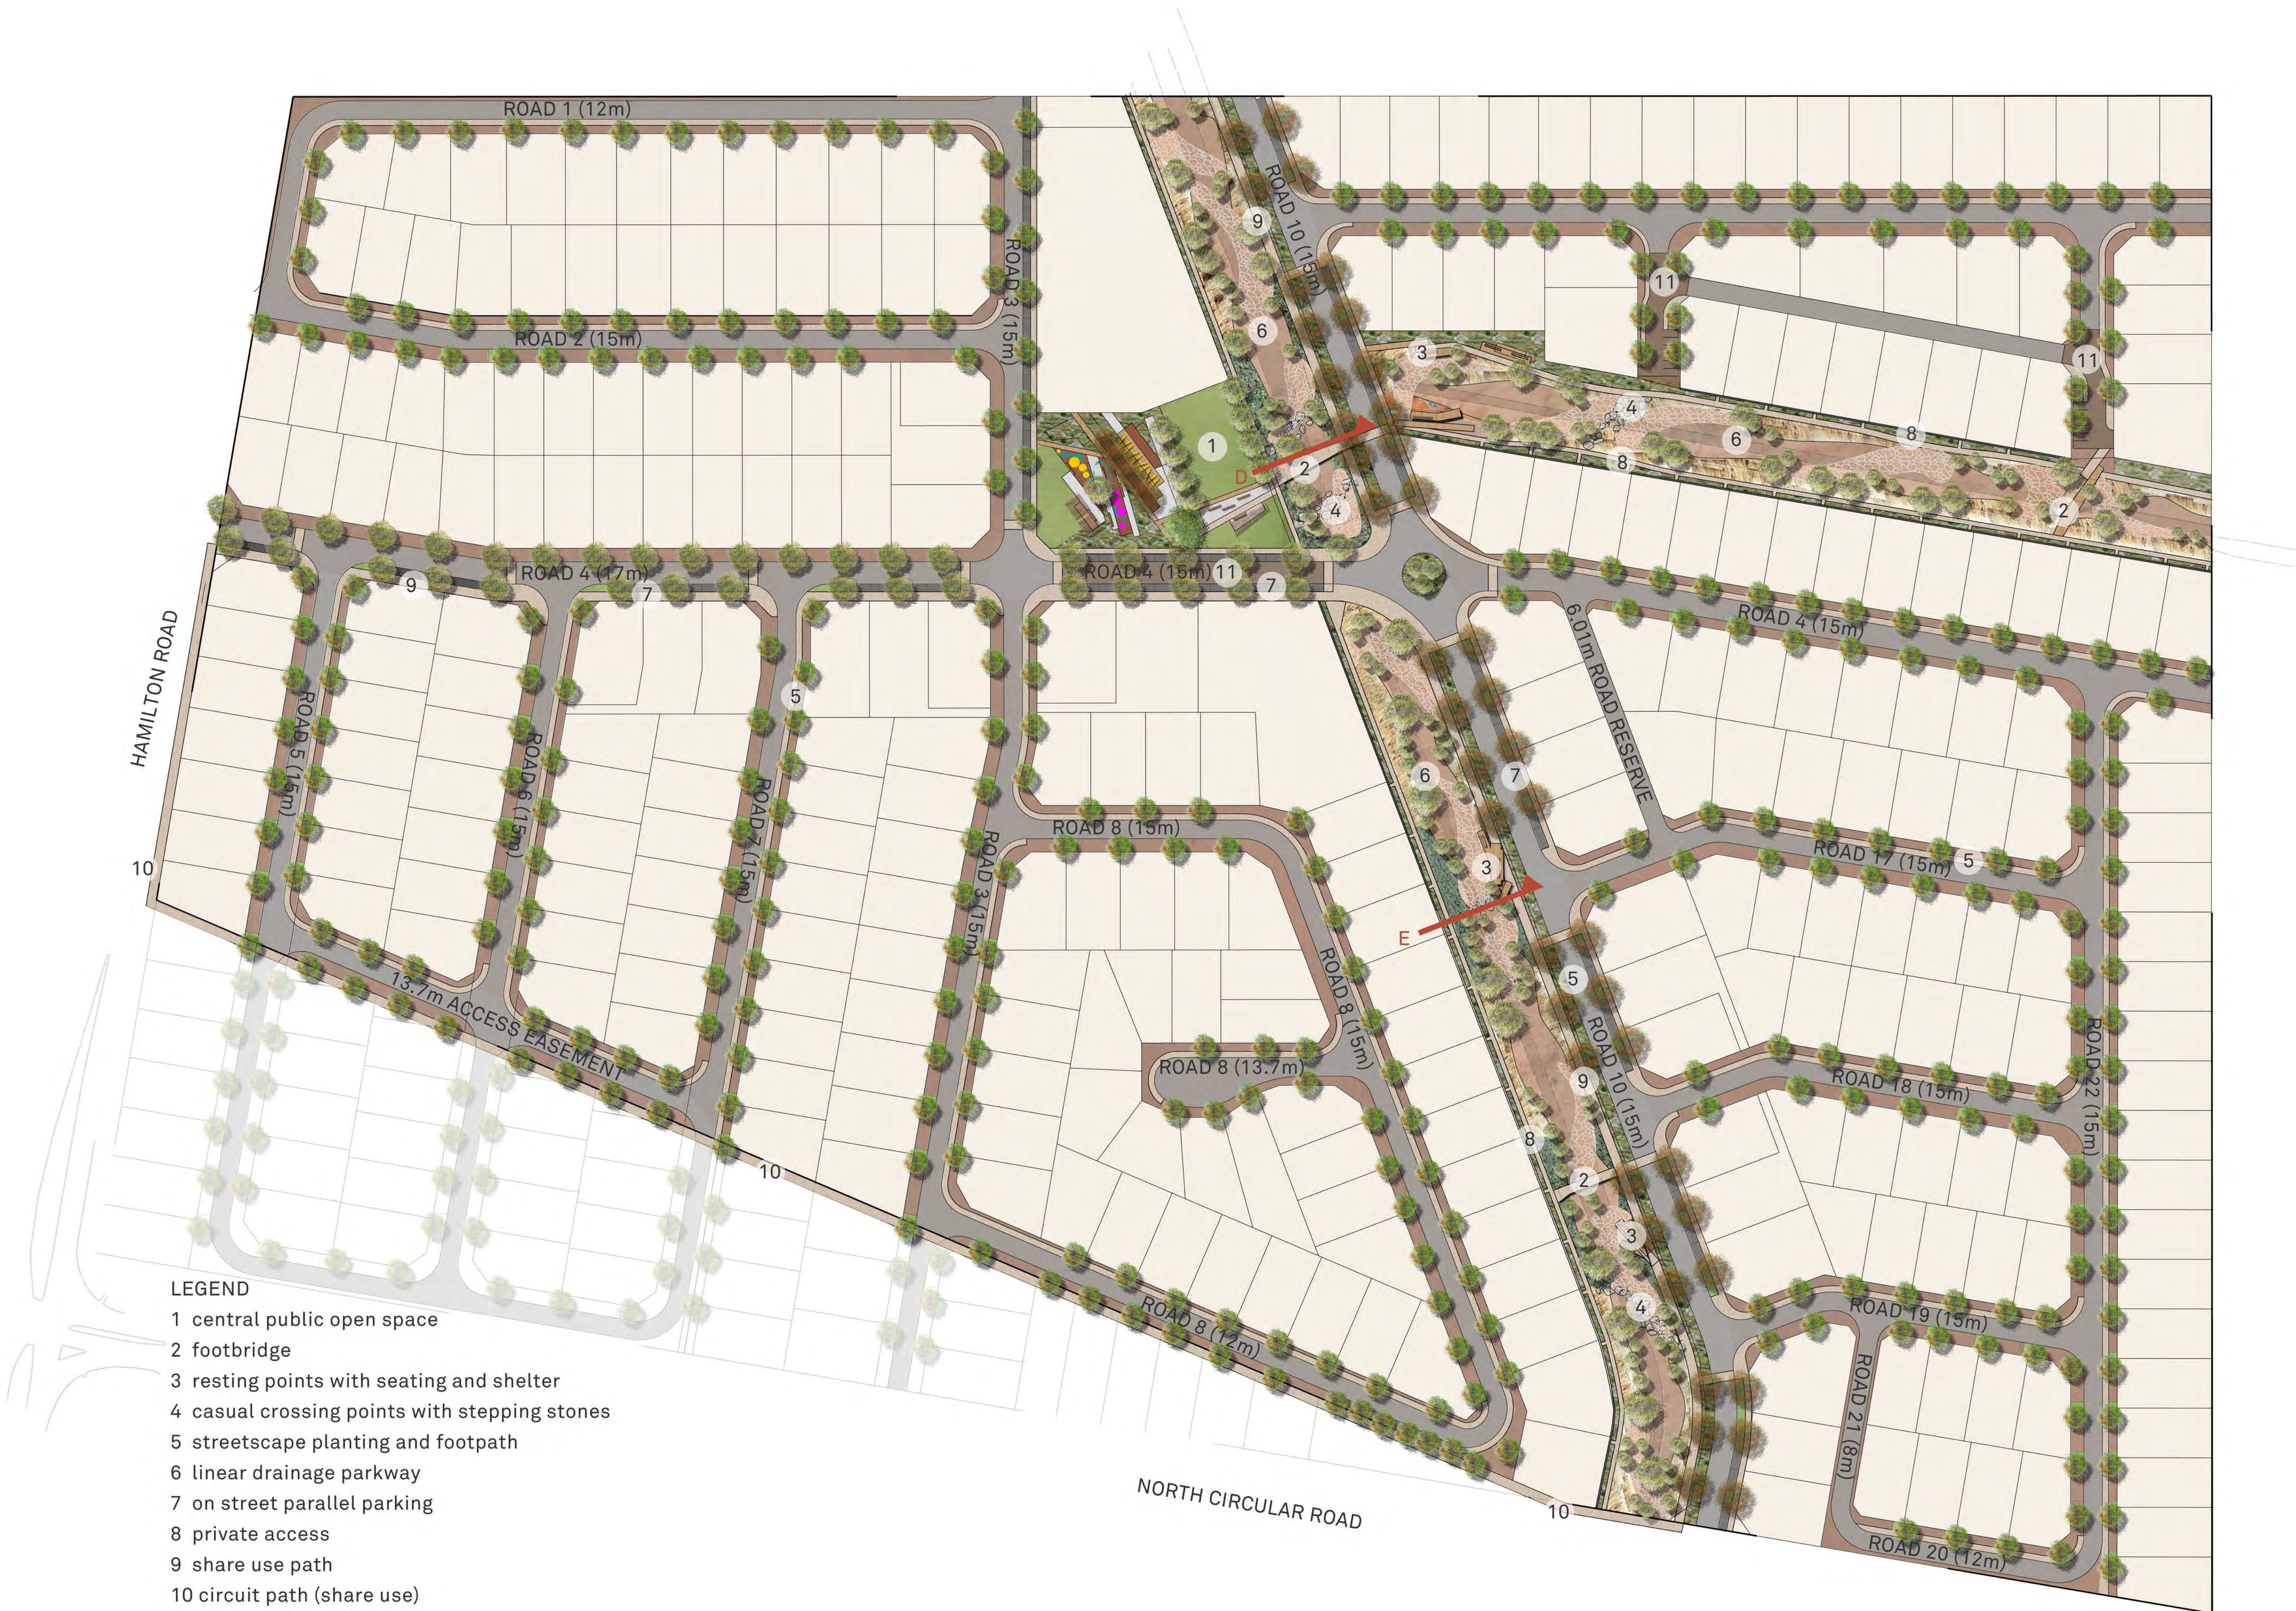
### Concept Landscape Master Plan

- 1 casual kick about field
- 2 bridge crossing
- 3 resting points with seating and shelter
- 4 casual crossing points with concrete stepping stones
- 5 opportunity for future kiosk with shade and seating
- 6 shade shelter with seating and bbq facilities
- 7 base of drainage channel
- 8 rock boulders locally sourced
- 9 native planting to channel bank
- 10 opportunity for future water play area
- 11 teenage play area
- 12 junior play area
- 13 native planting bed
- 14 trafficable paving

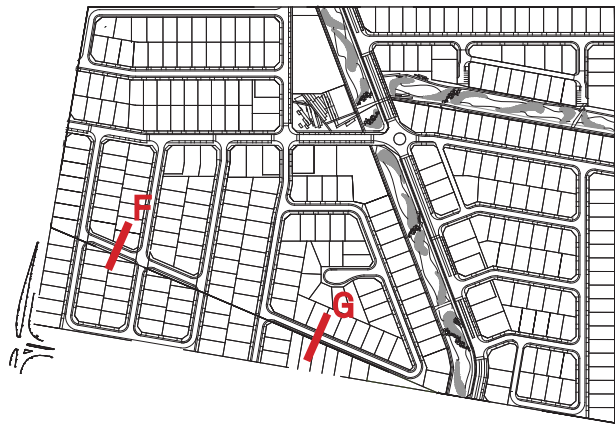
**TYPICAL 13.7m ROAD\_SECTION F**
