# CARABOODA URBAN PRECINCT DISTRICT STRUCTURE PLAN

Engineering Servicing Report  
July 2026

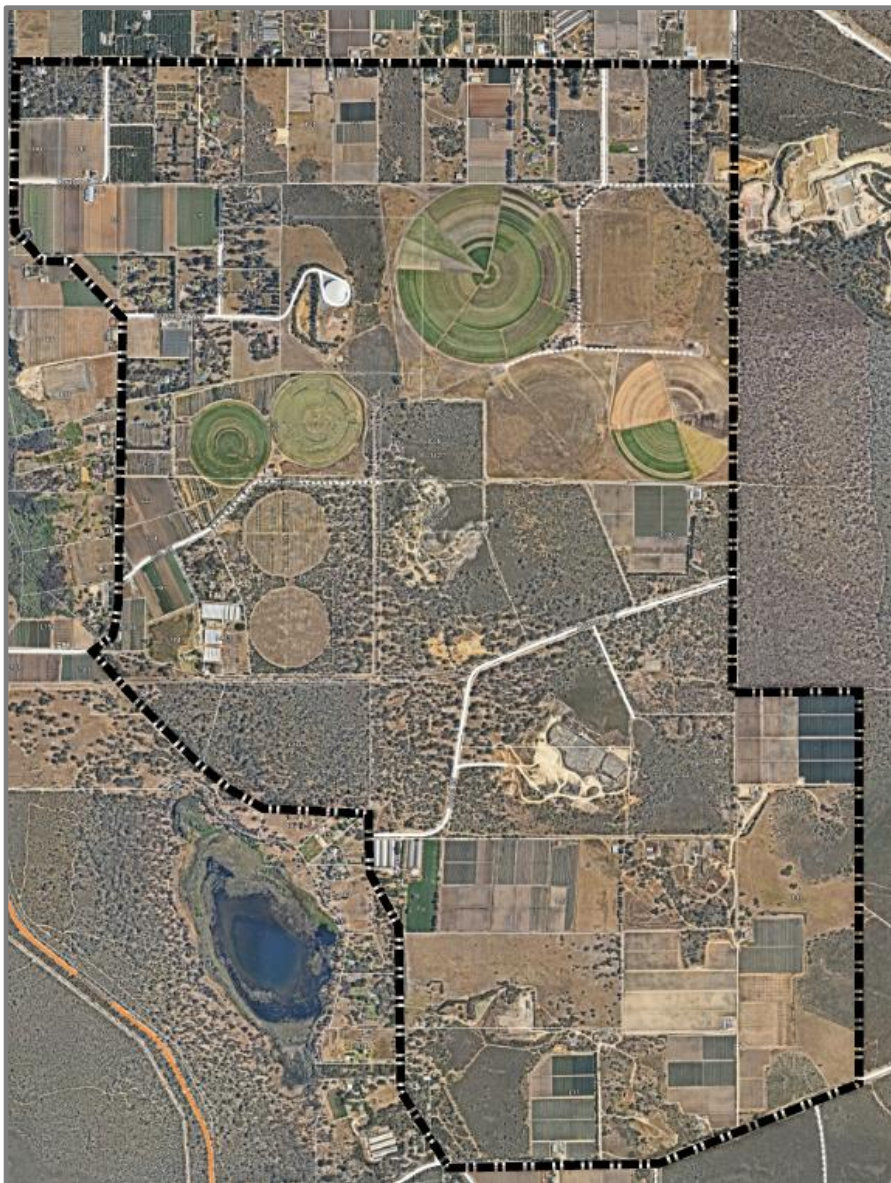
*Figure 2: Aerial Photography (MNG Access)*

The DSP area is situated within the City of Wanneroo, approximately 47 kilometres north-west of the Perth city centre. The Site is predominantly used for agriculture purposes with some areas of the site utilised for extraction of sand and limestone. There is some remnant vegetation across the site, a significant amount of which is retained as shown on the DSP Concept Plan in Figure 1. An aerial view of the site is shown in Figure 2 below.

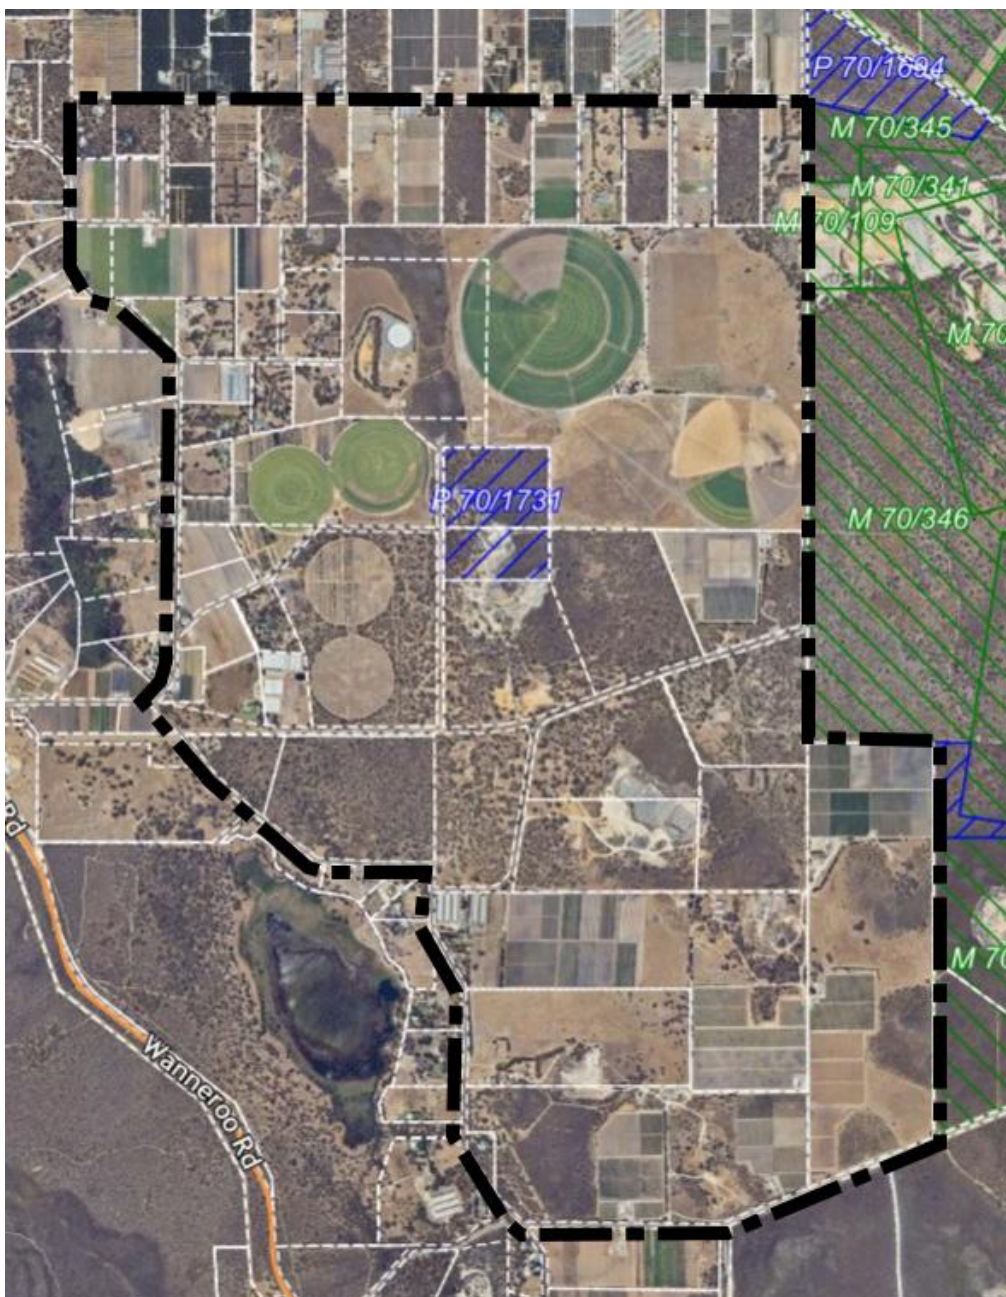
Figure 6: Existing Mining Tenement (MNG Access)

We understand there will be a need to provide suitable buffers to mining extraction, which we intend to deal with through the development of a staging plan that responds to these buffers.

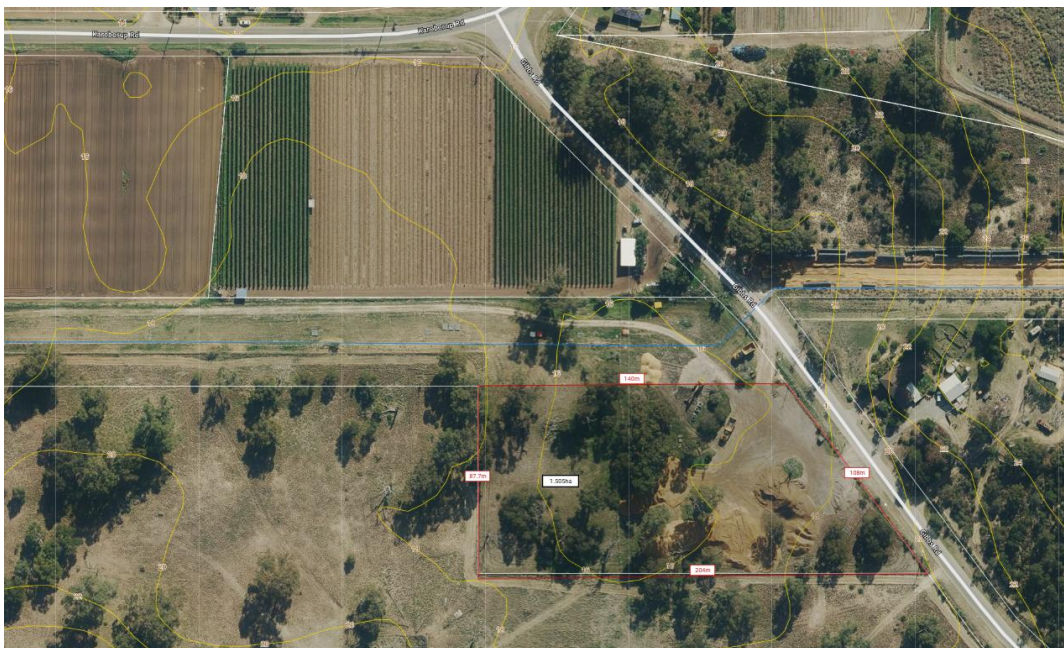
*Figure 8: Water Corporation Site Lot 204 Gibbs Road (MNG Access, 2026)*

The wastewater pumpstation at the western edge of the Carabooda DSP will transfer all flows in a western direction ultimately discharging to the Alkimos Main Sewer (AMS) that has already been constructed under the Yanchep rail. Water Corporation confirmed that Lot 204 Gibbs Road is owned by Water Corporation and would be the site of the wastewater pumping station that would receive all wastewater flows from the Carabooda DSP. The available lot area of approximately 1.5ha is shown in Figure 6 below.

This site is planned by Water Corporation to cater for the ultimate Carabooda Type 500 transfer wastewater pumping station which will service the greater Carabooda area and surrounds.

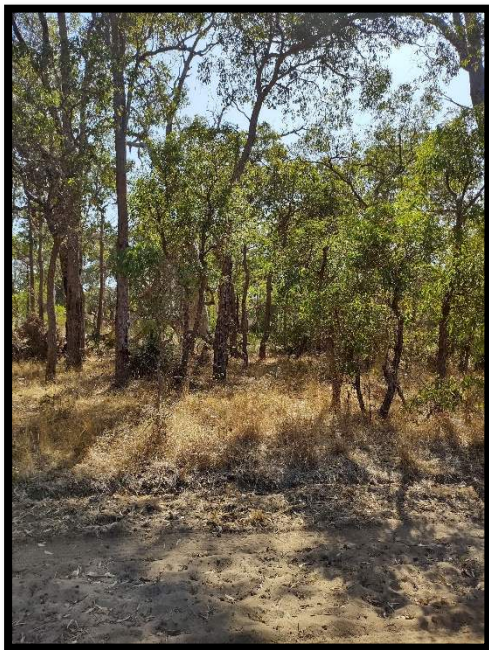
**Photo 1: Remnant bushland**

The site comprises a gently undulating landform with low hills and ridges, and includes area of bushland, market gardens, turf farming, limestone quarries and rural residential properties, as indicated in Photos 1 to 3 below.

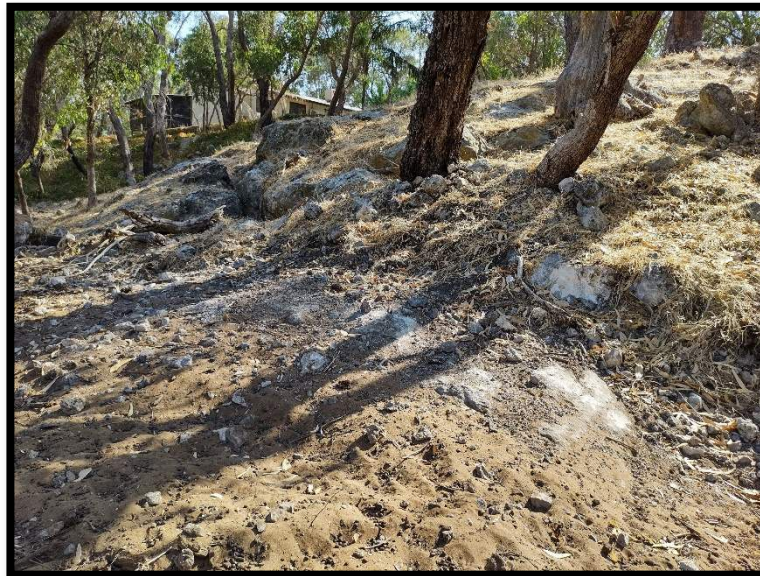
The ground conditions visible at surface during the visit generally corroborate the geological mapping and Douglas Partners' expectations for the site. Limestone outcropping was observed in the south-western corner of the site, which is mapped as the Limestone unit (LS2), as evident in Photo 4, below. Karst features such as caves which can occur within this unit, were not observed during the site visit, although the nature of the limestone outcrops in this area of the site are indicative of the landforms in which karst features may be present.

**Photo 4: Limestone outcrops**

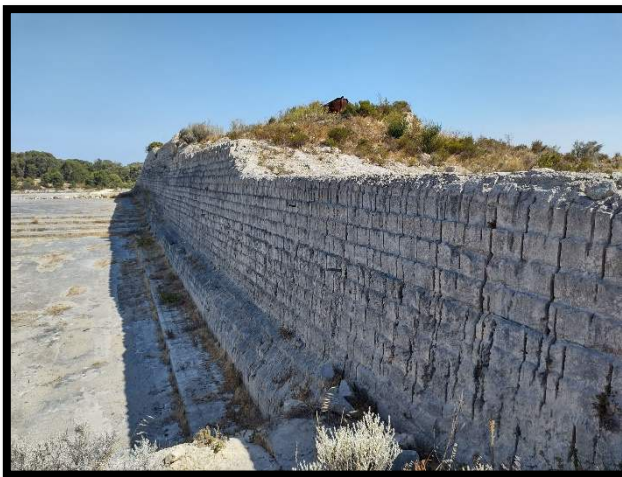
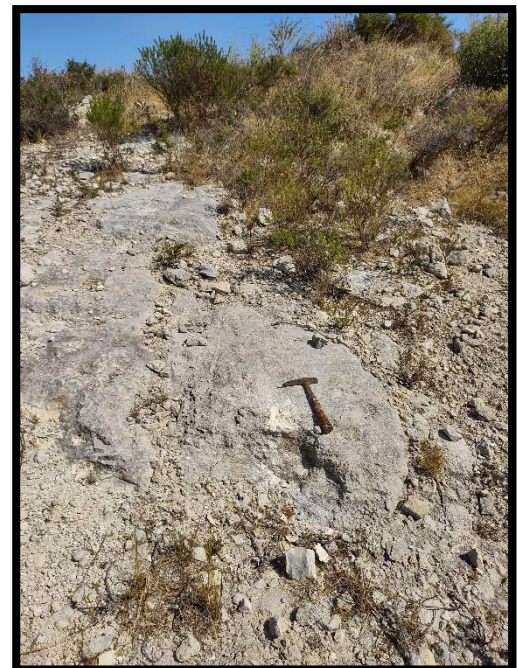
Photos 5 and 6 indicate the presence of limestone in a quarry area in the central part of the site, which is mapped as Limestone unit (LS1). The exposed limestone faces were estimated to be of low to medium strength, and the rock in this area has apparently been utilised for limestone block cutting.

**Photos 5 and 6: Exposed limestone**

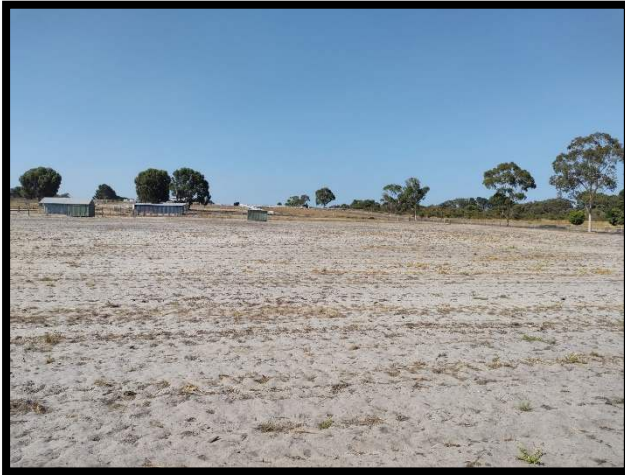
The surficial soils across the majority of the site comprise pale grey and light brown sand, as typical for the Sand unit (S7), indicated to be present in the geological mapping. Photos 7 to 9 indicate the sand conditions observed within the site. Limestone boulders and cobbles were highly prevalent across the surface of the site, and were observed near surface in shallow cuts across the site, as present in the centre of Photo 8. These observations across the sandy parts of the site indicate the presence of shallow limestone in some areas.

**Photo 7: Sand soils**

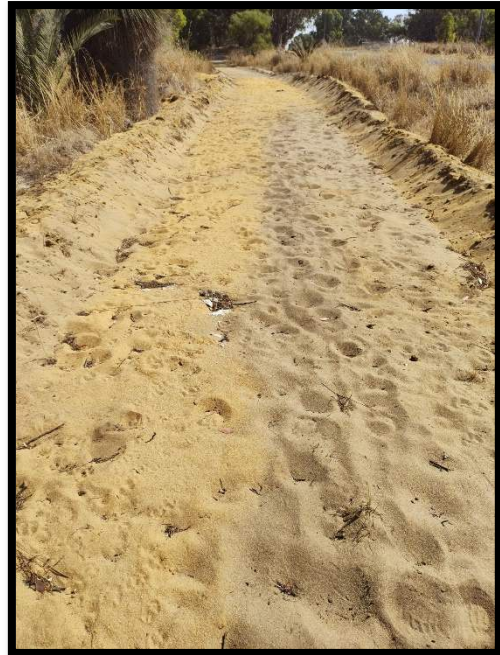
**Photo 8: Sand soils with limestone**
