ABANDONED MINE FEATURES ASSESSMENT

MORAWA-YALGOO ROAD GEOTECHNICAL REPORT

12009-G-R-001 Public Document

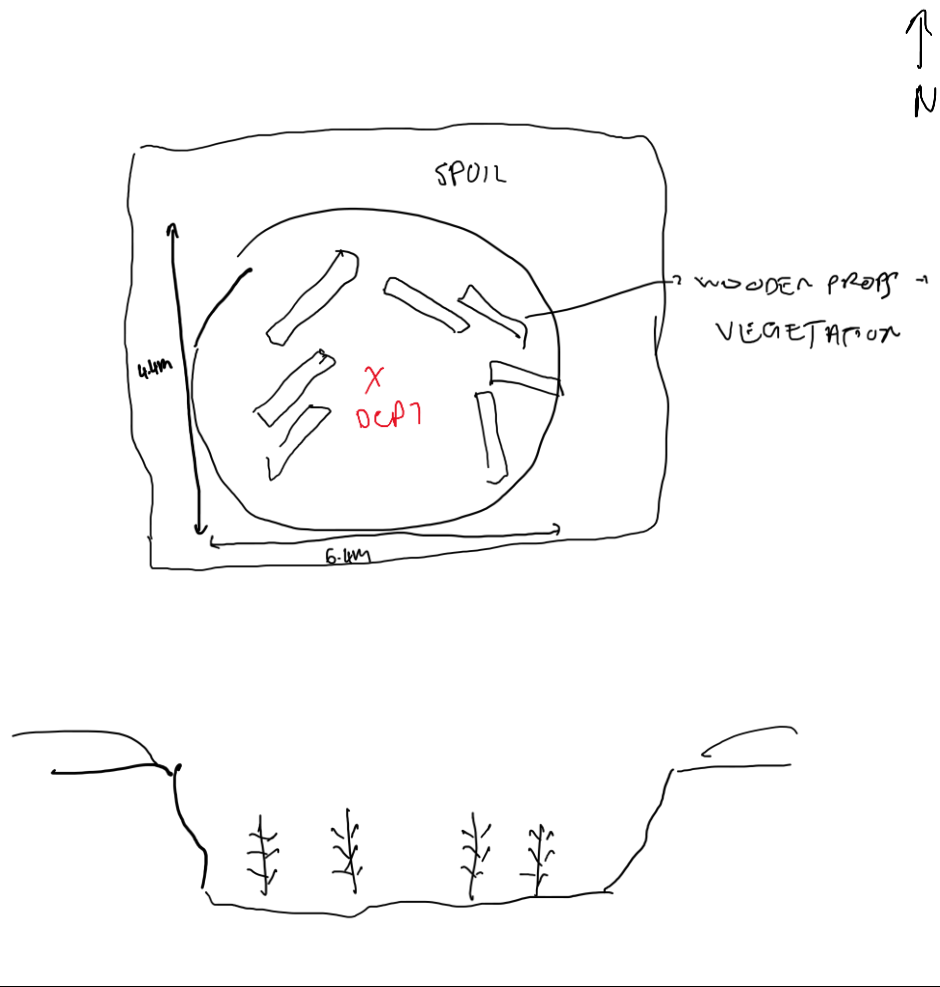
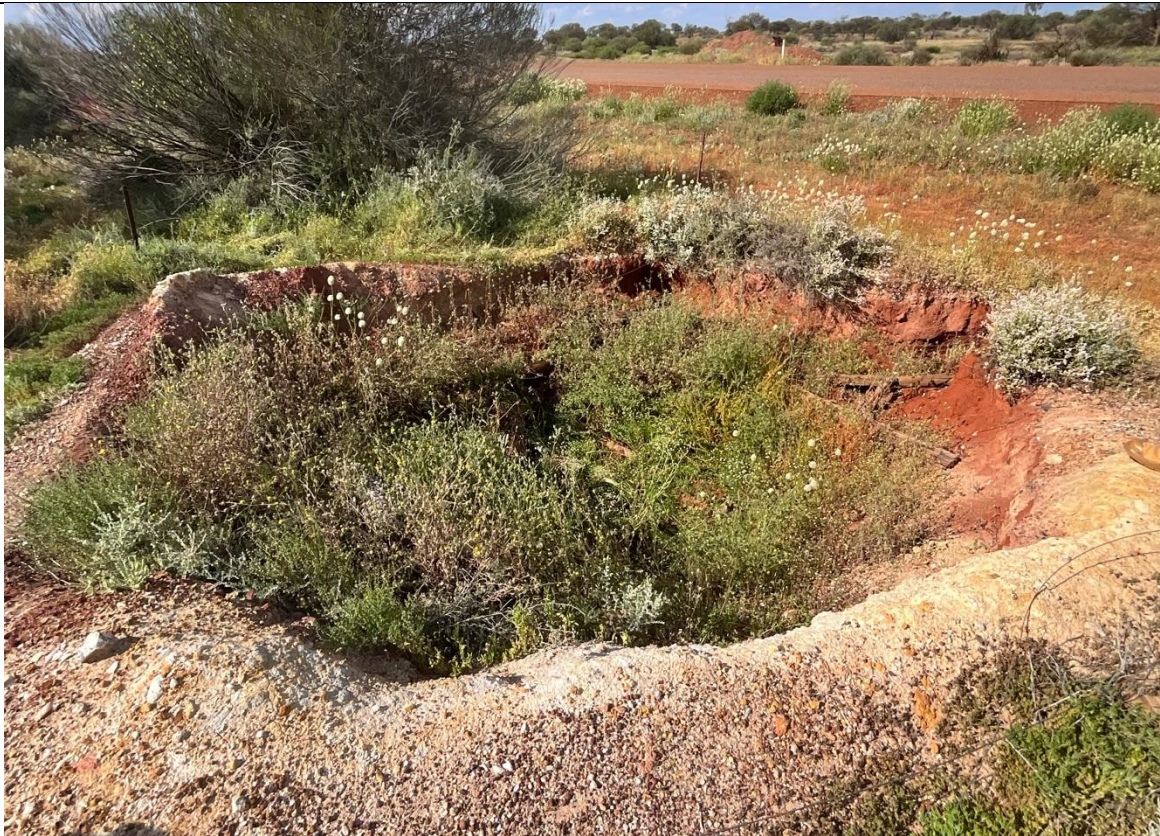
Rock mass / soil profile comments:	Preliminary remediation recommendations:
Silty sands with gravels present in the base. No visible evidence of rock walls in the feature.	Likely to be mirafi cone plug backfill pending disturbance works.

Coordinates	Recommendations for future investigation:
Latitude: -28.663110 Longitude: 116.315450	Disturbance: ram with excavator and clean out soil. Geophysical: no
Geometric characteristics:	Flora and fauna:
Approximate Dimensions (L x W x D): 2.7 x 5 x 2.5 Approximate Volume (m³): 15-20 Depth to groundwater (m): n/a Hydrological Features: The feature is positioned to the west of a culvert beneath the road and silt wash runoff has backfilled the shaft. Drainage issues may affect remediation method unless elevated / propped from existing ground surface.	No evidence of fauna detected within or surrounding the feature. Ground surface covered by grass, and the vegetation is dense surrounding the feature in this location. Small to medium sized trees surround the feature.
Description / comments / observations:	Noxious / flammable gas readings:
Collapsed shaft. Siltwash has backfilled the feature and evidence of erosion to the east near the road (drainage underneath the road) is evidenced in the walls. Small spoil pile surrounds the opening. Very soft base conditions as evidenced by DCP results.	CH₄: 0.0% CO₂: 0.0% H₂S: 0 ppm LEL: 3.9% O₂: 20.7% CO: 0 ppm

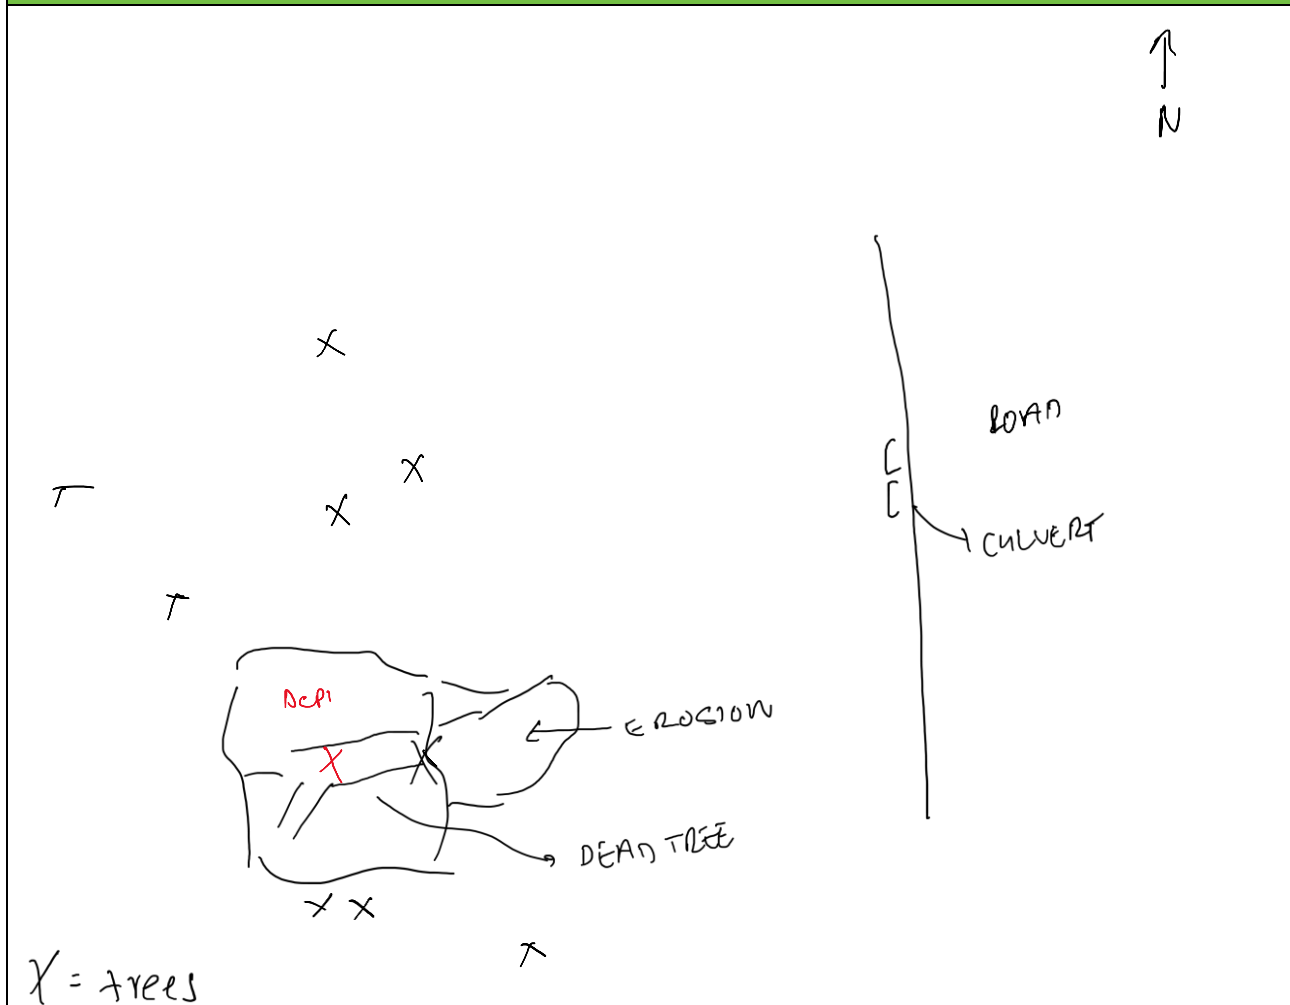
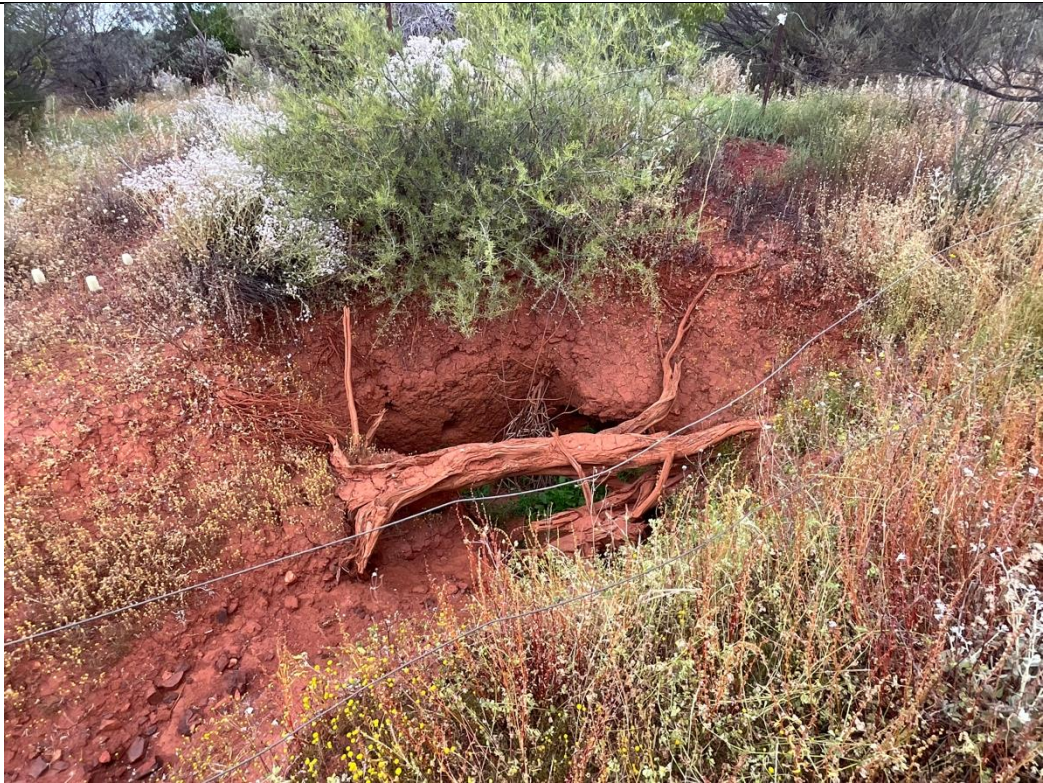
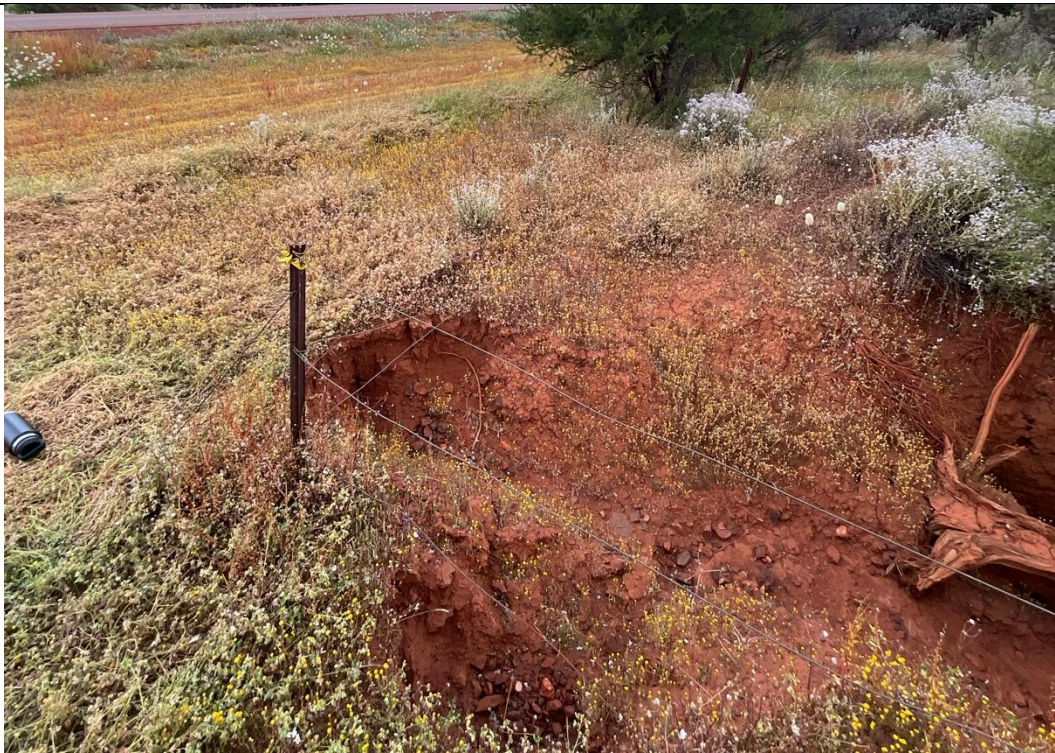
Rock mass / soil profile comments:	Preliminary remediation recommendations:
Cemented pizolithic gravels.	Mirafi cone plug – pending phase 2 results.

Coordinates	Recommendations for future investigation:
Latitude: -28.662156 Longitude: 116.316133	Disturbance: ram with excavator and clear out tin metal. Geophysical: yes?
Geometric characteristics:	Flora and fauna:
Approximate Dimensions (L x W x D): 2.5 x 1.5 x 1.1 Volume (m³): 3-4 Depth to groundwater (m): n/a Hydrological Features: The feature is positioned on high ground and is elevated from the adjacent road; surface run-off water is not considered risk for the remediation of this feature. No significant drainage issues were identified.	No evidence of fauna detected within or surrounding the feature. Ground surface covered by grass. The surrounding area is relatively free of vegetation.
Description / comments / observations:	Noxious / flammable gas readings:
The feature is a rectangular collapsed shaft. Pea gravel, wooden props and tin metal were observed in the base of the feature. A very small spoil pile surrounds the opening. Wooden pillars are propping the collar open. It is likely significantly deeper. A road delineator has been placed on the spoil pile to the west. A gravel stockpile is situated to the east nearby. A DCP was attempted, however, the base is obstructed. It is recommended the base be cleared, a scan undertaken, DCP to be done, and excavator ramming.	CH₄: 0.0% CO₂: 0.0% H₂S: 0 ppm LEL: 3.9% O₂: 20.8% CO: 0 ppm

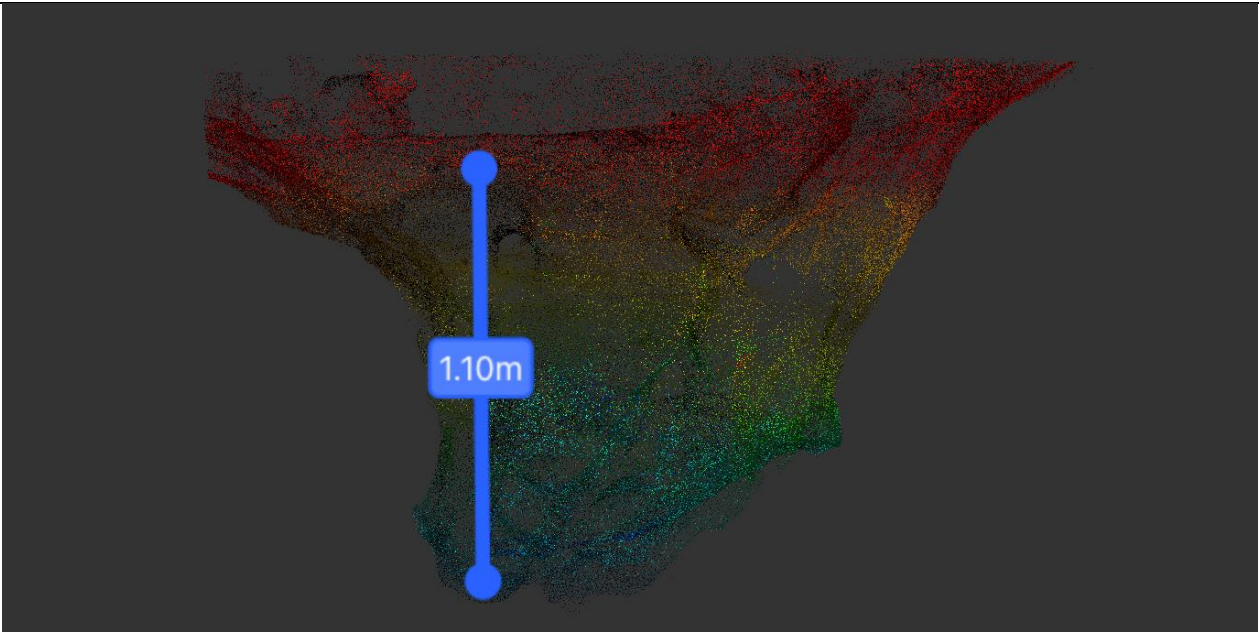
Feature WML4	Project No:	12009
	Client: Department of Energy, Mines, Industry Regulation and Safety (DEMIRS)	Date:	26/9/24

Rock mass / soil profile comments:	Preliminary remediation recommendations:
Very poor quality rock mass. Lateritic highly weathered rock from the ground surface.	Concrete cone plug, or a mirafi cone plug backfill solution.

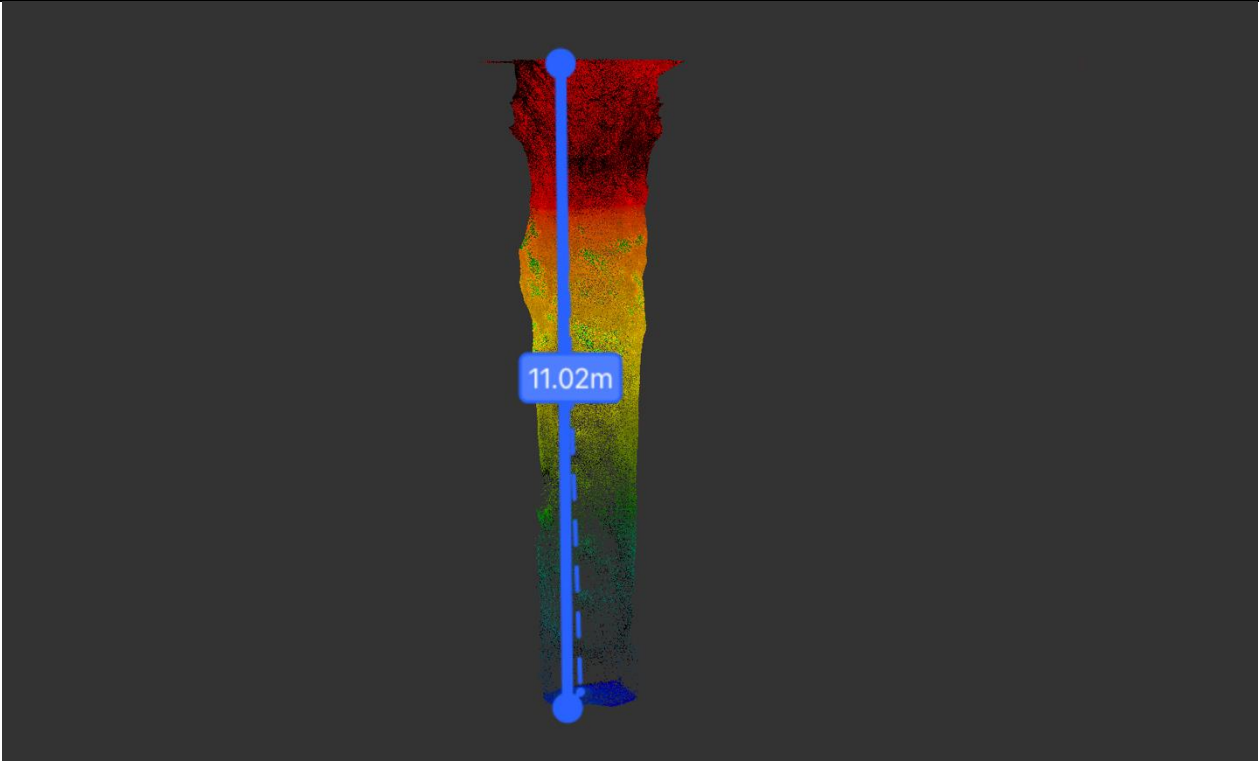
Feature S0227515	Project No:	12009
	Client: Department of Energy, Mines, Industry Regulation and Safety (DEMIRS)	Date:	26/9/24

Rock mass / soil profile comments:	Preliminary remediation recommendations:
Pizolithic gravels and sands from the ground surface.	Concrete cone plug ? If a planking solution is to be adopted, removal of the spoil pile and top 1 m if crumbly rock material will be required. Alternatively, use a mirafi cone plug backfill.

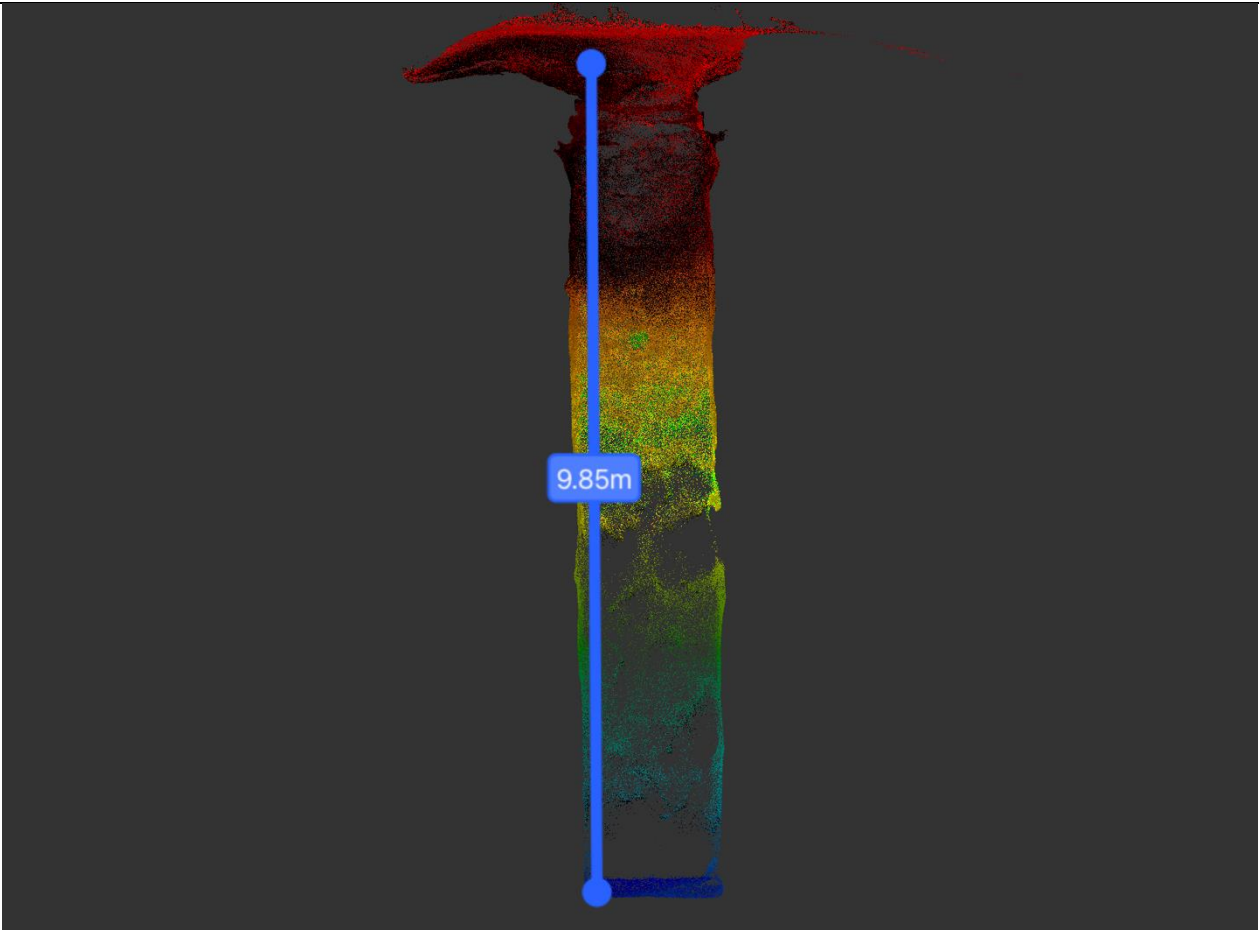
Feature S0227528	Project No:	12009
	Client: Department of Energy, Mines, Industry Regulation and Safety (DEMIRS)	Date:	26/9/24

Rock mass / soil profile comments:	Preliminary remediation recommendations:
Pizolitic gravels and sands from the ground surface.	Concrete cone plug ? If planking, remove spoil pile and top 1 m if crumbly rock material. Or backfill with large rocks over the groundwater and then spoil material and mine waste rock from gullewa mine?

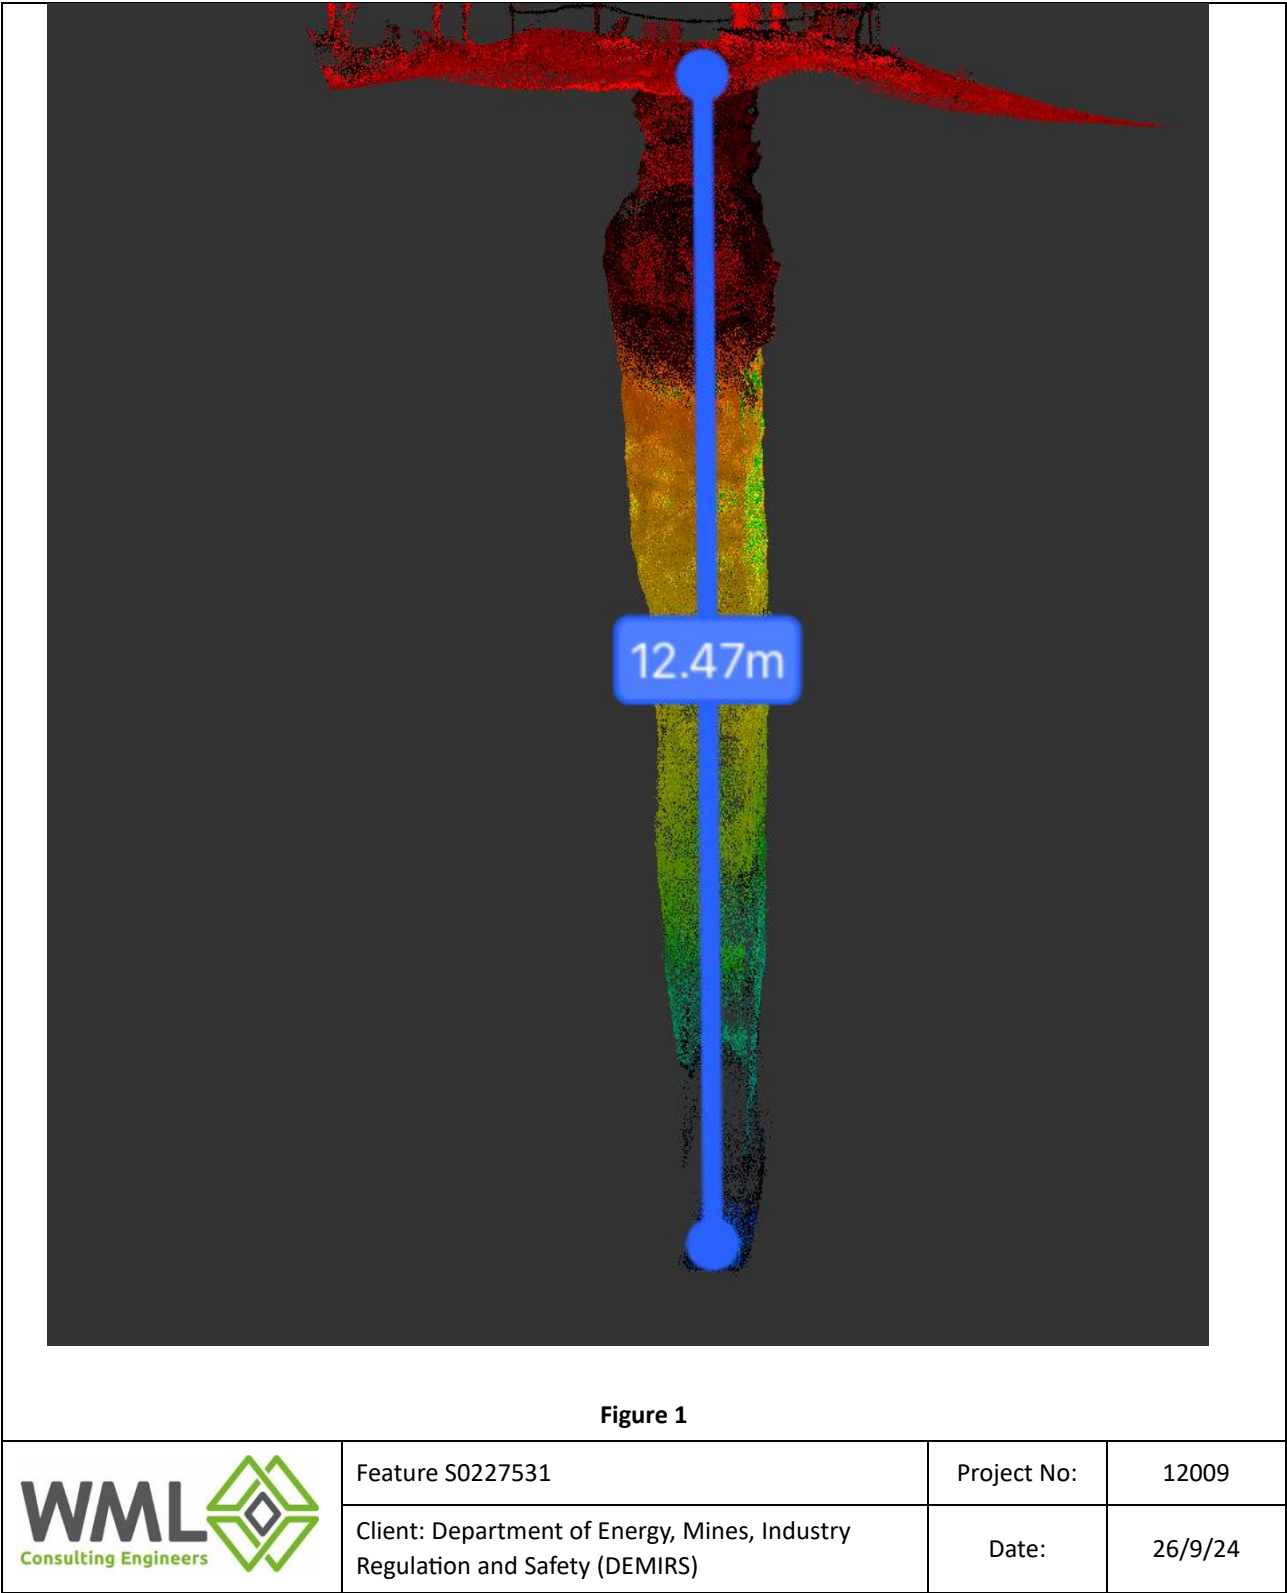
Feature S0227531	Project No:	12009
	Client: Department of Energy, Mines, Industry Regulation and Safety (DEMIRS)	Date:	26/9/24

Rock mass / soil profile comments:	Preliminary remediation recommendations:
Cemented pizolithic gravels from the ground surface. This material is more cemented and less crumbly at this location that features S0227532 % S0227531.	Mirafi soil cone backfill plug ? If planking, remove spoil pile and top 0.6 m.

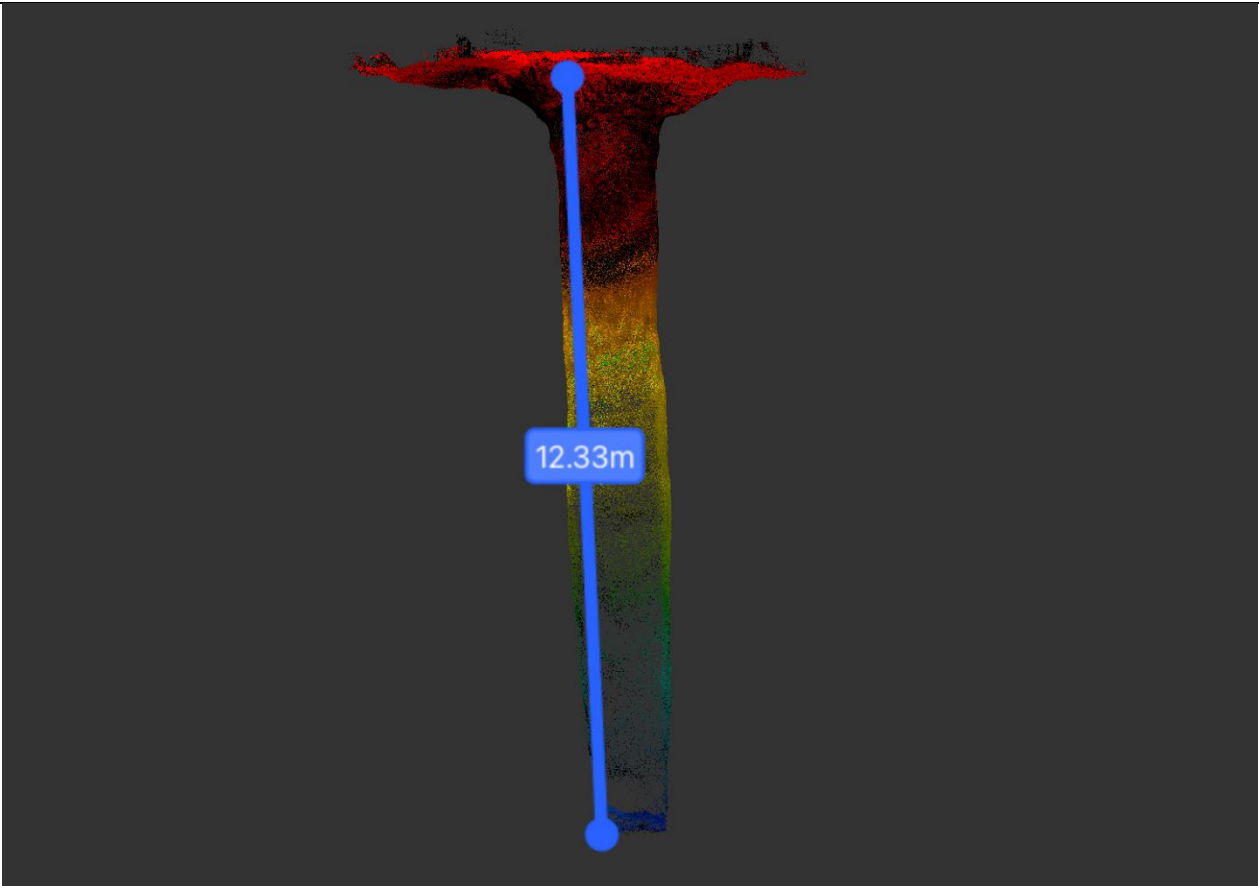
Feature S0227532	Project No:	12009
	Client: Department of Energy, Mines, Industry Regulation and Safety (DEMIRS)	Date:	26/9/24

Rock mass / soil profile comments:	Preliminary remediation recommendations:
Reasonably good quality and competent rock mass. Moderately weathered. Near vertical rock walls that are jagged.	Concrete cone plug ?

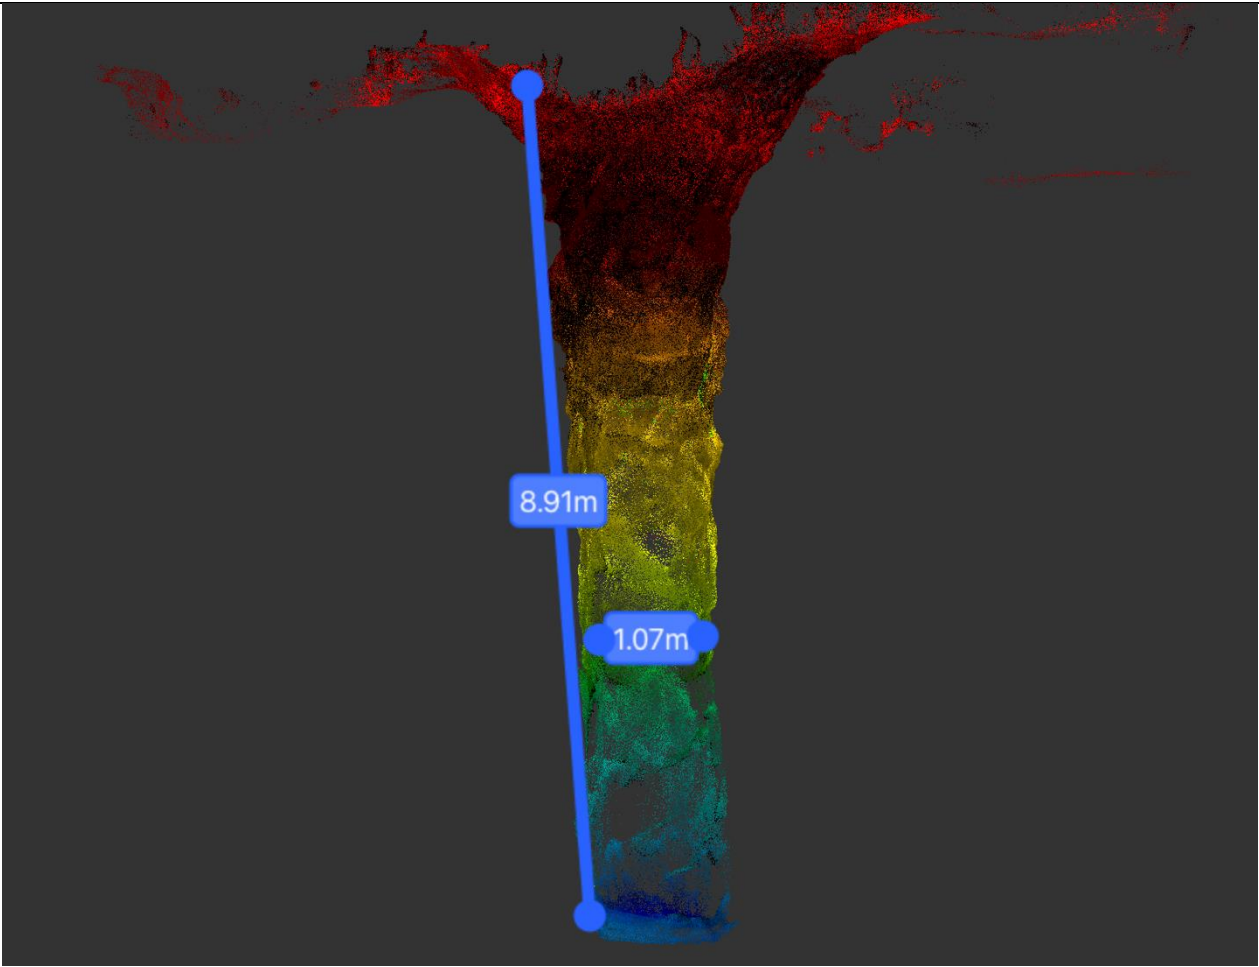
Feature S0229117	Project No:	12009
	Client: Department of Energy, Mines, Industry Regulation and Safety (DEMIRS)	Date:	26/9/24

Rock mass / soil profile comments:	Preliminary remediation recommendations:
Poor quality rock mass and reasonably competent. Highly weathered rock, that is jagged and near vertical rock walls.	Concrete cone plug.

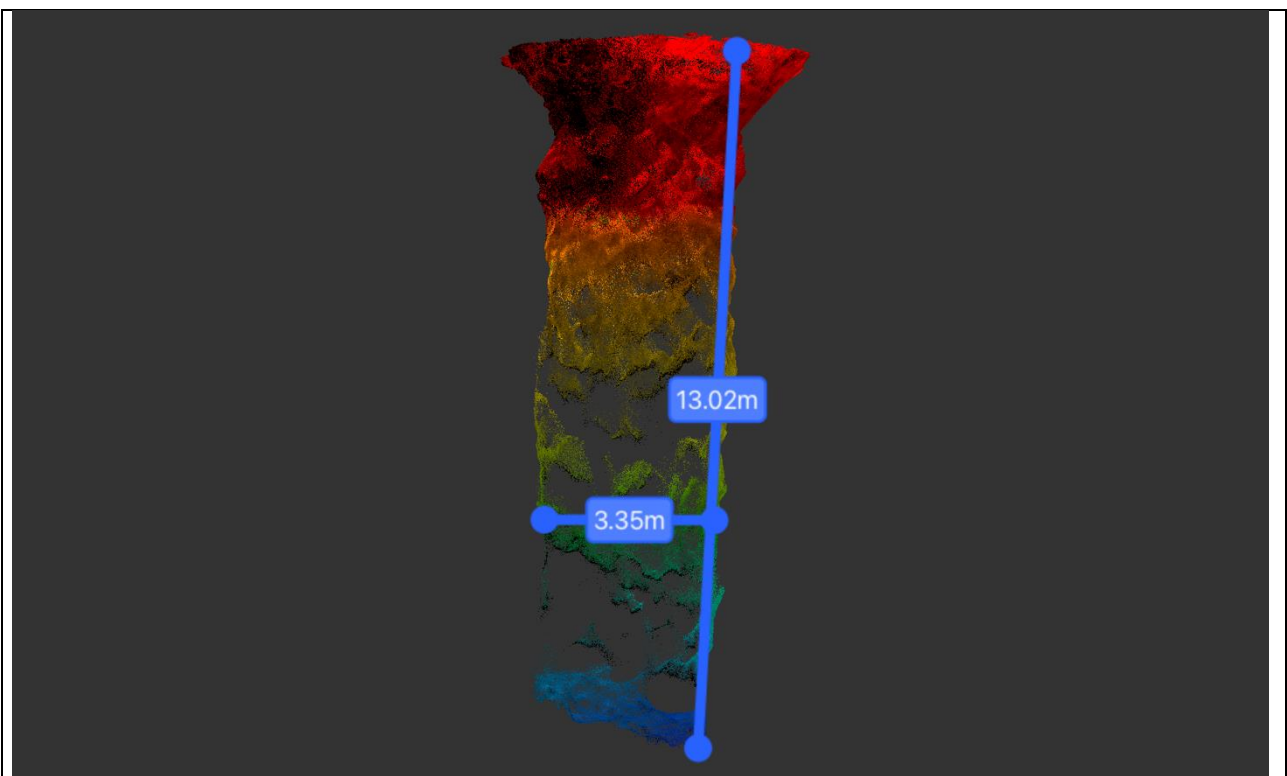
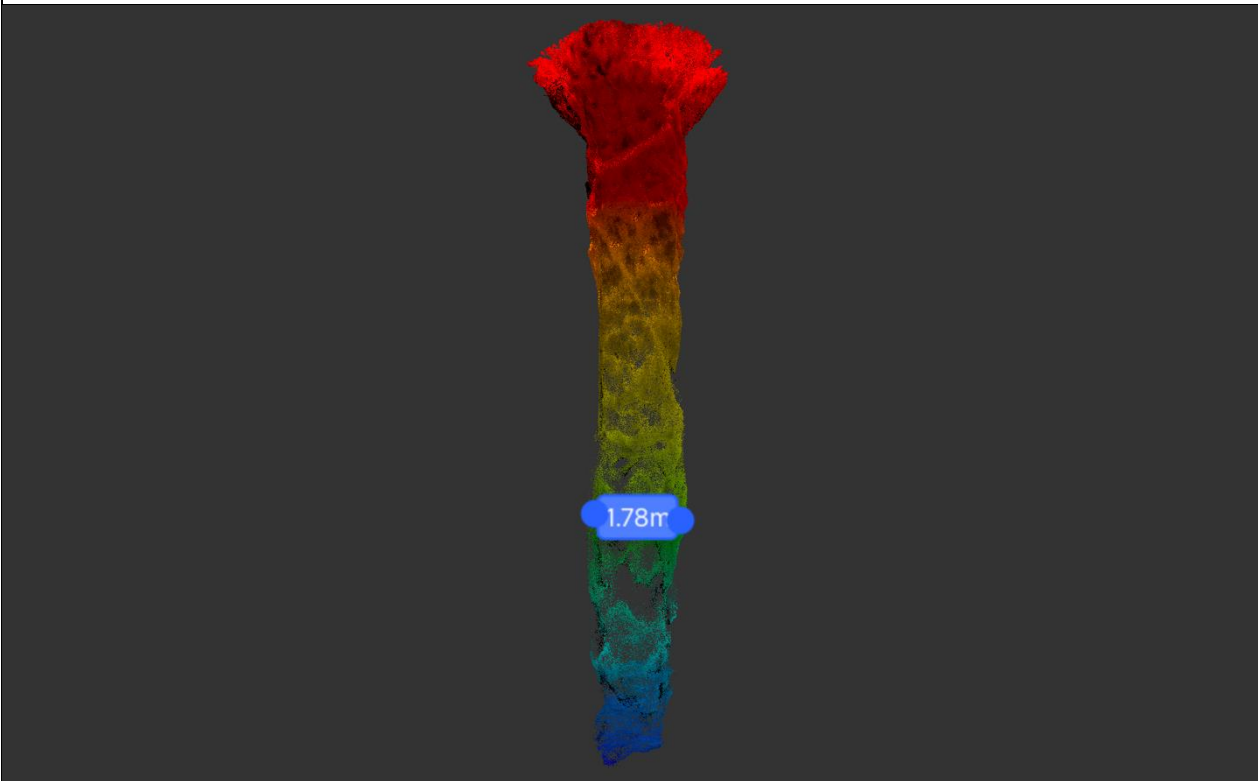
Feature S0229118	Project No:	12009
	Client: Department of Energy, Mines, Industry Regulation and Safety (DEMIRS)	Date:	26/9/24

Rock mass / soil profile comments:	Preliminary remediation recommendations:
Very poor crumbly soil like rock mass for top 1 m overlying very poor quality rock mass. Highly weathered. Near vertical walls.	Concrete cone plug? If planking, remove spoil pile and top 1 m if crumbly rock material. Or backfill with large rocks over the groundwater and then spoil material and mine waste rock from gullewa mine?

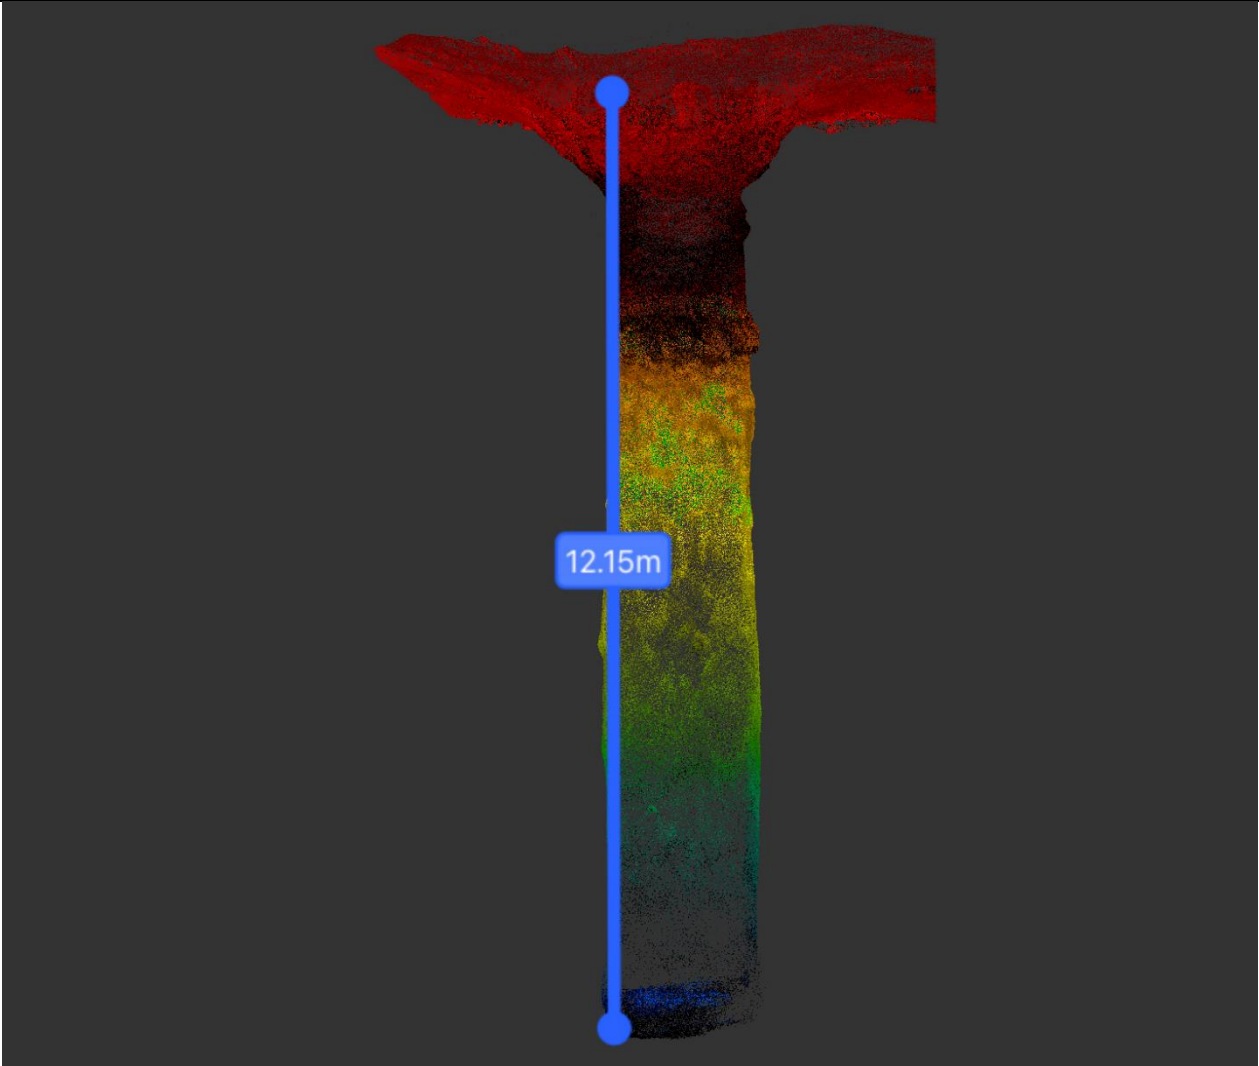
Feature S0229157	Project No:	12009
	Client: Department of Energy, Mines, Industry Regulation and Safety (DEMIRS)	Date:	26/9/24

Rock mass / soil profile comments:	Preliminary remediation recommendations:
Very poor crumbly soil like rock mass. Extremely weathered rock and cemented lateritic soils near the surface. Near vertical walls.	Mirafi cone plug? Ground unsuitable for founding planks or capping solutions.

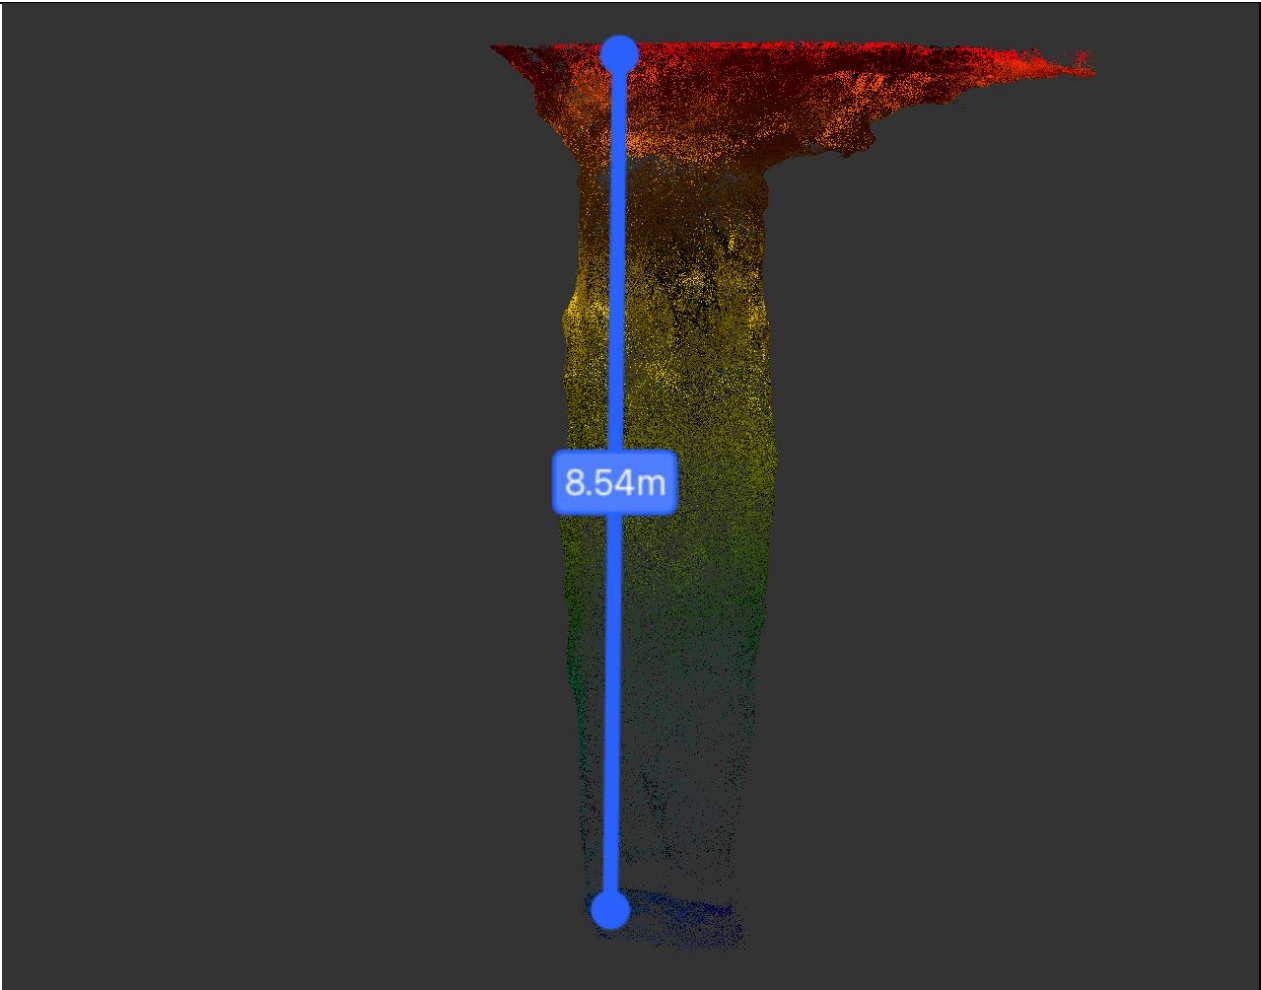
Feature S0229158	Project No:	12009
	Client: Department of Energy, Mines, Industry Regulation and Safety (DEMIRS)	Date:	26/9/24

Rock mass / soil profile comments:	Preliminary remediation recommendations:
Very poor crumbly soil like rock mass. Extremely weathered rock. Near vertical walls.	Mirafi cone plug? Ground is unsuitable for founding planks or capping solutions.

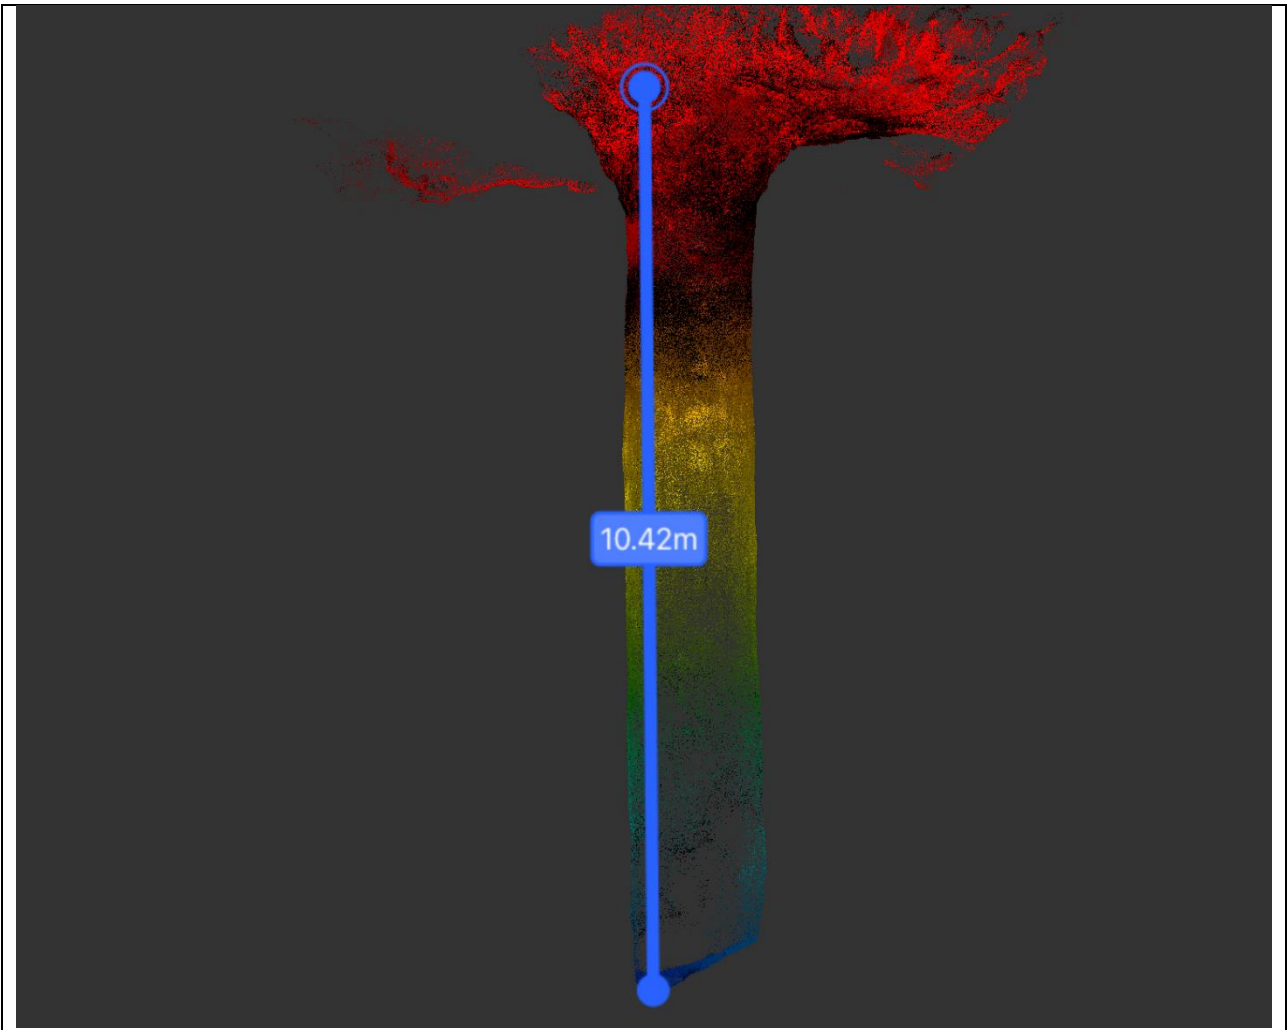
Feature S0229159	Project No:	12009
	Client: Department of Energy, Mines, Industry Regulation and Safety (DEMIRS)	Date:	26/9/24

Rock mass / soil profile comments:	Preliminary remediation recommendations:
Very poor soil like rock mass. Extremely weathered. Near vertical walls. Approximately 2 m of gravelly lateritic soils overlying the rock.	Mirafi cone plug ?

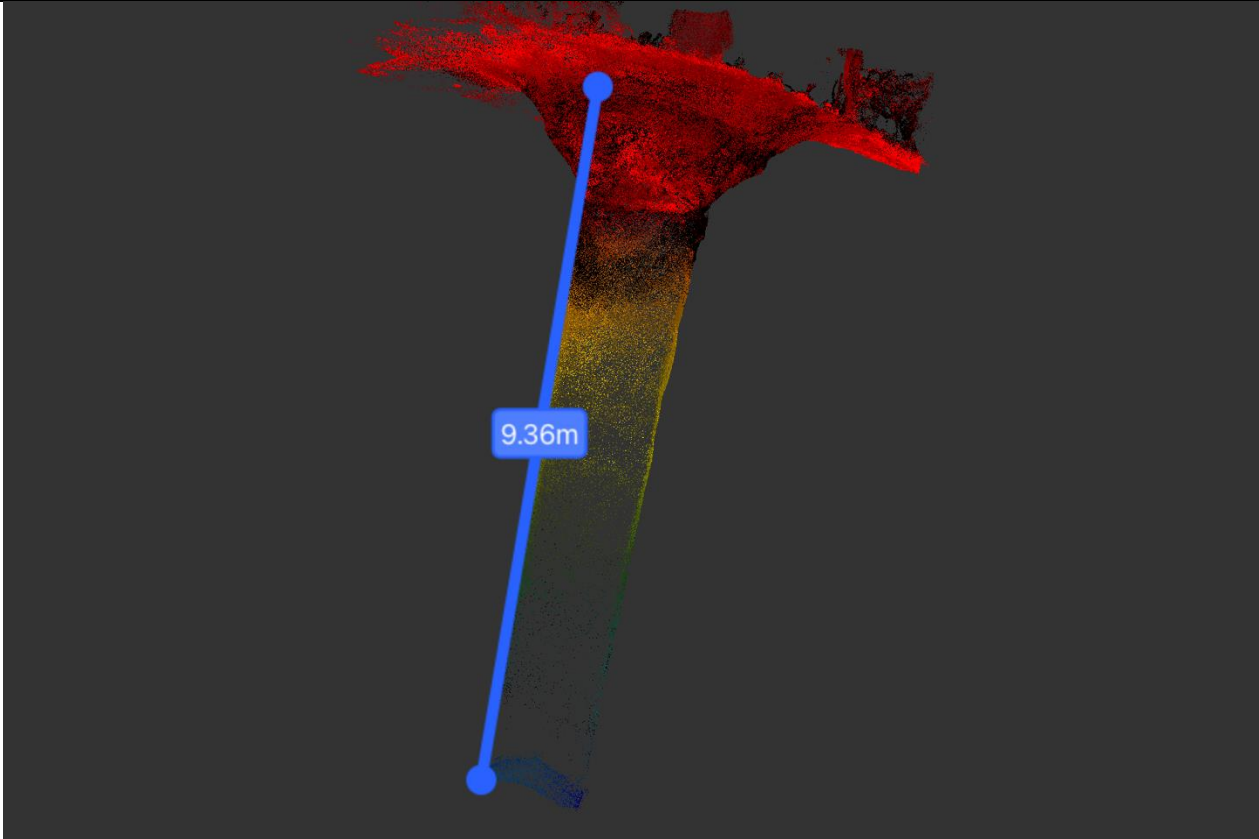
Feature S0229160	Project No:	12009
	Client: Department of Energy, Mines, Industry Regulation and Safety (DEMIRS)	Date:	26/9/24

Rock mass / soil profile comments:	Preliminary remediation recommendations:
Very poor soil like rock mass. Extremely weathered. Near vertical rock walls. There is approximately 1 m of crumbly lateritic soils overlying very poor quality rock mass.	Mirafi cone plug?

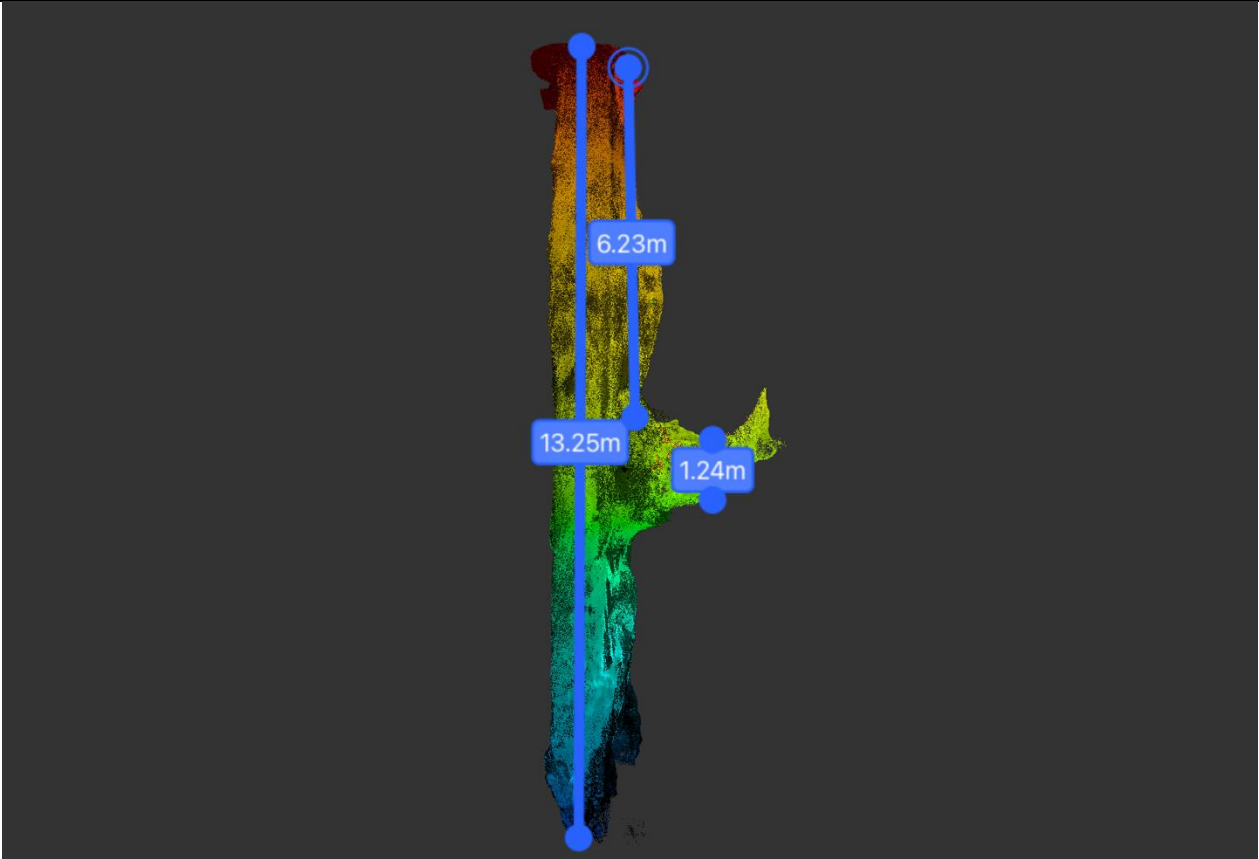
Figure 1

Coordinates	Recommendations for future investigation:
Latitude: -28.658410 Longitude: 116.316199	Disturbance: no Geophysical: yes
Geometric characteristics:	Flora and fauna:
Approximate Dimensions (L x W x D): 3.3 x 1.8 x 13.5 (to water level) Approximate Volume (m³): 80 (to the water level) Depth to groundwater (m): 13.5 m. Hydrological Features: The feature is positioned high and flat ground; surface run-off water is not considered risk for the remediation of this feature. No significant drainage issues were identified.	No evidence of fauna detected within or surrounding the feature. Ground surface covered by grass, and the surrounding area is relatively free of vegetation.
Description / comments / observations:	Noxious / flammable gas readings:
<p>The feature exists as an almost shaft oriented at approximately 60 degrees east.</p> <p>The 3D LiDAR scans suggested the feature is 13.5 m deep, however, the base was partially plugged and obscured and the actual depth is likely far greater. The depth of the feature below the encountered water level is also unknown.</p> <p>The LiDAR scan reflected on the water surface. Lateral workings approximately 1-2 m wide at about 3.6 m bgl were identified heading both in both eastern and western directions. This may have been connected to feature S0229119 across the road to the west, however this western drive is now backfilled.</p> <p>The eastern drive may be backfilled, however, due to the orientation of the shaft, LiDAR scanning was unable to determine this with great accuracy.</p> <p>A large spoil pile is situated to the east.</p>	CH₄: 0.0% CO₂: 0.0% H₂S: 0 ppm LEL: 4.0% O₂: 20.8% CO: 0 ppm

Rock mass / soil profile comments:	Preliminary remediation recommendations:
Poor quality rock mass, however, more competent than the features further south.	Mirafi plug backfill. No need to collapse the drive.
