ABANDONED MINE FEATURES ASSESSMENT

MORAWA-YALGOO ROAD GEOTECHNICAL REPORT

12009-G-R-001 Public Document

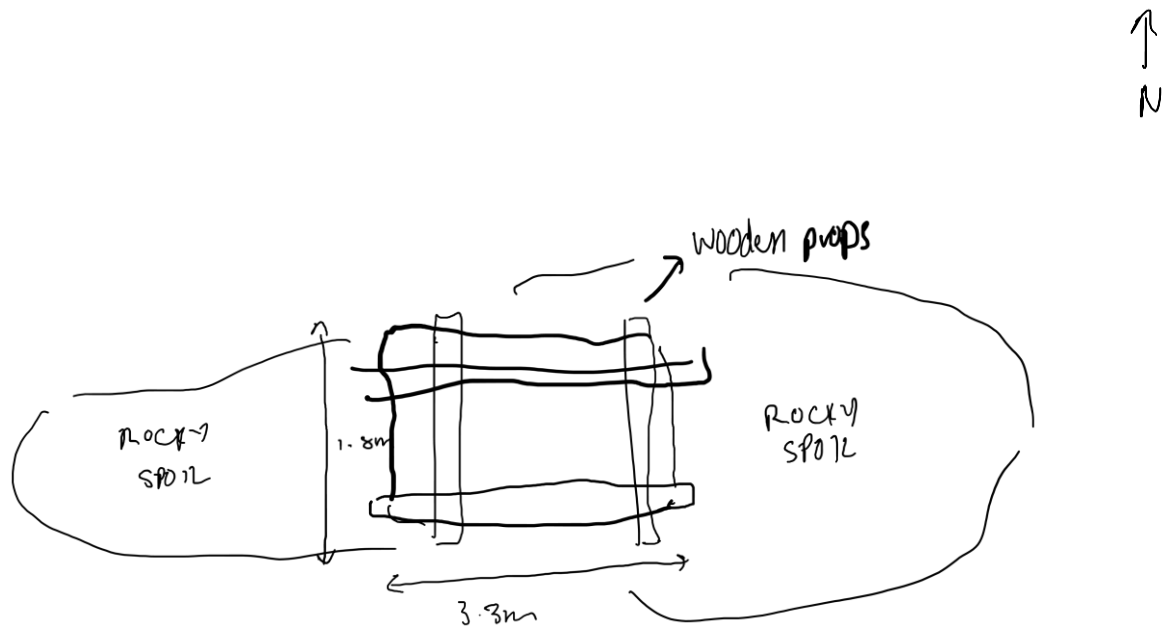
Sketch of Feature:

Rock mass / soil profile comments:	Preliminary remediation recommendations:
Poor quality rock mass, however, more competent than the features further south.	Mirafi plug backfill. No need to collapse the drive.

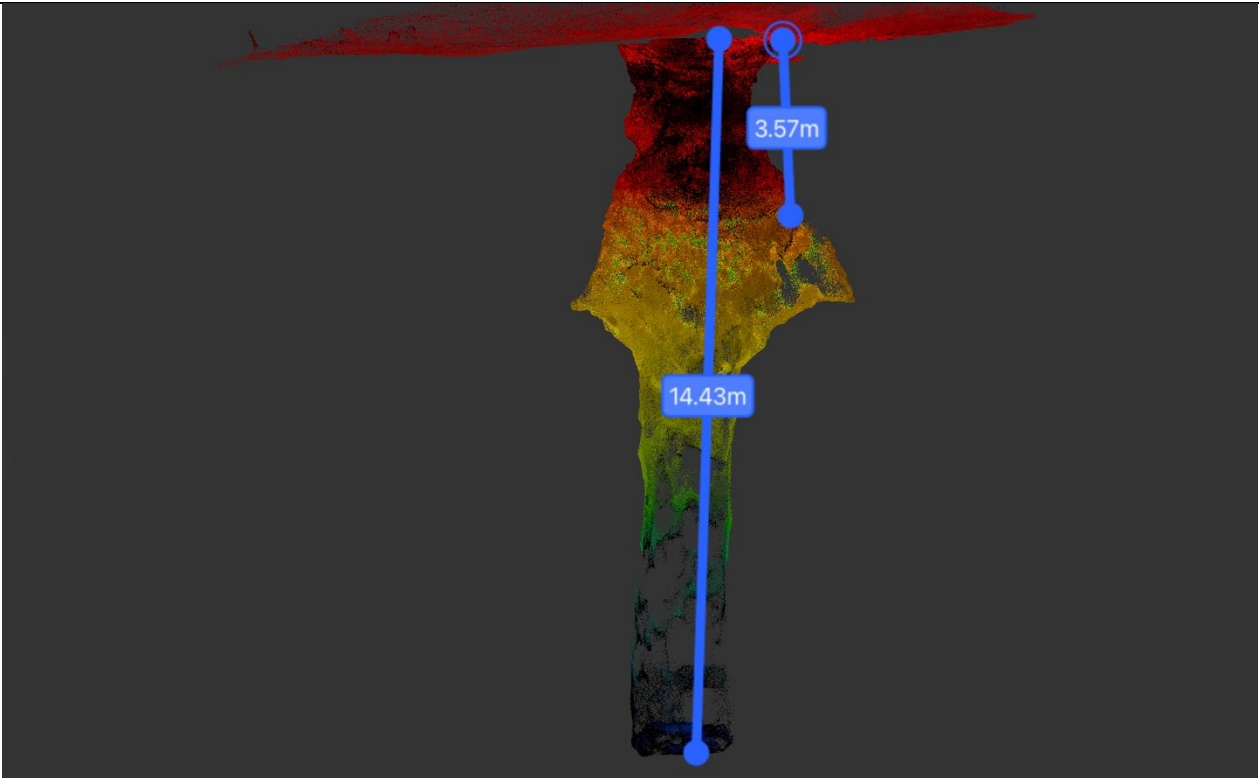
Figure 1

Coordinates	Recommendations for future investigation:
Latitude: -28.659050 Longitude: 116.316120	Disturbance: test pits to determine competency of ground for founding concrete planks. Geophysical: yes
Geometric characteristics:	Flora and fauna:
Approximate Dimensions (L x W x D): 5.8 x 2 x 11 Volume (m³): 120-150 (to the visible floor) Depth to groundwater (m): n/a Hydrological Features: The feature is positioned on high and flat ground; surface run-off water is not considered risk for the remediation of this feature. No significant drainage issues were identified.	No evidence of fauna detected within or surrounding the feature. Ground surface covered by grass and weeds. There is very little vegetation surrounding the feature.
Description / comments / observations:	Noxious / flammable gas readings:
<p>The feature is a stope that is held propped open by wooden pillars. There are drives trending east at approximately 4 m bgl. The LiDAR scan showed the depth of the feature to be 11 m however the feature is significantly deeper.</p> <p>A drive may potentially be connected to S0122139 to the south west, however, it may be backfilled now. The eastern drive was likely connected to S0122137 at one stage. The LiDAR scans could not determine whether the drives are backfilled due to blind spots and dipping shape of the feature.</p>	CH₄: 0.0% CO₂: 0.0% H₂S: 0 ppm LEL: 3.6% O₂: 20.7% CO: 0 ppm

Rock mass / soil profile comments:	Preliminary remediation recommendations:
Poor quality rock mass. Near vertical rock walls.	Break out and collapse drive to the east – explosives? And backfill the main stope using mirafi?
