ABANDONED MINE FEATURES ASSESSMENT

YALGOO, WA REHABILITATION OPTIONS STUDY

11715-G-R-002 Public Document

Issued to:	Department of Energy, Mines, Industry Regulation & Safety (DEMIRS)
WML Project Number:	11715
Document Name:	11715-G-R-002 Public Document

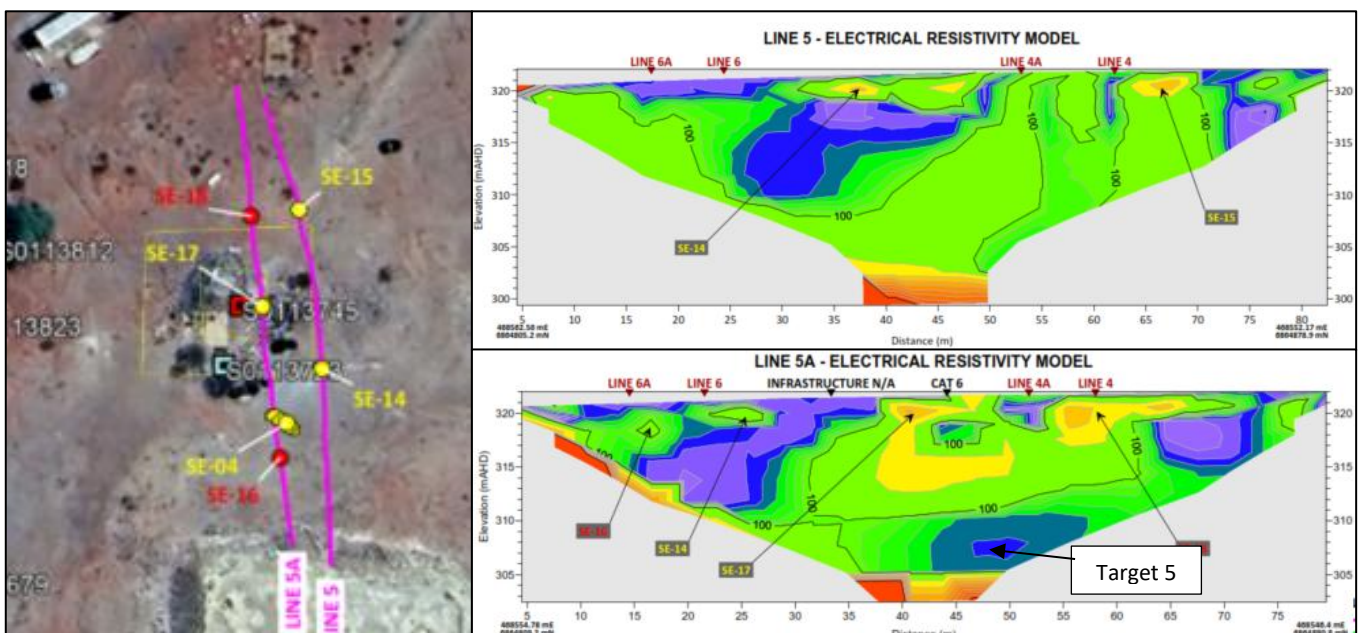
Figure 10: Electrical Resistivity Model Line 5 and Line 5A

Line 5A SE-17	1.5	S0113745	ERT testing undertaken in the south-western portion of the site detected numerous shallow anomalies around the main shaft. SE-17 may be suggestive of what may have been a trench sloping downwards into the shaft from the east in the older portion of the shaft.	No lateral workings were detected within the top 13 m of the shaft during the 3D LiDAR scan; therefore, the majority of the anomalies may be interpreted as localised zones of hard rock as opposed to voids.	The potential for a trench or shallow drive within the older shaft within this feature shall be considered during the rehabilitation design. Note that this was also detected during the 3D LiDAR scanning.
Line 5 Target 5	15.0	S0113745	Figure 10 shows a zone of very low electrical resistivity at approximately 15.0 m bgl to the south of the feature. This target is located below the water	This target has been identified beyond the depth of the shaft which was scanned with the 3D LiDAR scanner.	Any voids at this depth are unlikely to cause any significant surface subsidence expressions (very low risk).

Geophysical Target ID	Depth of Target (m)	Feature	Geophysical Interpretation	Historic Data & Site Observations	Significance
			table and is suggestive of a waterlogged underground mine void / lateral working.	This feature is a main shaft that extended to 38 m based on the historical information.	Based on the depth of these features, quality of the rock mass, and width of the mined lodes in the area, any below the target depths are not expected to cause any significant surface subsidence and pose very low risk of surface subsidence expressions or ground collapse. However, the presence of lateral workings shall be considered during rehabilitation design.
<u>Line 7</u> CW-04	10.0	S0113334	As shown in Figure 12, a target with an electrical resistivity of approximately 600 Ωm, was identified at 10.0 m bgl. This is likely to be indicative of a collapsed and backfilled void, however, a void may also still exist at this location.	The 3D LiDAR scanning identified that the feature stopes towards the west. This target is strongly correlated to the known void identified during the geotechnical investigation at Feature S0113334.	The geophysical data does not suggest this target to be voids as the electrical resistivities do not correspond to air voids, and therefore, these targets pose very low risk of surface subsidence. This is likely to be backfilled / collapsed. However, there is a possibility that air voids still exist at this depth in this location. However, CW-04 is deep and narrow enough that it is unlikely to cause any significant surface subsidence in the event of collapse.

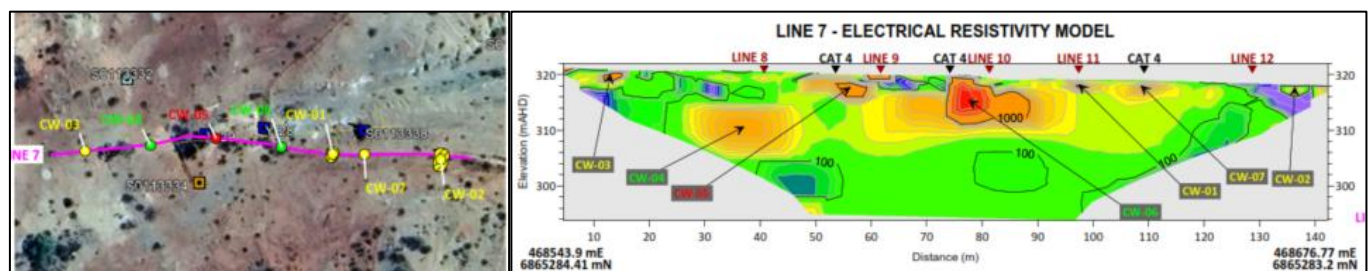
Figure 12: Electrical Resistivity Model Line 7

<u>Line 7</u> CW-05	2.8	Y-29	As shown in Figure 12, a target with an electrical resistivity of approximately 600 Ωm, was identified at 2.8 m bgl. This is likely to be indicative of a collapsed and backfilled void, however, a void may also still exist at this location.	The 3D LiDAR scanning identified that the feature stopes towards the west. This target is strongly correlated to the known void identified during the geotechnical investigation at Feature Y-29.	The geophysical data does not suggest this target to be voids as the electrical resistivities do not correspond to air voids, and therefore, these targets pose very low risk of surface subsidence. This is likely to be backfilled / collapsed. However, there is a possibility that air

Geophysical Target ID	Depth of Target (m)	Feature	Geophysical Interpretation	Historic Data & Site Observations	Significance
					voids still exist at this depth in this location. The shallower depth of CW-05 shall be considered for the rehabilitation of this feature.
<u>Line 7</u> CW-06	4.6	Y-28	<p>As shown in Figure 12, a relatively high resistivity target (4000 Ωm), was identified 4.6 m bgl. This target is likely to be indicative of a void below the false floor identified on site during the geotechnical investigation.</p> <p>The target is located approximately 8.6 m to the southeast of the feature.</p>	<p>The 3D LiDAR scanning of feature Y-28 showed the presence of shallow lateral workings (< 4 m deep) as well as the presence of lateral workings tending to the west of the feature beneath a false floor.</p> <p>Due to obstructions, the southern and eastern portions of the feature below the false floor were not able to be LiDAR scanned, therefore, the geophysical target to the south below the depth of the false floor is very likely to be a void.</p>	Lateral workings identified to the southeast of Feature Y-28; however, they are small and deep enough such that they pose very low risk of surface subsidence expression in the event of void collapse.

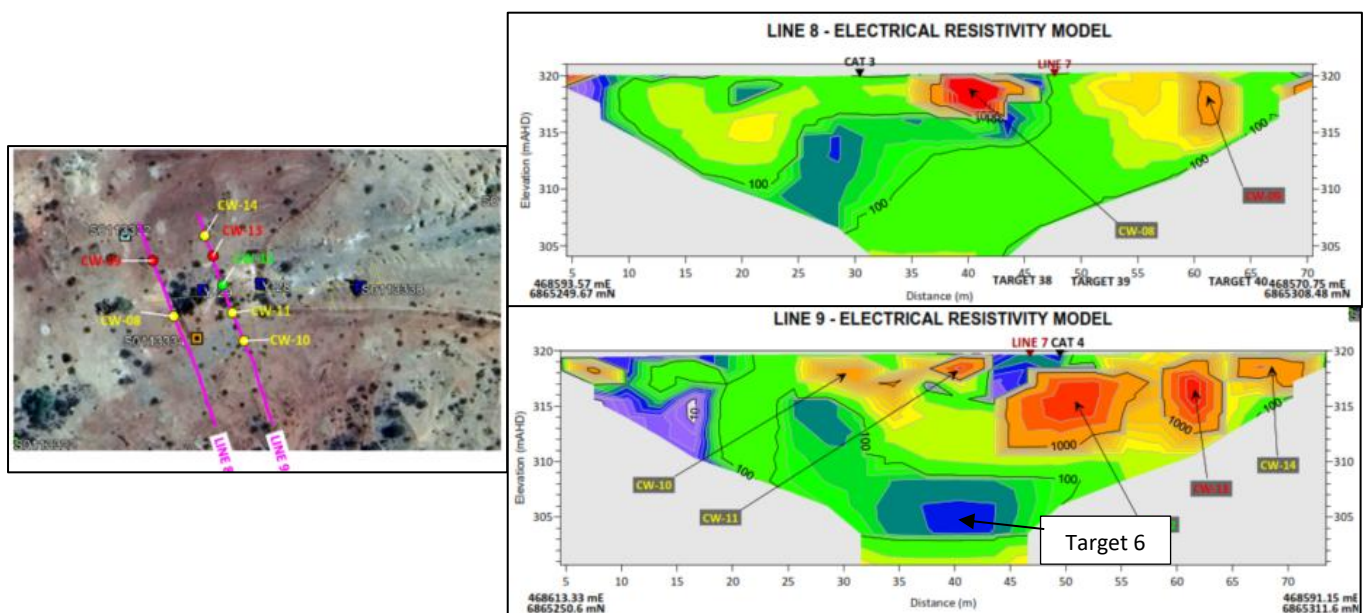
Figure 13: Electrical Resistivity Model Line 8 and Line 9

<u>Line 9</u> Target 6	15.0	Y-29 S0113338	Figure 13 shows a zone of very low electrical resistivity at approximately 15.0 m bgl. This target is located below the assumed water table and is indicative of a waterlogged underground mine void / lateral working. The relatively rectangular shape of the target is suggestive of an underground drive. This target may also be a saturated backfilled / collapsed drive.	Based on the available historical information, several deep shafts were sunk in the Emerald Reward Claim, and these are likely to have been interconnected with lateral workings.	Any voids at this depth are unlikely to cause any significant surface subsidence expressions (very low risk).
<u>Line 10</u> Target 7 <u>Line 11</u>	12.0	Y-28 S0113338	Figure 14 suggests a zone of very low electrical resistivity at approximately 12.0 m bgl. These targets are located below the water table and may be	Y-28 is a shaft with a false floor was identified in the base during the geotechnical investigation. 3D LiDAR scanning picked up some lateral working	Any voids at this depth are unlikely to cause any significant surface subsidence expressions (very low risk).

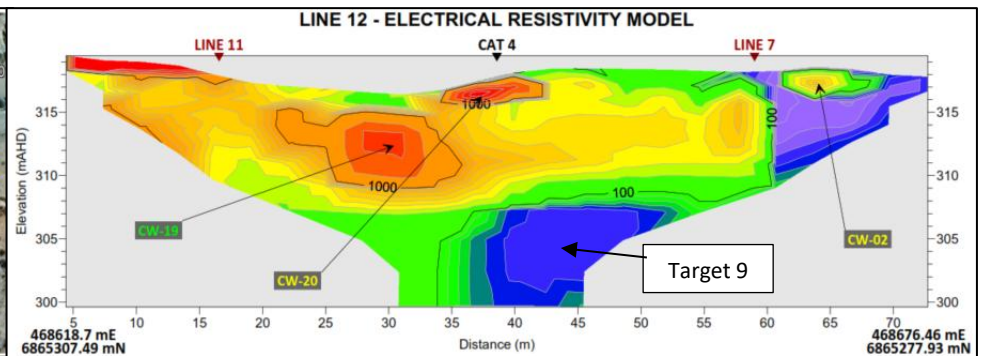
Figure 15: Electrical Resistivity Model Line 12

<u>Line 12</u> CW-19 CW-20	1.1 – 4.0	S0113338	As shown in Figure 15, higher resistivity targets (3000 – 5000 Ωm) have been identified around this feature at depths of approximately 1.1 m (CW-20) and 4 m bgl (CW-19).	S0113338 may be a backfilled shaft or stope, and the targets detected around this feature suggest high risk of voids based on the fact that more extensive workings had been undertaken in the Emerald Reward Claim and that several shafts once existed in the area. They likely comprised lateral workings and underground stopes and interconnectivity.	The high risk of voids associated with these geophysical targets shall be considered for the rehabilitation design of this feature.
<u>Line 12</u> Target 9	12.5	S0113338	Figure 15 suggests a zone of very low electrical resistivity at approximately 13.0 m bgl. This target is located below the water table and may be indicative of waterlogged underground mine void / lateral workings. This target may also be a saturated backfilled / collapsed drive.	S0113338 may be a backfilled shaft or stope, and the target detected at depth at this feature suggests high risk of voids based on the fact that more extensive workings are known to have been undertaken in the Emerald Reward Claim and that several shafts once existed in the area. They likely comprised lateral	Any voids at this depth are unlikely to cause any significant surface subsidence expressions (very low risk). Based on the depth of these features, quality of the rock mass, and width of the mined lodes in the area, any below the target depths are not expected to cause any significant surface subsidence and pose very low risk of surface

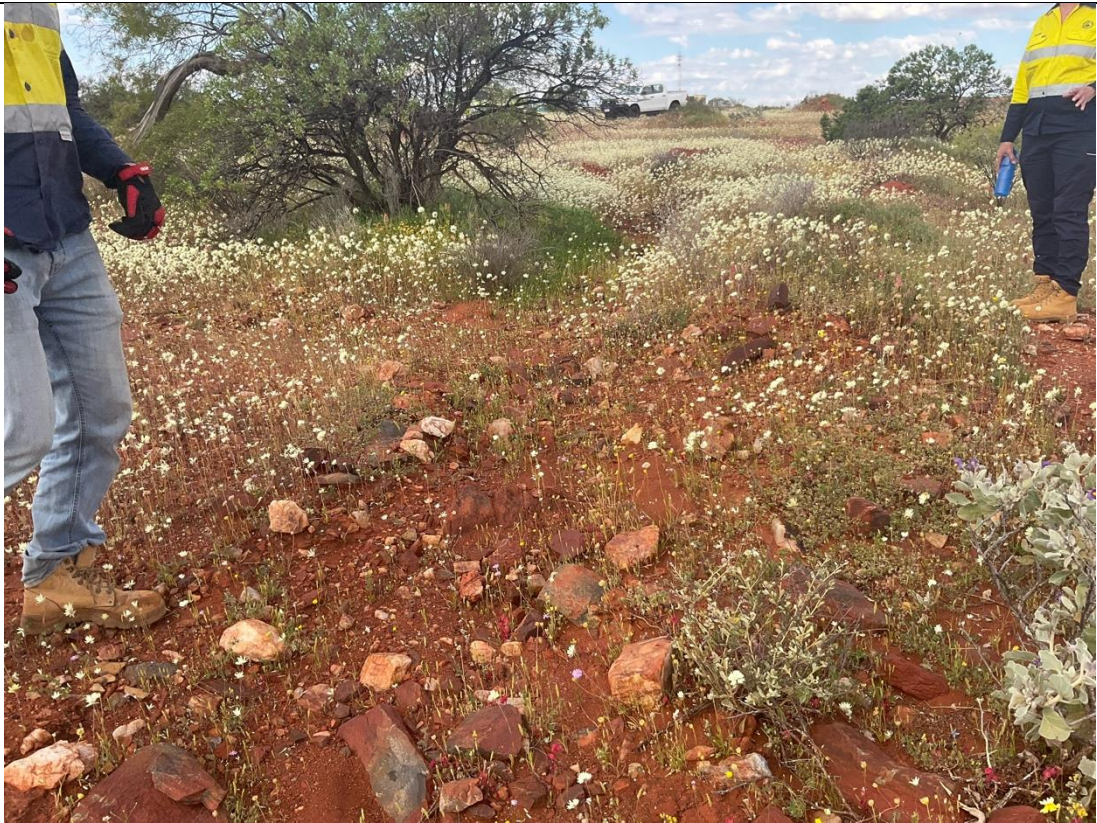
Figure 1

Rock mass / soil profile comments:	Preliminary remediation recommendations:
No visible outcrops. Rocks along base of feature. Soils are red clays and gravels.	No remediation required. Feature poses no risk.

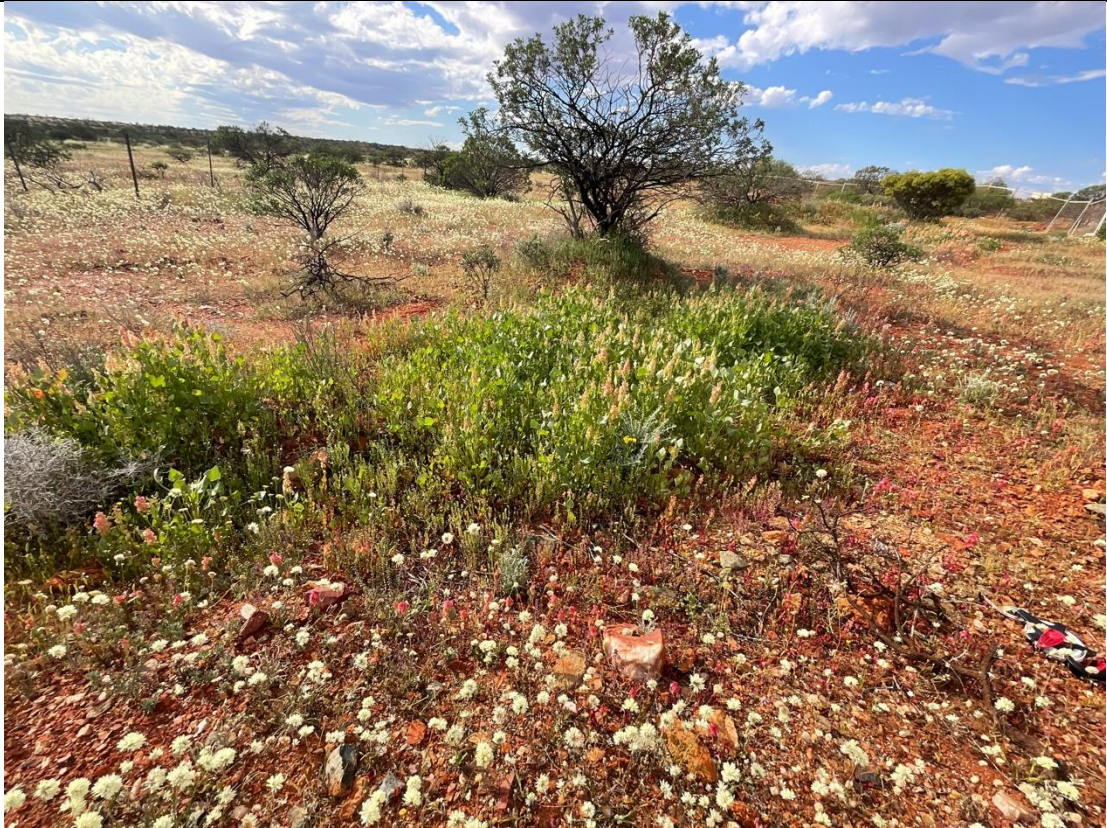
Figure 1

The feature is a shallow depression imperceptible from natural ground surface. A very small spoil pile is situated to the north of the feature under a small tree. The base of the feature is highly vegetated – very green and overgrown compared to the surrounding landscape. Surrounding ground surface is vegetated with low lying grass, wildflowers, and small trees / shrubs. No LiDAR scan undertaken.	CH₄: 0.0% CO₂: 0.0% H₂S: 0 ppm LEL: 0.0% O₂: 20.7% CO: 0 ppm
Rock mass / soil profile comments:	Preliminary remediation recommendations:
No visible evidence of rocky outcrops. Soils are red clays and gravels.	Well-backfilled shaft. No remediation required. Feature poses no risk.

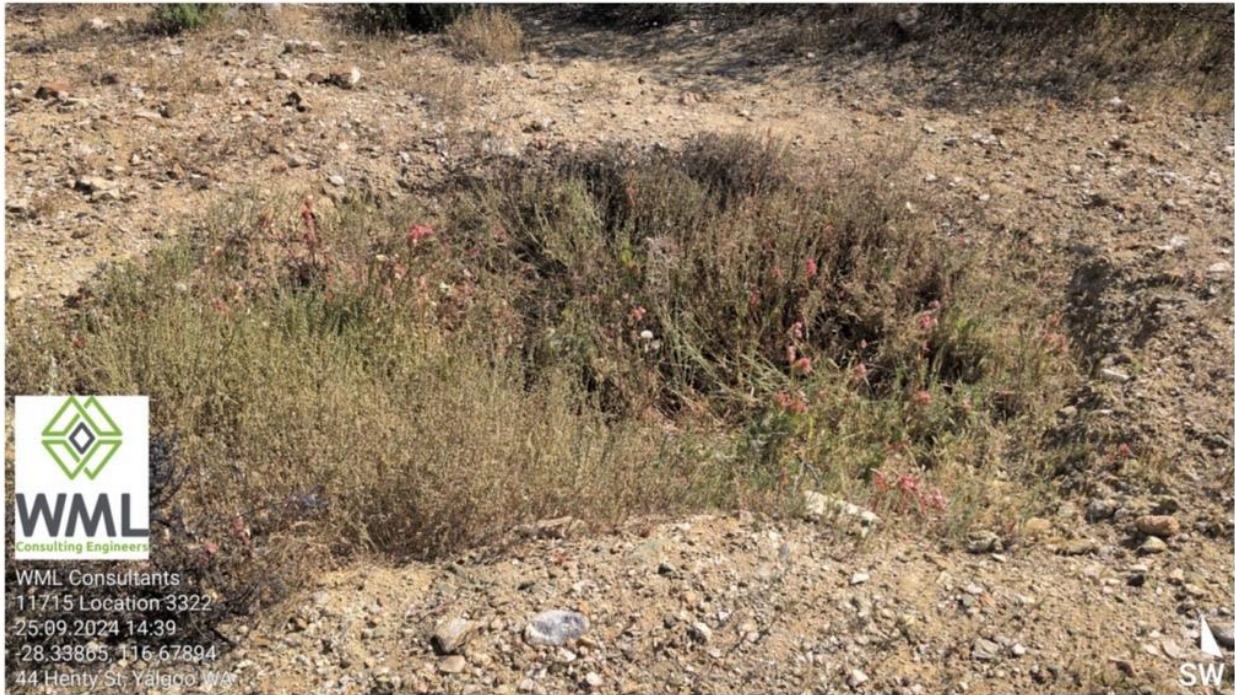
Figure 1

Rock mass / soil profile comments:	Preliminary remediation recommendations:
No visible evidence of rocky outcrops. The ground surface comprises a thin layer of gravelly clay soils overlying rock.	No remediation required.

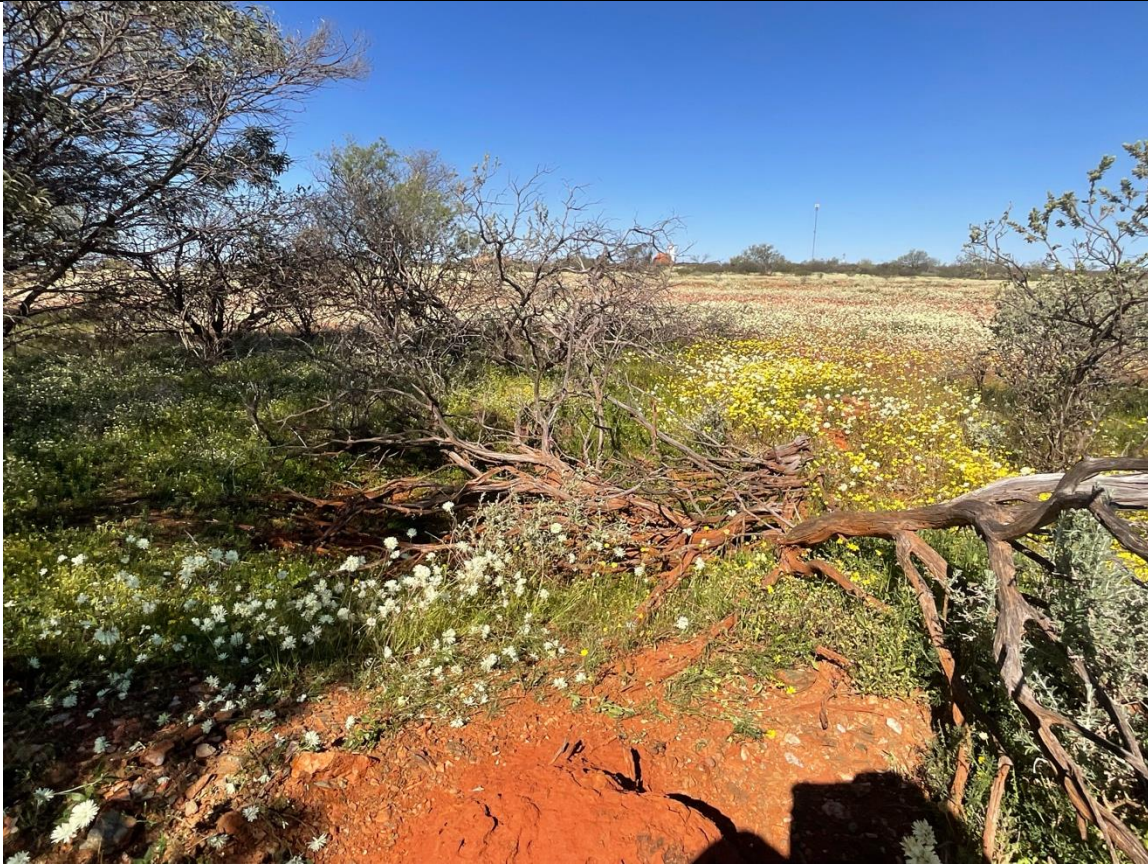
Figure 1

Rock mass / soil profile comments:	Preliminary remediation recommendations:
No visible evidence of rocky outcrops.	No remediation required. Feature poses no risk. Or blade in to soften edges.

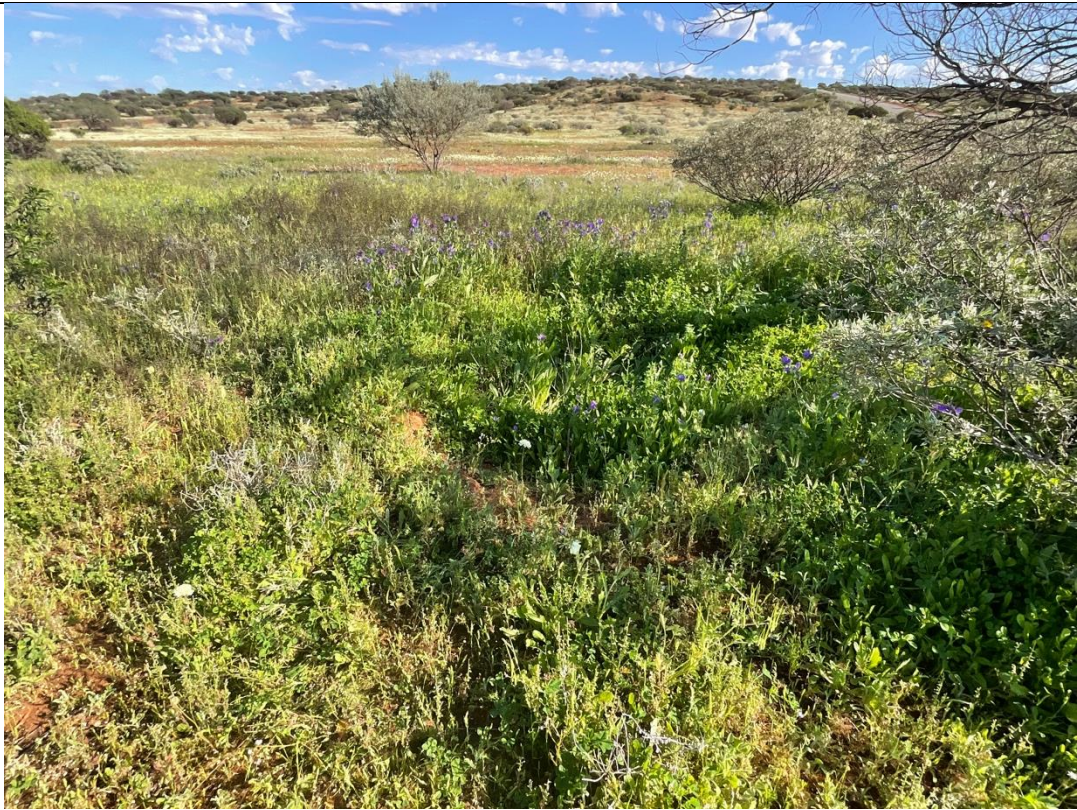
Figure 1

Rock mass / soil profile comments:	Preliminary remediation recommendations:
No visible evidence of rocky outcrops.	No remediation required. Feature poses no risk. Or blade in to soften edges.

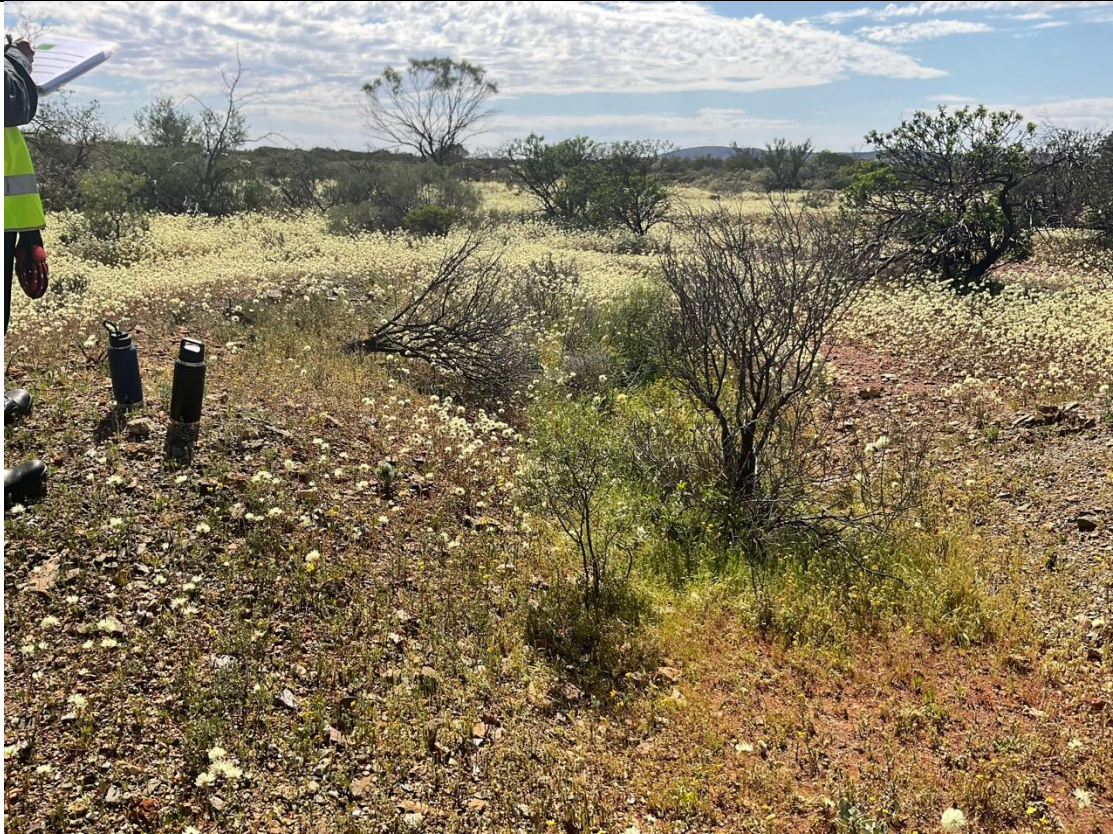
Figure 1

Rock mass / soil profile comments:	Preliminary remediation recommendations:
No visible evidence of rocky outcrops. Red clayey gravel soils.	No remediation required. Feature poses no risk.

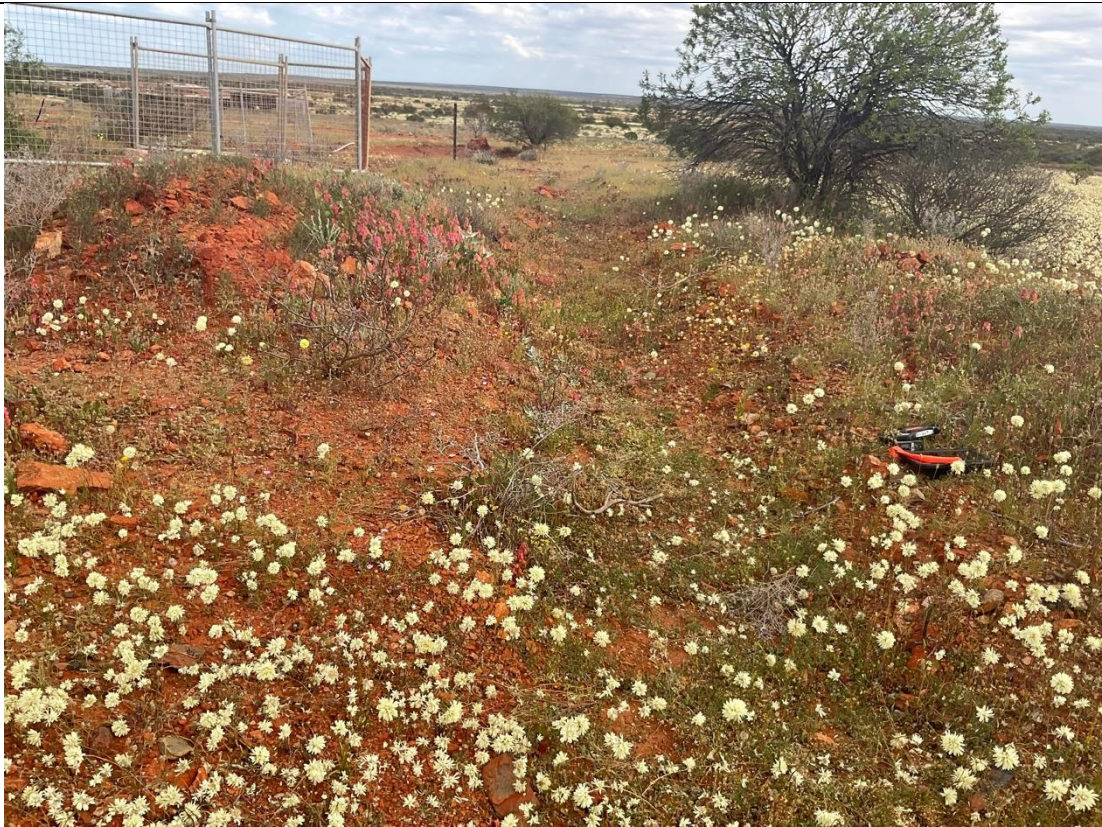
Figure 1

Rock mass / soil profile comments:	Preliminary remediation recommendations:
Red clayey gravel soils and crushed rock pieces.	No remediation required. Feature poses no risk.

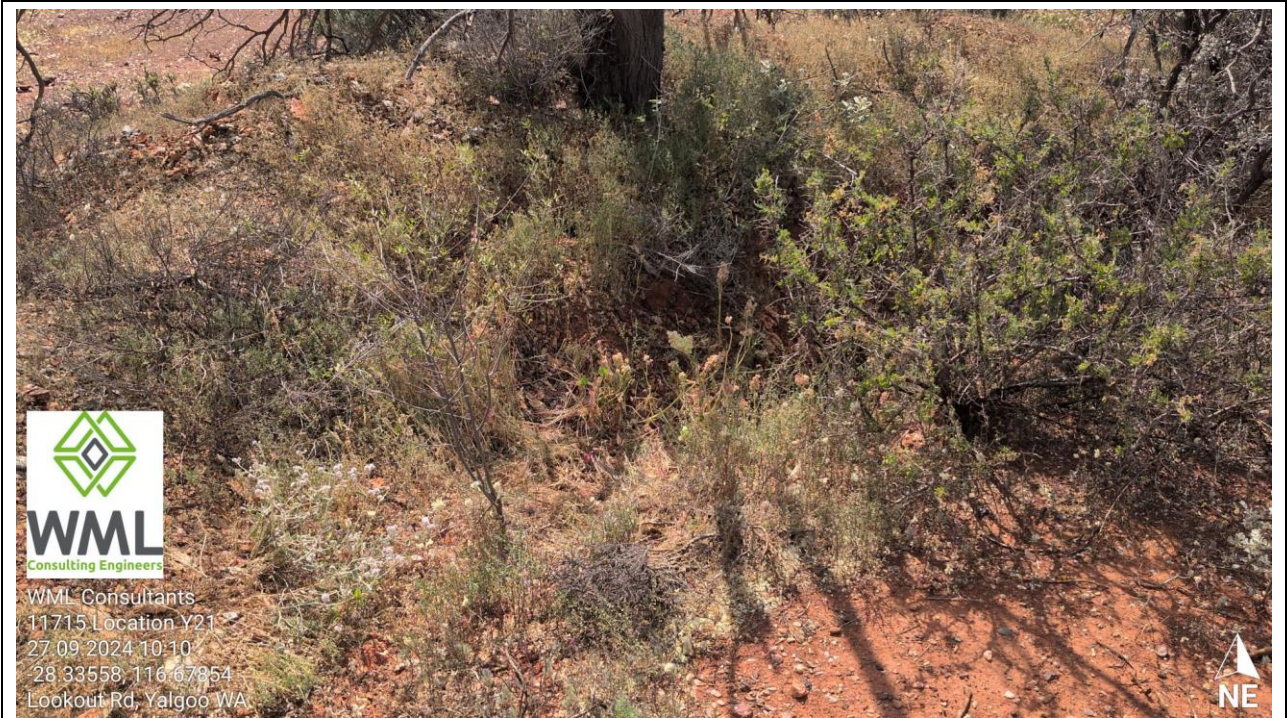
Figure 1

Rock mass / soil profile comments:	Preliminary remediation recommendations:
No visible evidence of rocky outcrops. The ground surface comprises a thin layer of gravelly clay soils overlying rock.	No remediation required. Feature poses no risk.

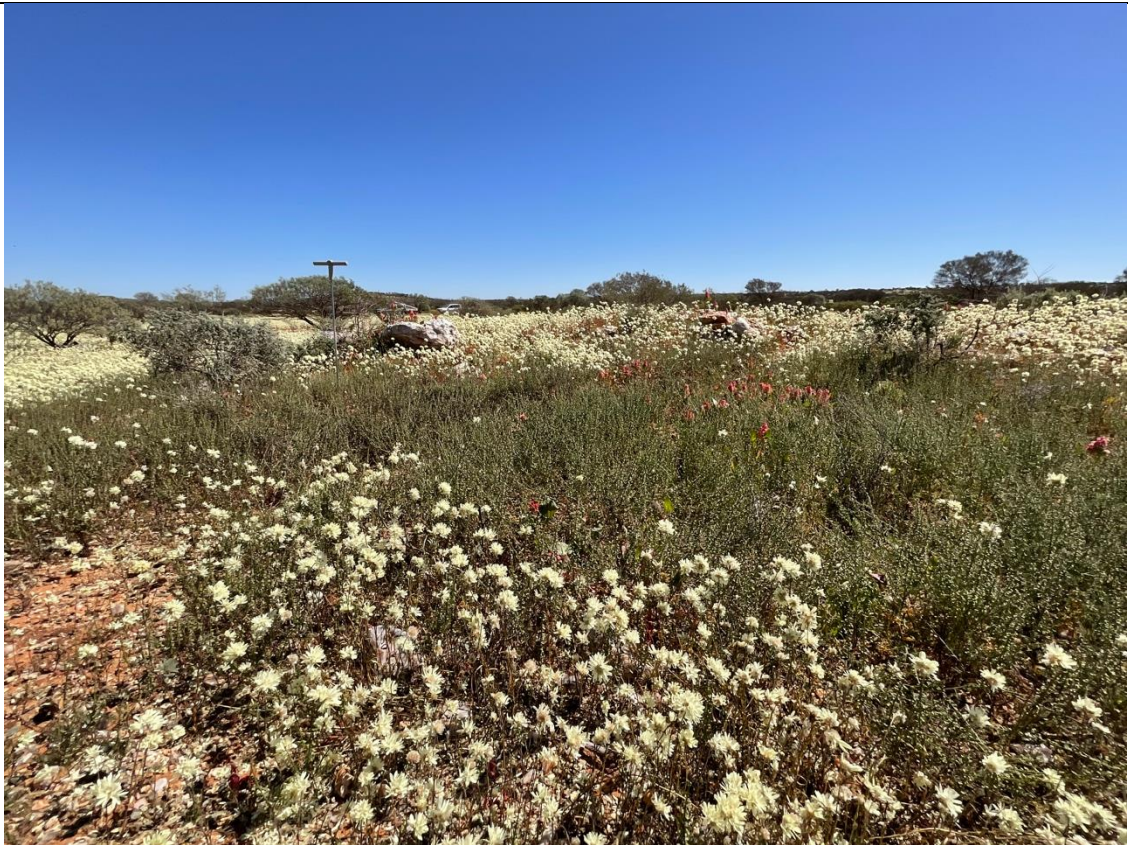
Figure 1

Potentially backfilled feature. Loose soil identified in base. Small quartz rock spoil pile situated to the North. Quartz pieces on ground surface. Ground conditions at the surface around the opening and base of the feature are generally good, as evidenced by DCP results. Top 0.6 m of loose soils. No LiDAR scan undertaken.	CH₄: 0.0% CO₂: 0.0% H₂S: 0 ppm LEL: 0.0% O₂: 20.7% CO: 0 ppm
Rock mass / soil profile comments:	Preliminary remediation recommendations:
Rock evidenced on ground surface around the feature. Orange red clayey gravels.	No remediation required. Feature poses no risk.

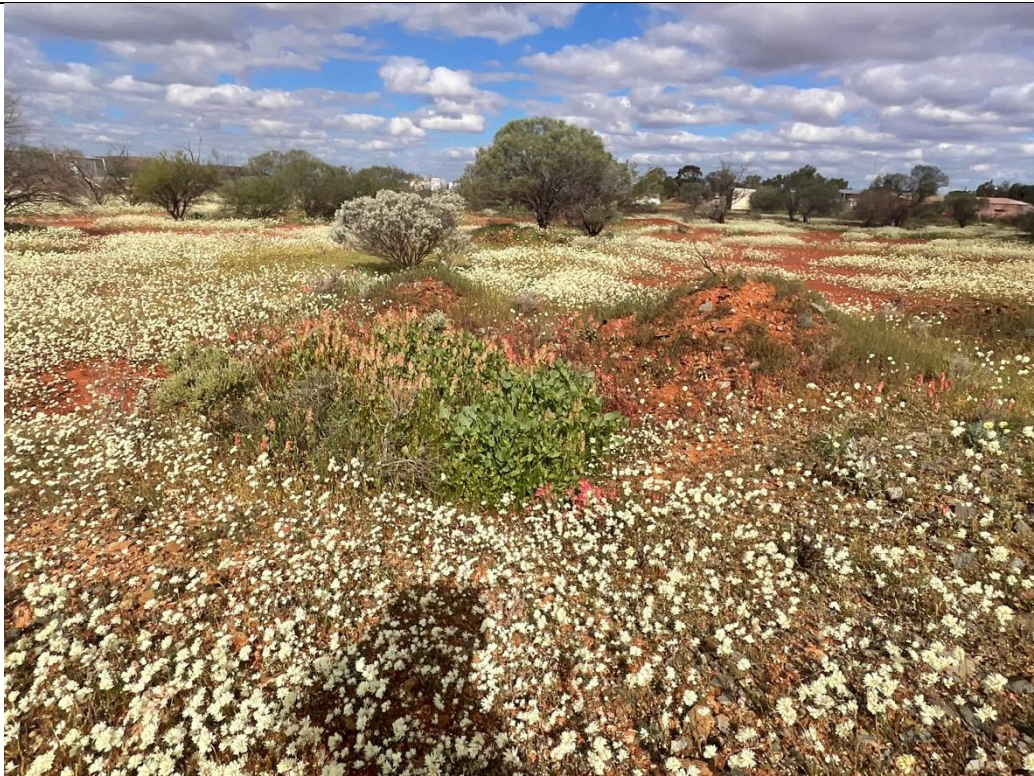
Figure 1

Description / comments / observations:	Noxious / flammable gas readings:
<p>The feature is a shallow depression with potential for a false floor. However, very little amount of spoil surrounding the feature. Tin scrap metal and some household debris hidden in the base of the feature. The vegetation in the base is greener and thicker than surrounding landscape.</p> <p>Surrounding ground surface is moderately vegetated with some low lying grass, wildflowers, and small trees / shrubs. Small spoil pile around the perimeter of the feature. Scrap tin metal, broken glass and rock pieces in the waste piles.</p> <p>The base of the feature exhibits potential for a false floor. DCP not undertaken due to risk that base may give way.</p> <p>LiDAR scan was not undertaken.</p>	<p>CH₄: 0.0% CO₂: 0.0% H₂S: 0 ppm LEL: 0.0% O₂: 20.6% CO: 0 ppm</p>
Rock mass / soil profile comments:	Preliminary remediation recommendations:

<p>No visible evidence of rocky outcrops. The ground surface comprises a thin layer of gravelly clay soils overlying rock.</p>	<p>No remediation required. Feature poses no risk.</p> <p>The desktop study suggested this may be an 18 m deep shaft, however it is unlikely it reached this depth.</p>

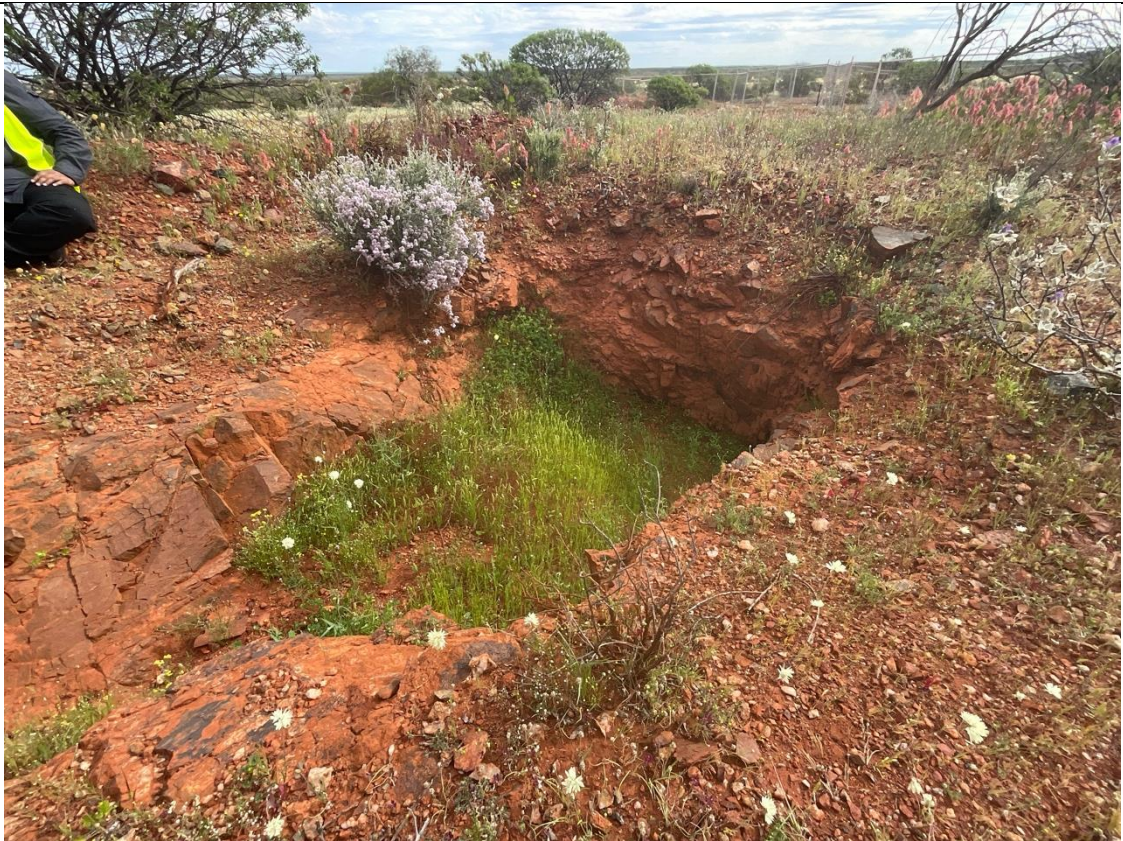
Figure 1

Rock mass / soil profile comments:	Preliminary remediation recommendations:
Poor rock mass quality. Near vertical walls. Red clays and gravels at the ground surface.	Geotextile line and backfill with soil plug.

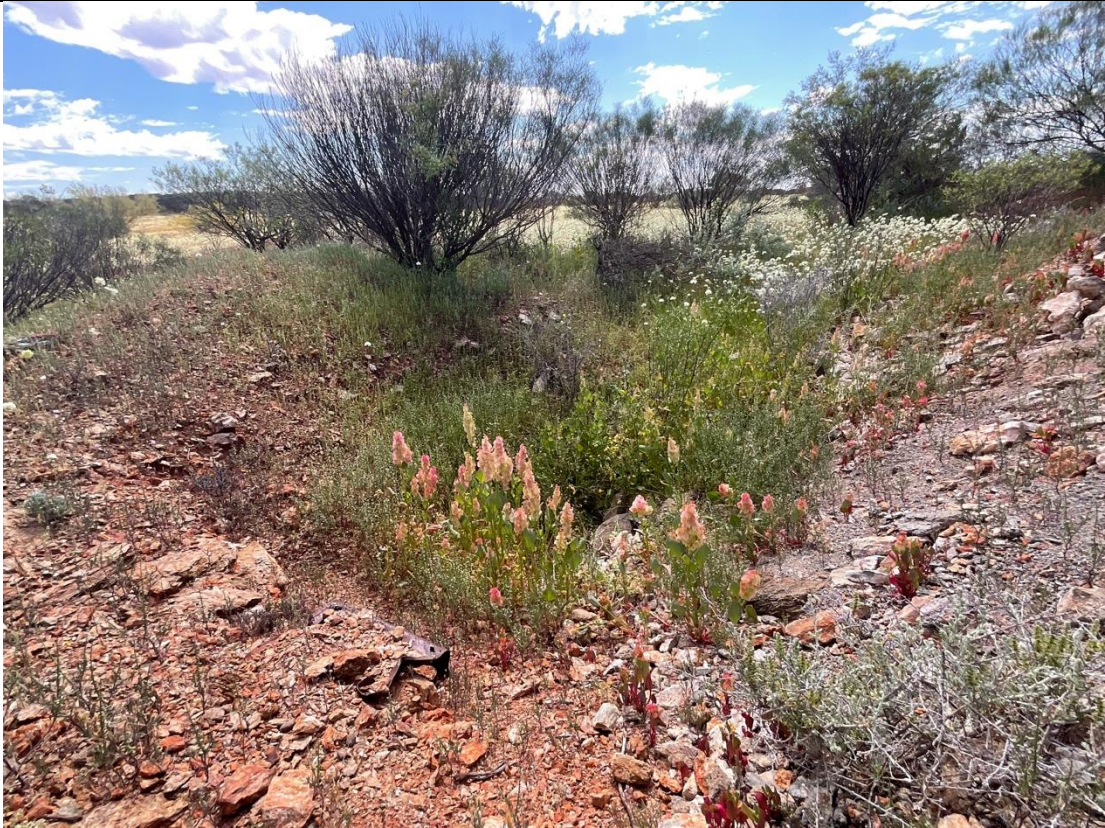
Figure 1

Rock mass / soil profile comments:	Preliminary remediation recommendations:
No visible rocky outcrops.	Blade in spoil surrounding the feature which may be suitable for re-use as backfill and rehabilitate.

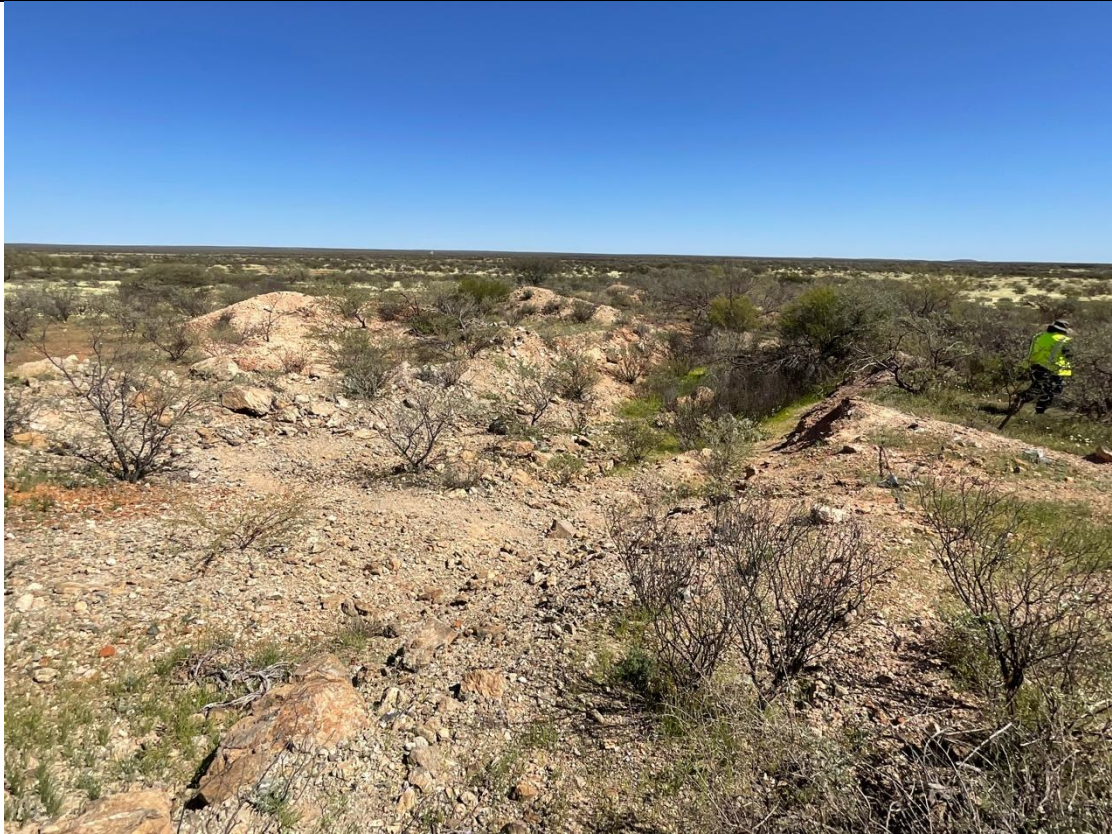
Figure 1

Costean shaped feature with mine rock waste spoil piles surrounding it. Feature Y-01 is a costean spoil pile. Ground conditions at the base of the feature are generally good, as evidenced by DCP results. Trees / shrubs cover the feature base and surrounding spoil piles. No LiDAR scan undertaken.	CH₄: 0.0% CO₂: 0.0% H₂S: 0 ppm LEL: 0.0% O₂: 20.7% CO: 0 ppm
Rock mass / soil profile comments:	Preliminary remediation recommendations:
No visible evidence of rocky outcrops.	Waste rock spoil piles may be suitable for re-use as fill material elsewhere on site. No remediation required. Feature poses no risk. Alternatively, blade spoil piles into feature to flatten slopes.

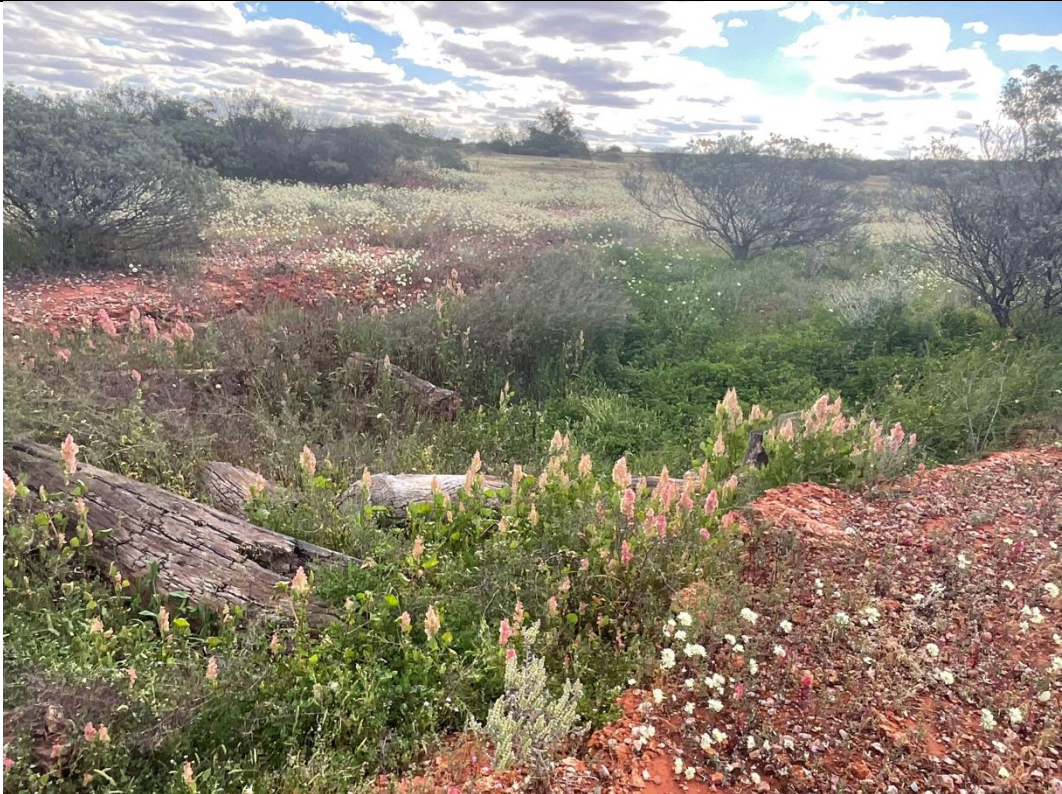
Figure 1

Rock mass / soil profile comments:	Preliminary remediation recommendations:
Poor quality rock mass observed from the surface and western wall of the feature. The ground surface comprises a thin layer of gravelly clay soils overlying rock.	Blade perimeter to soften edges or backfill. Sides are reasonably steep.

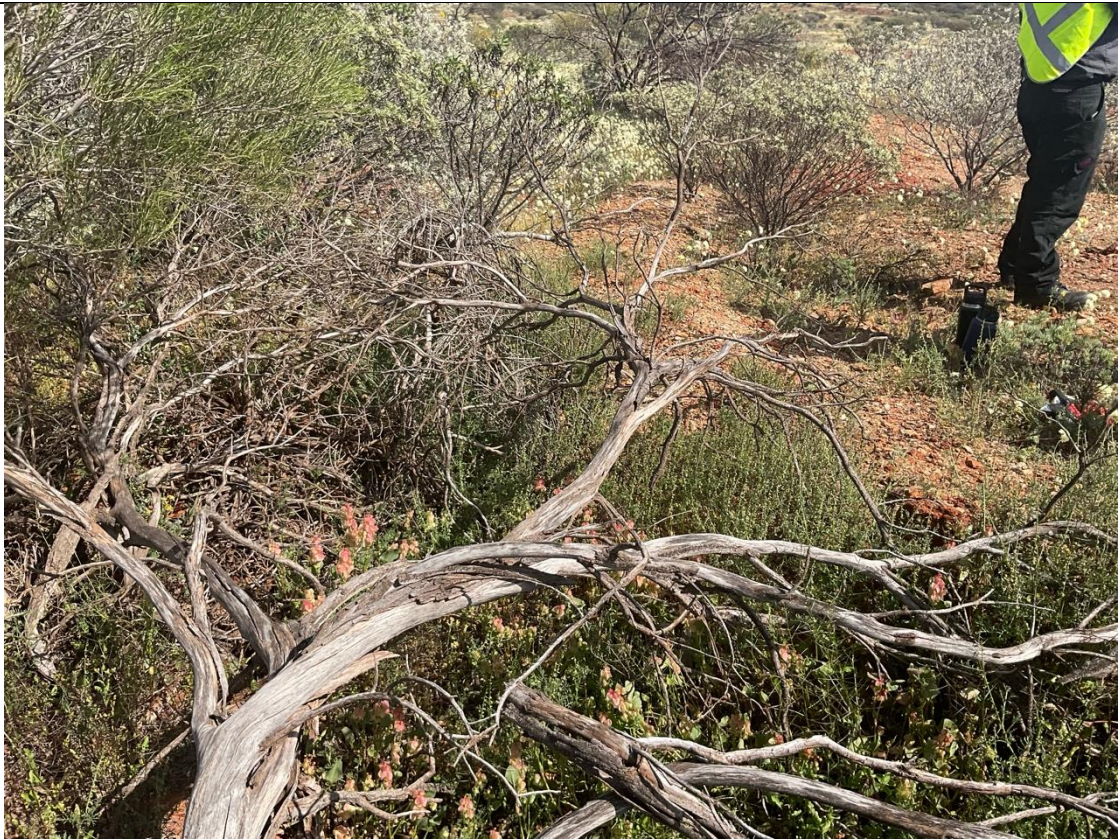
Figure 1

Rock mass / soil profile comments:	Preliminary remediation recommendations:
No visible evidence of rocky outcrops. Red clayey gravel soils.	Blade in surrounding spoil material to rehabilitate remaining portion of the trench.

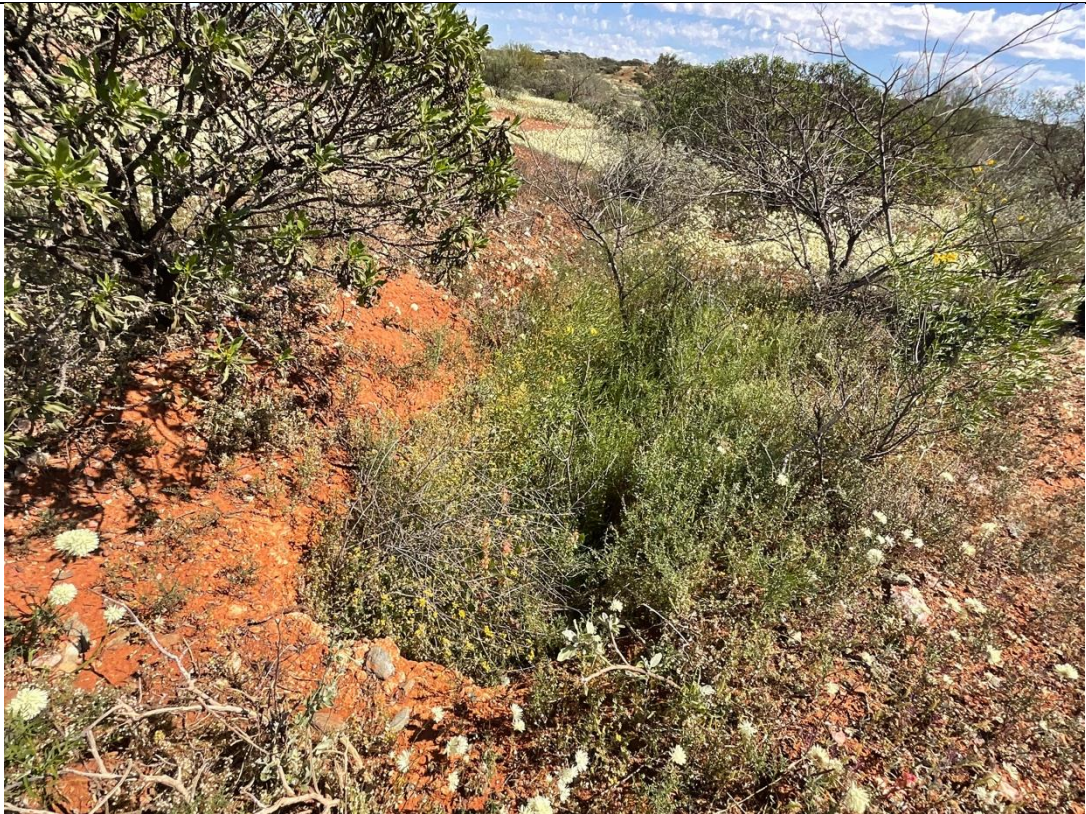
Figure 1

Rock mass / soil profile comments:	Preliminary remediation recommendations:
Poor quality rock mass evidenced to southern end of trench. Red clayey gravel soils.	No remediation required. Feature poses no risk. Or blade in sides to soften the feature walls.

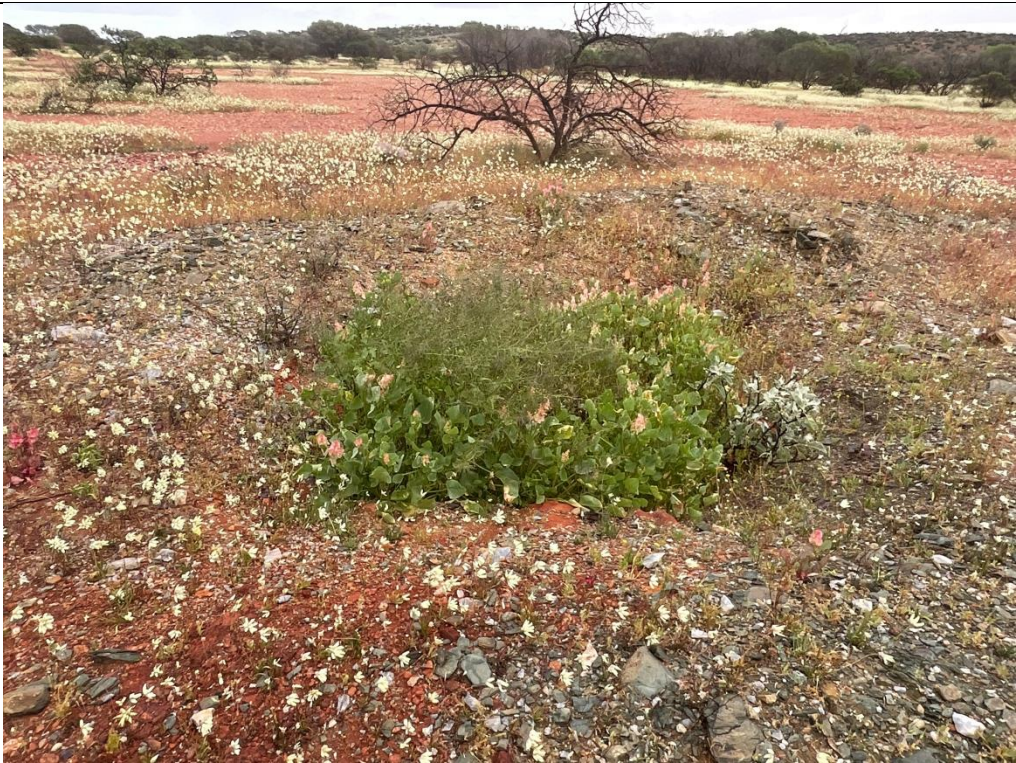
Figure 1

Rock mass / soil profile comments:	Preliminary remediation recommendations:
Rock visible in walls of the feature. Moderate quality rock mass. The ground surface comprises a thin layer of gravelly clay soils overlying rock.	Backfill with surrounding spoil.

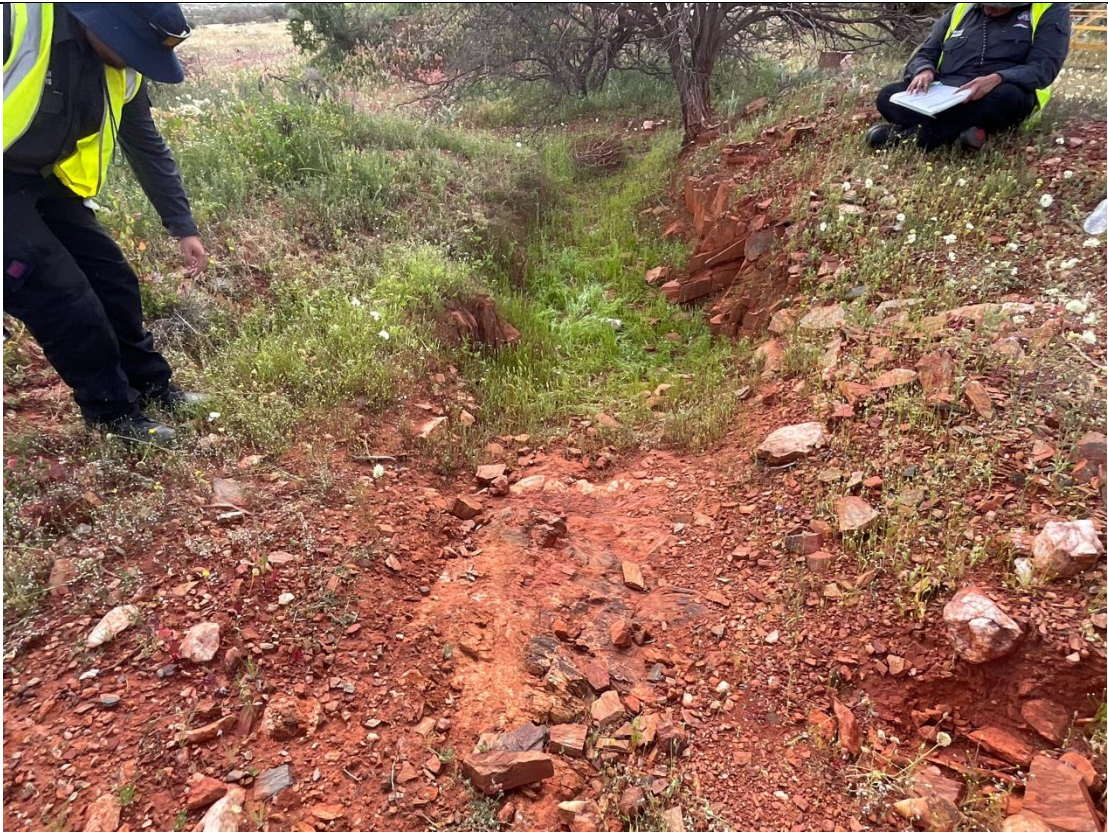
Figure 1

Rock mass / soil profile comments:	Preliminary remediation recommendations:
Hard rock identified within base of costean. Red clayey gravel soils.	Blade existing waste spoil material into the trench.
