ABANDONED MINE FEATURES ASSESSMENT

YALGOO, WA REHABILITATION OPTIONS STUDY

11715-G-R-002 Public Document

Issued to:	Department of Energy, Mines, Industry Regulation & Safety (DEMIRS)
WML Project Number:	11715
Document Name:	11715-G-R-002 Public Document

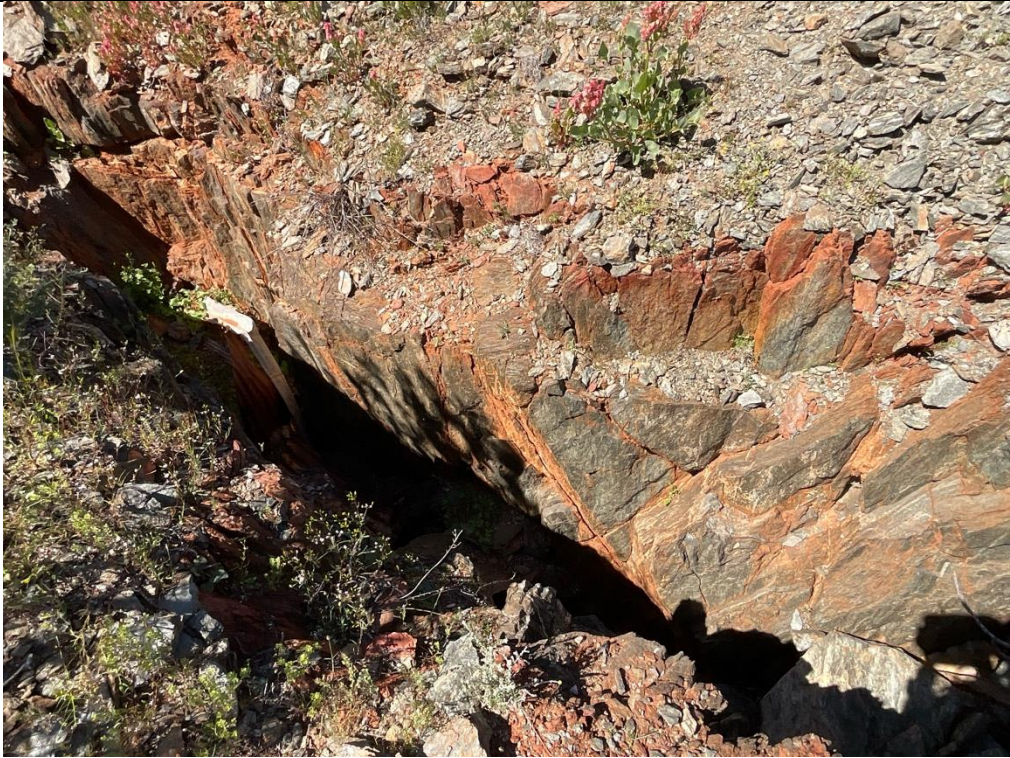
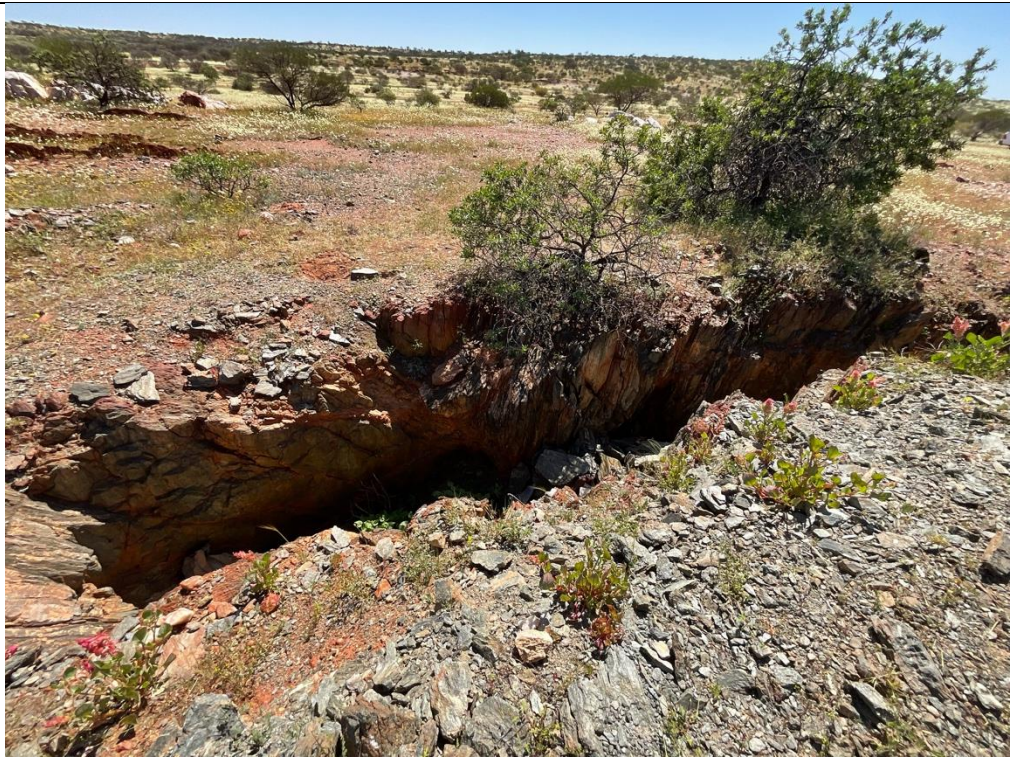
Rock mass / soil profile comments:	Preliminary remediation recommendations:
Moderate rock mass quality. Red silty gravel soils.	Likely to be a surficial scratching. Carve out side walls to create dome shape, line with high strength geotextile and backfill with spoil material that may be suitable for re-use.

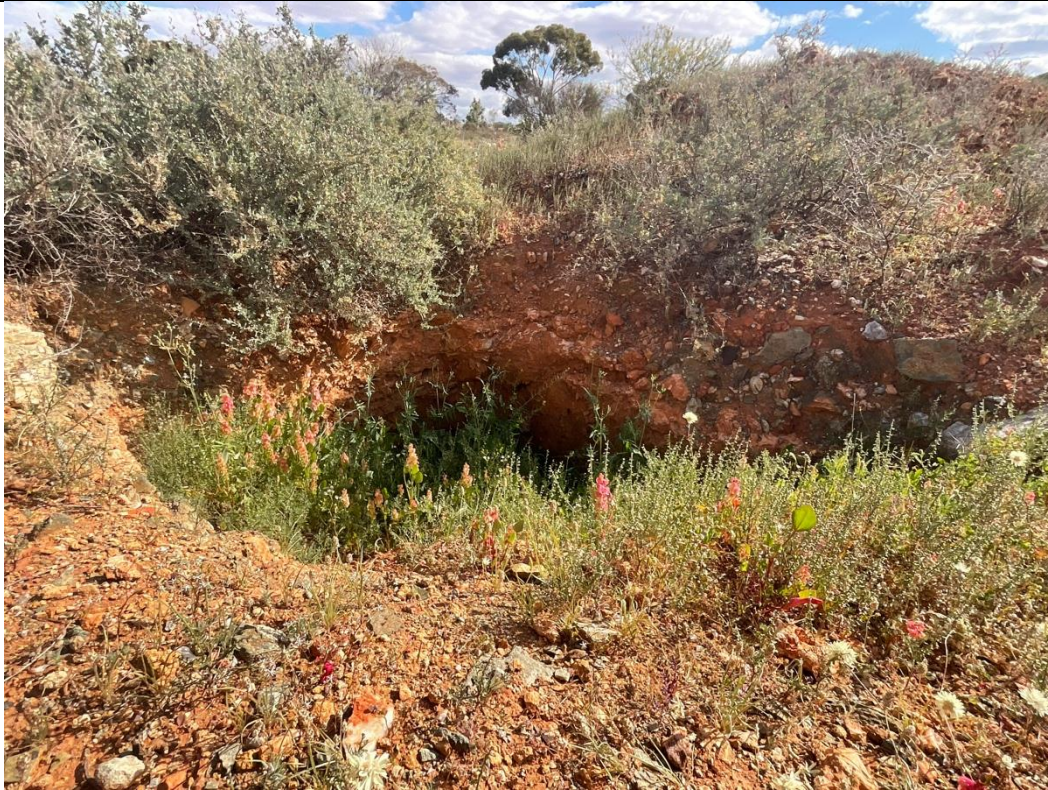
Figure 1

The feature is a circular depression with potential for a false floor. There is some spoil piles surrounding the feature. The vegetation in the base is greener and thicker than surrounding landscape. Excavator ramming suggested hard base conditions. LiDAR scan was undertaken and shows this feature is a stope, the visible base is likely shallow and stable.	H₄: 0.0% CO₂: 0.0% H₂S: 0 ppm LEL: 0.0% O₂: 20.6% CO: 0 ppm
Rock mass / soil profile comments:	Preliminary remediation recommendations:
Poor quality rock mass. Walls of the feature are vertical. There exists approximately 0.5 m of spoil waste gravels overlying rock. The ground surface comprises a thin layer of gravelly clay soils overlying rock.	Break in to collapse drive and backfill. The desktop study suggests this may have been a shaft 11.5 m deep and may have a drive to the north connected to S0113338.

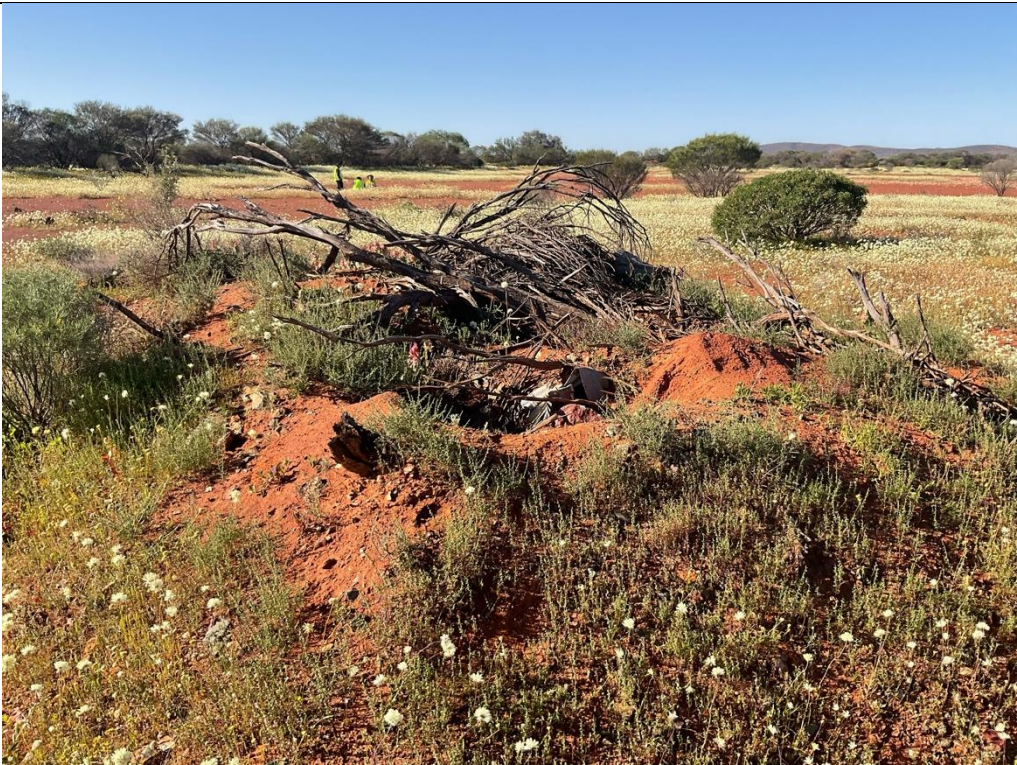
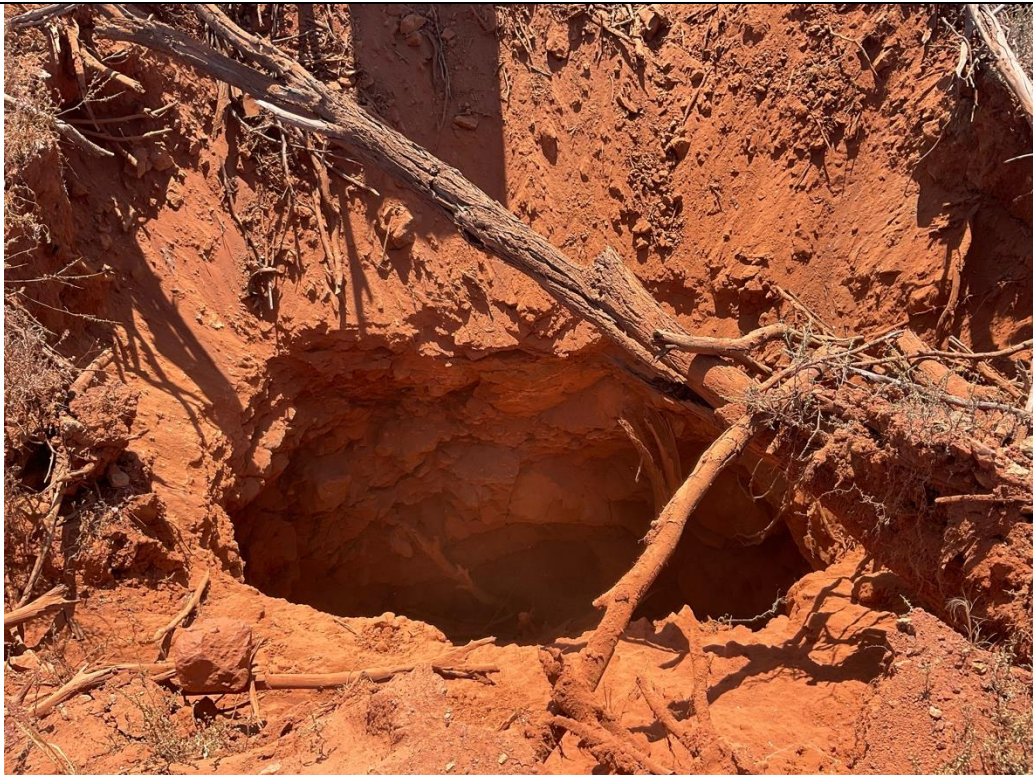
Circular shaft feature filled with branches, tin scrap metal and waste gravel rock. Tree / shrub branches obscure view of base conditions at this stage. 1 m tall spoil pile surrounds the feature. Ground conditions at the surface around the opening of the feature are generally good, as evidenced by shallow borehole refusal. LiDAR scan undertaken after dead tree had been cleared out of the shaft.	CH₄: 0.0% CO₂: 0.0% H₂S: 0 ppm LEL: 0.0% O₂: 20.7% CO: 0 ppm
Rock mass / soil profile comments:	Preliminary remediation recommendations:
Poor quality rock mass.	The shaft may have a false floor and risk of void collapse exists. Mirafi soil backfill plug.

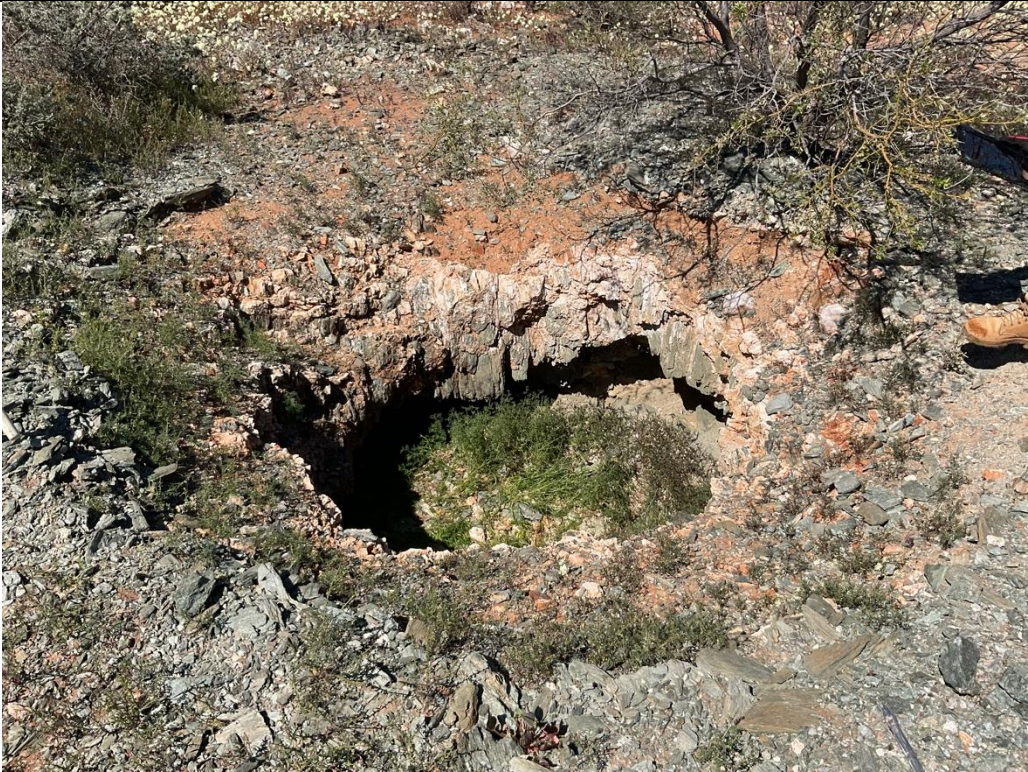
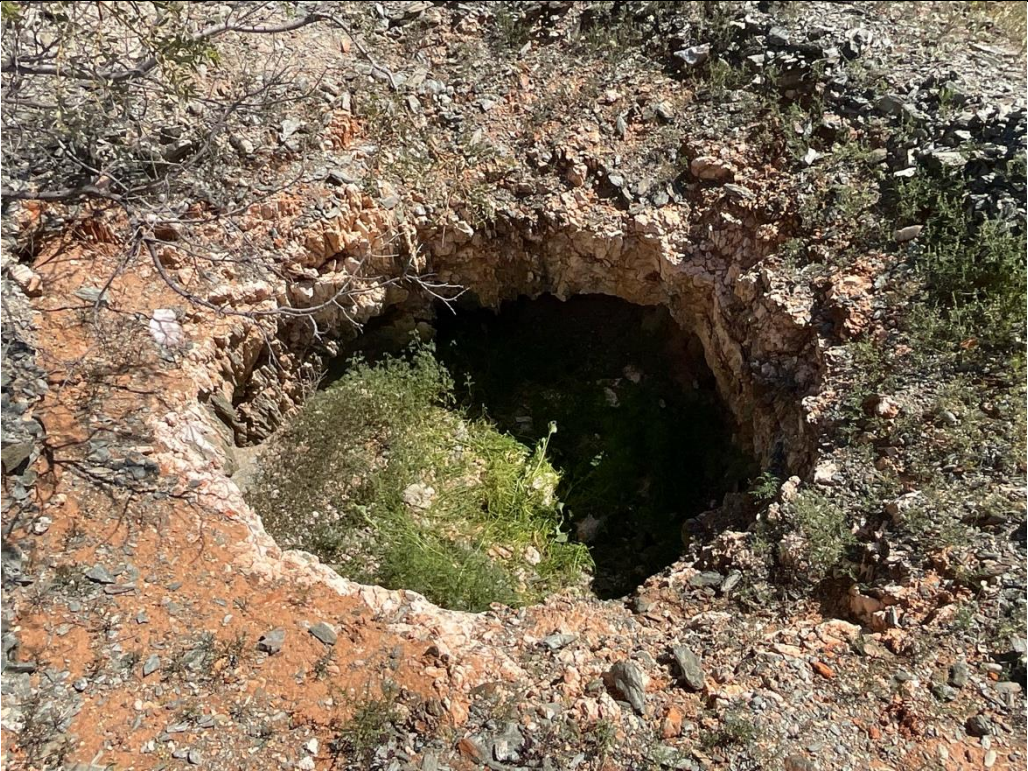
Rock mass / soil profile comments:	Preliminary remediation recommendations:
Very poor and crumbly rock mass quality. Red clayey gravel soils.	Potentially mirafi plug soil backfill, dome out the feature to form a plug shape prior to backfill.

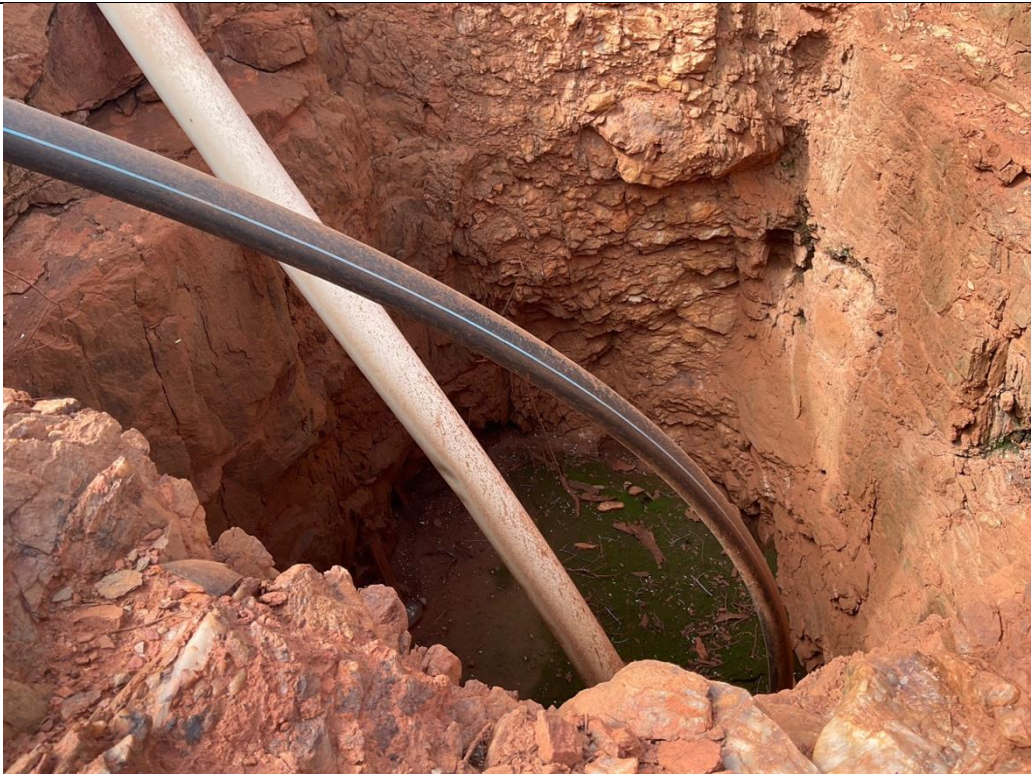
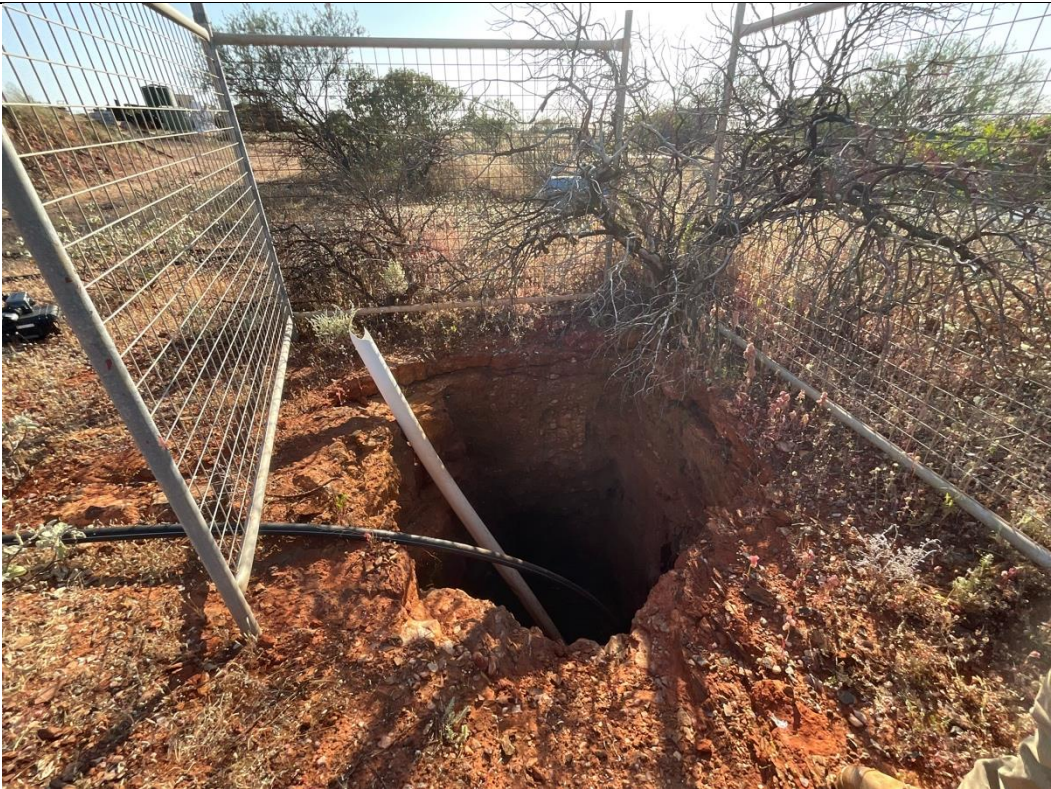
Rock mass / soil profile comments:	Preliminary remediation recommendations:
Moderate rock mass quality. Near vertical walls.	Remove material from crest and backfill and cave in. Line with geotextile.

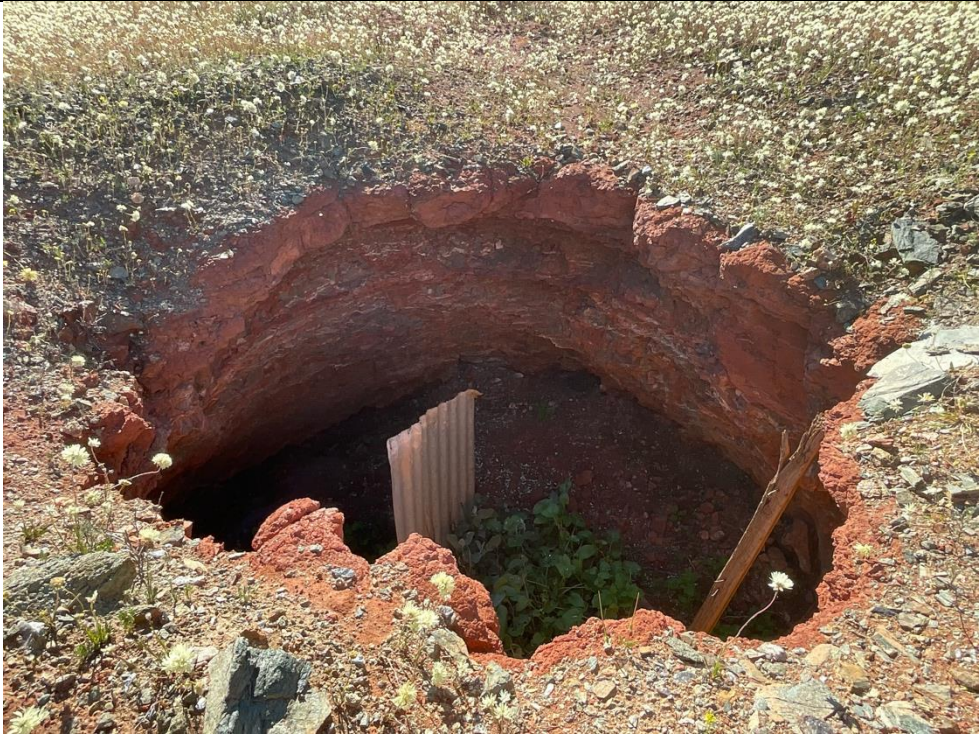
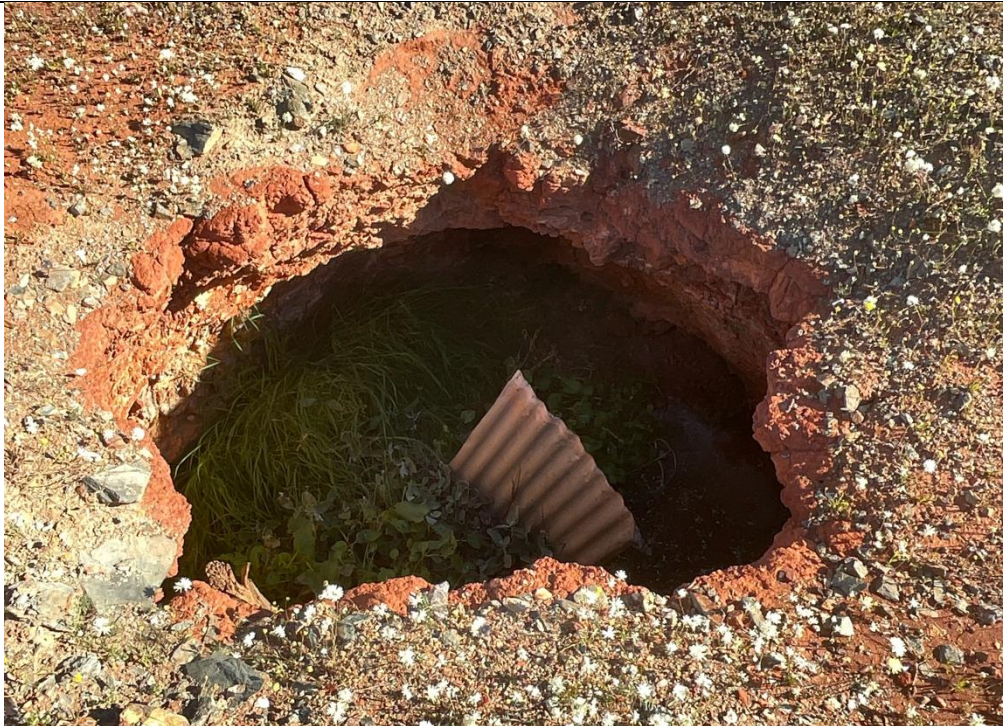
Circular feature that bulges out at the base. The base is filled with waste rock sandy gravels and some tin sheet metal. Very small to no spoil around the feature. Ground conditions at the surface around the opening of the feature are generally good, as evidenced by shallow auger borehole refusal. LiDAR scan undertaken.	CH₄: 0.0% CO₂: 0.0% H₂S: 0 ppm LEL: 0.0% O₂: 20.6% CO: 0 ppm
Rock mass / soil profile comments:	Preliminary remediation recommendations:
Very poor rock quality mass. Near vertical walls.	Hollow out, dome and backfill with mirafi soil plug.

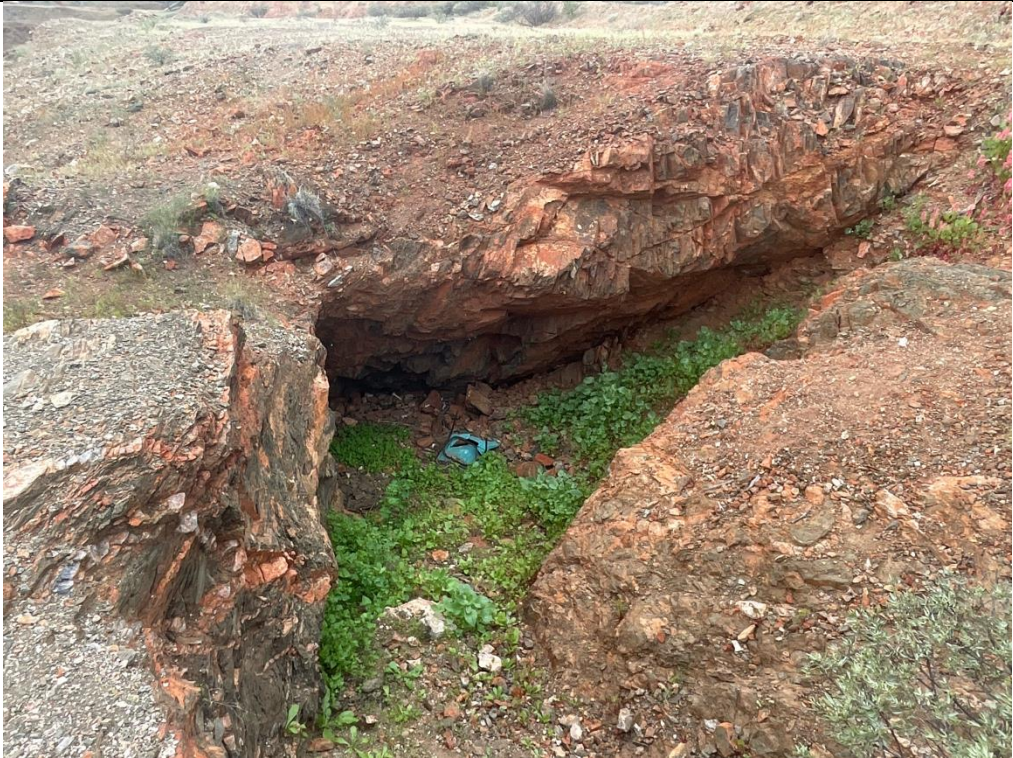
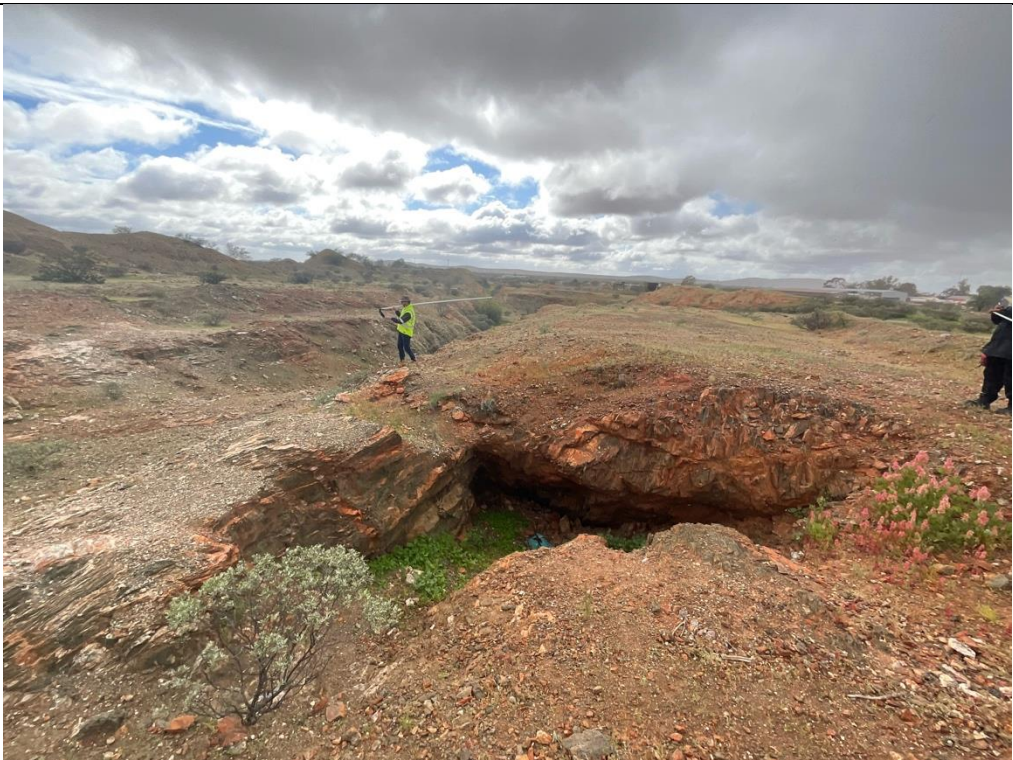
Rock mass / soil profile comments:	Preliminary remediation recommendations:
Moderate and hard quality rock mass. Walls of the feature are near vertical. The ground surface comprises a thin layer of gravelly clay spoil overlying rock.	<p>Potentially comprises an unstable base. Mirafi or concrete cone shaped plug?</p> <p>The desktop study suggests this may have been a shaft 10 – 15 m deep.</p>

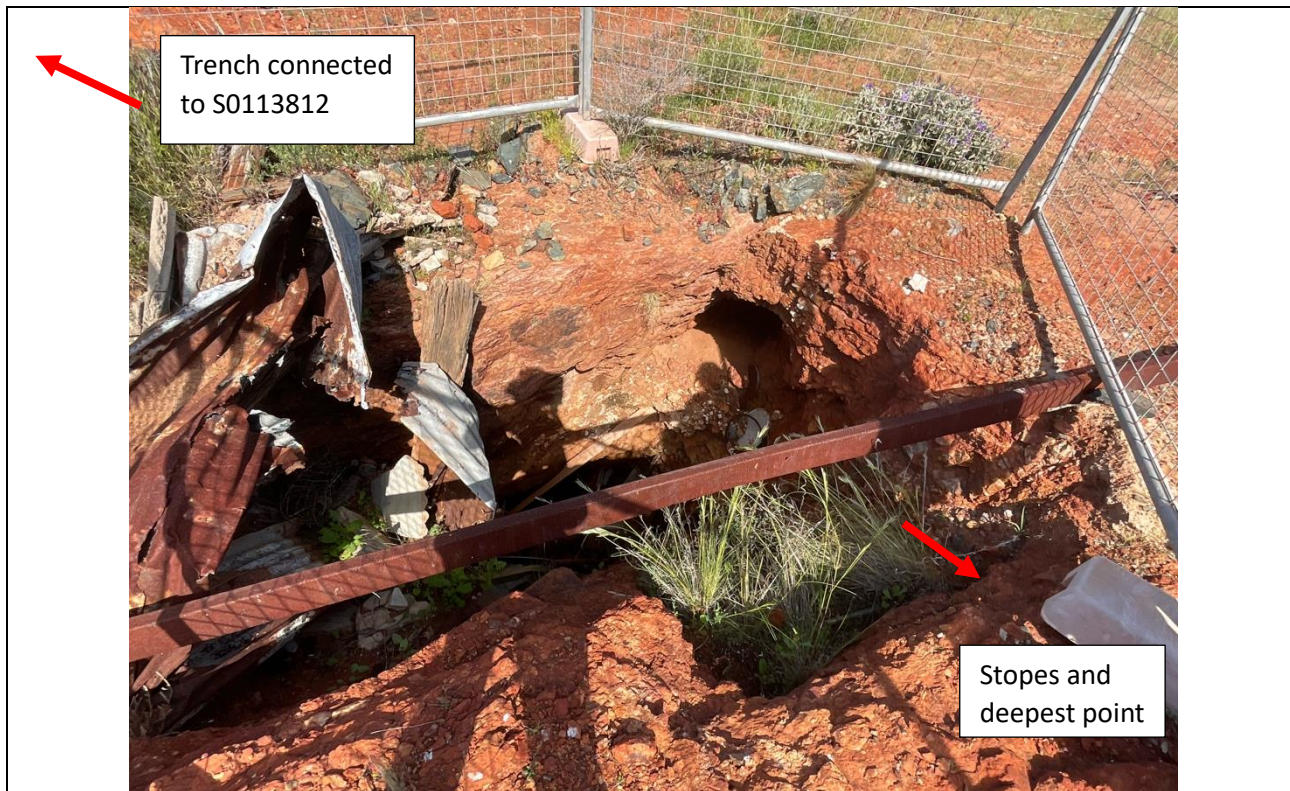
Figure 1

Rock mass / soil profile comments:	Preliminary remediation recommendations:
Moderate rock mass quality. Near vertical walls. Red clay soils at the surface.	Dome out, high strength geotextile plug. Or concrete plug.

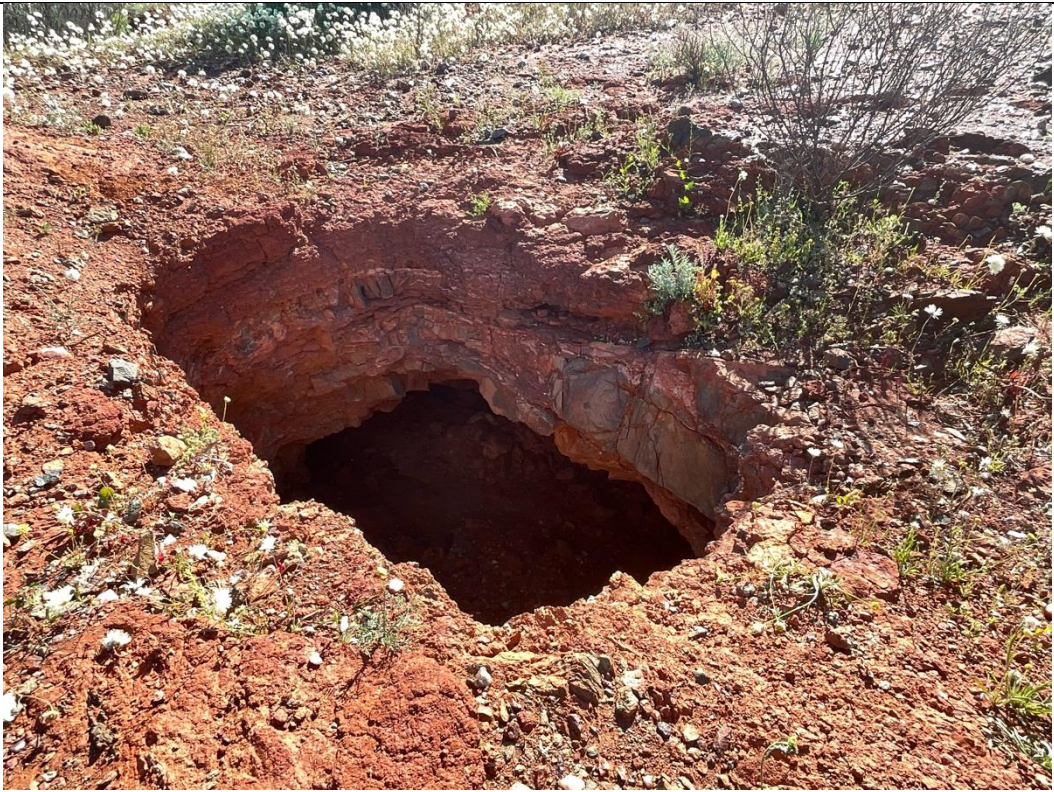
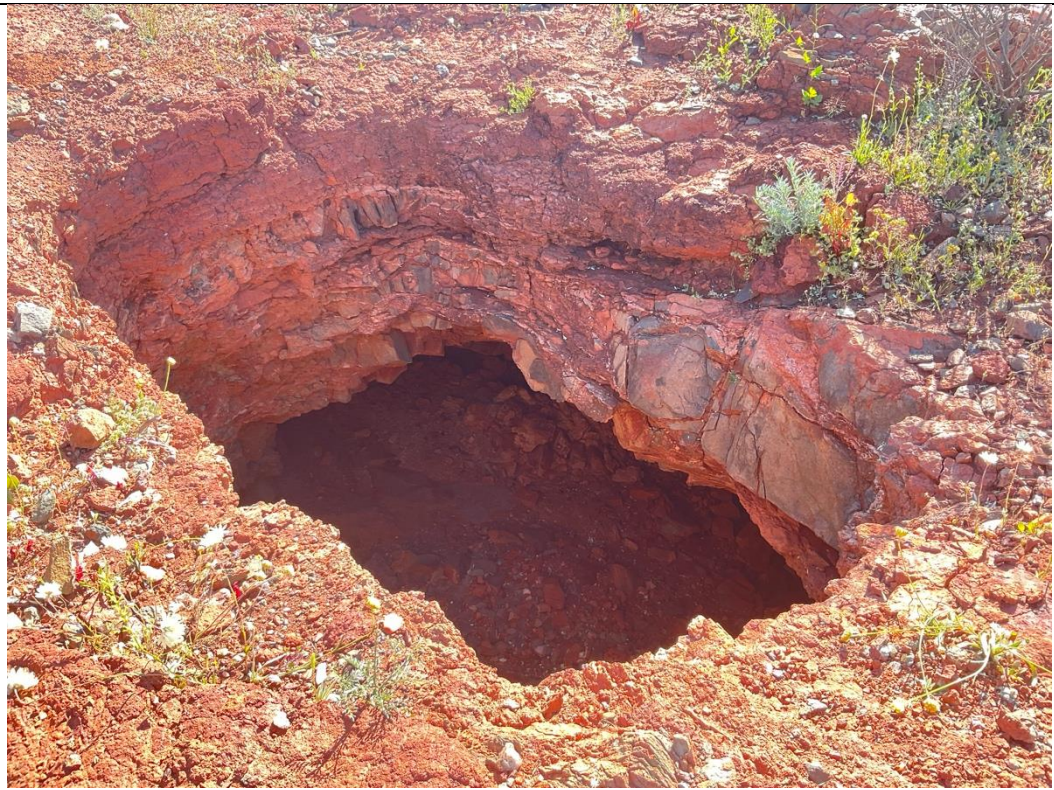
Rock mass / soil profile comments:	Preliminary remediation recommendations:
Very poor quality rock mass.	Break out tunnel to collapse connected drive S01453306. Line with high strength geotextile, backfill on top to form plug.

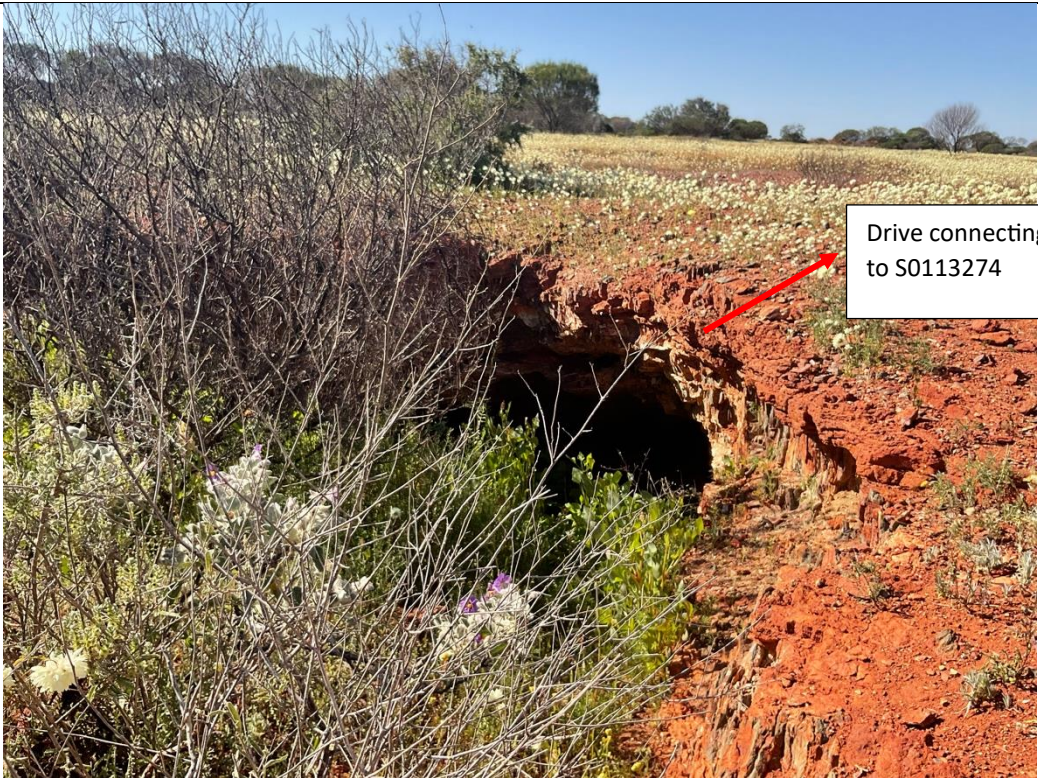
Figure 1

Rock mass / soil profile comments:	Preliminary remediation recommendations:
Very poor quality rock mass.	Break out tunnel to collapse connected drive. Line with high strength geotextile, backfill on top to form plug.

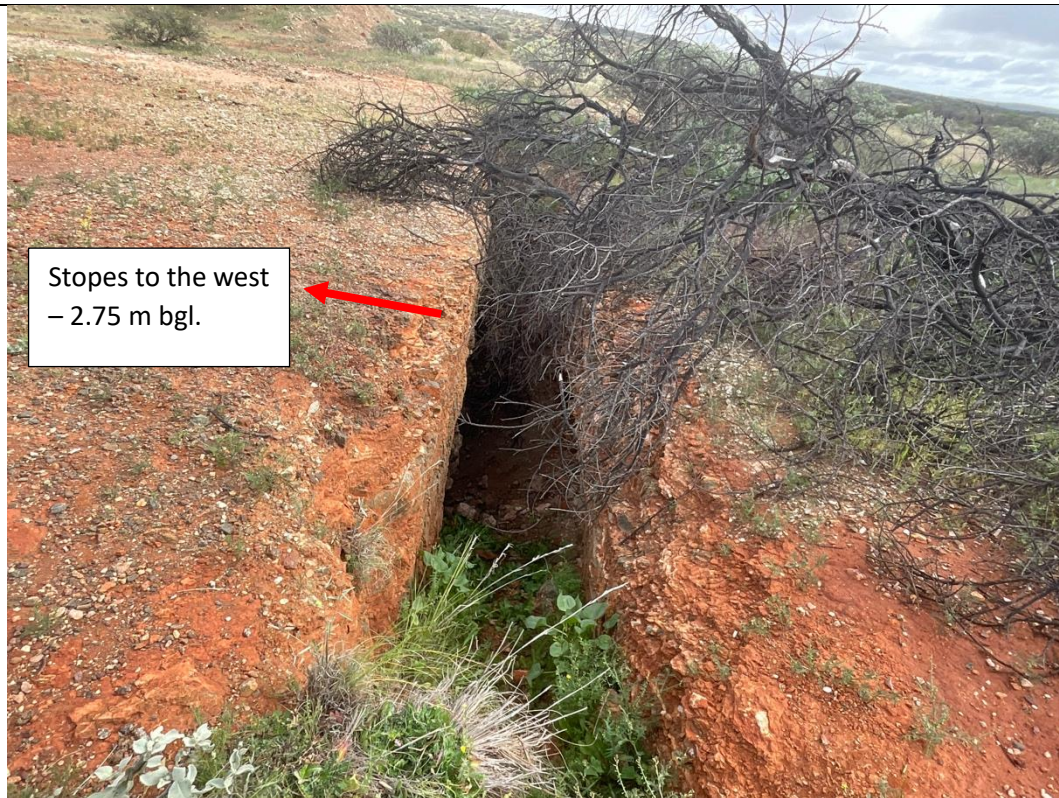
Figure 1

Rock mass / soil profile comments:	Preliminary remediation recommendations:
<p>Poor quality rock mass. Walls of the feature are vertical.</p> <p>The ground surface comprises a thin layer of gravelly clay soils overlying rock.</p>	<p>Potentially comprises an unstable base and lateral workings based on LiDAR scans. Approx. 4 m deep excavation will be required to break out and cave the drive to the west followed by backfill.</p>

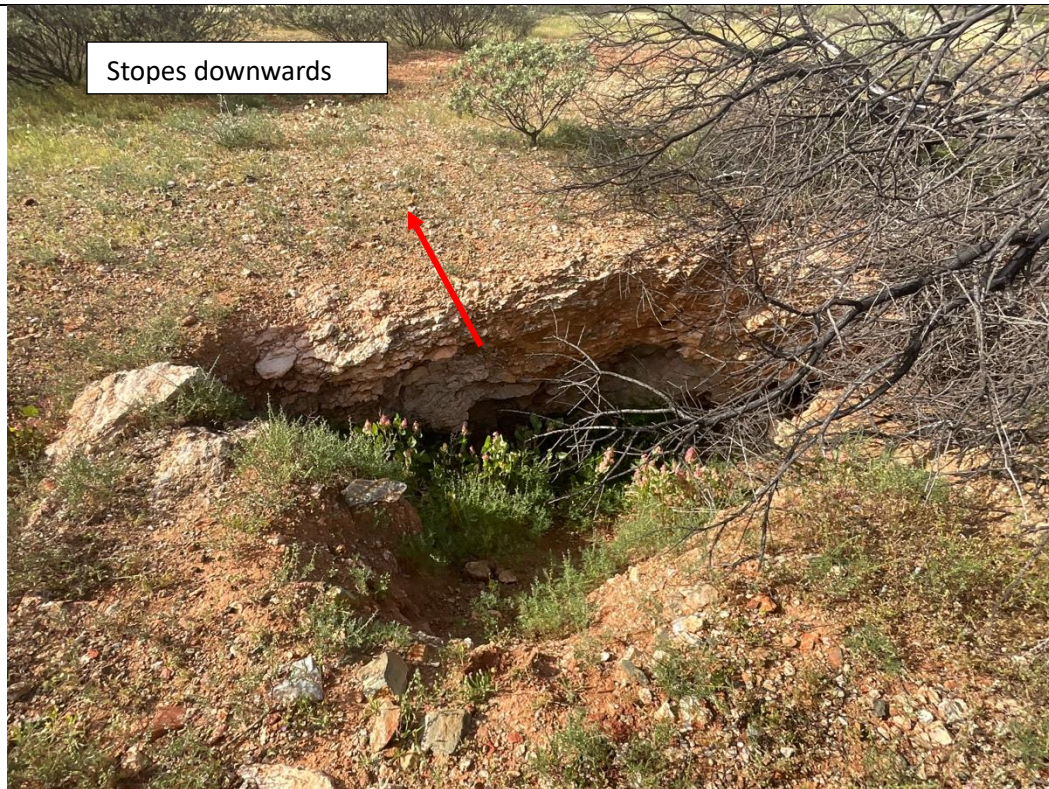
Figure 1

<p>The feature is an irregular shaped cavity in the ground with potential for a false floor and some lateral workings are located within to the south west. The LiDAR scans indicate lateral workings / drives to the west for approx. 2 m and are 0.8 m tall, very narrow and 1.3 m bgl. There is no spoil surrounding the feature.</p> <p>The base of the feature exhibits potential for a false floor. DCP not undertaken due to potential for unstable base.</p> <p>LiDAR scan was undertaken.</p>	H₄: 0.0% CO₂: 0.0% H₂S: 0 ppm LEL: 0.0% O₂: 20.7% CO: 0 ppm
Rock mass / soil profile comments:	Preliminary remediation recommendations:
Poor quality rock mass. Walls of the feature are dipping approx. 70 degrees to the south. The ground surface comprises a thin layer of gravelly clay soils overlying rock.	Potentially comprises an unstable base and lateral workings based on LiDAR scans. Approx. 2-3 m deep excavation will be required to break out and cave the drive to the west followed by backfill. Use fine grained soils to backfill after collapse of feature.

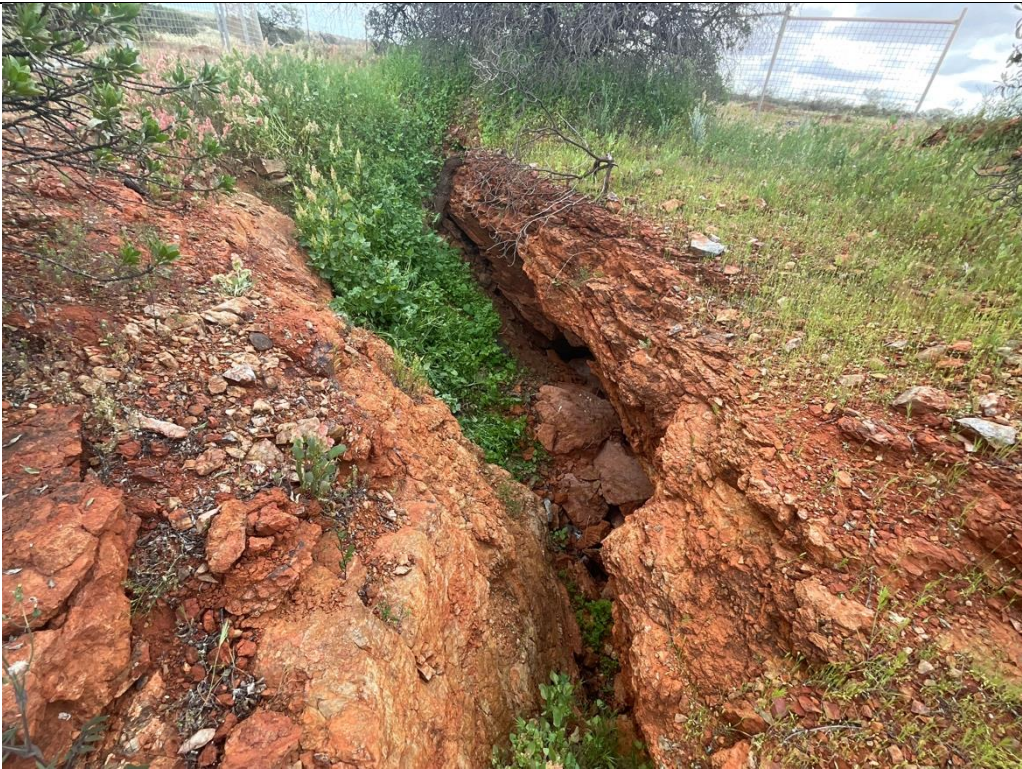
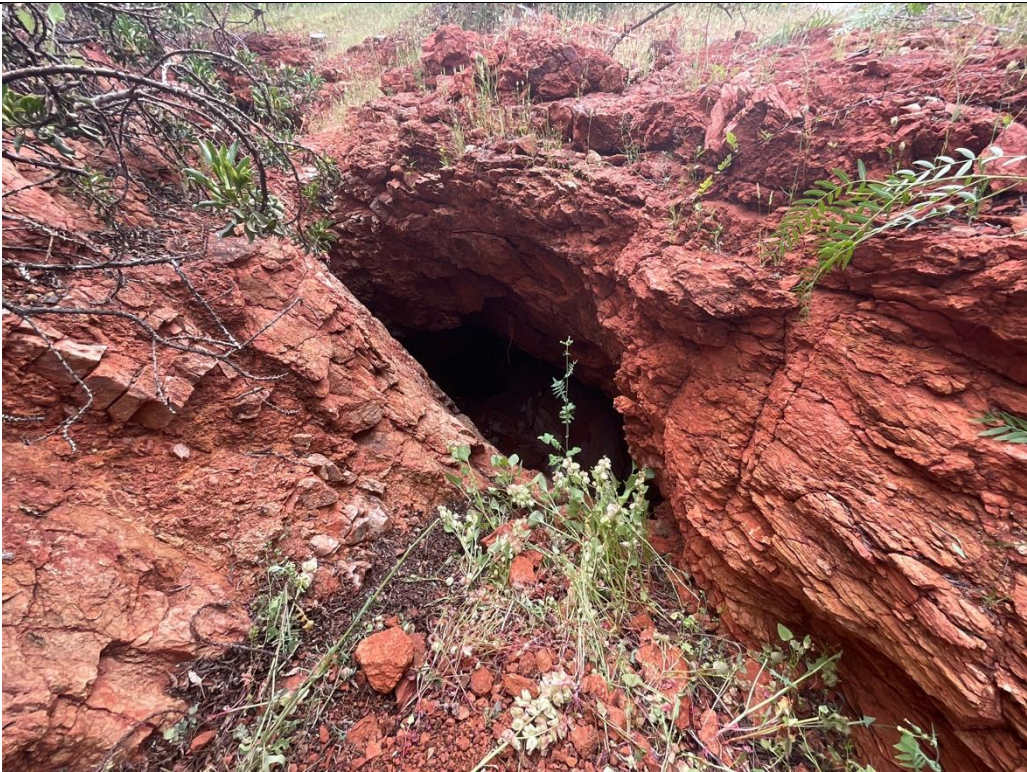
Rock mass / soil profile comments:	Preliminary remediation recommendations:
Moderate quality rock mass. The ground surface comprises a thin layer of gravelly clay soils overlying rock.	Backfill and collapse – staged, lined longways with mirafi, buried a few meters deep, potentially bridge perpendicular with mirafi as well nearer to surface.

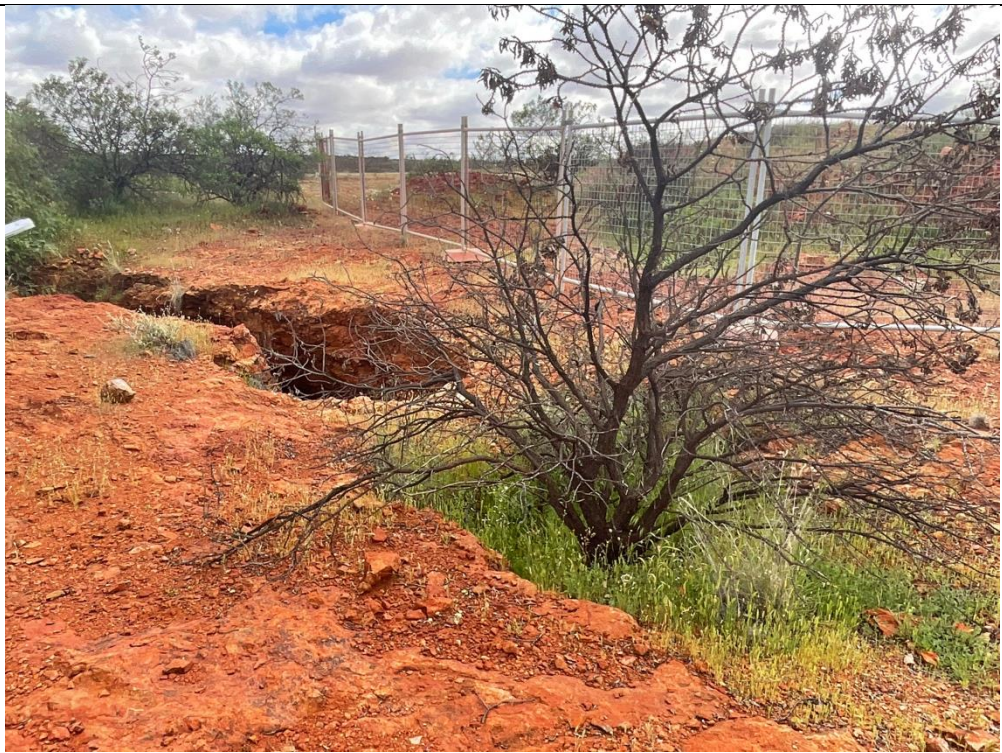
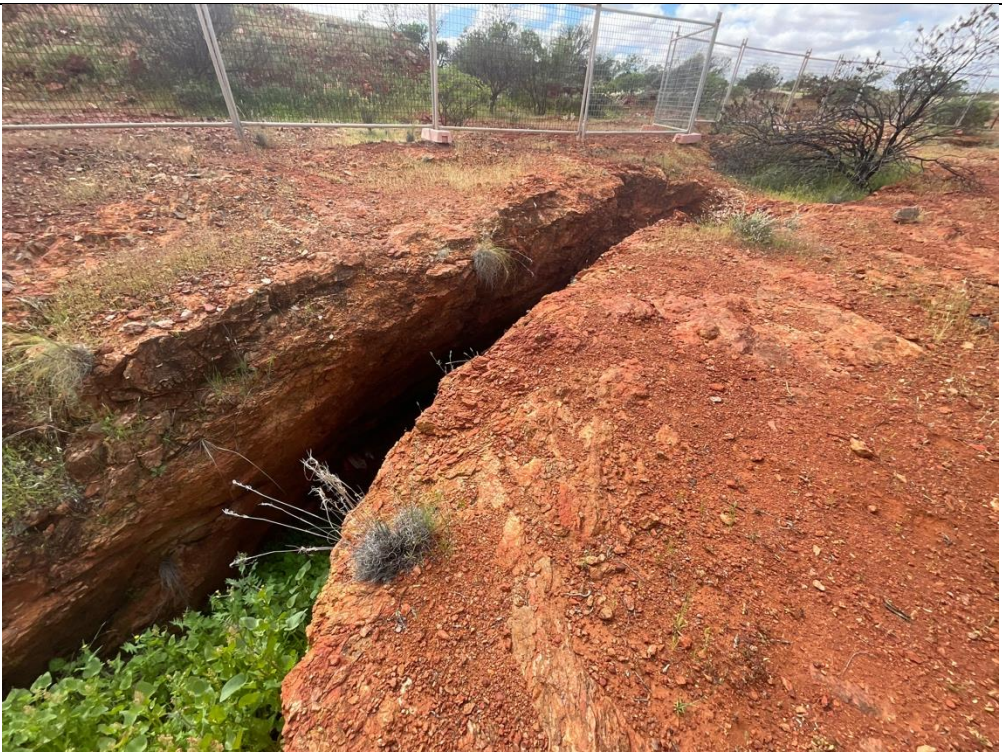
Rock mass / soil profile comments:	Preliminary remediation recommendations:
Moderate quality rock mass. The ground surface comprises a thin layer of gravelly clay soils overlying rock.	Backfill – staged, lined longways with mirafi, buried a few meters deep, potentially bridge perpendicular with mirafi as well nearer to surface.

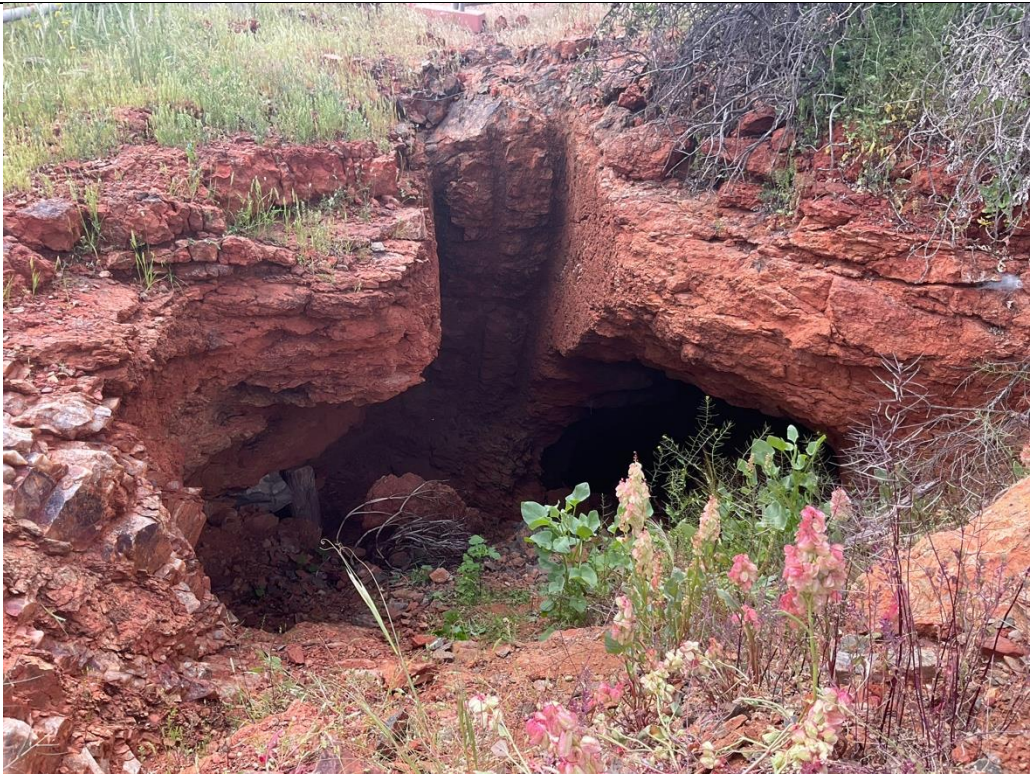
Rock mass / soil profile comments:	Preliminary remediation recommendations:
Moderate quality rock mass. The ground surface comprises a thin layer of gravelly clay soils overlying rock.	Backfill by collapsing drives to cave it in on itself – staged, lined with mirafi, buried a few meters deep, potentially bridge perpendicular with mirafi as well nearer to surface.

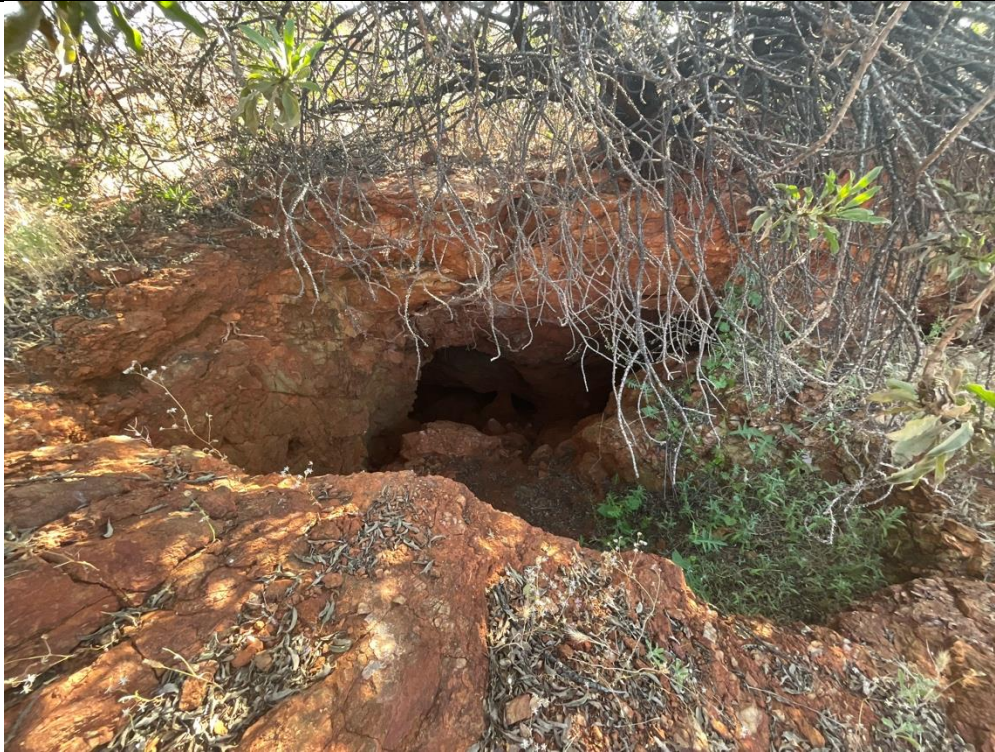
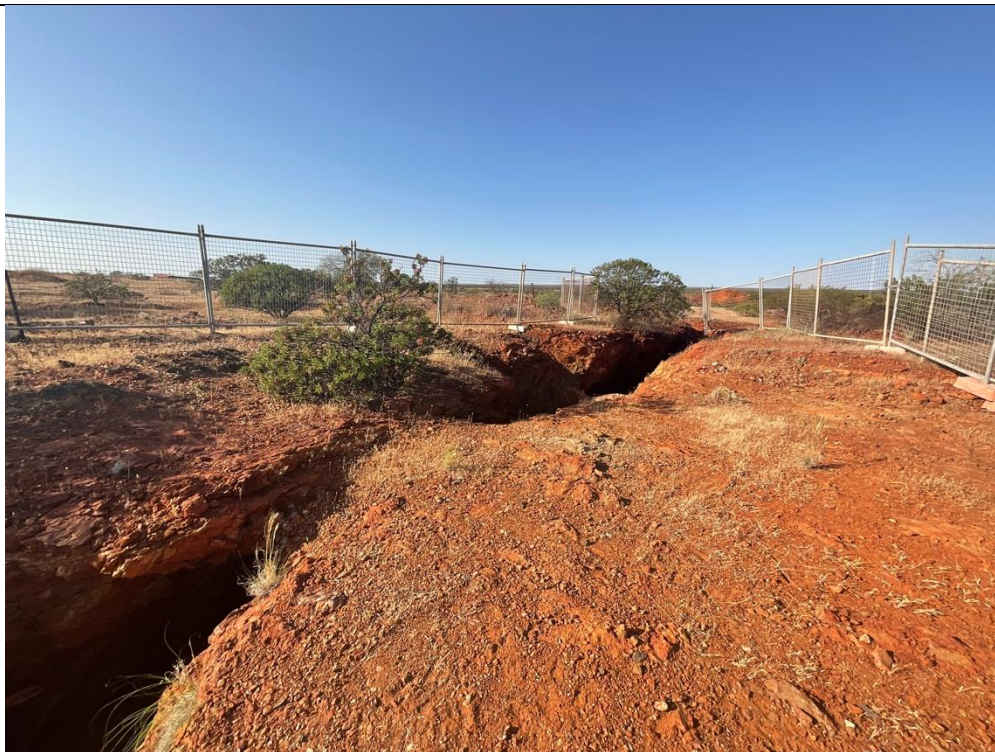
Rock mass / soil profile comments:	Preliminary remediation recommendations:
Moderate quality rock mass. The ground surface comprises a thin layer of gravelly clay soils overlying rock.	Backfill – staged, lined longways with mirafi, buried a few meters deep, potentially bridge perpendicular with mirafi as well nearer to surface.
