ABANDONED MINE FEATURES ASSESSMENT

YALGOO, WA REHABILITATION OPTIONS STUDY

11715-G-R-002 Public Document

Issued to:	Department of Energy, Mines, Industry Regulation & Safety (DEMIRS)
WML Project Number:	11715
Document Name:	11715-G-R-002 Public Document

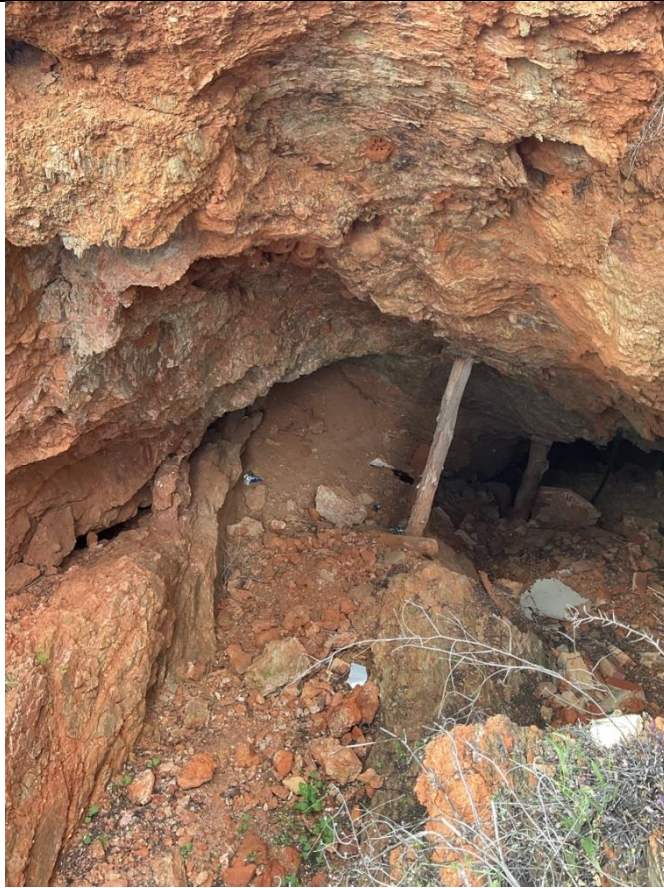
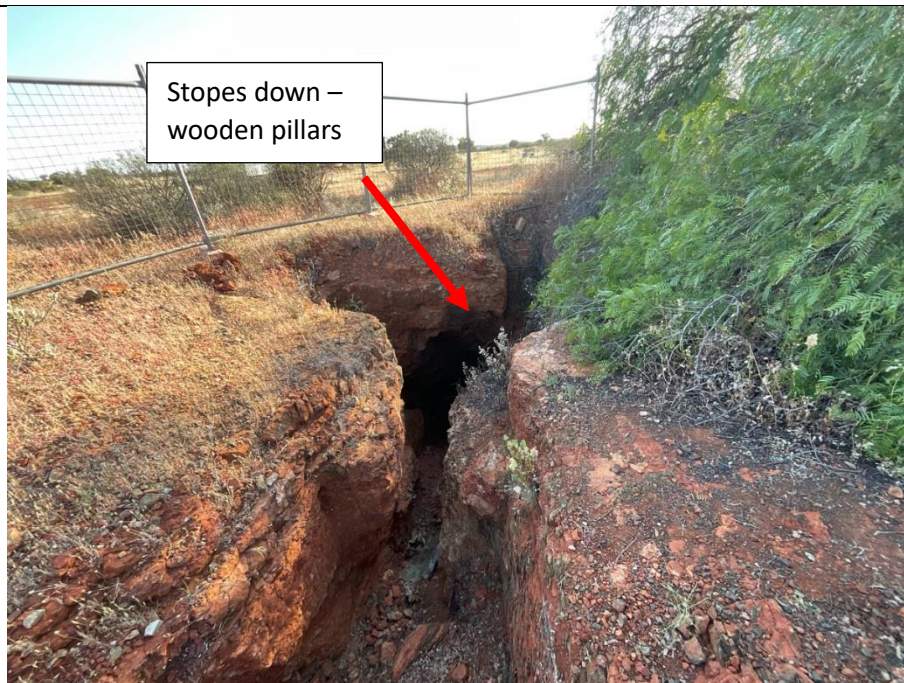
Rock mass / soil profile comments:	Preliminary remediation recommendations:
Moderate rock mass quality. Near vertical walls. Red clays and gravel soils.	Remove material from crest and backfill and cave in. Line with geotextile.

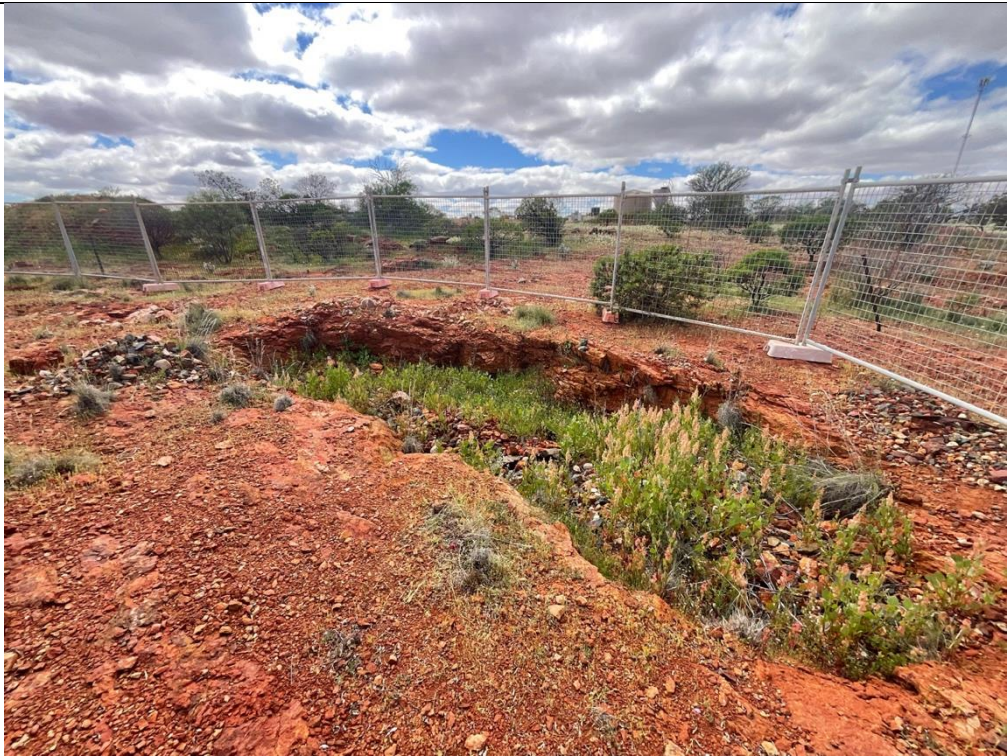
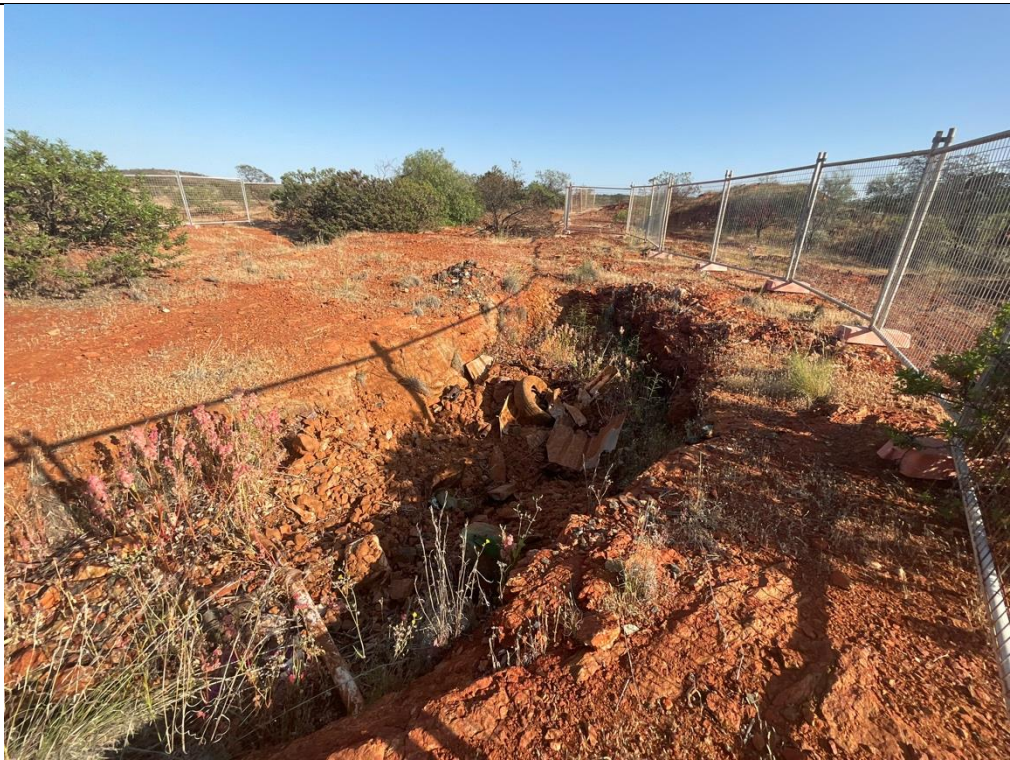
Rock mass / soil profile comments:	Preliminary remediation recommendations:
Moderate quality rock mass. The ground surface comprises a thin layer of gravelly clay soils overlying rock.	Potential contamination at this feature was identified which should be verified by further investigation. Ideally, rehabilitation would involve clearing feature of waste and fill material via excavation, to be placed in large skip bins, assessed for contamination, and sent to an appropriate landfill for suitable disposal. Potential for solution via laying down mirafi and forming a plug.

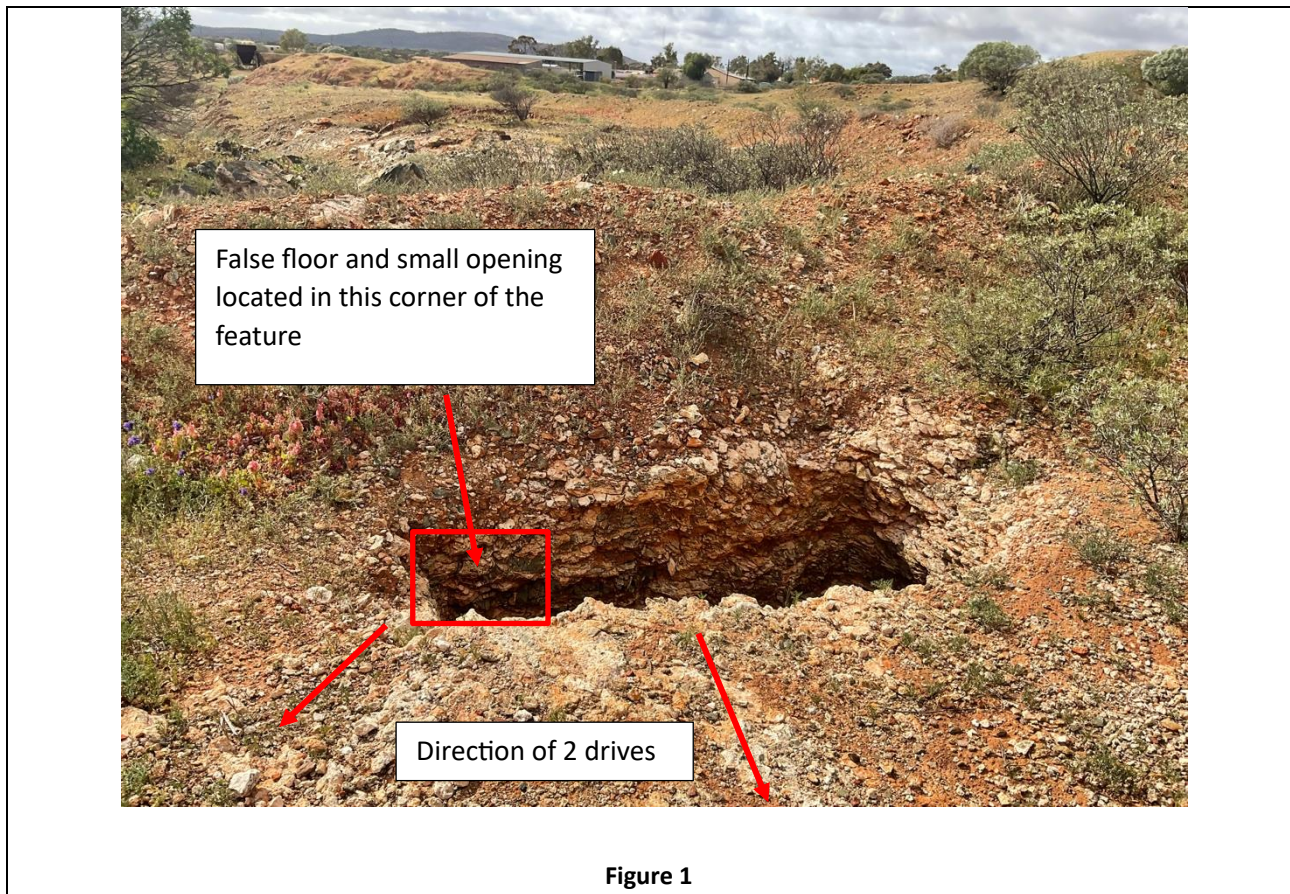
Rock mass / soil profile comments:	Preliminary remediation recommendations:
Crumbly and poor quality rock mass. Walls of the feature are near vertical. The ground surface comprises a thin layer of gravelly clay soils overlying rock.	Dig out and excavate drive, dig out false floor base, backfill and cone plug with concrete. Bury the concrete plug below ground. The desktop study suggests this may have been a shaft 10 – 15 m deep.

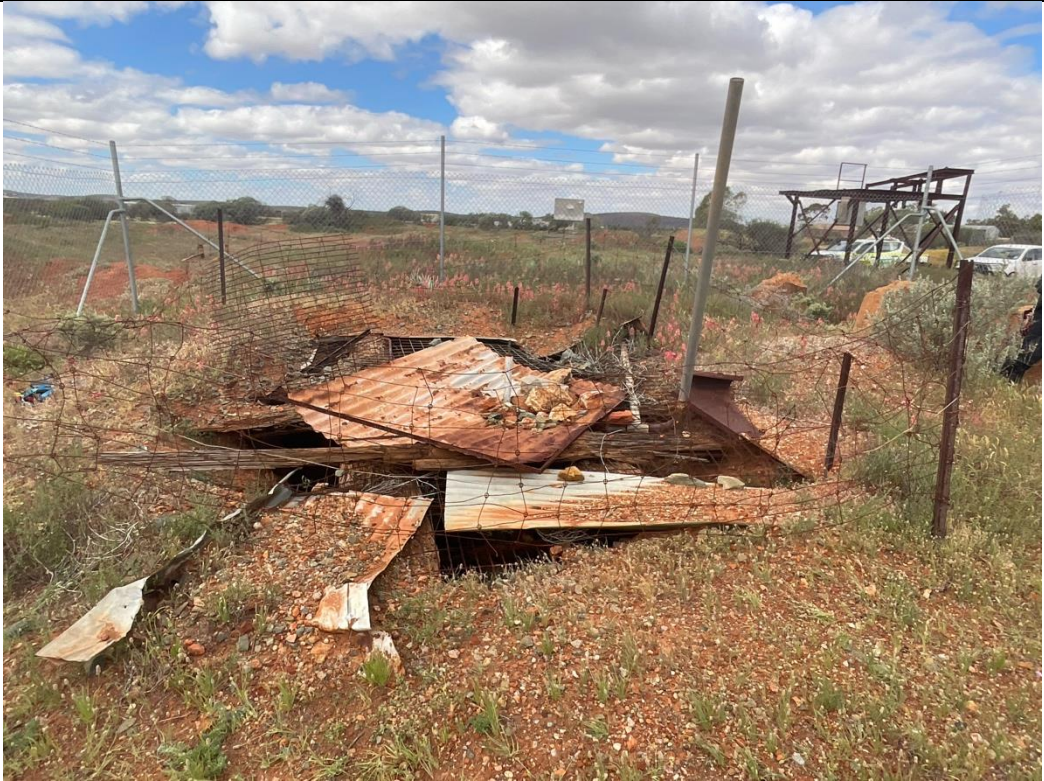
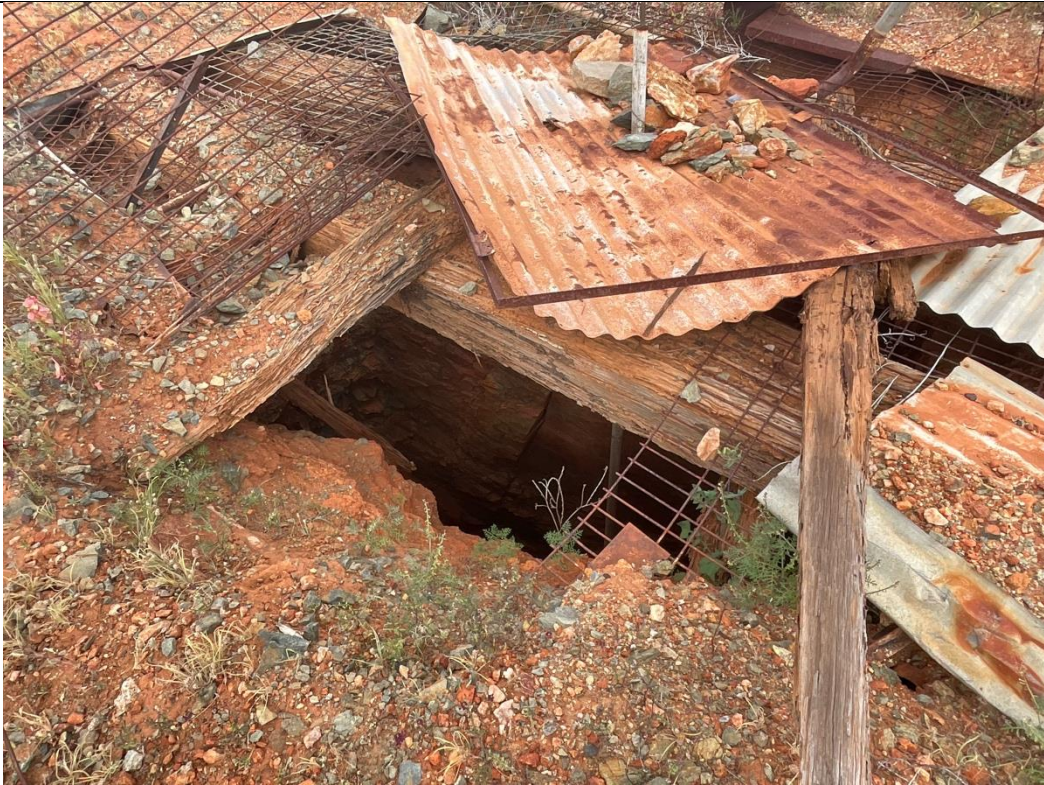
Rock mass / soil profile comments:	Preliminary remediation recommendations:
<p>Moderate to poor quality rock mass (GSI = 20) – vertical walls of square feature. The ground surface comprises a thin layer of clayey gravel soils overlying rock.</p>	<p>Backfill with really coarse rock to above the water level. Line with mirafi and form plug to prevent fines migrating into the coarse rock and being washed away.</p> <p>The desktop information suggests the shaft terminated once water was reached, however, this was taken from a newspaper in 1895; it is likely that further progress had been made to dewater the shaft in later years. A drive to the south connected to a southern feature is also noted – and is likely situated below the water level.</p>

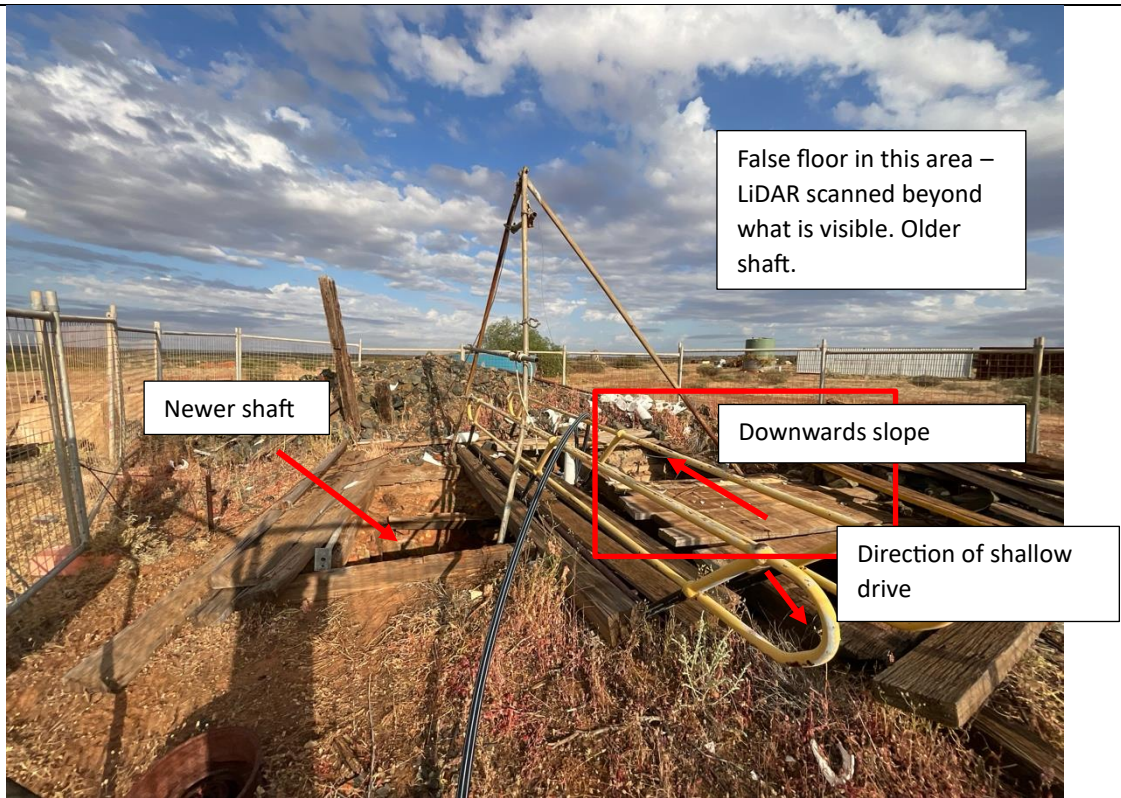
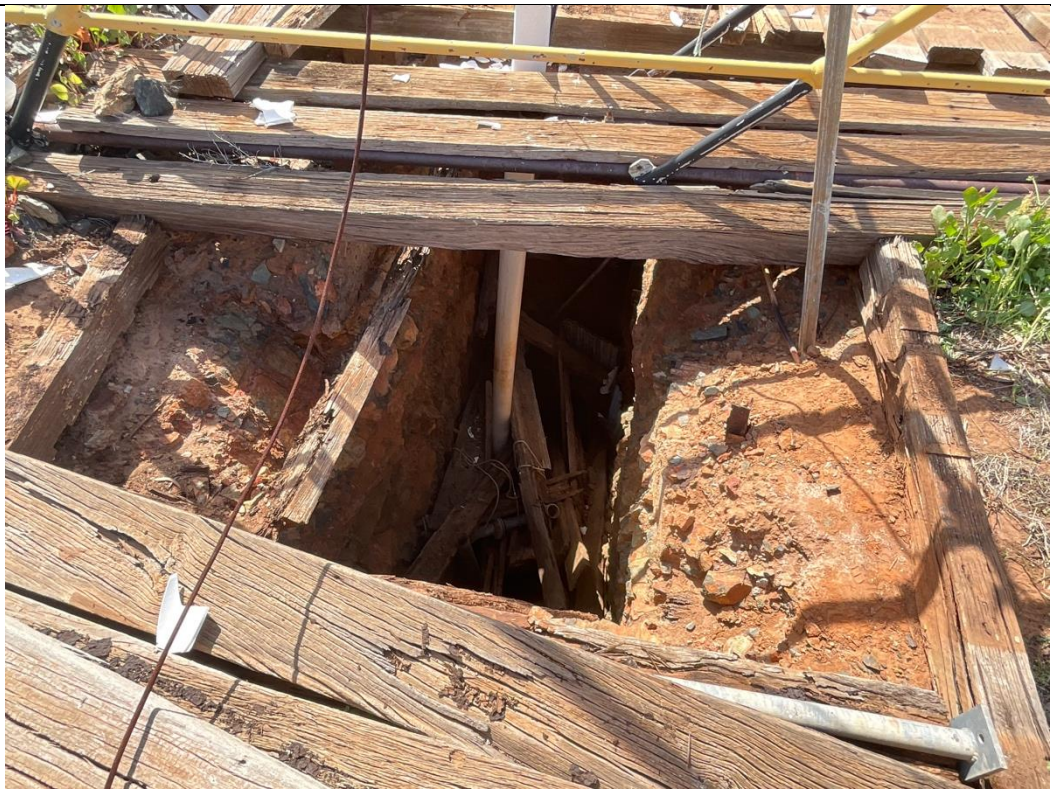
Rock mass / soil profile comments:	Preliminary remediation recommendations:
Moderate quality rock mass. Vertical slope walls. Suitable for founding concrete planks. Red clays and gravel soils around ground surface.	Cone out top 2 m, backfill shaft with rock fill material and cap with concrete cone cap. The desktop study suggests this is a 38 m deep main shaft which comprised 75 m of driving northwest to reach the emerald lode. It should be noted that a potential water pipeline may be located to the east of the feature (running North – South).

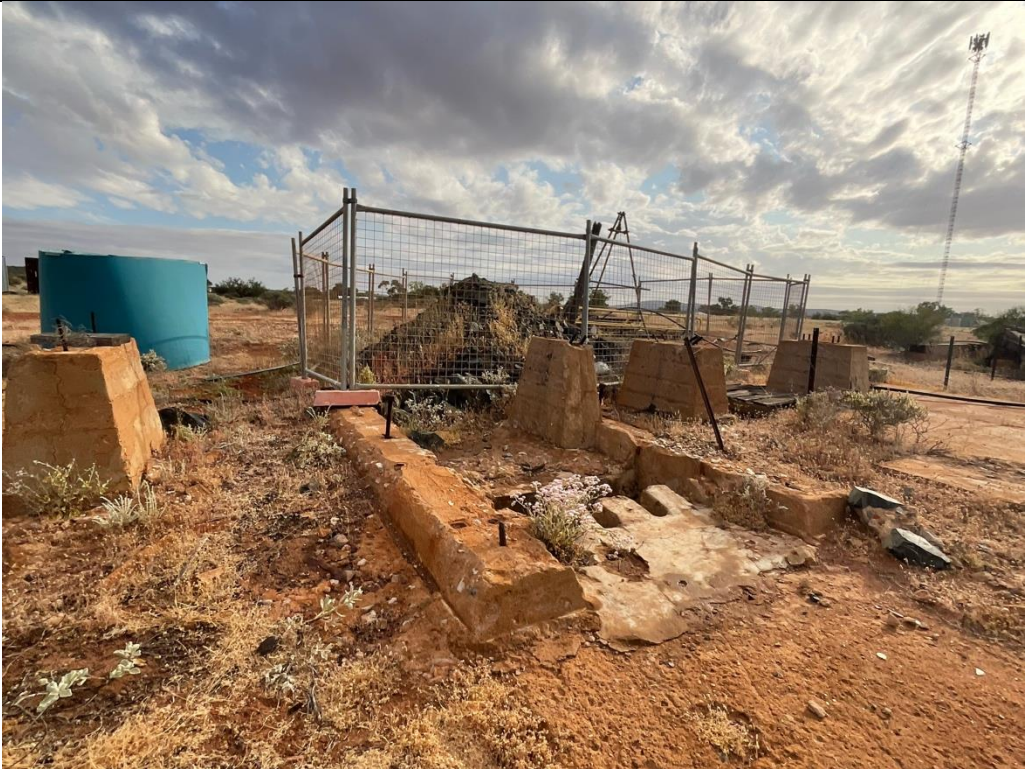
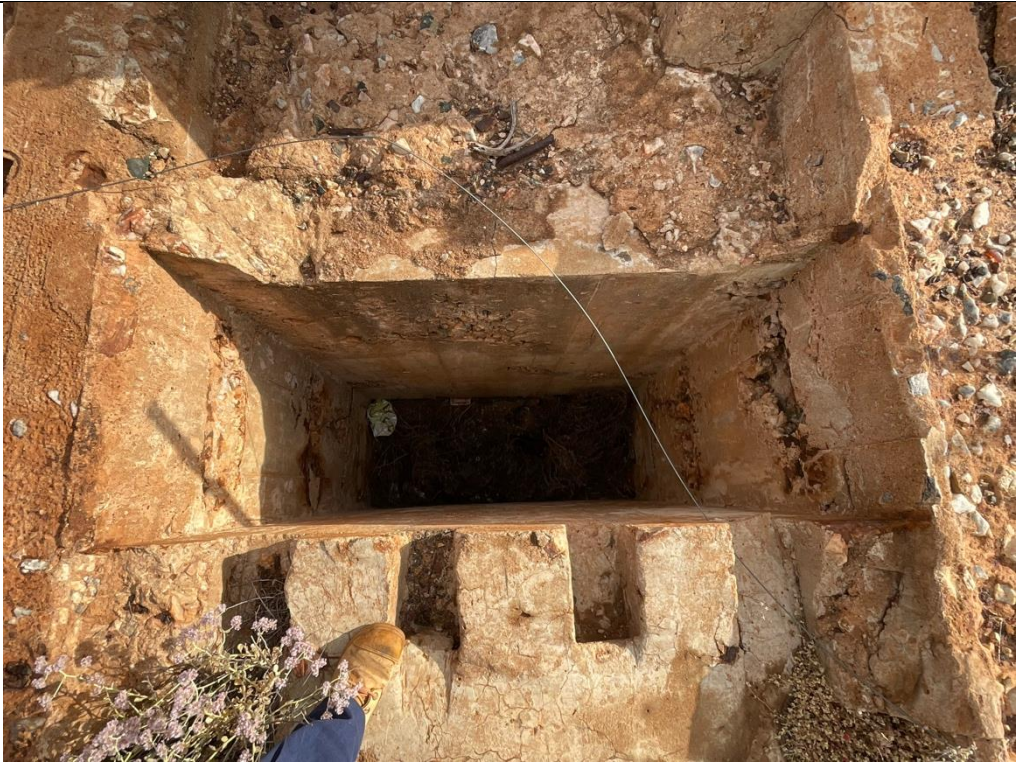
Coordinates	Disturbance investigation:
Latitude: -28.342305 Longitude: 116.679044	N/A
Geometric characteristics:	Flora and fauna:
Approximate Dimensions (L x W x D): 1.5 x 0.6 x 1.9 Approximate Volume (m³): 1.5-2 Depth to groundwater (m): n/a Hydrological Features: n/a	N/A
Description / comments / observations:	Noxious / flammable gas readings:
Concrete slab poses no risk. Leave as is. However, the sump should be remediated as it exists as a vertical excavation.	H₄: 0.0% CO₂: 0.0% H₂S: 0 ppm LEL: 0.0% O₂: 20.6% CO: 0 ppm
Rock mass / soil profile comments:	Preliminary remediation recommendations:
N/A	Backfill the concrete sump.

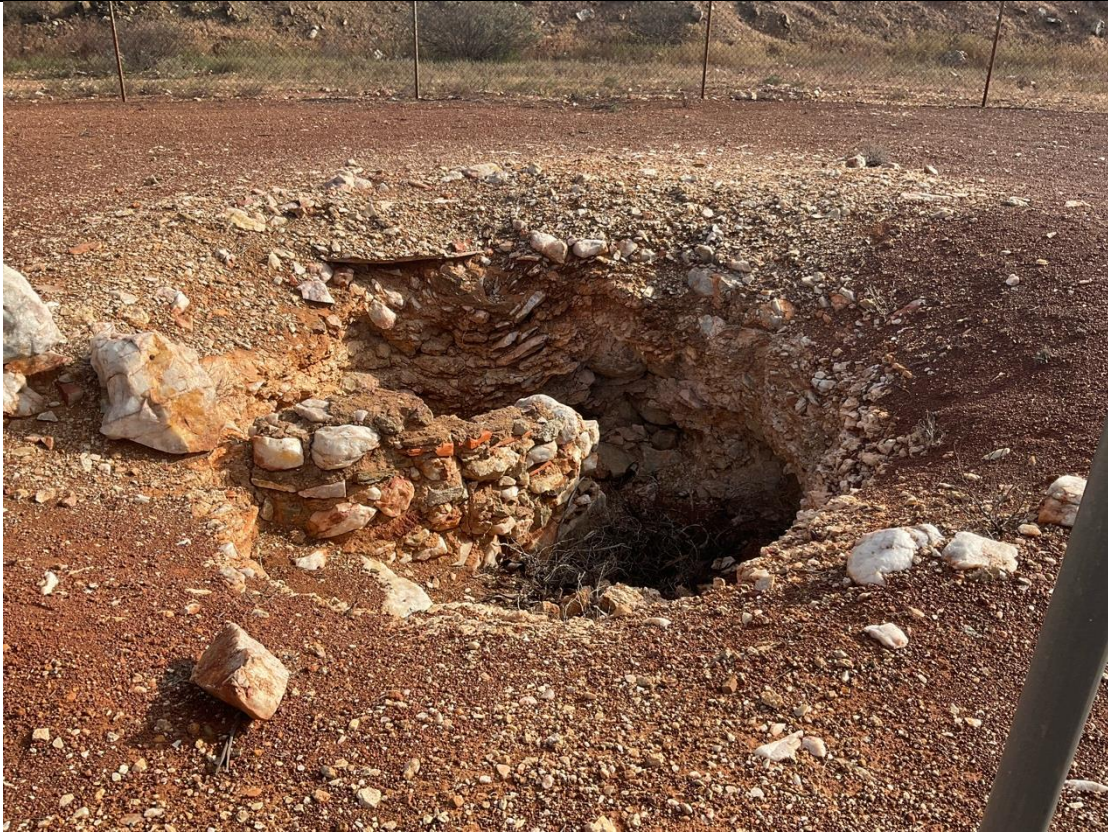
Rock mass / soil profile comments:	Preliminary remediation recommendations:
Poor rock mass quality evidenced in the side walls of the feature.	Unlikely to be a mining related feature and base poses no risk of collapse / false floors. Likely a cold room. Fence with white picket fence as a potential solution?

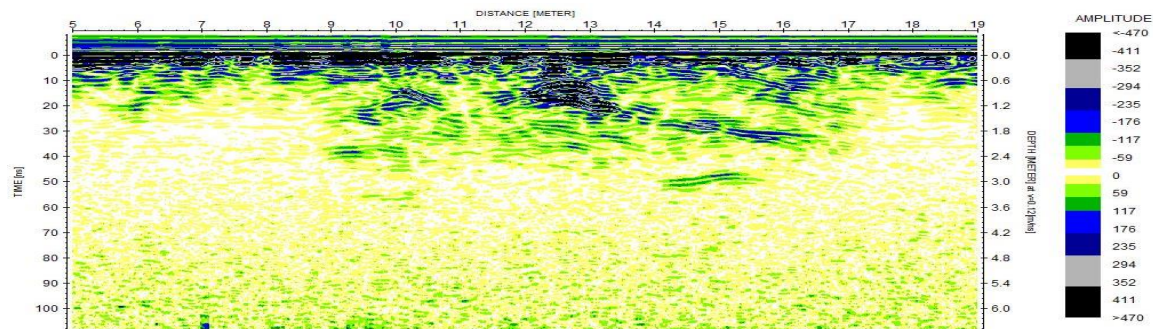
Figure 3: GPR radar-gram showing an anomaly at x=12.5m, y = 0.6m relating to a potential underground mine working.

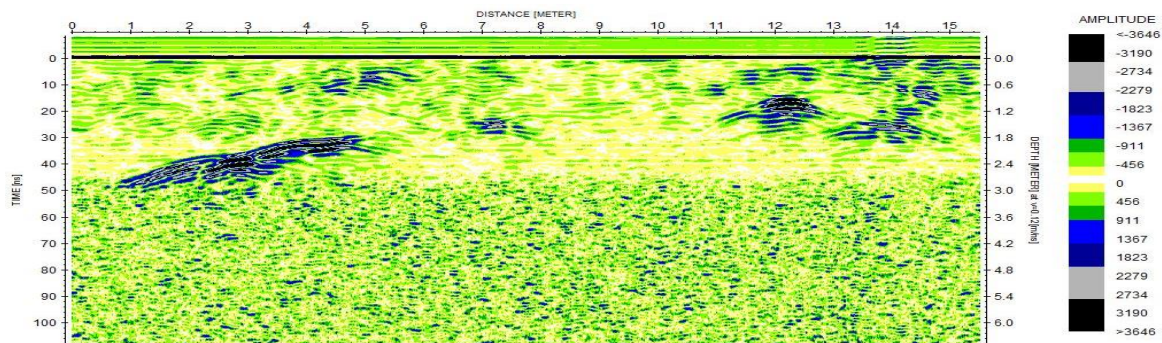
Figure 4: GPR radar-gram showing an anomaly at x=3m, y=2.4m relating to a potential underground mine working.

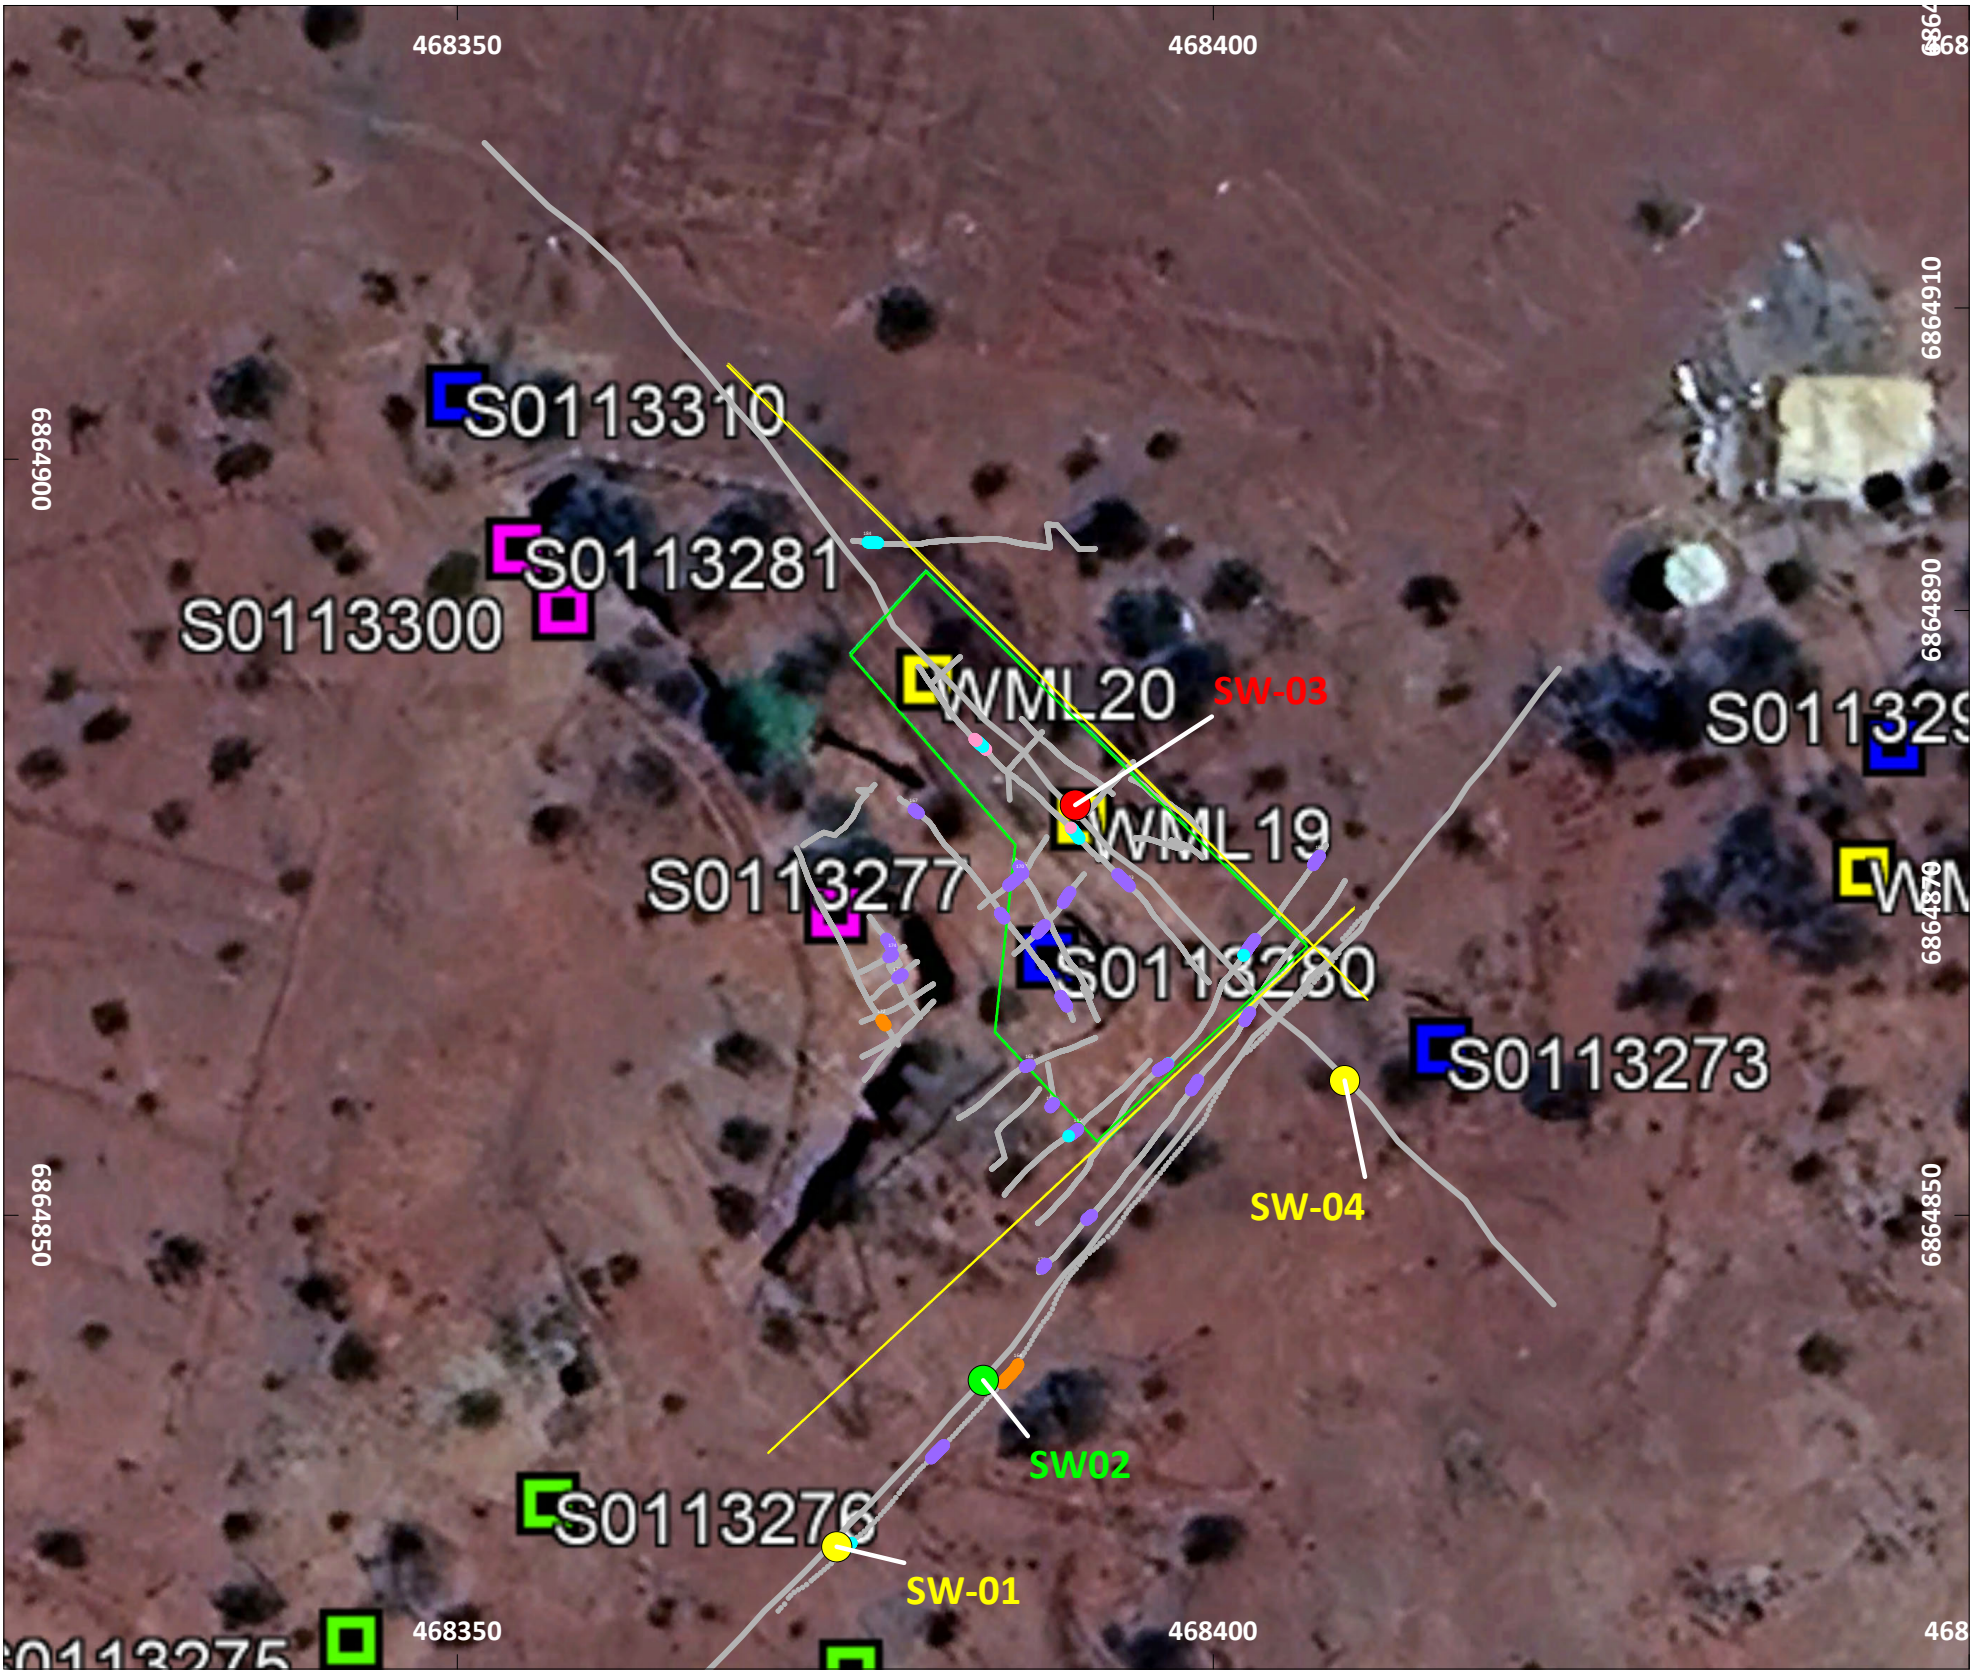
INVESTIGATION SITE MAP WITH IDENTIFIED SUBSURFACE ANOMALIES - YALGOO SOUTH WEST

Analysis of the processed GPR dataset has identified a number of subsurface anomalies potentially related to shallow mine workings within the areas investigated which are presented in a site map in drawing 3133-09. It should be noted that GPR anomalies in the 3-5 mBLG range, particularly in the south-east of the site are likely to be due to edge effects from adjacent identified shafts.
