# ABANDONED MINE FEATURES ASSESSMENT

## YALGOO PHASE 1 GEOTECHNICAL REPORT

11715-G-R-001 Public Document

<b>Issued to:</b>	Department of Energy, Mines, Industry Regulation & Safety (DEMIRS)
<b>WML Project Number:</b>	11715
<b>Document Name:</b>	11715-G-R-001 Public Document

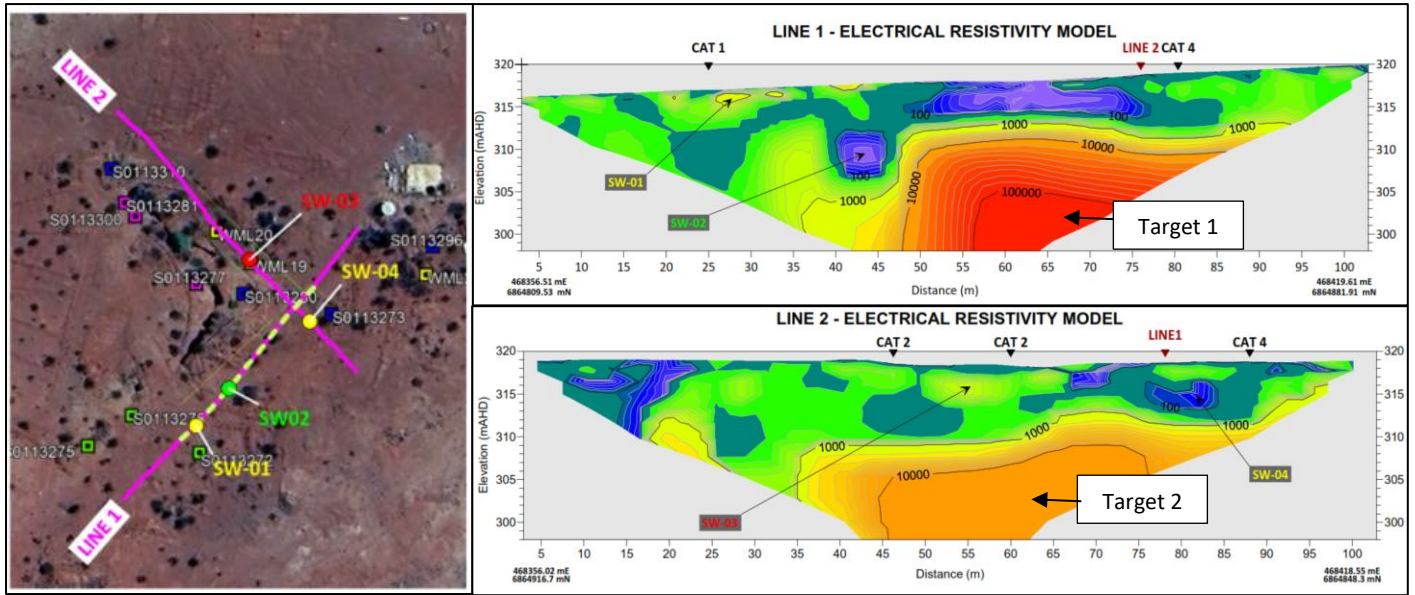
Figure 7: ERT transects – Line 1 and Line 2

Geophysical Target ID	Depth of Target (m)	Feature	Geophysical Interpretation	Historic Data & Site Observations	Significance
<b>Electrical Resistivity Testing (ERT)</b>					
<u>Line 1</u> Target 1	11.0	S0113300 (S)	As shown on Figure 7, a zone of very high electrical resistivity (100,000 $\Omega$ m), was detected at a depth of approximately 11 m bgl. This may potentially be a shadow resulting from interference from the known void (stopes) in the area.	This is evidenced by the 3D LiDAR scans and the available historical information suggesting relatively narrow mined stopes that do not extend far below the water table depth. Any voids in the area would likely be narrow. Alternatively, it may be very hard rock. As the available historical information suggests groundwater below 8.5 – 12 m, any voids at this target depth are likely to be waterlogged, which would display low electrical resistivity values; as such, this target is unlikely to be a void and is more likely to be interference. Relatively competent and hard rock mass was identified at depth.	Any voids at this depth are unlikely to cause any significant surface subsidence expressions (very low risk). Based on the depth of these features, quality of the rock mass, and width of the mined lodes in the area, any below the target depths are not expected to cause any significant surface subsidence and pose very low risk of surface subsidence expressions or ground collapse. However, the presence of lateral workings shall be considered during rehabilitation design.

<u>Line 2</u> Target 2	12.0	S0113300 (N) S0113280 S0113277	As shown on Figure 7, a zone of very high electrical resistivity (10,000 $\Omega$ m), was detected at a depth of approximately 12 m bgl. This may potentially be a shadow resulting from interference from the known void (stopes) in the area.	This is evidenced by the 3D LiDAR scans and the available historical information suggesting relatively narrow mined stopes that do not extend far below the water table depth). Any voids in the area would likely be narrow. Alternatively, it may be very hard rock. As the available historical information suggests groundwater below 8.5 – 12 m, any voids at this target depth are likely	The geophysical data does not suggest these targets to be air voids as the electrical resistivities do not correspond to air voids, and therefore, these targets pose very low to no risk of surface subsidence.

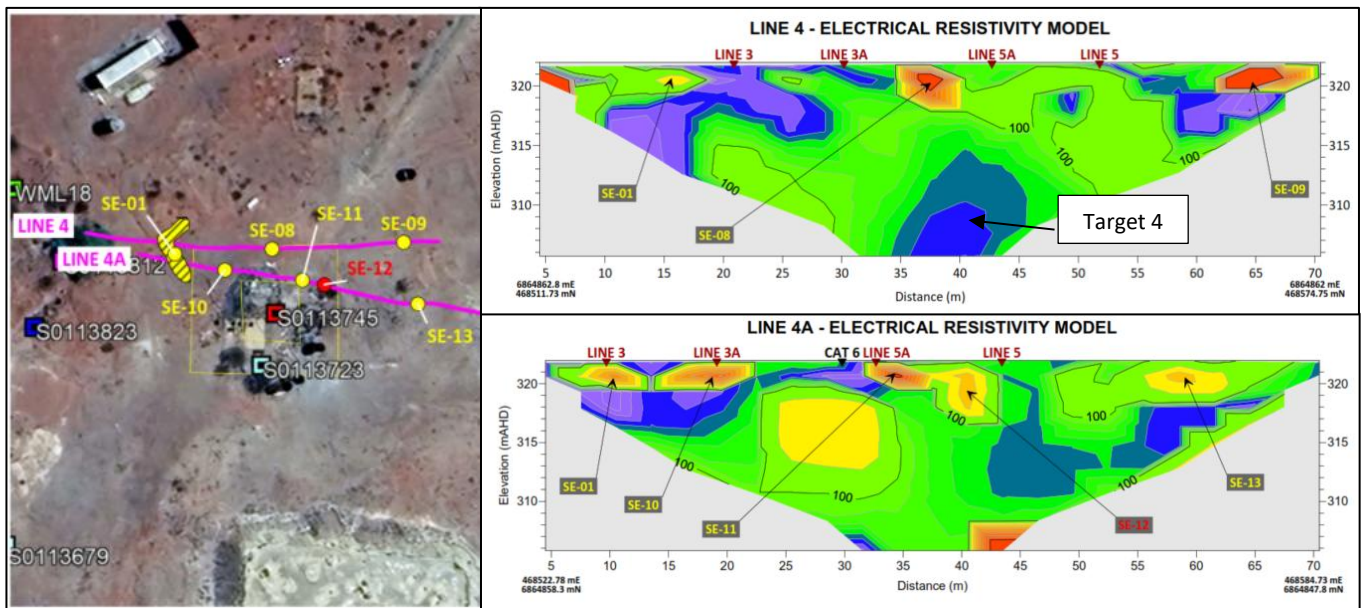
Figure 9: Electrical Resistivity Model Line 4 and Line 4A

<u>Line 4</u> Target 4	12.0	S0113745	Figure 9 shows a zone of very low electrical resistivity at approximately 12.0 m bgl. This target is located below the water table and is indicative of a waterlogged underground mine void / lateral working.	<p>This target has been identified beyond the depth of the shaft which was scanned with the 3D LiDAR scanner.</p> <p>This feature is a main shaft that extended to 38 m based on the historical information.</p> <p>The available historical information also indicates that a 75 m long drive to the</p>	<p>Any voids at this depth are unlikely to cause any significant surface subsidence expressions (very low risk).</p> <p>Based on the depth of these features, quality of the rock mass, and width of the mined lodes in the area, any below the target depths are not expected to cause any significant surface subsidence</p>

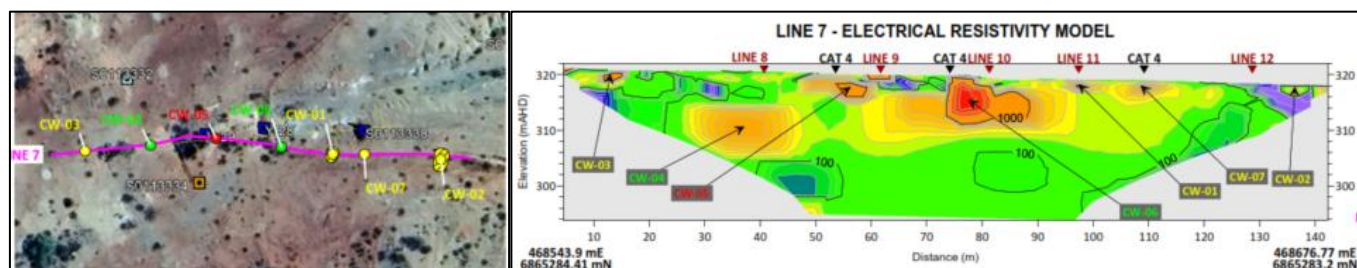
Figure 12: Electrical Resistivity Model Line 7

<u>Line 7</u> CW-05	2.8	Y-29	As shown in Figure 12, a target with an electrical resistivity of approximately 600 $\Omega$ m, was identified at 2.8 m bgl. This is likely to be indicative of a collapsed and backfilled void, however, a void may also still exist at this location.	The 3D LiDAR scanning identified that the feature stopes towards the west. This target is strongly correlated to the known void identified during the geotechnical investigation at Feature Y-29.	The geophysical data does not suggest this target to be voids as the electrical resistivities do not correspond to air voids, and therefore, these targets pose very low risk of surface subsidence.  This is likely to be backfilled / collapsed. However, there is a possibility that air

Geophysical Target ID	Depth of Target (m)	Feature	Geophysical Interpretation	Historic Data & Site Observations	Significance
					voids still exist at this depth in this location. The shallower depth of CW-05 shall be considered for the rehabilitation of this feature.
<u>Line 7</u> CW-06	4.6	Y-28	<p>As shown in Figure 12, a relatively high resistivity target (4000 <math>\Omega</math>m), was identified 4.6 m bgl. This target is likely to be indicative of a void below the false floor identified on site during the geotechnical investigation.</p> <p>The target is located approximately 8.6 m to the southeast of the feature.</p>	<p>The 3D LiDAR scanning of feature Y-28 showed the presence of shallow lateral workings (&lt; 4 m deep) as well as the presence of lateral workings tending to the west of the feature beneath a false floor.</p> <p>Due to obstructions, the southern and eastern portions of the feature below the false floor were not able to be LiDAR scanned, therefore, the geophysical target to the south below the depth of the false floor is very likely to be a void.</p>	Lateral workings identified to the southeast of Feature Y-28; however, they are small and deep enough such that they pose very low risk of surface subsidence expression in the event of void collapse.

<u>Line 7</u> CW-01 CW-03 CW-07 <u>Line 10</u> CW-15 CW-16 CW-18	1.0 – 1.2	S0113334 Y-29 S0113338	Figure 12 and Figure 14 suggest several shallow targets which may be shallow voids or hard rock associated with gold deposits. These targets are approximately 1.0 – 1.2 m bgl.	Borehole drilling in the area indicated that the ground conditions are relatively hard.	These targets pose very low to no risk of surface subsidence. These are likely to be hard rock anomalies. However, these targets may be investigated and rehabilitated by collapsing and backfilling, if necessary, during the rehabilitation stage.
<u>Line 8</u> CW-08	1.9	S0113334	Figure 13 shows that a relatively high resistivity target (5000 $\Omega$ m), was identified 1.9 m bgl which correlates to	Feature S0113334 stopes to the west and this target is indicative of the void scanned with the 3D LiDAR scanner during the geotechnical investigation.	The high risk of voids associated with this geophysical target shall be considered for the rehabilitation design of this feature.

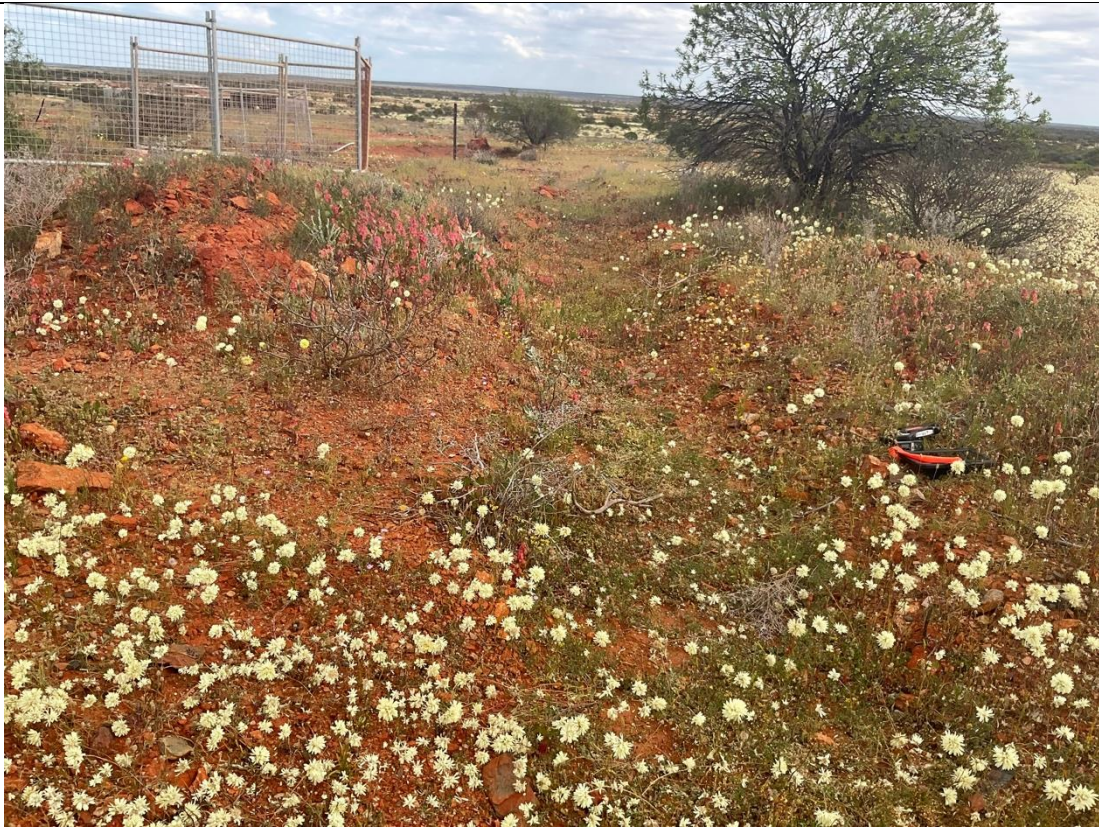
**Figure 1**

<b>Rock mass / soil profile comments:</b>	<b>Preliminary remediation recommendations:</b>
Red clayey gravel soils and crushed rock pieces.	No remediation required. Feature poses no risk.

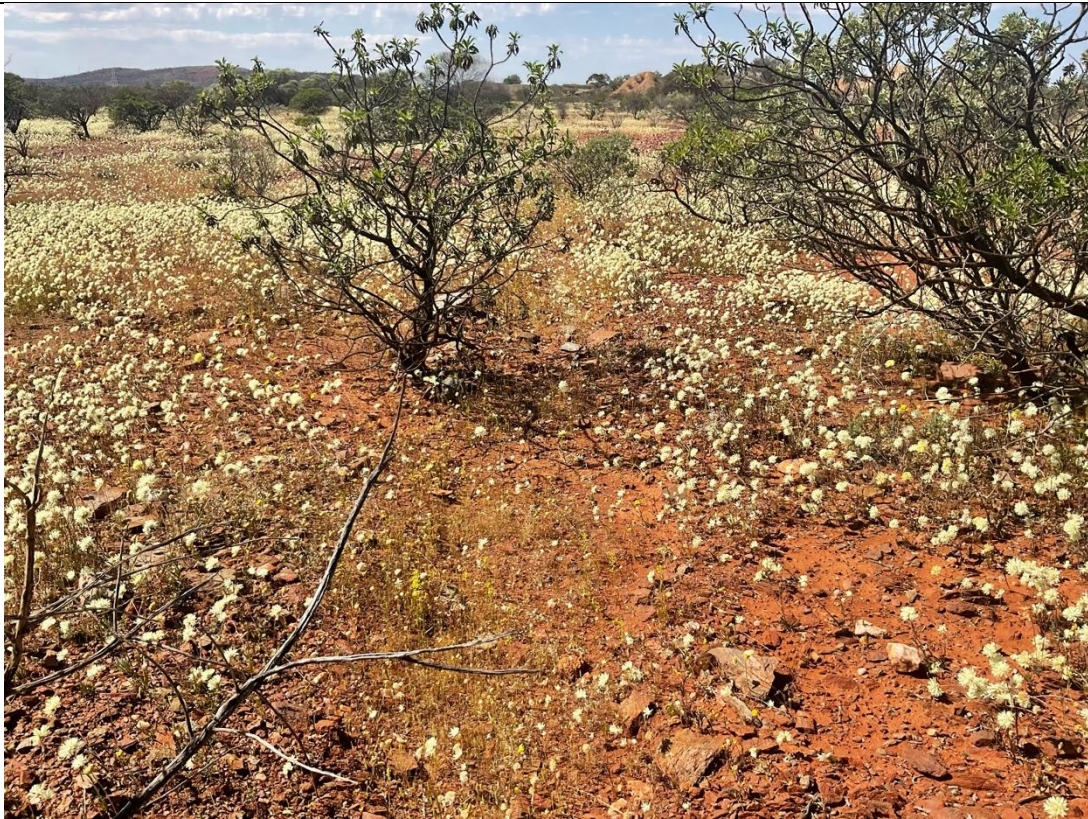
Figure 1

Remediated Costean narrow and shallow, small spoil pile situated to the east of the feature. No DCP undertaken due to visible rock. No LiDAR scan undertaken.	<b>CH<sub>4</sub>:</b> 0.0% <b>CO<sub>2</sub>:</b> 0.0% <b>H<sub>2</sub>S:</b> 0 ppm <b>LEL:</b> 0.0% <b>O<sub>2</sub>:</b> 20.6% <b>CO:</b> 0 ppm
<b>Rock mass / soil profile comments:</b>	<b>Preliminary remediation recommendations:</b>
Rock fabric evident in base of feature. Red clayey gravel soils.	No remediation required. Feature poses no risk.

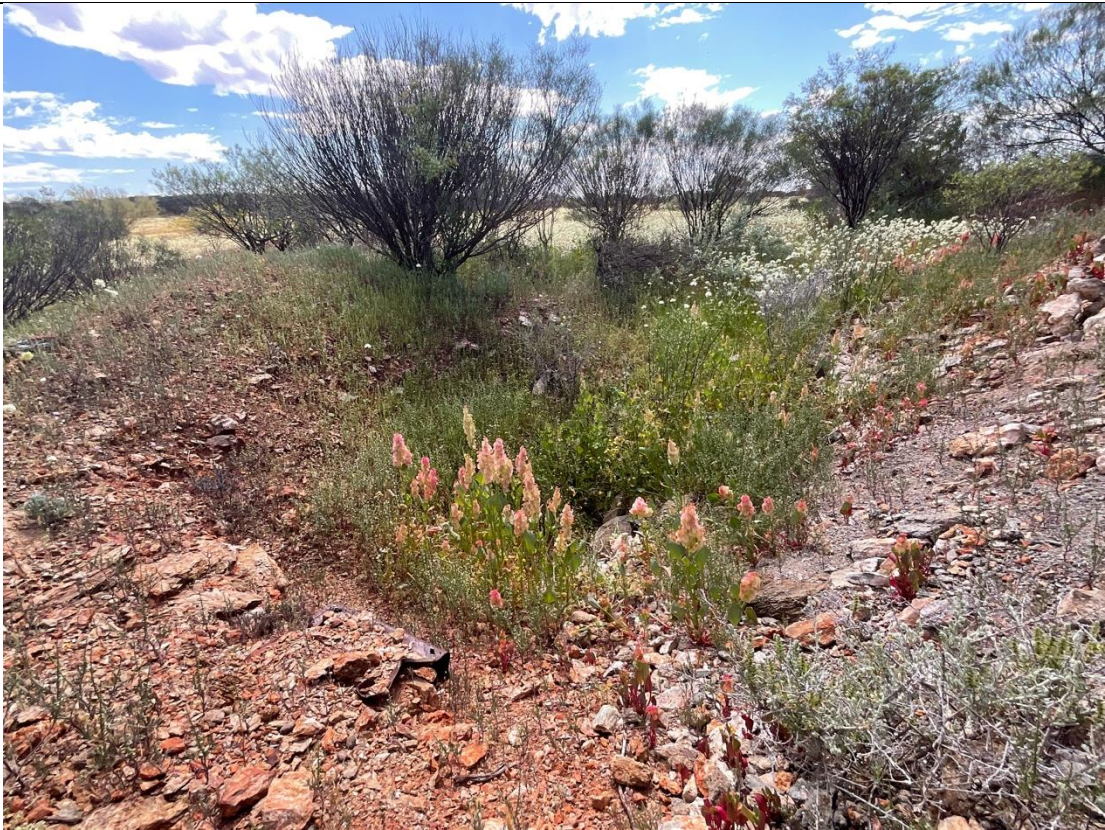
Figure 1

Rectangular feature. Base is filled with large pieces waste rock and vegetation and appears loose. Significant sized spoil pile size around the feature from size of depression. No DCP undertaken due to visible rock. No LiDAR scan undertaken.	<b>CH<sub>4</sub>:</b> 0.0% <b>CO<sub>2</sub>:</b> 0.0% <b>H<sub>2</sub>S:</b> 0 ppm <b>LEL:</b> 0.0% <b>O<sub>2</sub>:</b> 20.6% <b>CO:</b> 0 ppm
<b>Rock mass / soil profile comments:</b>	<b>Preliminary remediation recommendations:</b>
No visible rocky outcrops.	Blade in spoil surrounding the feature which may be suitable for re-use as backfill and rehabilitate.

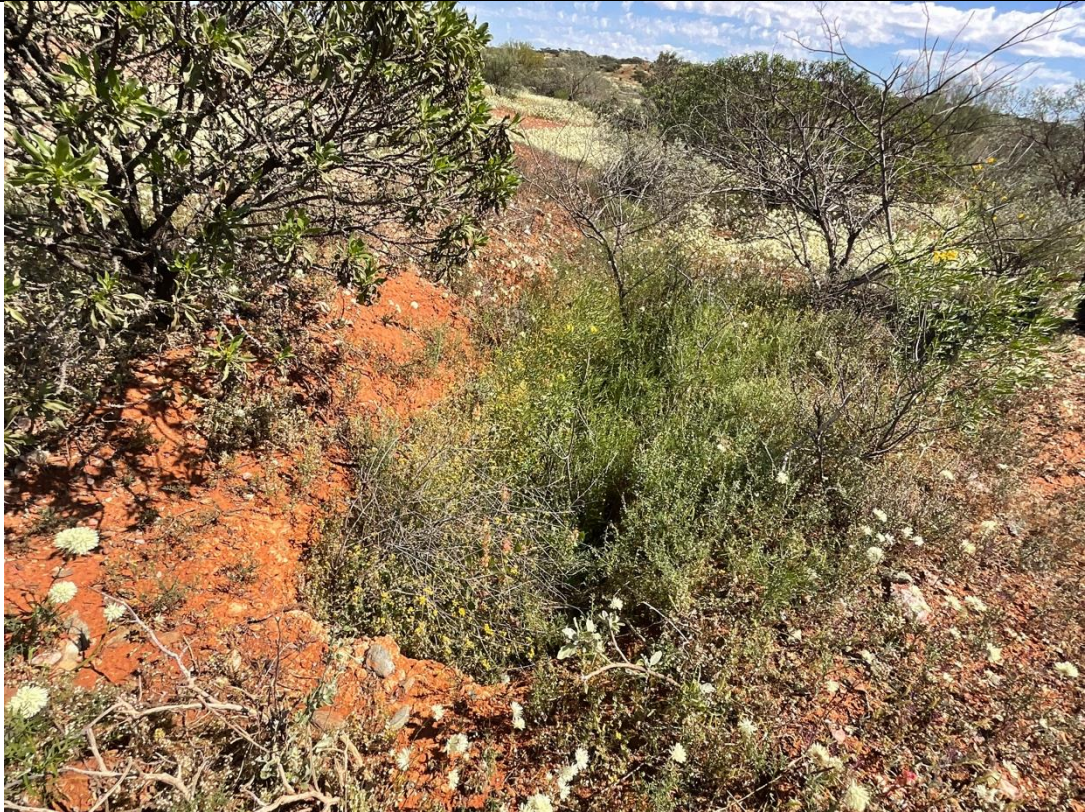
Figure 1

Rock mass / soil profile comments:	Preliminary remediation recommendations:
Poor quality rock mass evidenced to southern end of trench. Red clayey gravel soils.	No remediation required. Feature poses no risk. Or blade in sides to soften the feature walls.

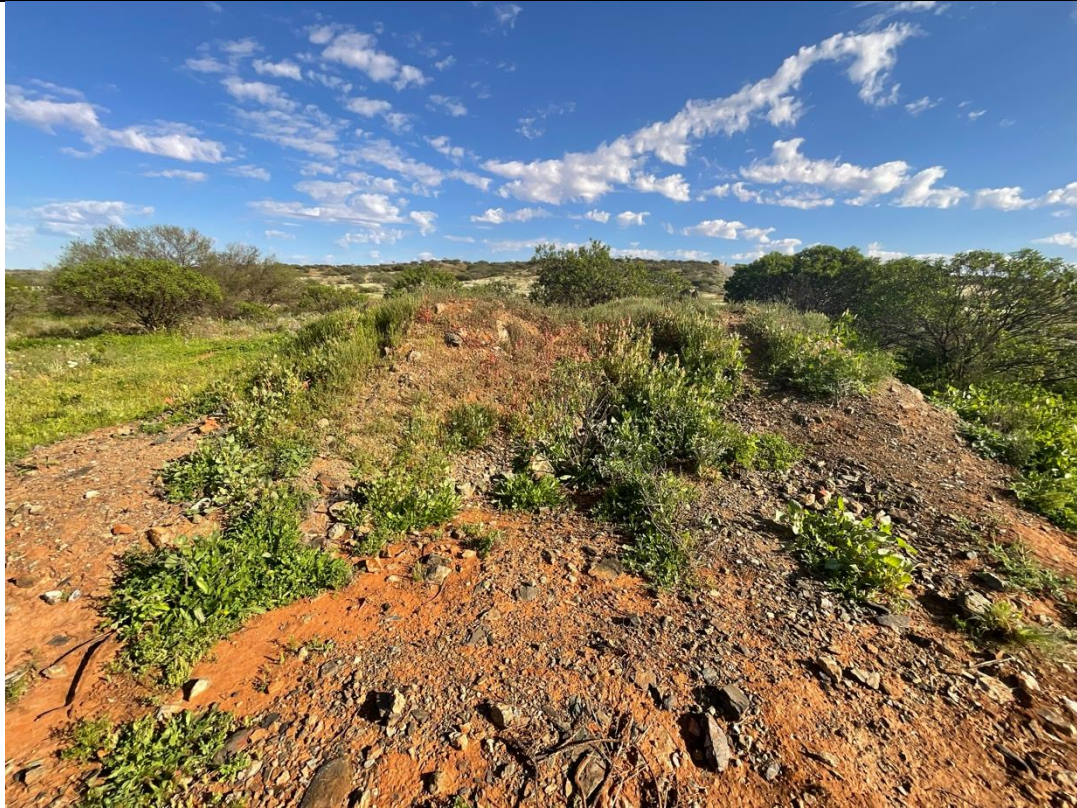
**Figure 1**

Small circular depression surrounded by large L shaped spoil pile of size 15 x 9 x 1.5 high No DCP undertaken due to water pipeline nearby. No LiDAR scan undertaken.	<b>CH<sub>4</sub>:</b> 0.0% <b>CO<sub>2</sub>:</b> 0.0% <b>H<sub>2</sub>S:</b> 0 ppm <b>LEL:</b> 0.0% <b>O<sub>2</sub>:</b> 20.7% <b>CO:</b> 0 ppm
<b>Rock mass / soil profile comments:</b>	<b>Preliminary remediation recommendations:</b>
No visible evidence of rocky outcrops.	No remediation required. Feature poses no risk. Or blade in to soften edges.

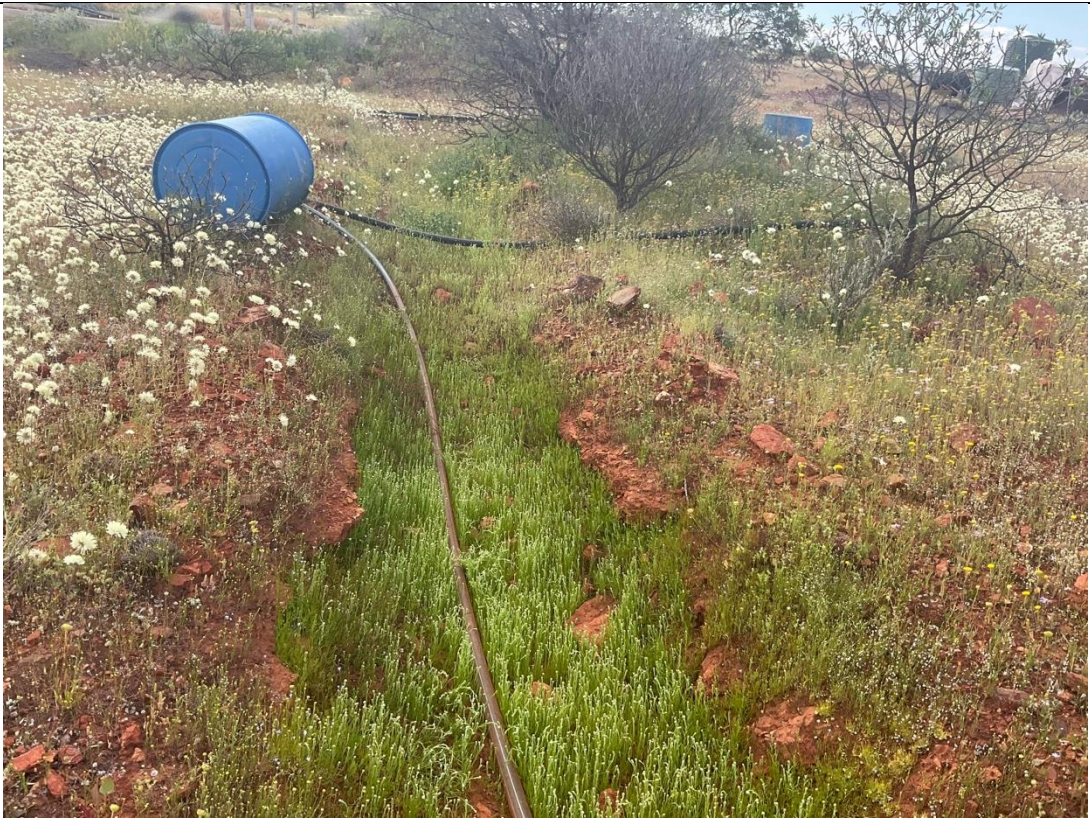
Figure 1

<b>Rock mass / soil profile comments:</b>	<b>Preliminary remediation recommendations:</b>
Red clayey gravel soils and crushed rock pieces.	No remediation required. Feature poses no risk.

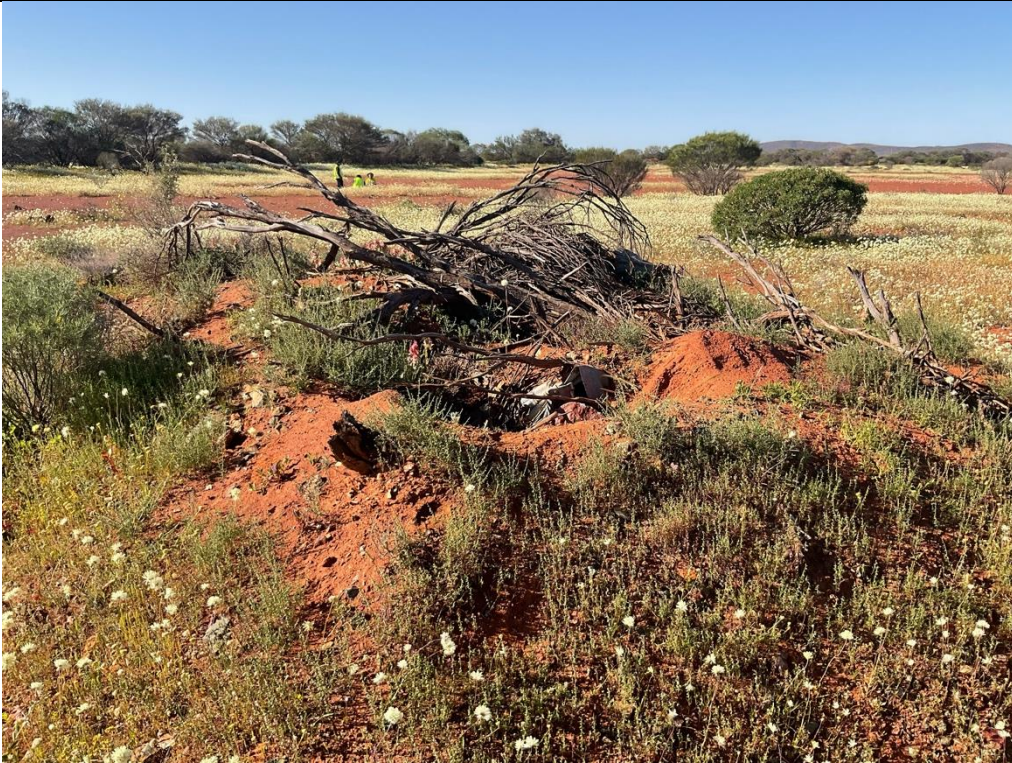
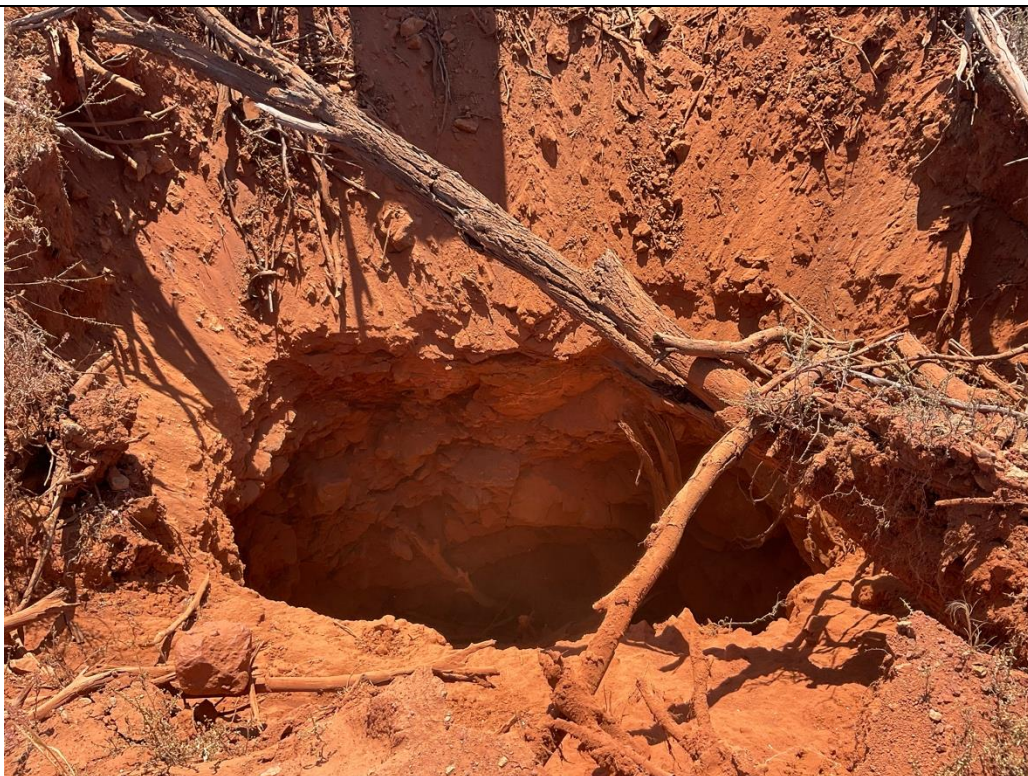
Description / comments / observations:	Noxious / flammable gas readings:
Circular shaft feature filled with branches, tin scrap metal and waste gravel rock. Tree / shrub branches obscure view of base conditions at this stage. 1 m tall spoil pile surrounds the feature.  Ground conditions at the surface around the opening of the feature are generally good, as evidenced by shallow borehole refusal.  LiDAR scan undertaken after dead tree had been cleared out of the shaft.	<b>CH<sub>4</sub>:</b> 0.0% <b>CO<sub>2</sub>:</b> 0.0% <b>H<sub>2</sub>S:</b> 0 ppm <b>LEL:</b> 0.0% <b>O<sub>2</sub>:</b> 20.7% <b>CO:</b> 0 ppm
Rock mass / soil profile comments:	Preliminary remediation recommendations:
Poor quality rock mass.	The shaft may have a false floor and risk of void collapse exists. Mirafi soil backfill plug.

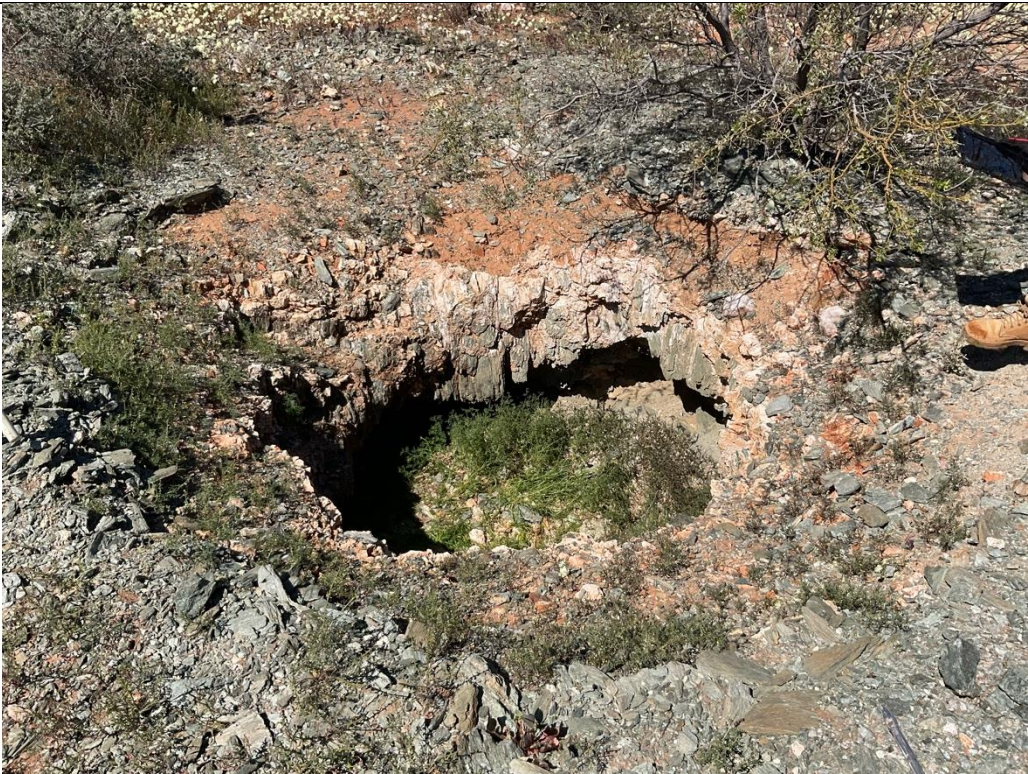
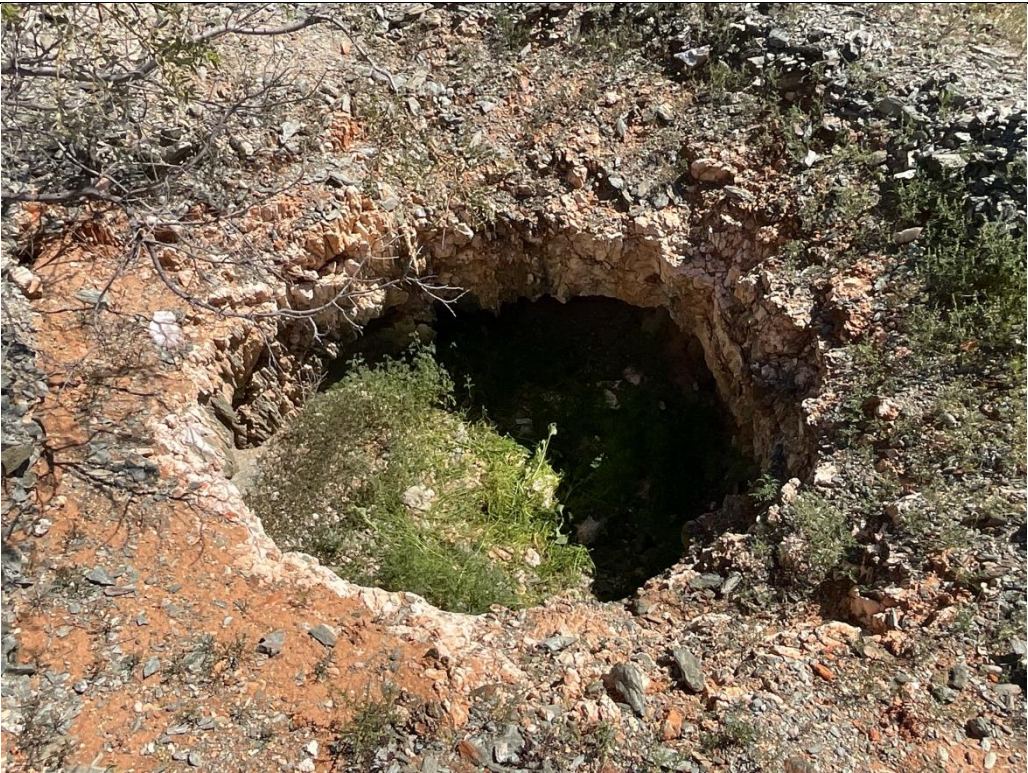
Rock mass / soil profile comments:	Preliminary remediation recommendations:
Very poor and crumbly rock mass quality. Red clayey gravel soils.	Potentially mirafi plug soil backfill, dome out the feature to form a plug shape prior to backfill.

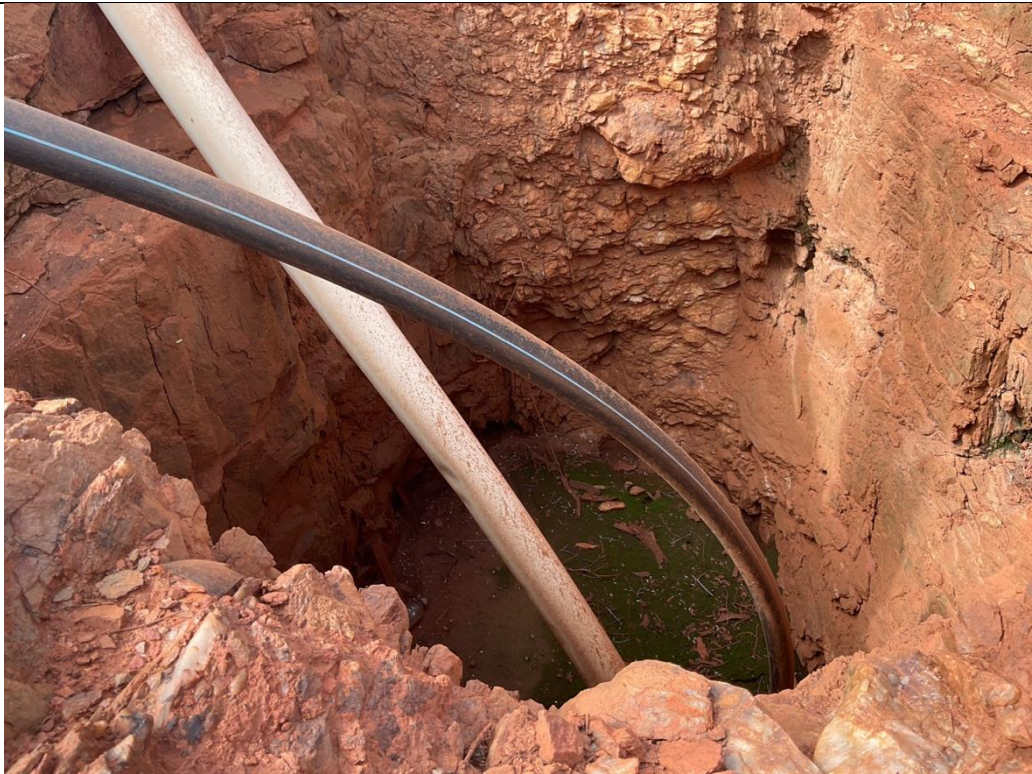
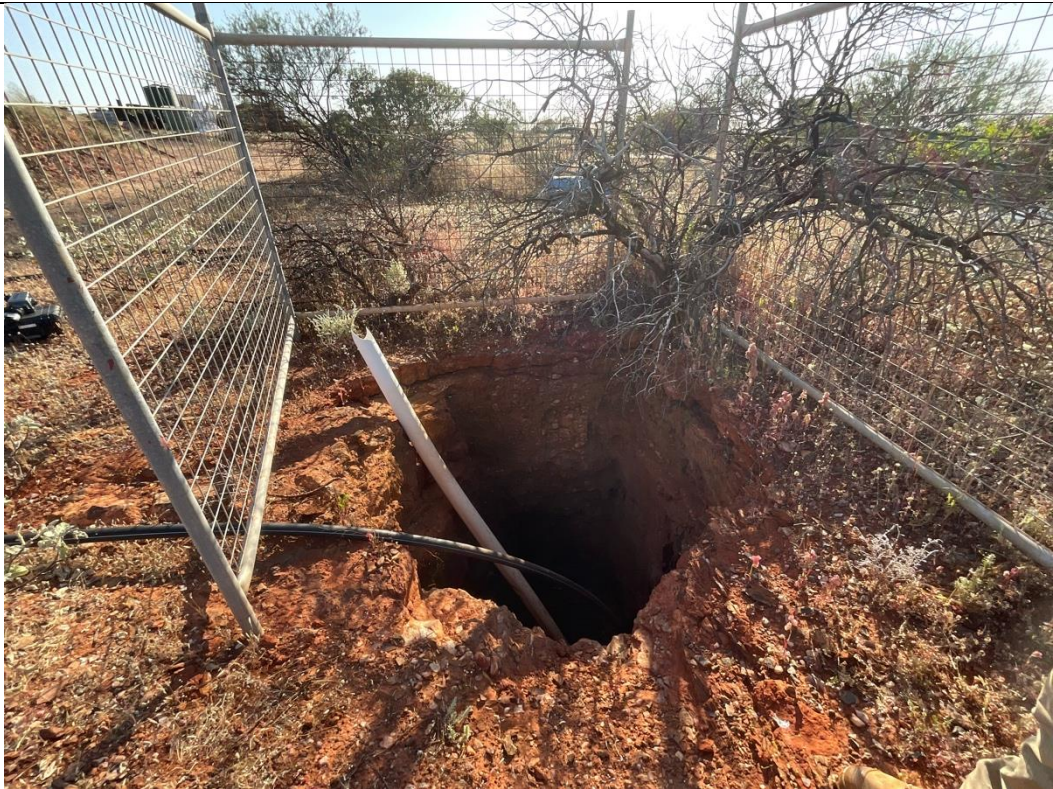
<b>Rock mass / soil profile comments:</b>	<b>Preliminary remediation recommendations:</b>
Moderate rock mass quality. Near vertical walls.	Remove material from crest and backfill and cave in. Line with geotextile.

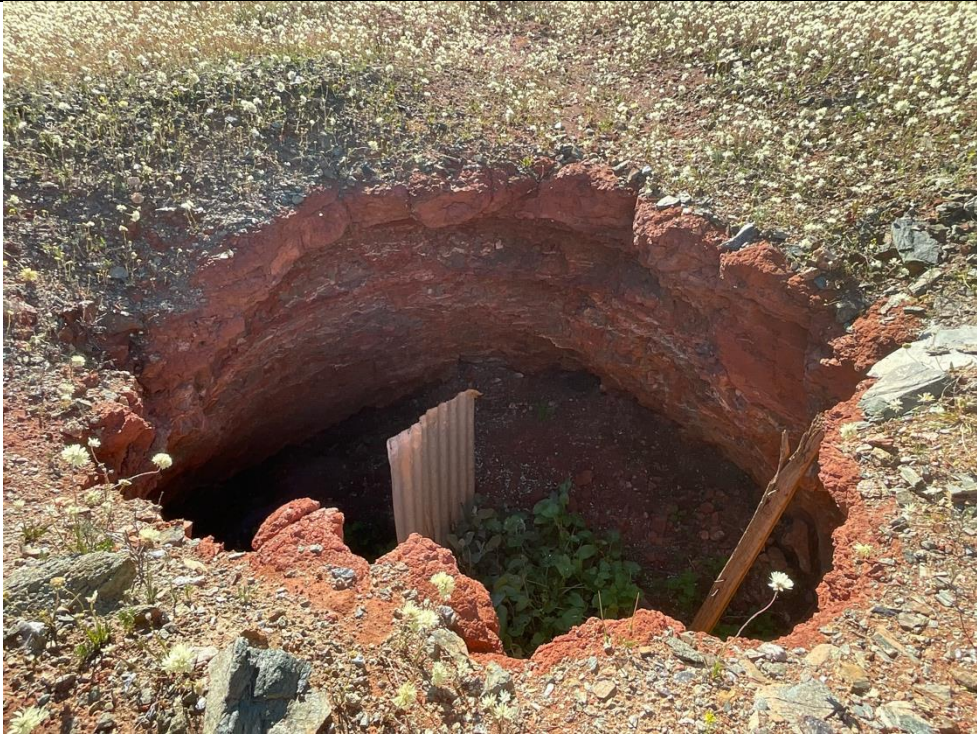
Circular feature that bulges out at the base. The base is filled with waste rock sandy gravels and some tin sheet metal. Very small to no spoil around the feature. Ground conditions at the surface around the opening of the feature are generally good, as evidenced by shallow auger borehole refusal. LiDAR scan undertaken.	<b>CH<sub>4</sub>:</b> 0.0% <b>CO<sub>2</sub>:</b> 0.0% <b>H<sub>2</sub>S:</b> 0 ppm <b>LEL:</b> 0.0% <b>O<sub>2</sub>:</b> 20.6% <b>CO:</b> 0 ppm
Rock mass / soil profile comments:	Preliminary remediation recommendations:
Very poor rock quality mass. Near vertical walls.	Hollow out, dome and backfill with mirafi soil plug.

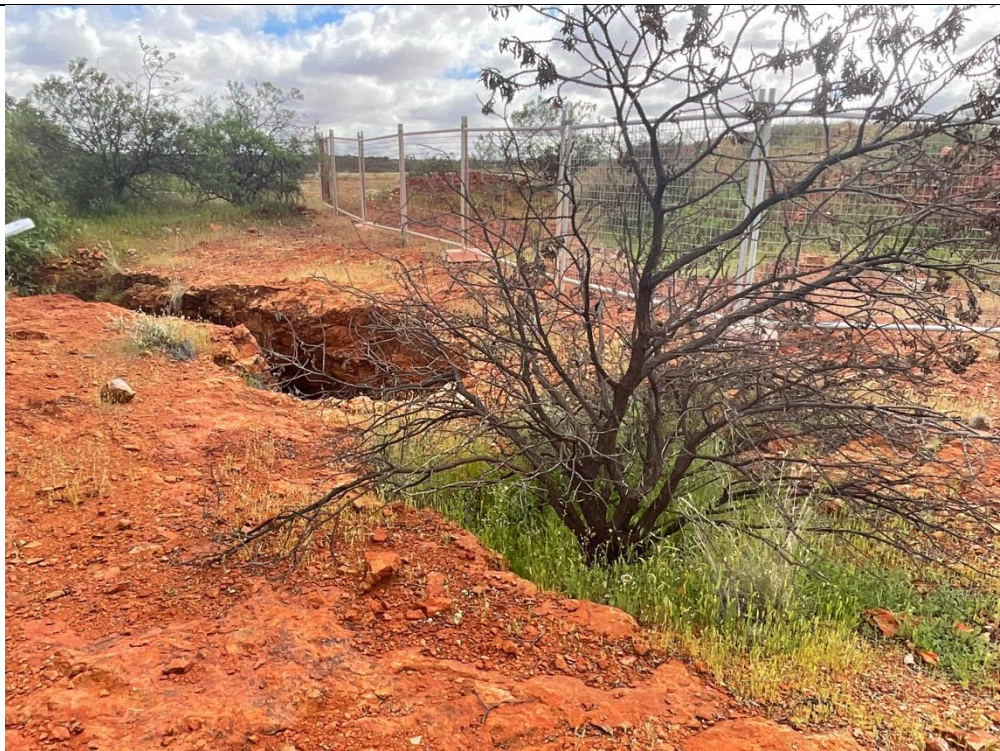
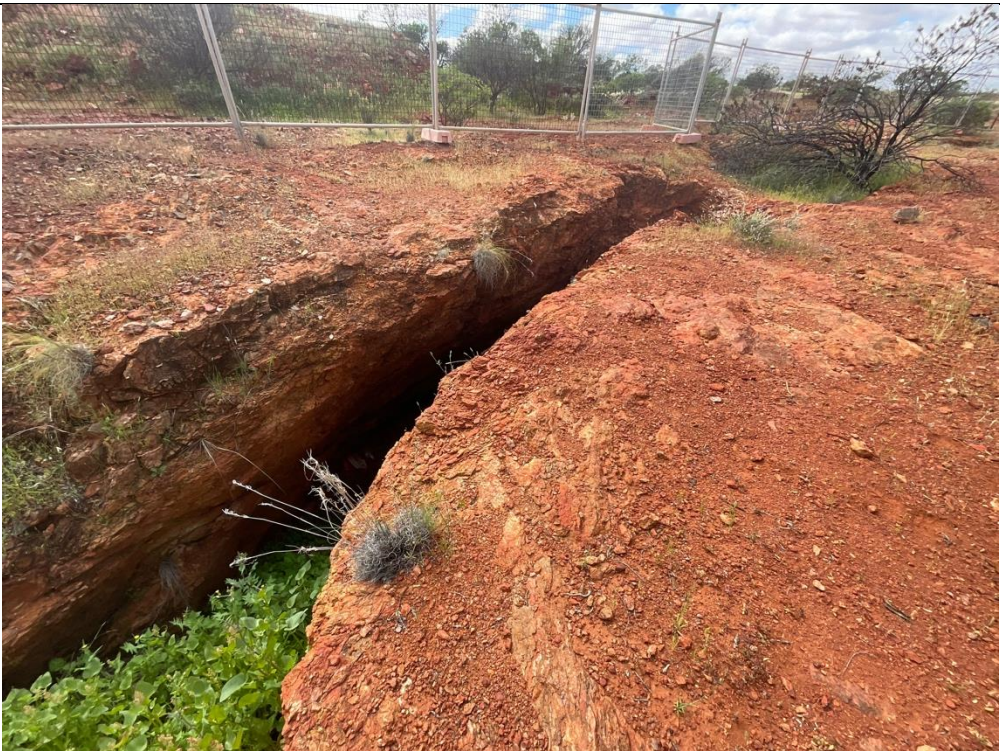
Feature S0113277	Project No:	11715
	Client: Department of Energy, Mines, Industry Regulation and Safety (DEMIRS)	Date:	4/9/24

Rock mass / soil profile comments:	Preliminary remediation recommendations:
Moderate quality rock mass. The ground surface comprises a thin layer of gravelly clay soils overlying rock.	Backfill – staged, lined longways with mirafi, buried a few meters deep, potentially bridge perpendicular with mirafi as well nearer to surface.

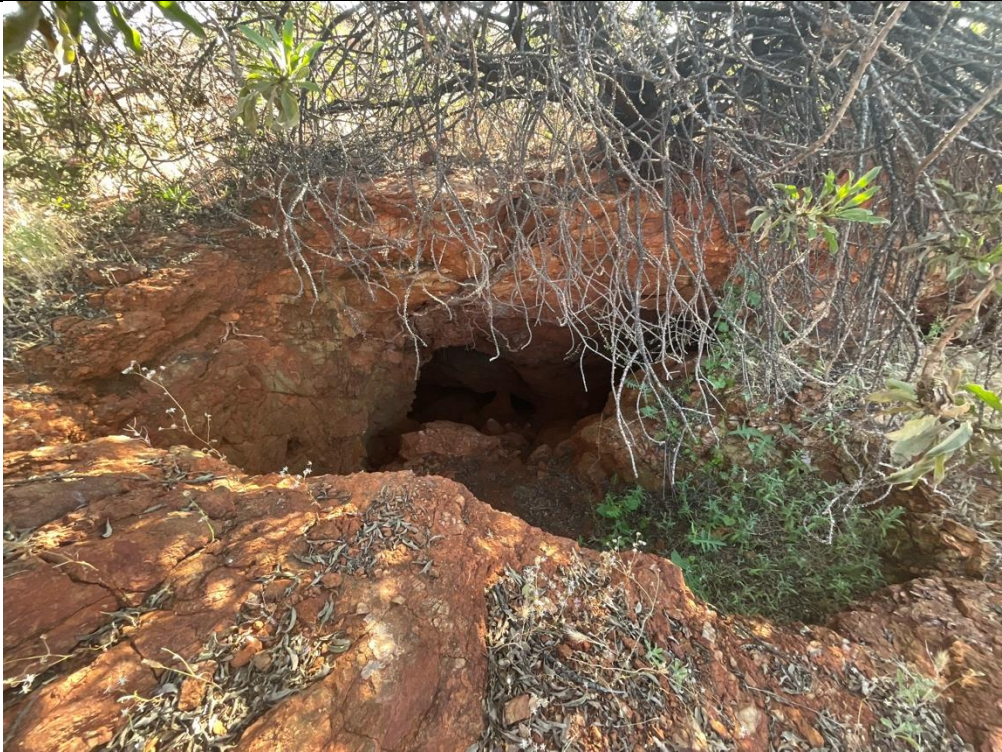
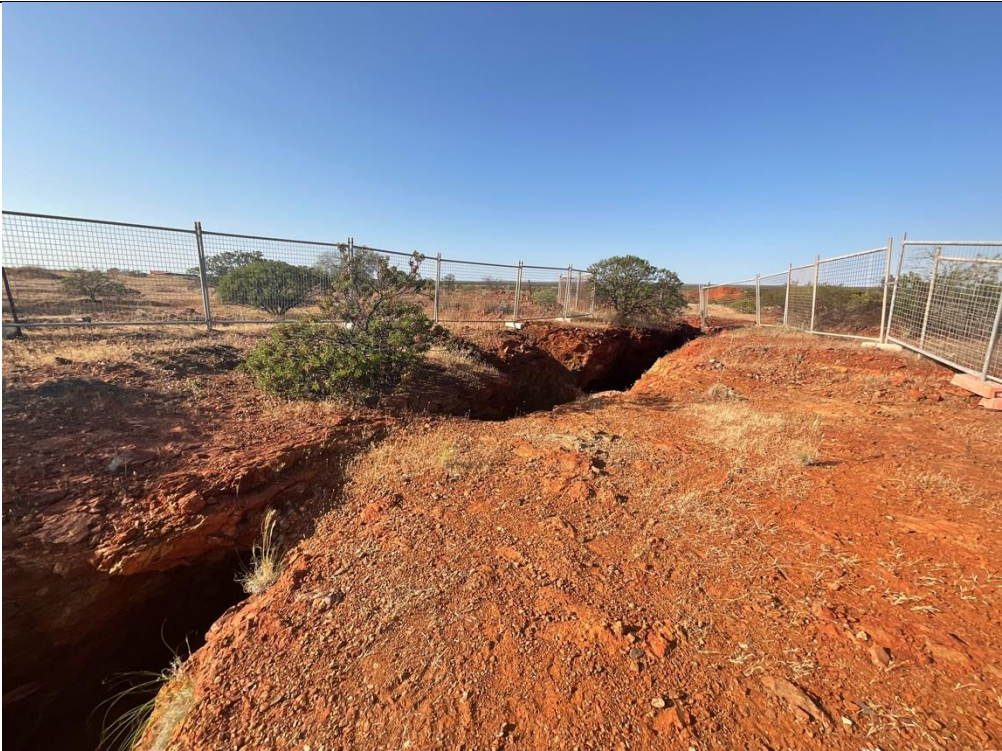
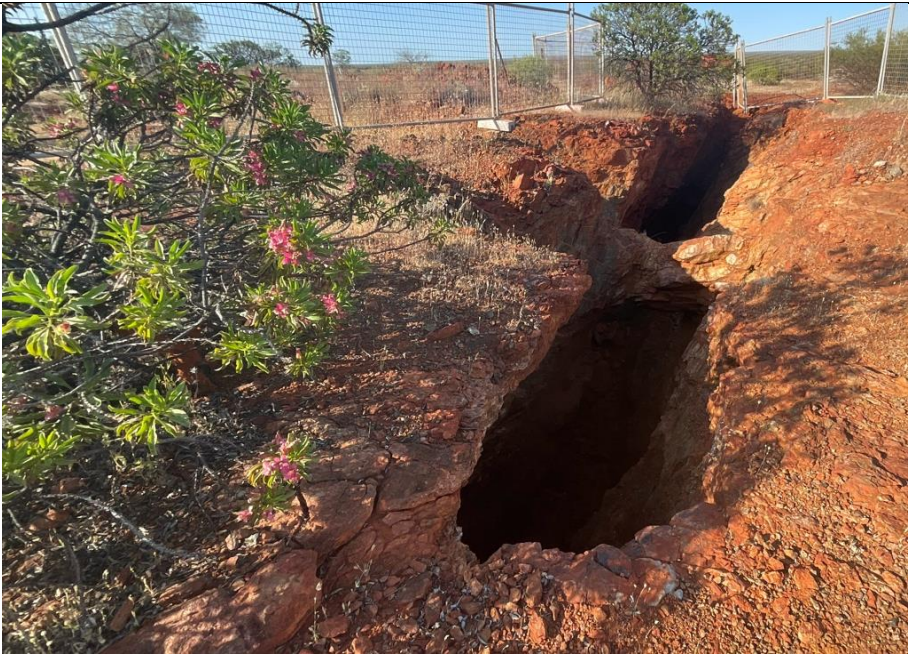
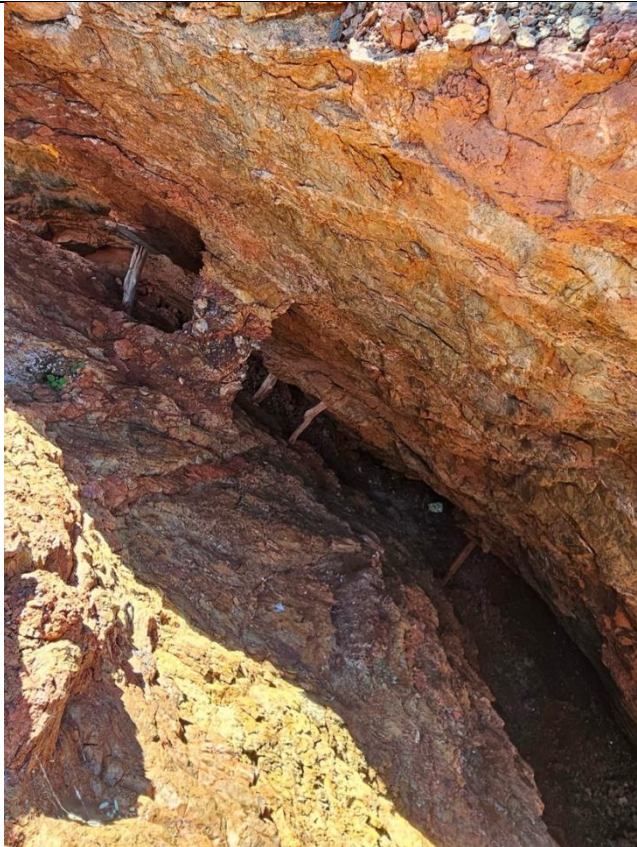
Feature S0113300	Project No:	11715
	Client: Department of Energy, Mines, Industry Regulation and Safety (DEMIRS)	Date:	3/9/24

<p>The feature is a trench cliff style excavation. Both wooden and remnant rock pillars remain propping the trench open (includes a small and thin rock bridge from the surface) Rock is visible on all the walls and is oriented 70-90 degrees from the horizontal. Base of feature is partially collapsed and contains some rubbish within. There is a circular cavity to the west of the trench approx. 7 m deep.</p> <p>Surrounding ground surface is vegetated with low lying grass, wildflowers, and small trees / shrubs.</p> <p>LiDAR scan undertaken.</p>	<b>CH<sub>4</sub>:</b> 0.0% <b>CO<sub>2</sub>:</b> 0.0% <b>H<sub>2</sub>S:</b> 0 ppm <b>LEL:</b> 0.0% <b>O<sub>2</sub>:</b> 20.7% <b>CO:</b> 0 ppm
Rock mass / soil profile comments:	Preliminary remediation recommendations:
Moderate quality rock mass. The ground surface comprises a thin layer of gravelly clay soils overlying rock.	Backfill – staged, lined longways with mirafi, buried a few meters deep, potentially bridge perpendicular with mirafi as well nearer to surface.

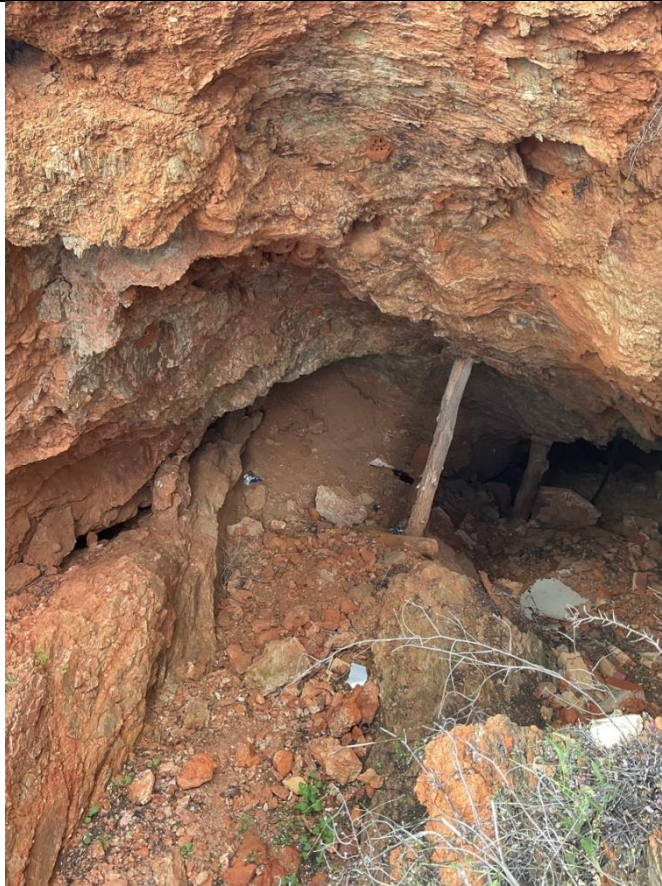
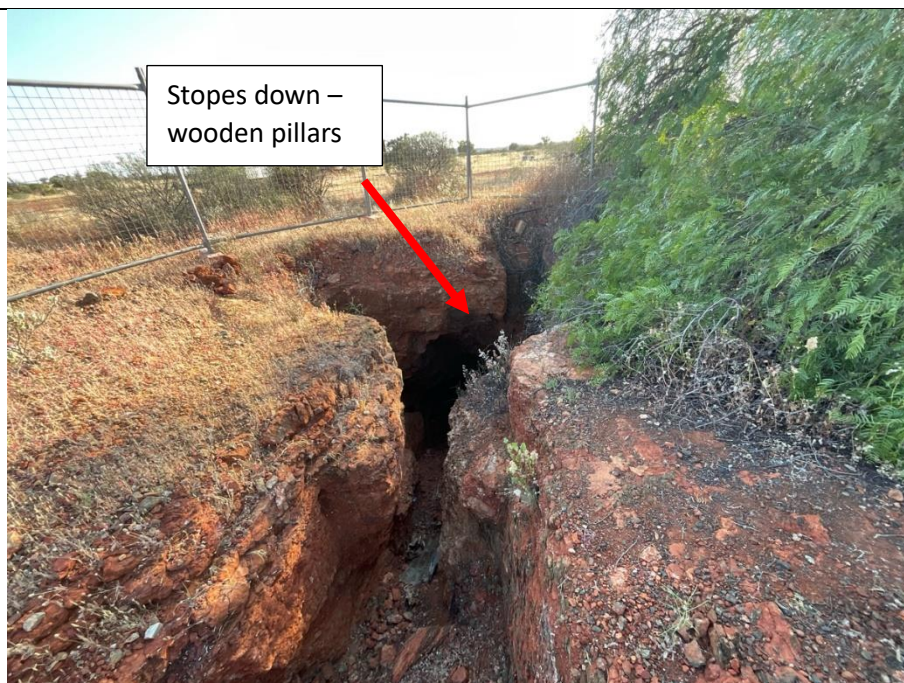
Feature S0113812	Project No:	11715
	Client: Department of Energy, Mines, Industry Regulation and Safety (DEMIRS)	Date:	3/9/24

Rock mass / soil profile comments:	Preliminary remediation recommendations:
Moderate rock mass quality. Near vertical walls. Red clays and gravel soils.	Remove material from crest and backfill and cave in. Line with geotextile.
