# ABANDONED MINE FEATURES ASSESSMENT

## YALGOO PHASE 1 GEOTECHNICAL REPORT

11715-G-R-001 Public Document

<b>Issued to:</b>	Department of Energy, Mines, Industry Regulation & Safety (DEMIRS)
<b>WML Project Number:</b>	11715
<b>Document Name:</b>	11715-G-R-001 Public Document

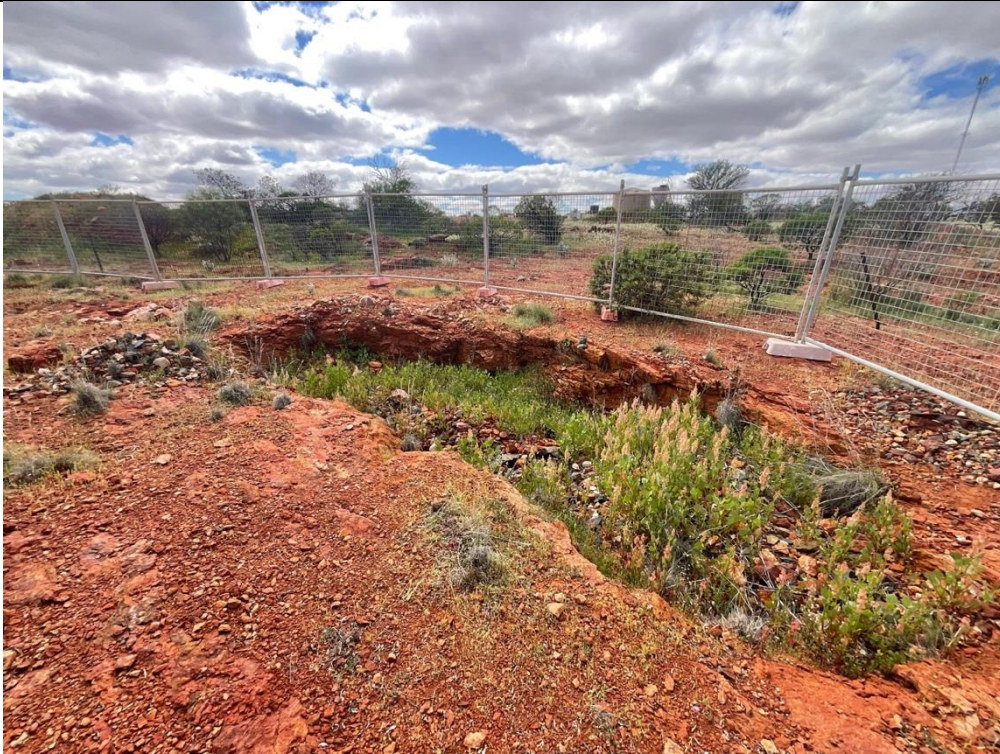
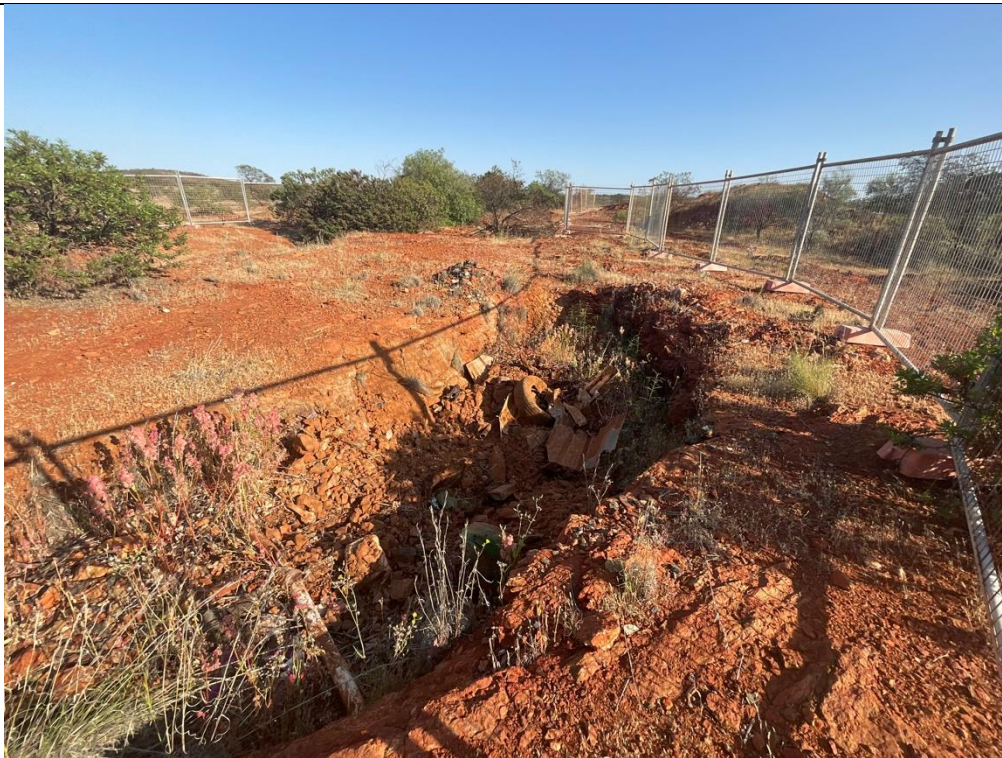
The feature is an open cut excavation that. Rock is visible on all the walls. Base of feature is filled with waste rock and some vegetation. The walls of the feature have some small shrubs.  Surrounding ground surface is poorly vegetated with some low lying grass, wildflowers, and small trees / shrubs.  No LiDAR scan undertaken.	<b>CH<sub>4</sub>:</b> 0.0% <b>CO<sub>2</sub>:</b> 0.0% <b>H<sub>2</sub>S:</b> 0 ppm <b>LEL:</b> 0.0% <b>O<sub>2</sub>:</b> 20.7% <b>CO:</b> 0 ppm  <i>Note: Olfactory evidence of potential presence of cyanide detected in the feature during excavation works.</i>
Rock mass / soil profile comments:	Preliminary remediation recommendations:
Moderate quality rock mass. The ground surface comprises a thin layer of gravelly clay soils overlying rock.	Potential contamination at this feature was identified which should be verified by further investigation.  Ideally, rehabilitation would involve clearing feature of waste and fill material via excavation, to be placed in large skip bins, assessed for contamination, and sent to an appropriate landfill for suitable disposal.  Potential for solution via laying down mirafi and forming a plug.

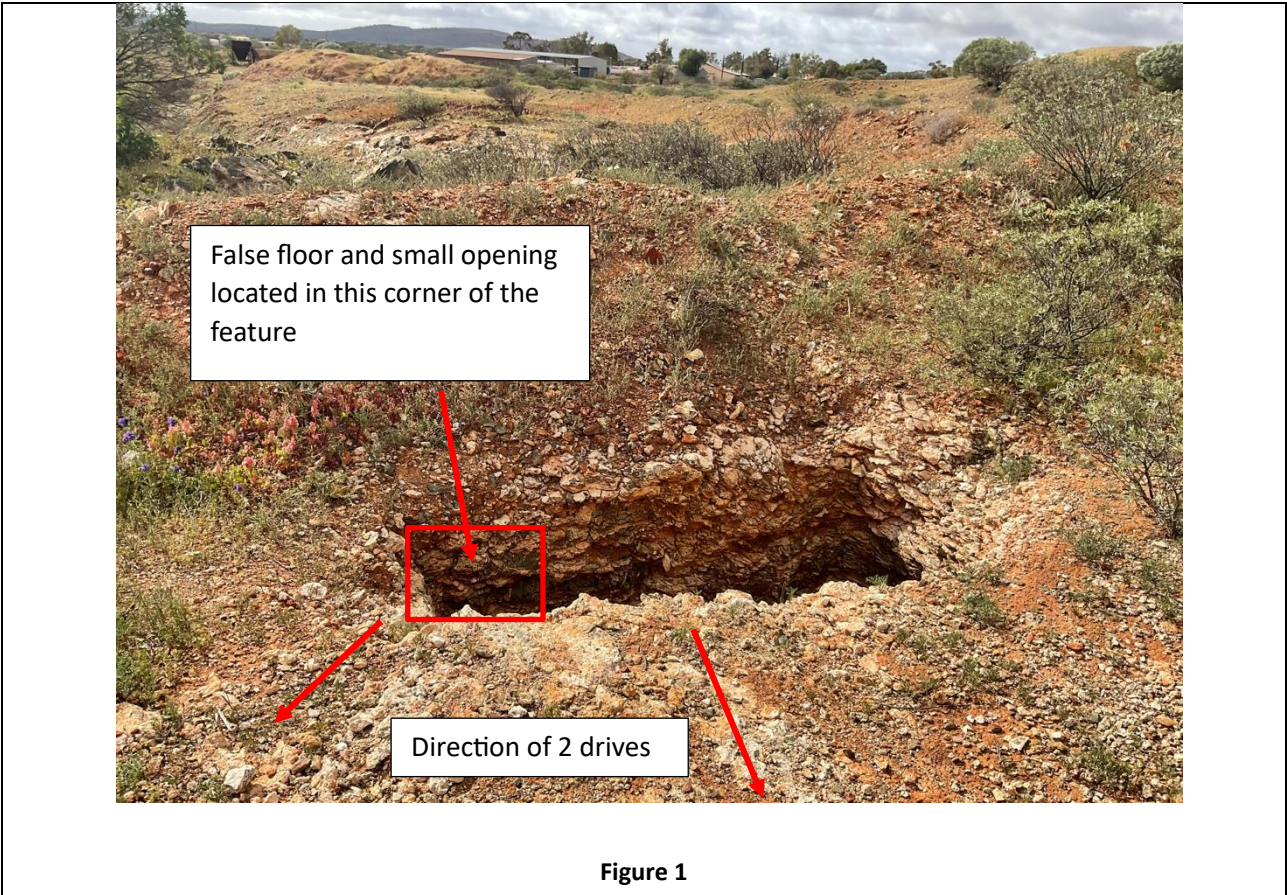
Feature Y-28	Project No:	11715
	Client: Department of Energy, Mines, Industry Regulation and Safety (DEMIRS)	Date:	5/9/24

Rock mass / soil profile comments:	Preliminary remediation recommendations:
Crumbly and poor quality rock mass. Walls of the feature are near vertical. The ground surface comprises a thin layer of gravelly clay soils overlying rock.	Dig out and excavate drive, dig out false floor base, backfill and cone plug with concrete. Bury the concrete plug below ground.  The desktop study suggests this may have been a shaft 10 – 15 m deep.

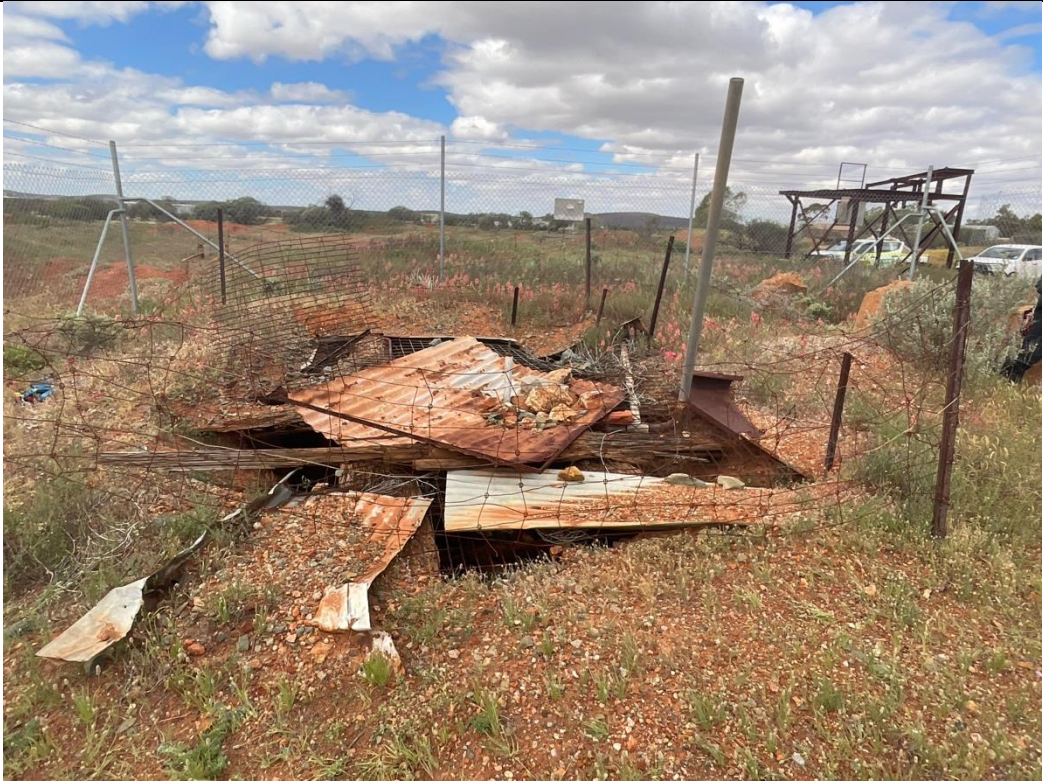
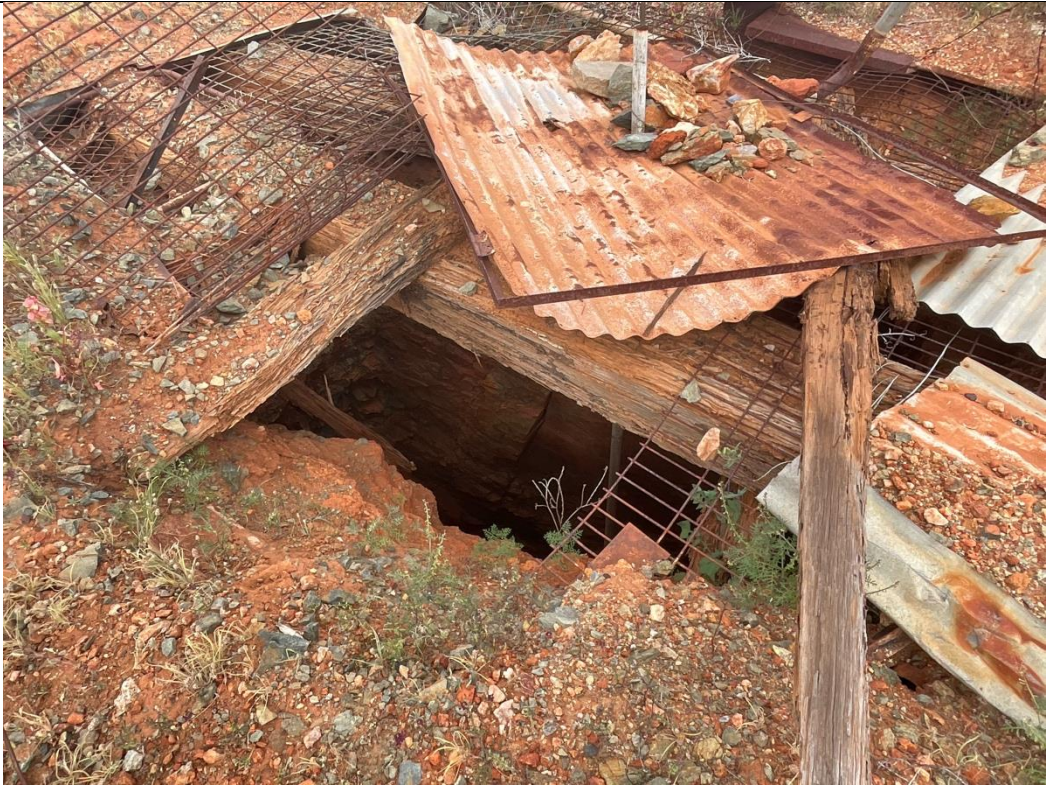
Feature S0113265	Project No:	11715
	Client: Department of Energy, Mines, Industry Regulation and Safety (DEMIRS)	Date:	4/9/24

Rock mass / soil profile comments:	Preliminary remediation recommendations:
<p>Moderate to poor quality rock mass (GSI = 20) – vertical walls of square feature. The ground surface comprises a thin layer of clayey gravel soils overlying rock.</p>	<p>Backfill with really coarse rock to above the water level. Line with mirafi and form plug to prevent fines migrating into the coarse rock and being washed away.</p> <p>The desktop information suggests the shaft terminated once water was reached, however, this was taken from a newspaper in 1895; it is likely that further progress had been made to dewater the shaft in later years. A drive to the south connected to a southern feature is also noted – and is likely situated below the water level.</p>

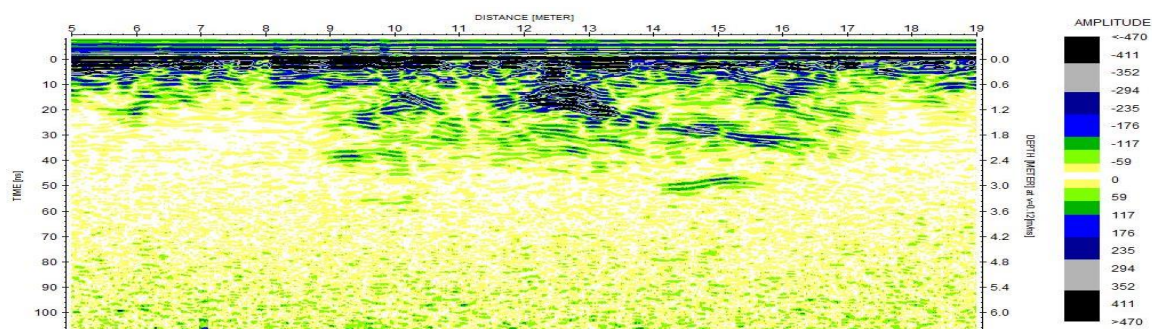
**Figure 3: GPR radar-gram showing an anomaly at x=12.5m, y = 0.6m relating to a potential underground mine working.**

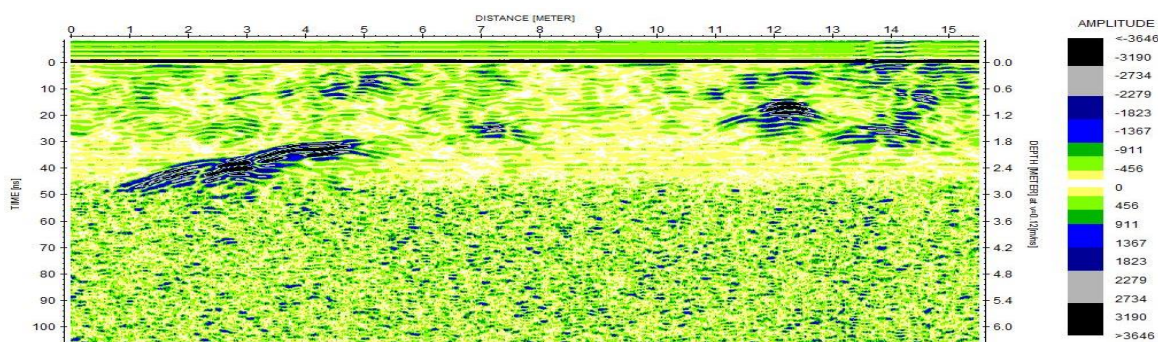
**Figure 4: GPR radar-gram showing an anomaly at x=3m, y=2.4m relating to a potential underground mine working.**

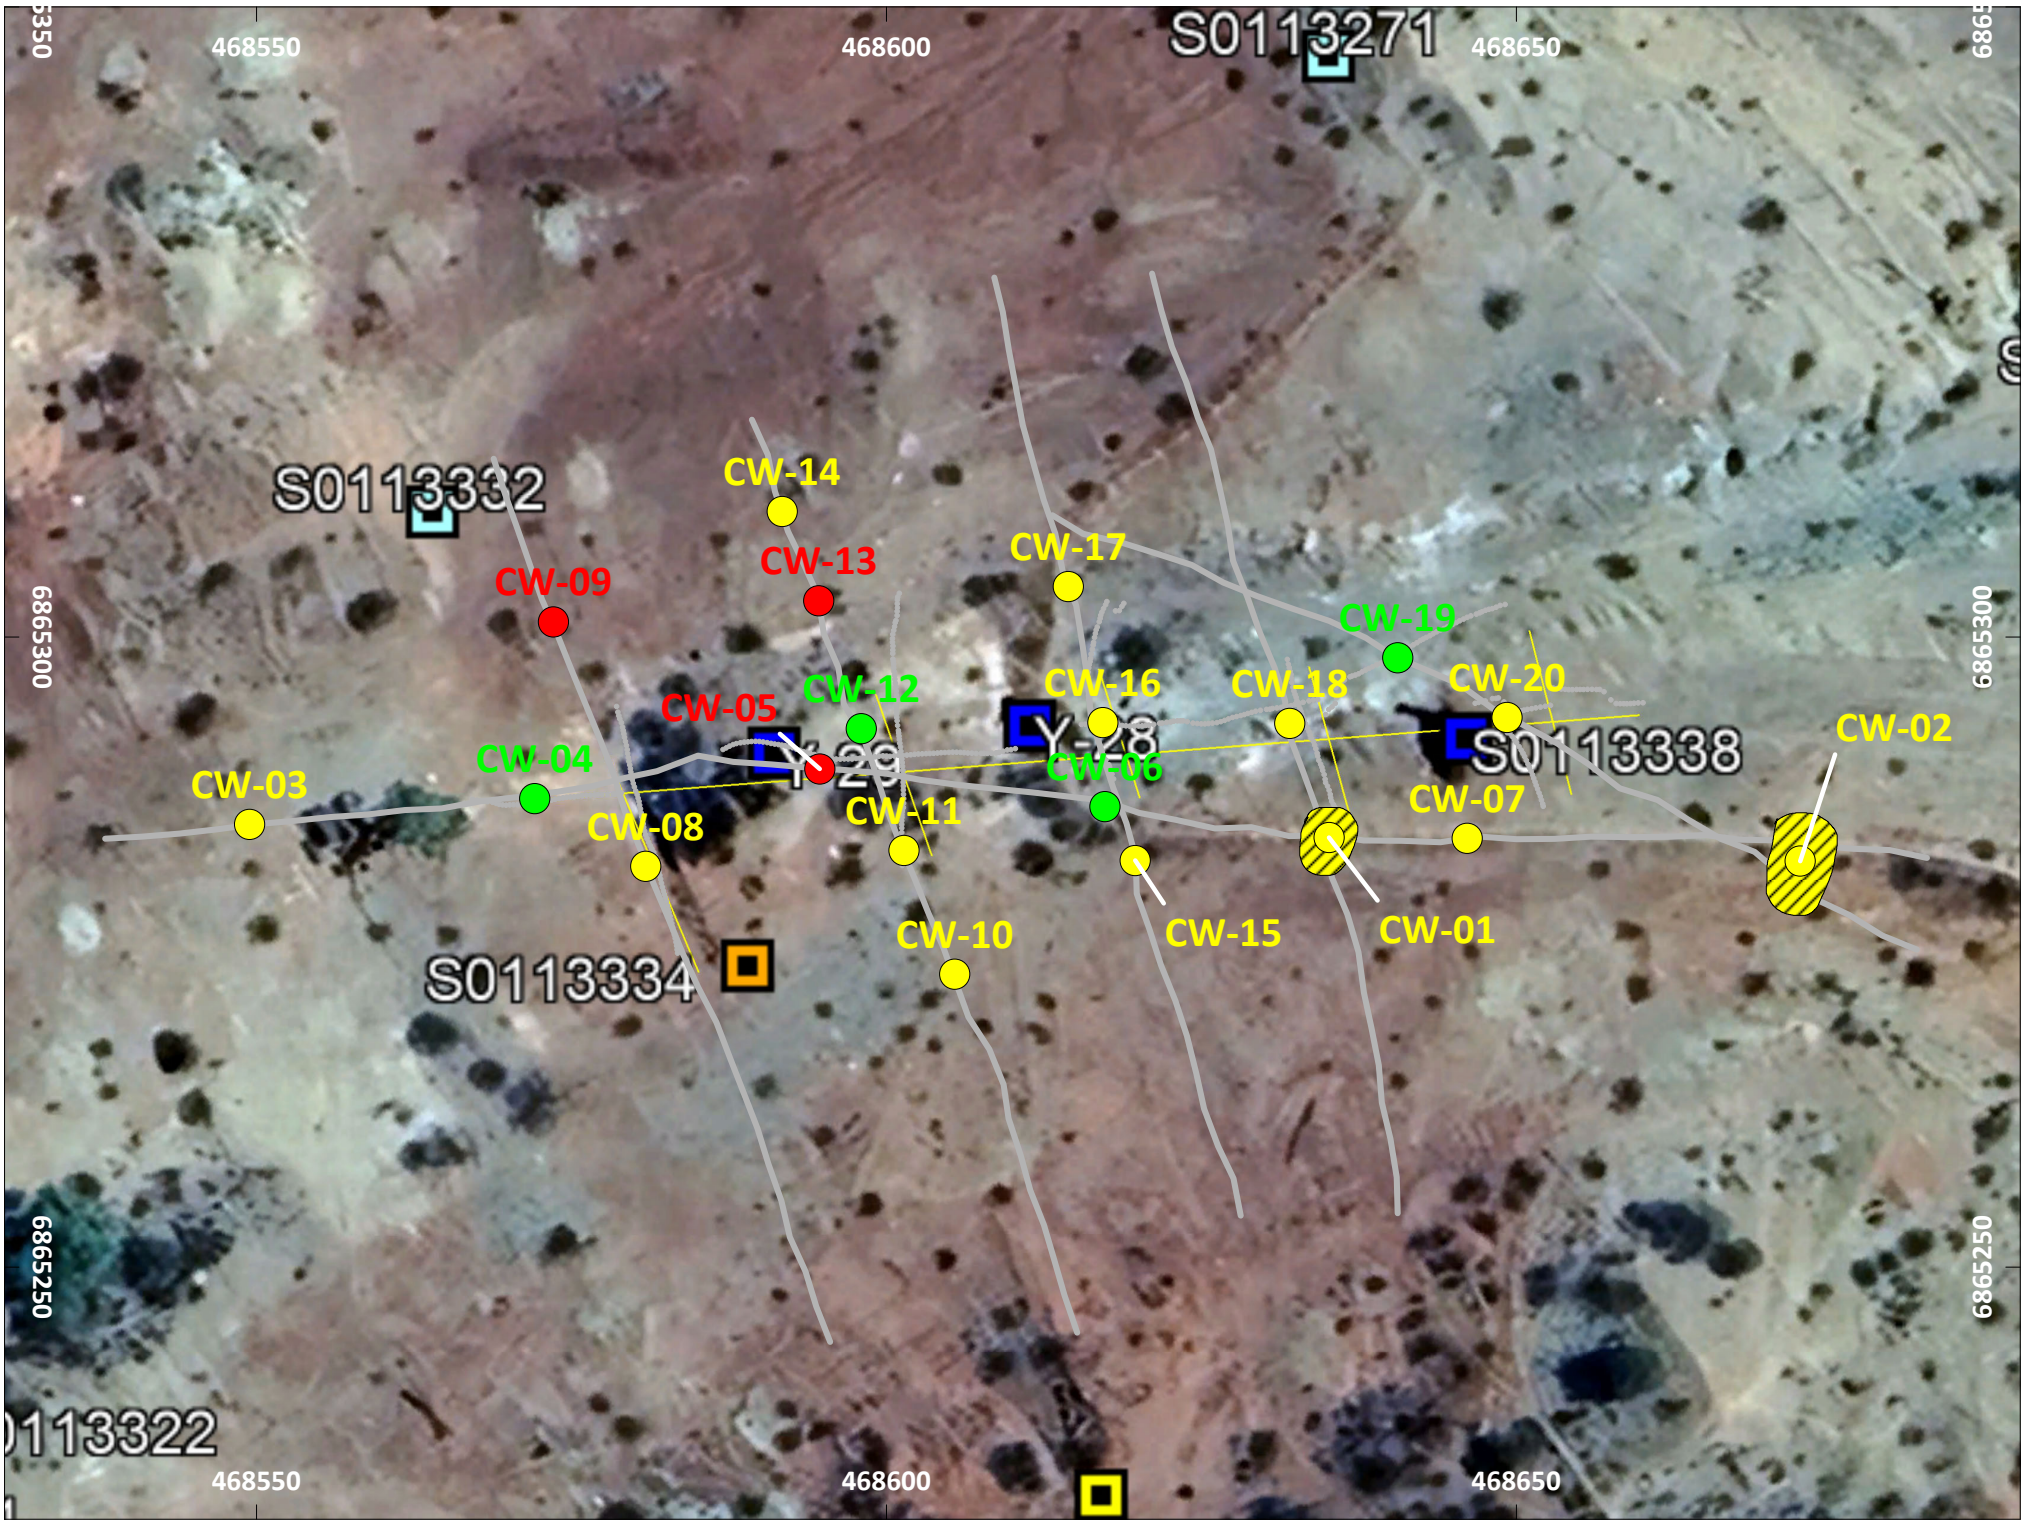
INVESTIGATION SITE MAP WITH IDENTIFIED SUBSURFACE ANOMALIES - YALGOO CENTRAL WEST

Analysis of the processed GPR dataset has identified a number of subsurface anomalies potentially related to shallow mine workings within the areas investigated which are presented in a site map in drawing 3133-09. It should be noted that GPR anomalies in the 3-5 mBLG range, particularly in the south-east of the site are likely to be due to edge effects from adjacent identified shafts.
