Assessment of the status of river pools in the Avon catchment

Water resource management series

Report No. WRM 47
December 2007

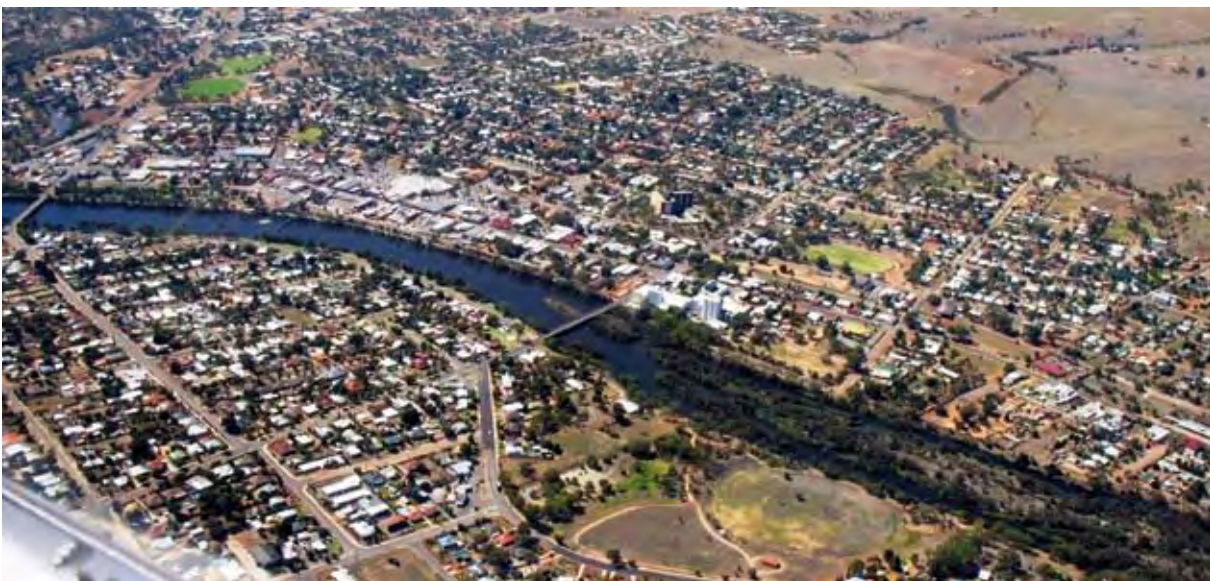
Bed sediment of the pool is almost entirely silt/clay with a higher sand content closer to the sand bars (Davies et al. 1996). Total phosphorous in the water varies from 0.10 mg/L to 0.17 mg/L. There is a high nutrient content in the sediments which is to

Aerial photograph of 'West Northam Forest' (on the right), an untrained section of the Avon River, with the Northam Town Pool (on the left) (Photo courtesy of Bernard Kelly)

be expected from clay/organic matter (Davies et al. 1996). Algal blooms are common in the Town Pool, particularly in the summer months when the flushing is reduced.

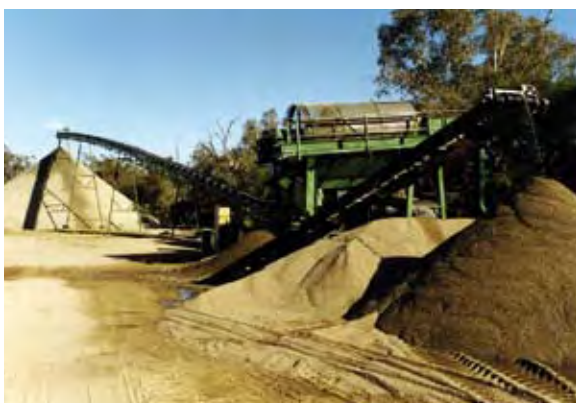
Screening plant which receives sand from the Burlong dredge (Photo courtesy Bernard Kelly)

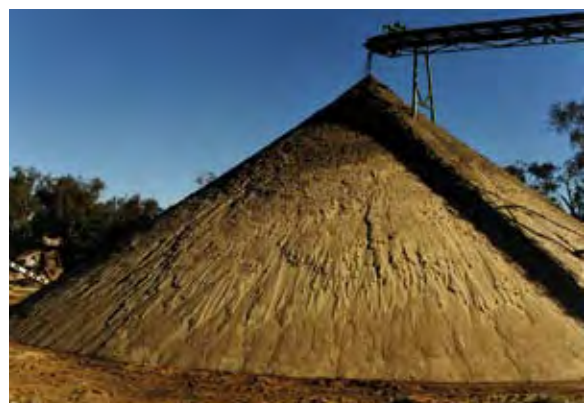
Stockpile of sediment removed from Burlong Pool in 2000 (Photo courtesy Bernard Kelly)

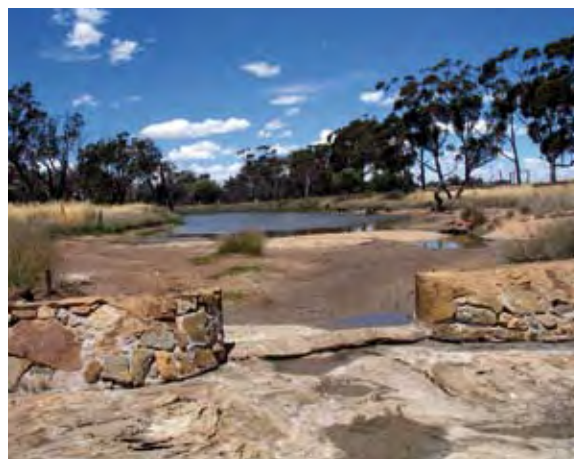
Weir-like structure at the downstream end of One Mile Pool. (Photo courtesy Prue Dufty)

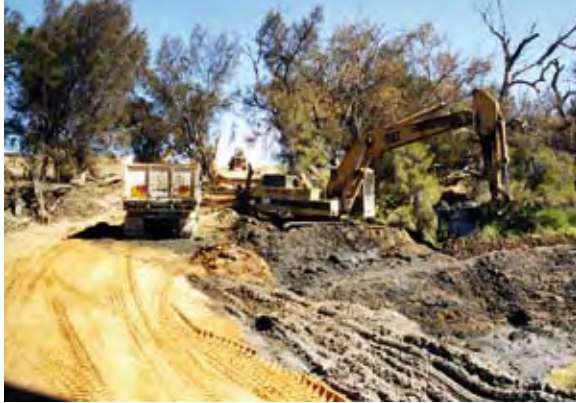
*Sediment being removed from Railway Pool and transported off site
(Photo courtesy Nina King)*
