# Capel River Action Plan

1999

Prepared for Geographe Catchment Council - GeoCatch  
and the Capel Land Conservation District Committee

by  
Kirrily White and Sarah Comer  
in association with  
Evangelisti & Associates

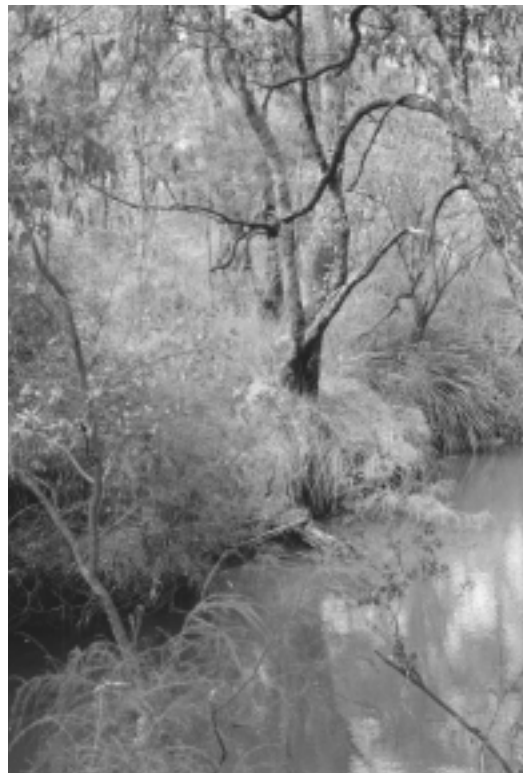
Plate 1: Riparian vegetation of reserve 3802.

With respect to the river action plan a few of the reserves on the Capel River provide some clues as to the type and structure of original riparian vegetation. In particular reserve 3802 (Plate 1, page 5) could provide a valuable source of provenance seed for revegetation projects, as this reserve contains an excellent representation of the vegetation of the riparian zone. Comments on the values of reserves on the Capel River are presented in Appendix A.

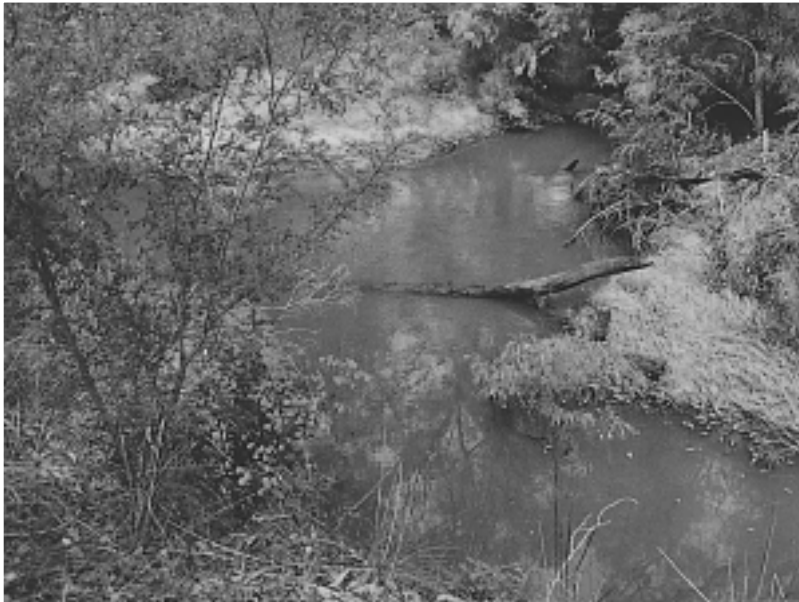
*Plate 5: A vegetated meander showing point bar formation.*

The lack of native vegetation to dissipate flow energy may allow more sediment to be removed from the riverbanks and carried downstream. Here it may accumulate into point bars which deflect flow onto the opposite bank creating a new erosion point, or cause upstream flooding by retarding flow under shallow conditions (Plate 5, page 13).

Erosion of the river channel was a notable problem along much of the surveyed area of the Capel River. A combination of physical disturbance from historical stock access and changes to the hydrological balance from clearing of the native vegetation within the catchment has led to the erosion problem. While some level of erosion and deposition is natural within any riverine system, the acceleration of these processes can cause management problems. Of particular concern is the cycle of erosion and deposition which can occur when eroded sediment accumulates downstream to form point bars which deflect flow onto the opposite bank thus creating a new point of erosion (Plate 5, page 13). Environmental issues associated with erosion problems include:

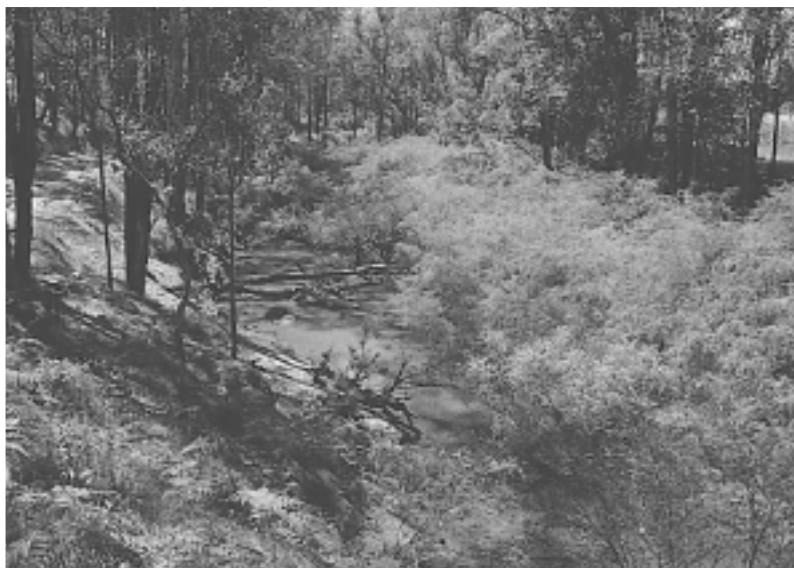
Plate 6: Swamp peppermint in the river channel.

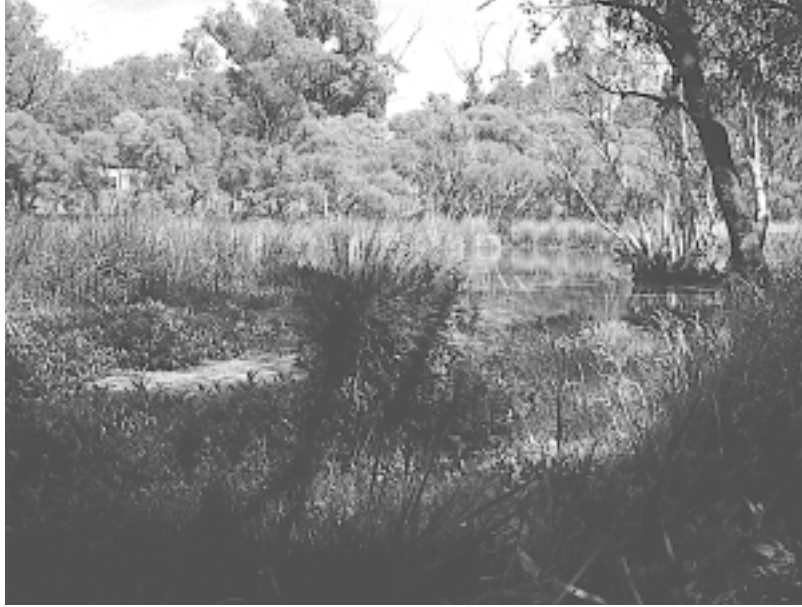
This vegetation community was highly disturbed along most of the lower reaches of the Capel River (Sections 1 and 2). The trees are the dominant species in this community type. In several areas *Astartea fascicularis* and modong *Melaleuca preissiana* were observed. Pale rush *Juncus pallidus*, jointed twig-rush *Baumea articulata*, common sword-sedge *Lepidosperma longitudinale*, marsh club-rush *Bolboschoenus caldwellii* were observed in this community type. In a few areas the backwaters supported a reasonably diverse flora, however even these were infested with weeds, in particular Typha and arum lily (Plate 7, page 18). Detailed surveys of these areas were not completed.

*Plate 7: A paperbark (Melaleuca sp.) swamp backwater.*

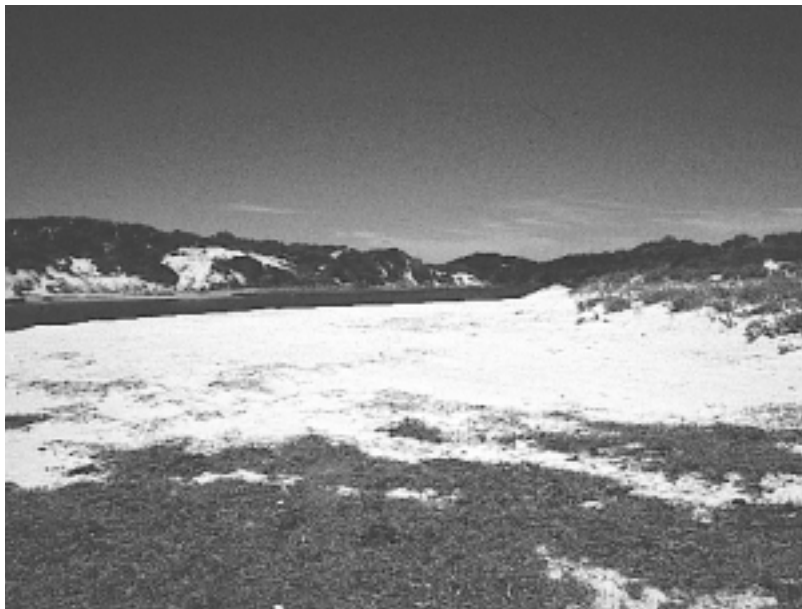
This reserve has been subjected to a high level of understorey disturbance, and was relatively poor in species diversity. However, a detailed community description for this area was prepared by Smith (1974), and this could be consulted for possible revegetation species. The location of this reserve with respect to the Capel River mouth is illustrated in (Plate 8, page 18).

*Plate 8: The Capel River mouth and reserve 24653.*

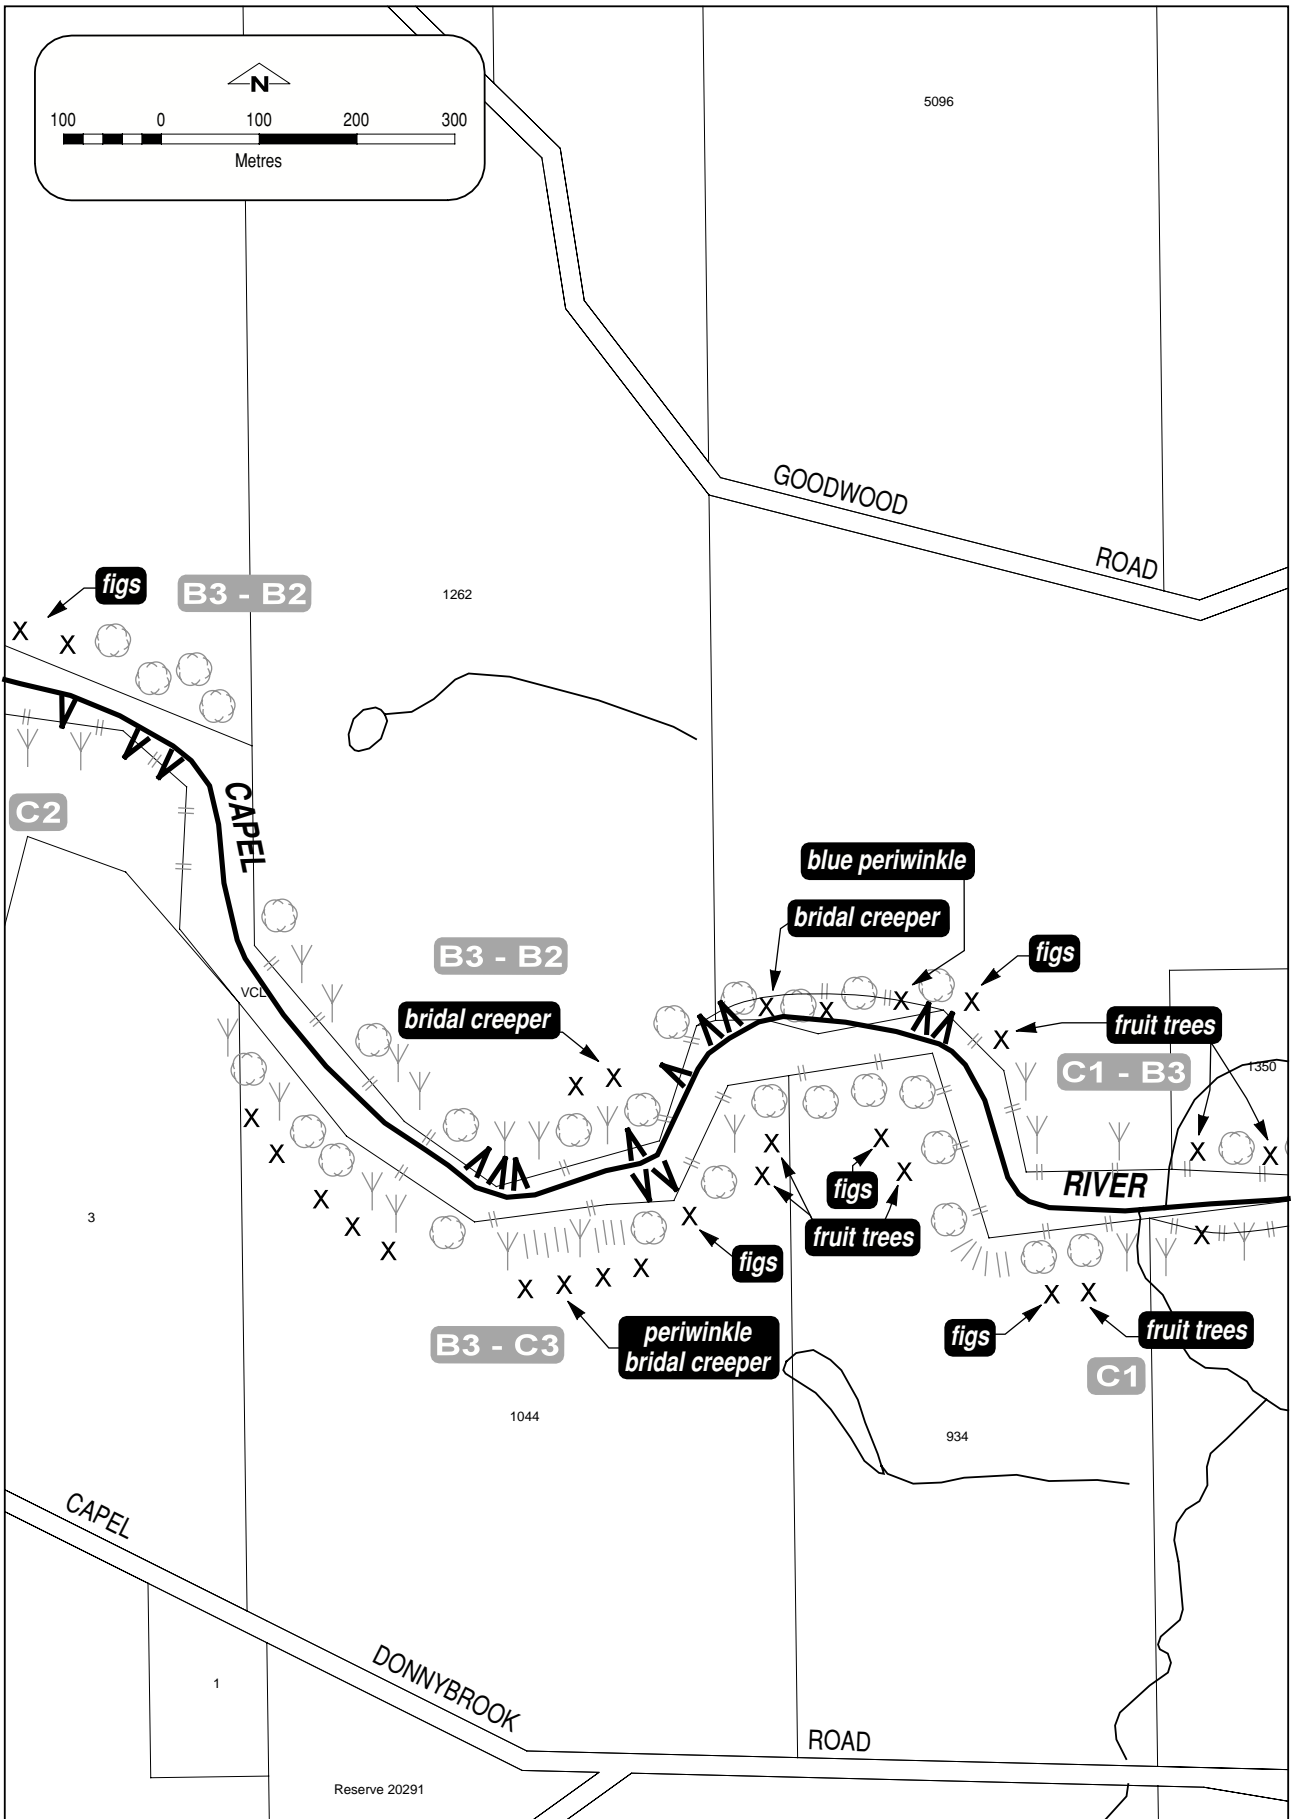
Capel River Map 13

Issues	Comments	Management Advice
General foreshore condition	While all of this section has been fenced and the lower section has reasonable vegetation cover, channel erosion remains a notable problem in the upper section and a variety of weed species were also prolific.	
Fencing	N/A	
Erosion	Frequent sites of scouring occurred along this section.	Refer to Erosion control Chapter 8.3, 1 and 2 (page 33).
Revegetation requirement	Some areas in this section require extensive revegetation, others require revegetation of understory species to increase diversity.	Select species from community type 1 on the riparian fringe & 2 on the floodplain, Table 8.1 (pages 28 & 29).
Weed invasion	Bridal creeper, figs, fruit trees, Pittosporum, periwinkle and snail creeper all found on this section.	Control weeds where possible. Refer to Specific weed management advice Chapter 8.1.2 points 5, 10, 12, 15, 4 and 13 (pages 23 - 25).

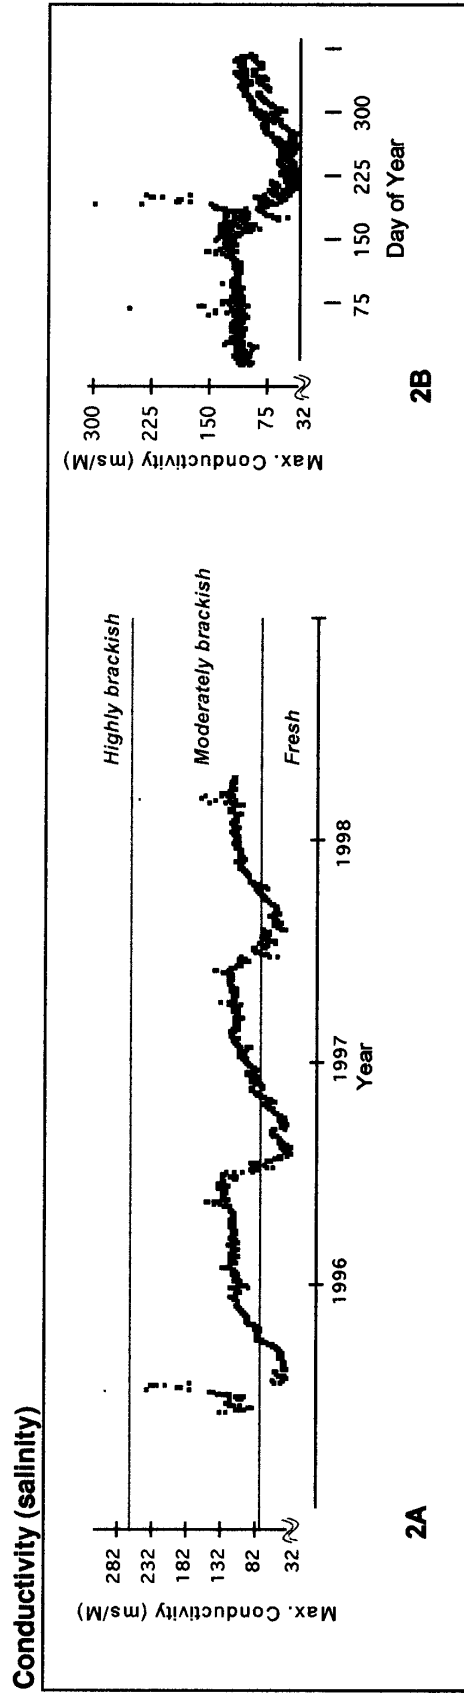
Daily measurements of conductivity for the Capel River were taken at the railway bridge between 1995 and 1998. Conductivity is a measure of a range of dissolved salts, the most common being sodium chloride. It is the level of sodium chloride that is referred to as 'salinity'. Figures 2A and 2B in Appendix B depict the time series and seasonal graphs of daily conductivity respectively. The criteria for 'fresh', 'moderately brackish' and 'highly brackish' water are marked on the graph. For much of each year sampled, the Capel River water at the railway bridge was

Figure 2A: Capel River maximum conductivity (ms/m) at the railway bridge between 1996 and 1998.

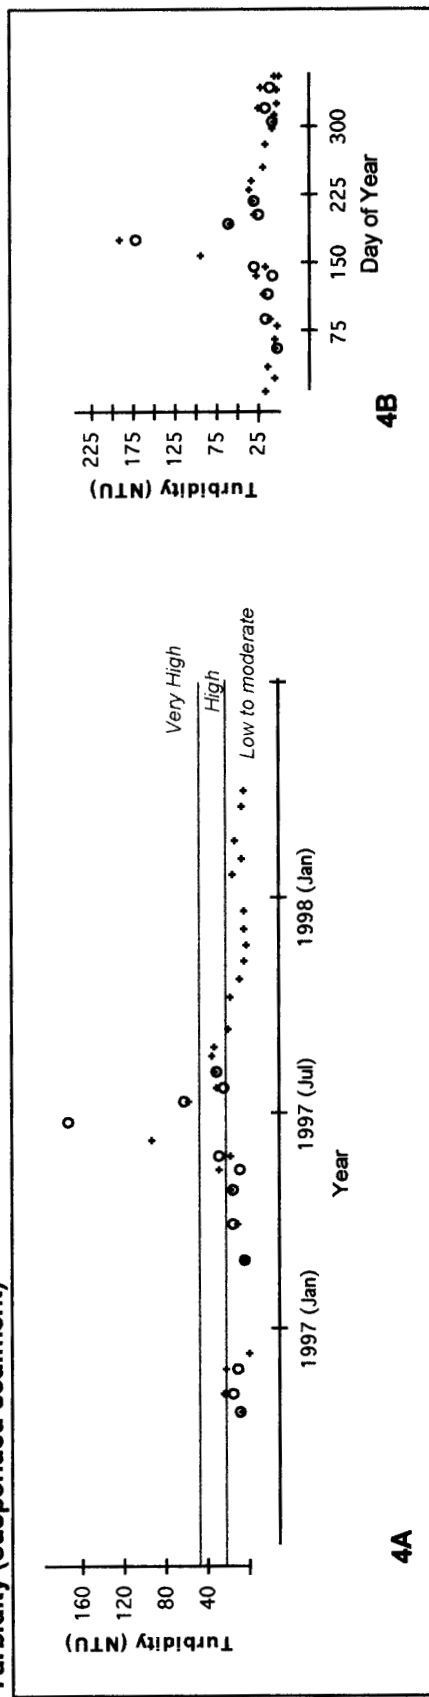
Turbidity measurements recorded for the Capel River between 1997 and 1998 are presented in Figures 4A and 4B of Appendix B. For much of period sampled, the turbidity was low to moderate, reflecting relatively stable conditions in the water. The only winter period monitored was in 1997. The peak in the graphs at July 1997 clearly shows the extreme turbidity measurements recorded at that time (values of over 160 NTU were recorded in the Capel River at both monitoring stations, indicating a serious erosion problem). The Swan River Trust recommends that for waterways with turbidity measurements exceeding 45 NTU, urgent action should be taken to reduce erosion.

**Figure 4A:** Capel River turbidity (NTU) between 1997 and 1998.

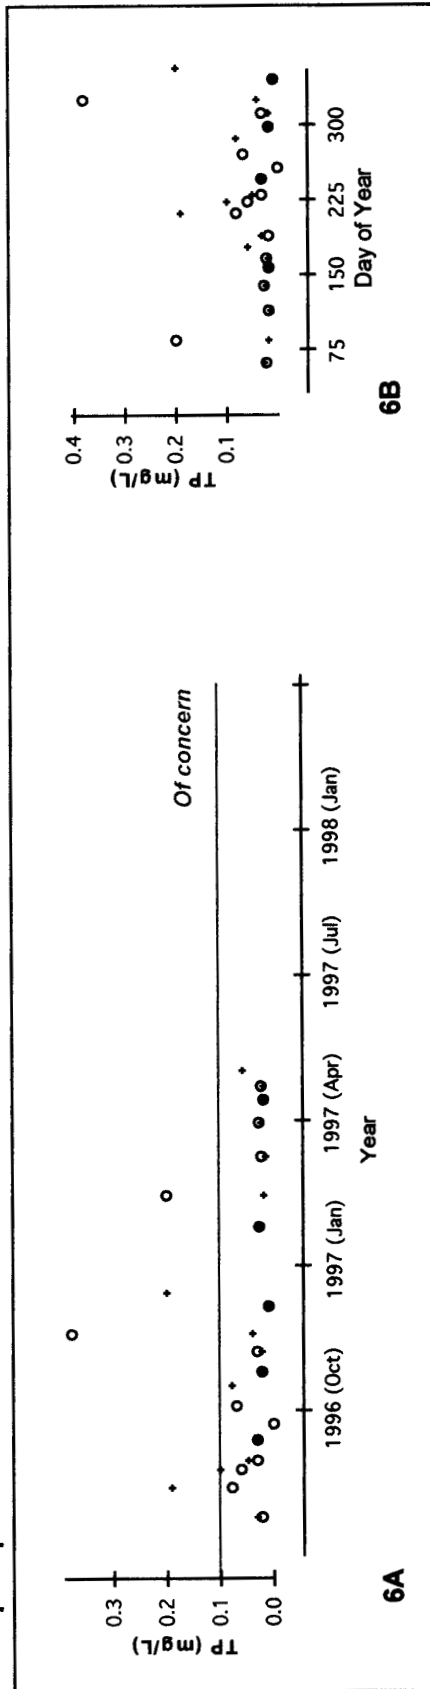
For the majority of the sampling period, total phosphorus levels in the Capel River were within acceptable criteria (Appendix B, Figures 6A and 6B). On a number of occasions values exceeding the acceptable criteria were recorded at both monitoring stations. Given the isolated occurrences and intermittent timing of these events, it is not possible to ascertain the causes of the elevated levels.

**Figure 6A:** Capel River total phosphorus (mg/L) between 1997 and 1998.
