## Foreshore and channel assessment of Jimperding Brook

Report No. WRM 48  
February 2008

Prepared by Viv Read & Associates for Department of Water  
and the Avon Waterways Committee

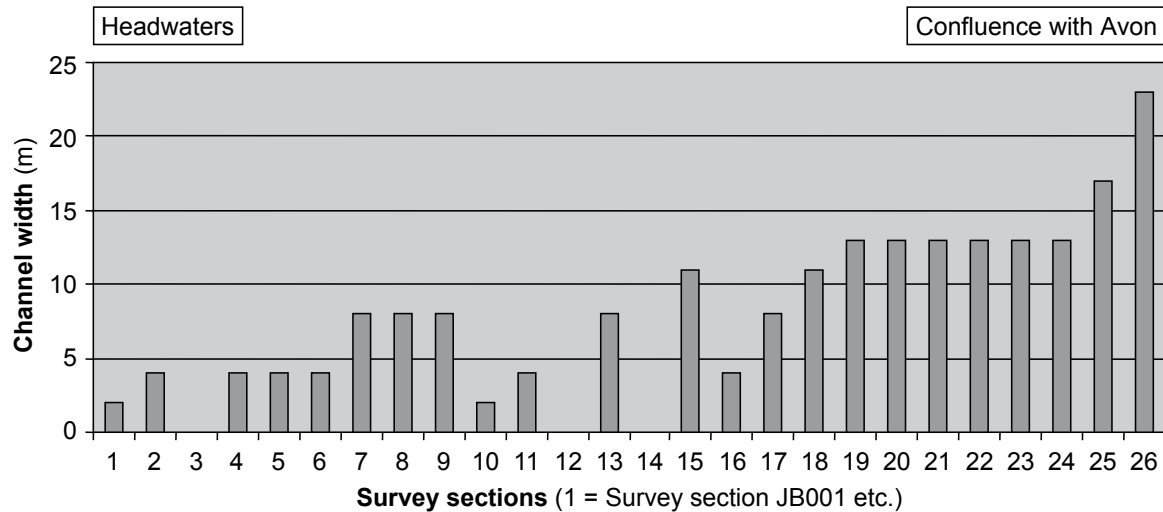
**Figure 1** Median channel width for Jimperding Brook survey sections

The width of the channel increased downstream. Figure 1 shows the median channel width for Jimperding Brook. Upstream from Salt Valley Road, the width was less than 10 metres with many sections less than five metres. Downstream from Salt Valley Road most stream channel widths were greater than 10 metres. There was a general increase in channel width as the brook flowed to its confluence with the Avon River.

Note: Section 3 is a broad wetland. No data was recorded for Sections 12 and 14.

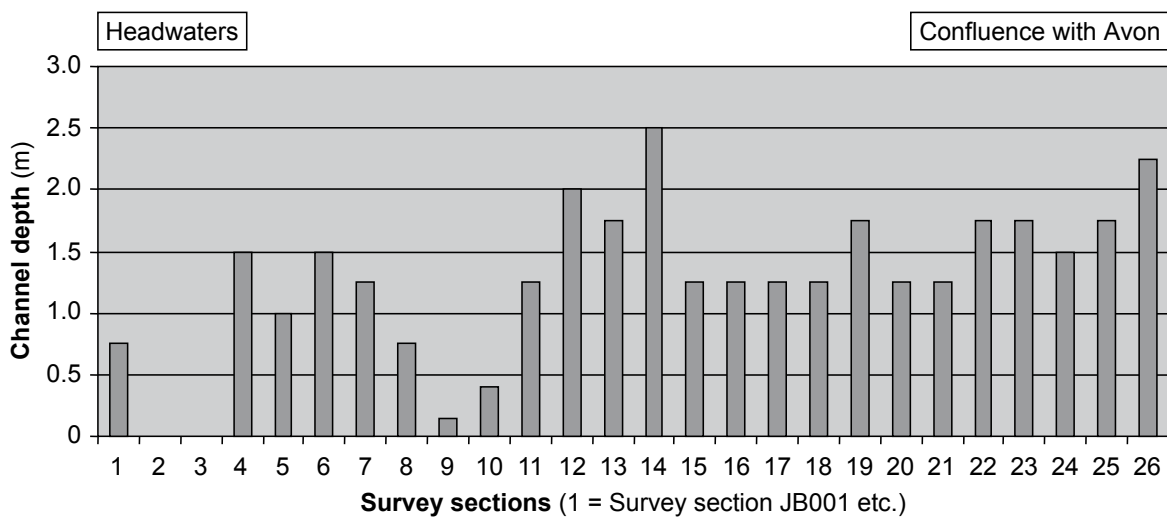
**Figure 2** Median channel depth for Jimperding Brook survey sections

Channel depth varied significantly within each section but not significantly between sections (Figure 2). The depth was recorded at the end of each section. Within sections, there were pools estimated to be 1.5 metres deep and many riffles less than 20 cm deep. There was no clear trend in channel depth downstream.

Note: Sections 2 and 3 were comprised of a shallow wetland.

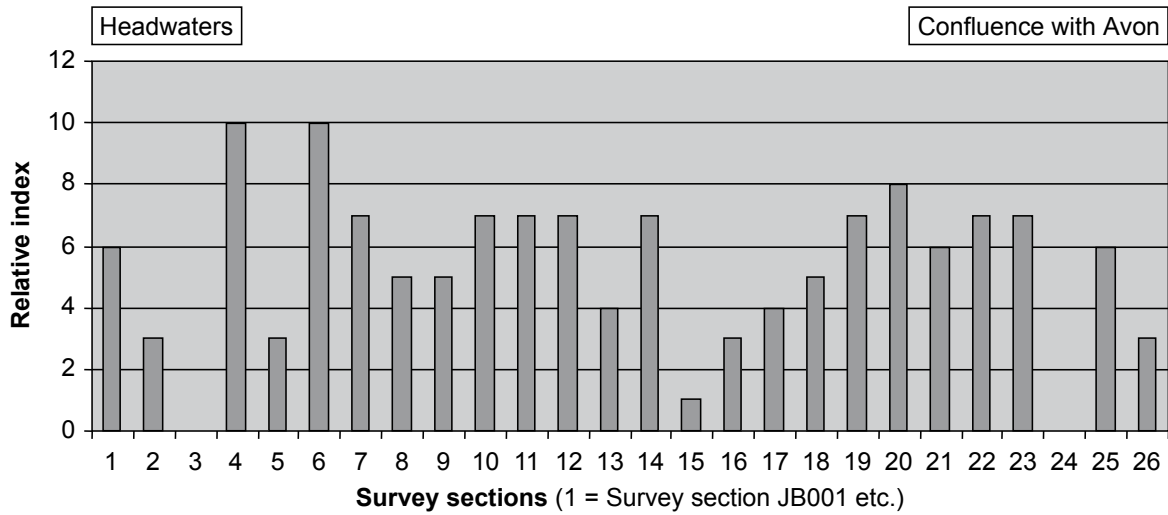
**Figure 3** Relative index for channel erosion of Jimperding Brook survey sections

This was recorded as 'subsidence', 'undercutting' and 'slumping' although it was difficult to differentiate clearly between these processes. Figure 3 shows a relative index that is cumulative for the scores recorded for each type of channel erosion. From this, it is clear that erosion was significant at all but three sites (JB003, JB015 and JB024). Erosion was particularly significant at JB004, JB006 and JB020.

Established saltwater couch (*Paspalum vaginatum*) had stabilised the banks and bed sediments in the lower part of JB003 (a section that was also well fenced) except where the channel was excavated (JB001 and JB002). However, the extent of saltwater couch (*Paspalum vaginatum*) stopped at the end of JB003 and the next section had a high level of channel erosion.

Note: Section 3 is comprised of a shallow wetland.

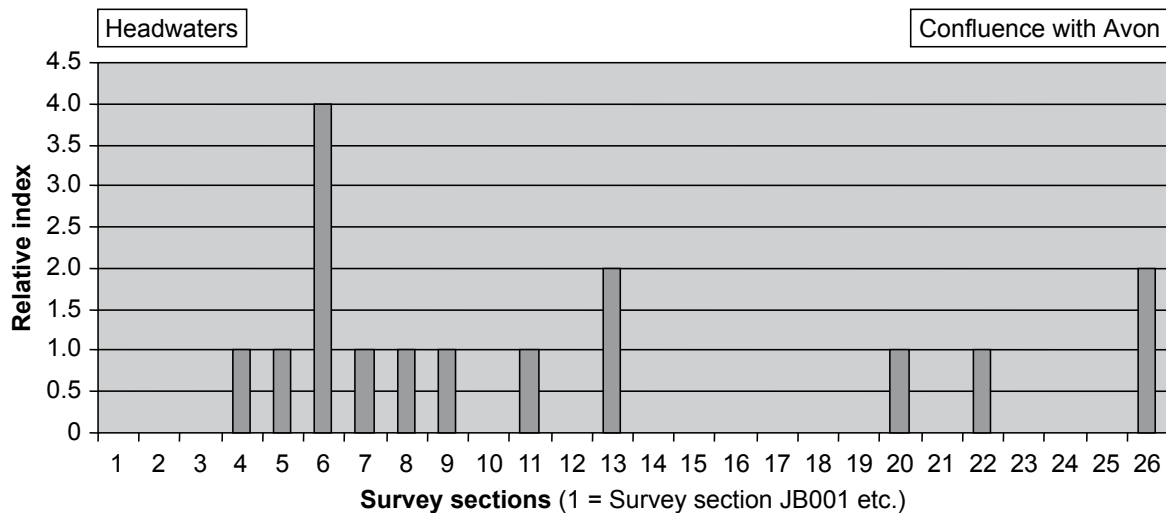
**Figure 4** Relative index for gully erosion of Jimperding Brook survey sections

The processes of gully erosion were very significant for Jimperding Brook and its tributaries. Figure 4 shows that gully erosion occurred in 11 sections; however, the low frequency of occurrence understated the importance of the process.

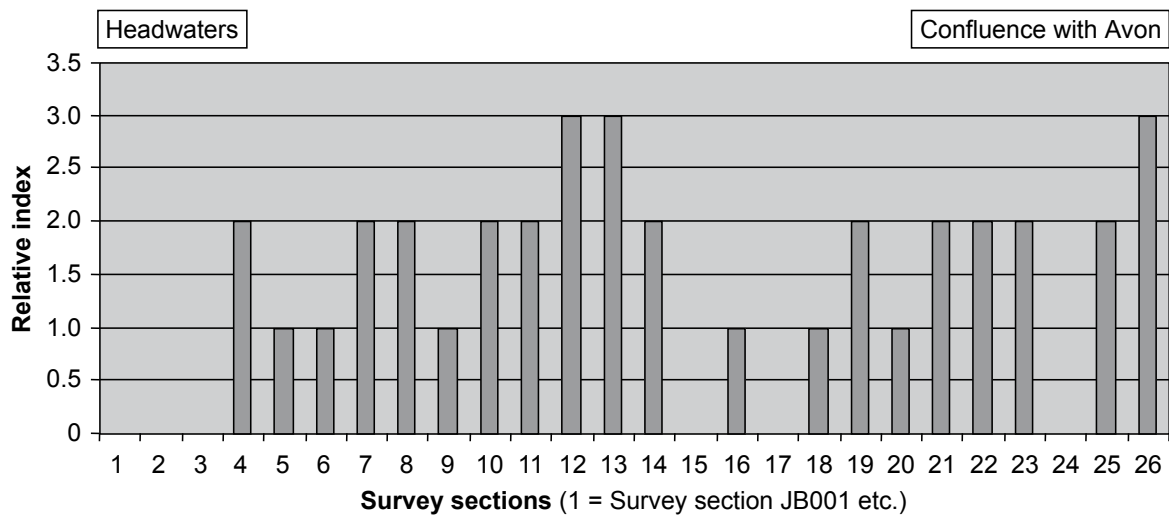
Figure 5 Relative index for sedimentation of Jimperding Brook survey sections

The occurrence of sediments was recorded for each section during the survey. Figure 5 shows that most sections had a medium level of sediment and there was a higher level for three sections (JB012, JB013 and JB026). However, observations of sediment did not provide estimates of volume. In most sections, there were only minimal amounts of sediment and pools, although small, were not filled with sediment.

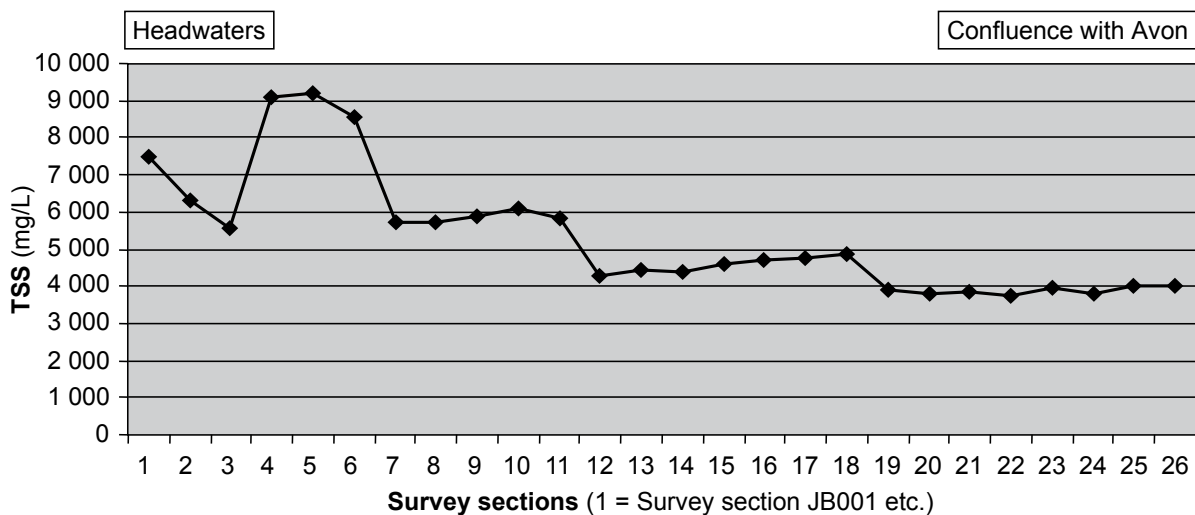
Figure 6 Stream flow salinity of Jimperding Brook survey sections

Stream flow salinity was measured at the downstream end of each section (Appendix 6, Table 5.4). The results shown in Figure 6 indicated a generally declining trend with the distinct exception for sections JB004-6. These were high due to saline groundwater discharge. In section JB006, salinity was exacerbated by intrusive bedrock.

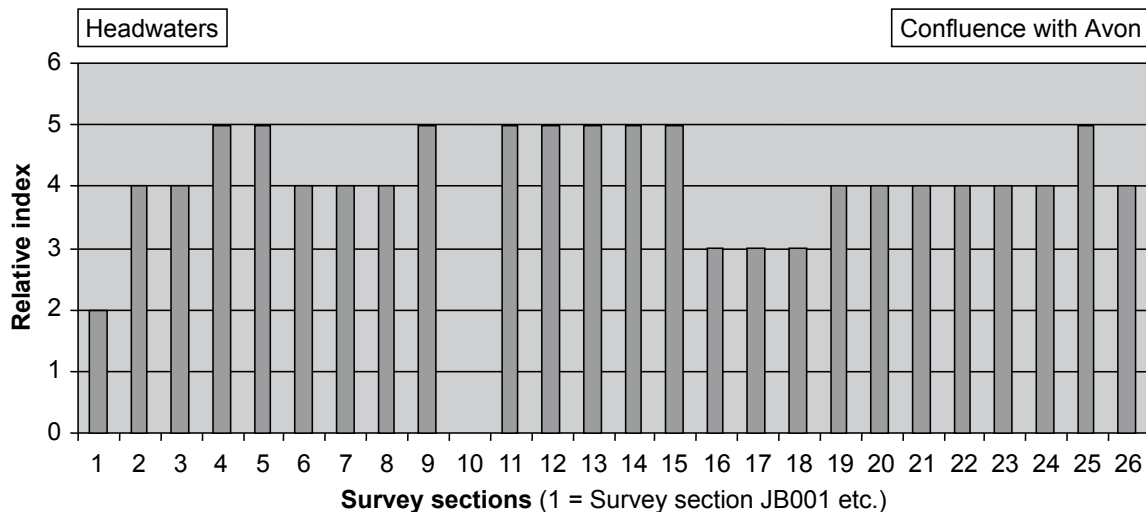
**Figure 7** Riparian zone vegetation health of Jimperding Brook survey sections

A subjective assessment was made of vegetation health. This was shown in Figure 7. In general, the dominant species were quite healthy. Salinity was affecting riparian vegetation in section JB001 (all trees in the riparian zone were dead), JB002 and JB006. Jarrah Leaf Miner (*Perthida glyphopa*), an insect that causes significant foliage damage to flooded gums (*Eucalyptus rudis*), has inflicted such damage downstream from section JB016.

Note: 5 = 'looks healthy'; 4 = 'some sick trees'; 3 = 'many sick trees'; 2 = 'some dead trees'; 1 = 'many dead trees'; 0 = no vegetation.

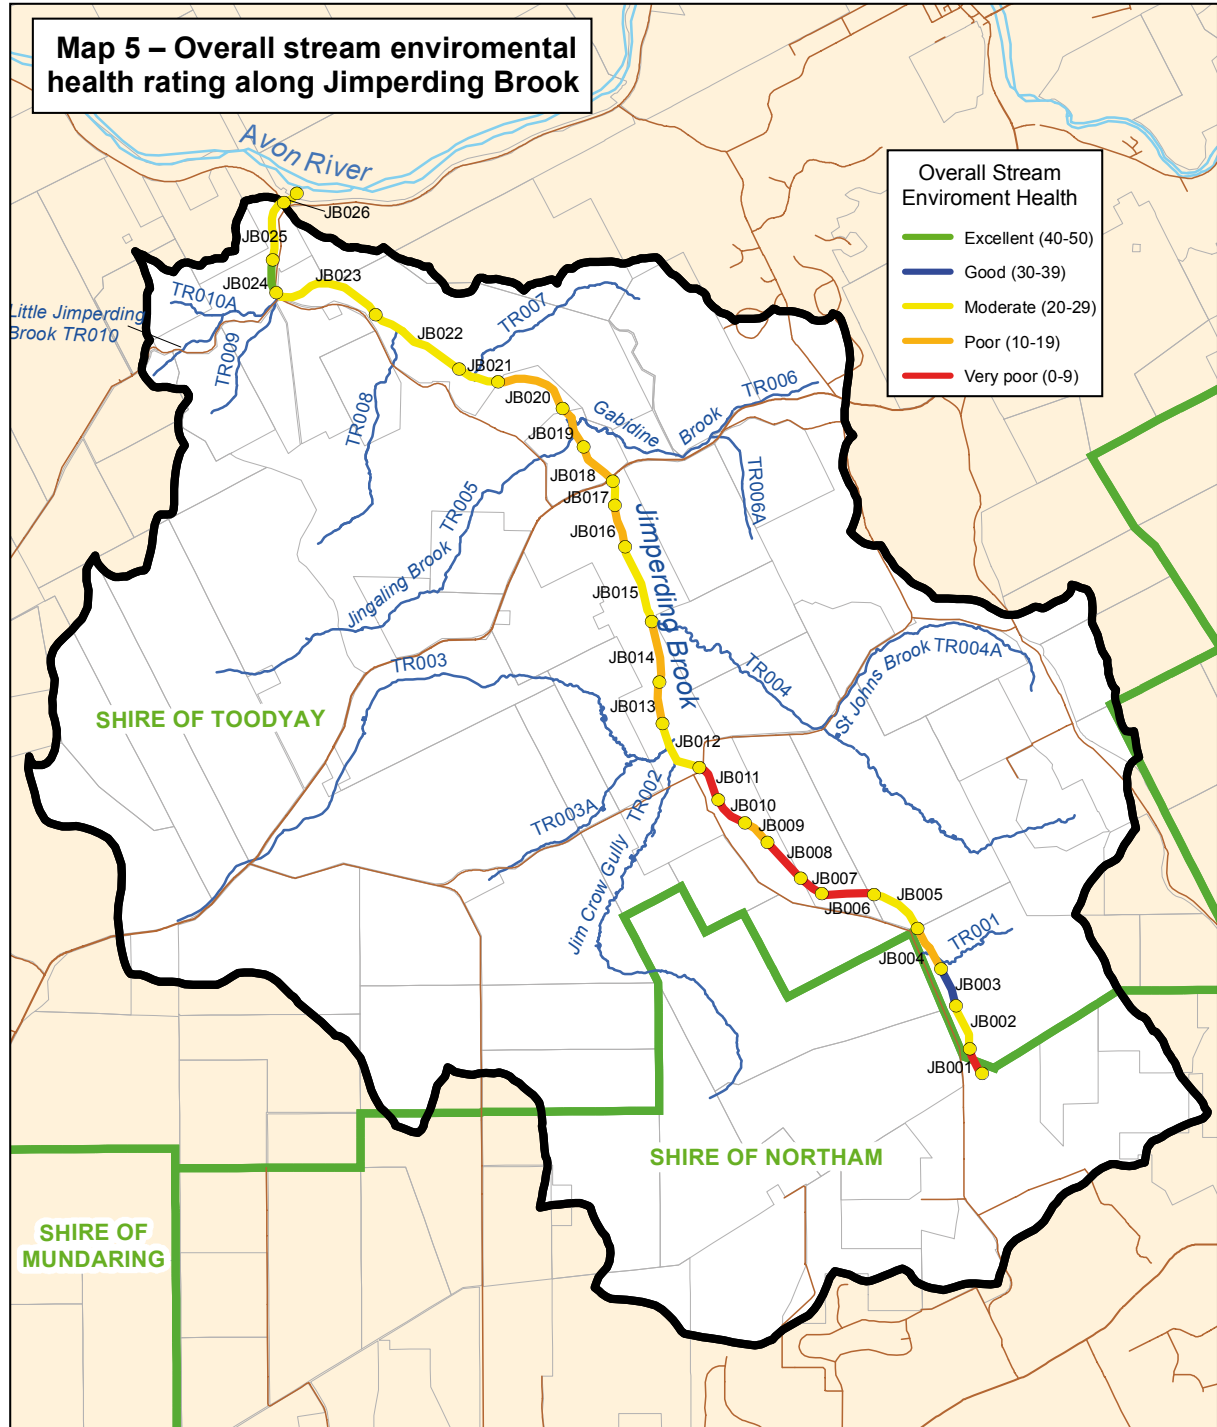
**Map 5 – Overall stream environmental health rating along Jimperding Brook**

Map 5 shows the rating for each of the sections. There was no clear trend in environmental health for the whole river system. It showed the first section to be poor compared with the two immediate downstream sections. The set of sections from JB006 to JB011 were consistently of poor environmental health with JB010 having an exceptionally low score (2).

While section JB018 was of poor environmental health, there was a steadily increasing health trend downstream to section JB024 which was rated as ‘excellent’ with a score of 42 (the maximum possible score is 55). The relatively low score for section JB025 reflected its previous degraded condition. This section was recovering as a result of good river management (fencing and revegetation) activities.
