Foreshore and channel assessment of the Dale River South Branch

Water resource management series

Report No. WRM 50
June 2008

Prepared by
BlueSands Environmental for
Department of Water

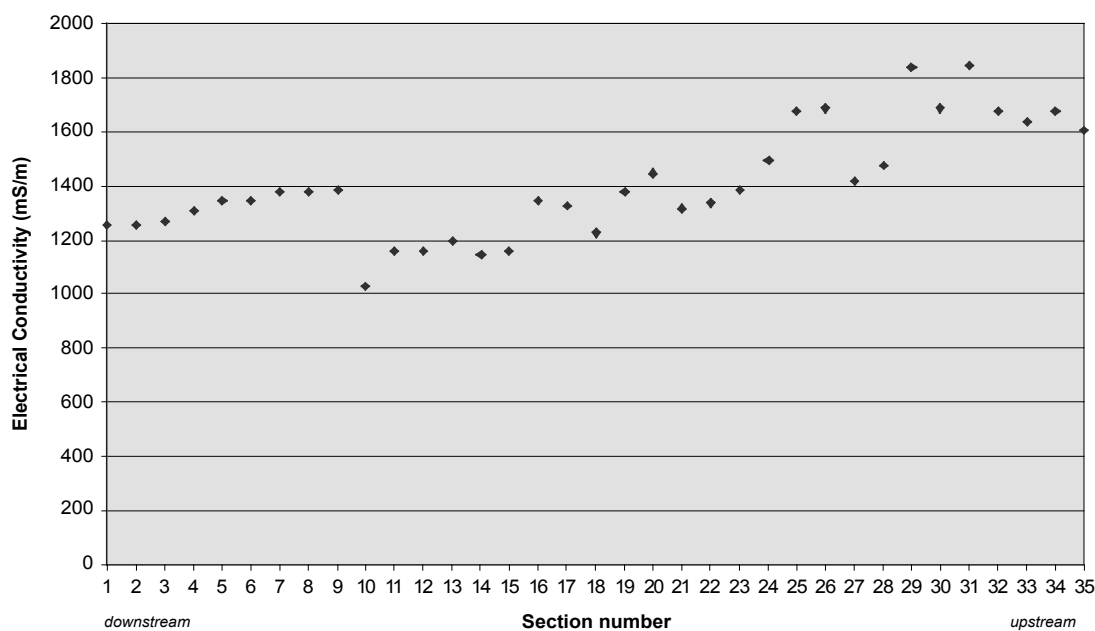
All salinity levels recorded in Dale River South are considered to be saline (Figure 2). A salinity classification is provided in Table 10.

Figure 2 Salinity levels recorded for each survey section on the Dale River South, June–July 2007 (Section number 1 indicates downstream end, 35 indicates upstream end)

Salinity levels generally increased upstream, although survey section DRS10 recorded a lower reading (1030 mS/m), probably because the sample was taken a week after the previous section, during which time there were a few days of rainfall.

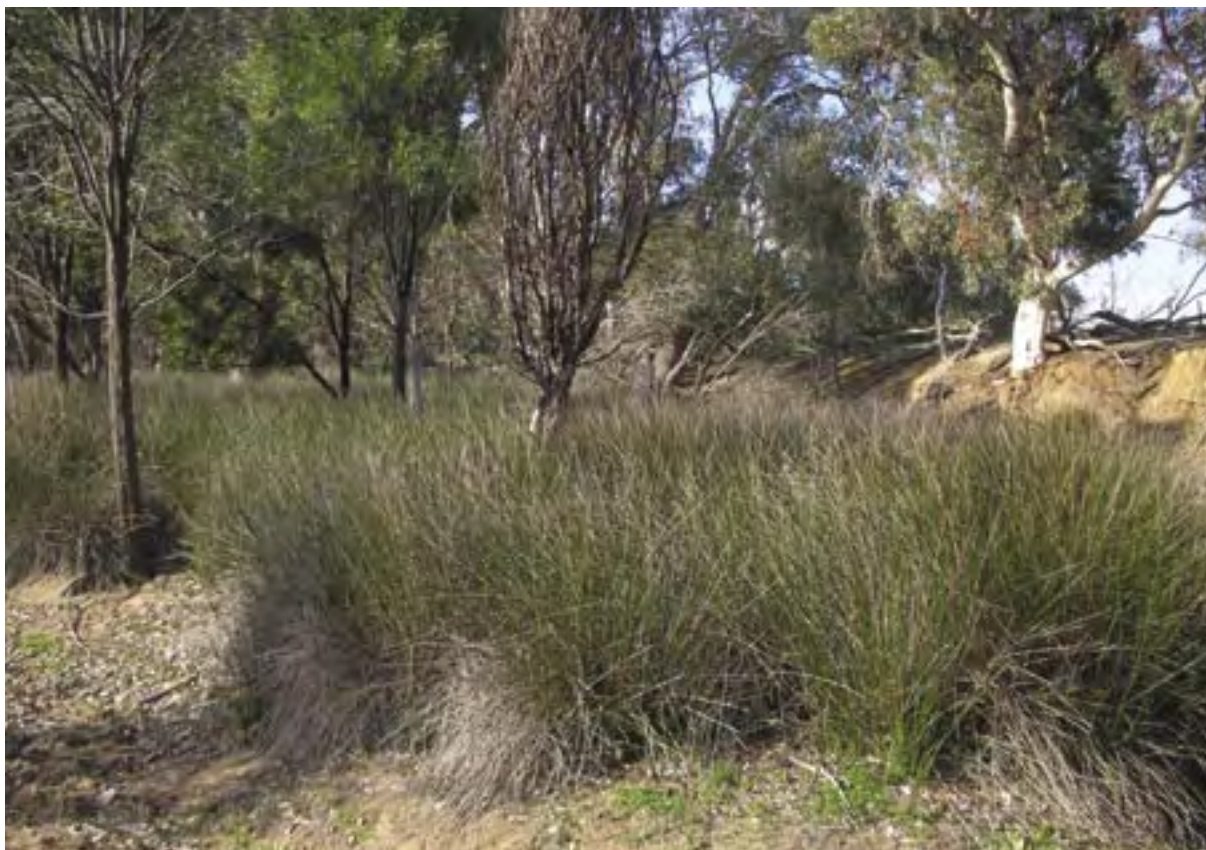
In sections where there was limited or no stock access, native species occurred in the understorey, including pithy saw sedge (*Lepidosperma longitudinale*), pale rush (*Juncus pallidus*), shore rush (*Juncus kraussii*) and bare twigrush (*Baumea juncea*).

Photo 12 Dense stand of shore rush (*Juncus kraussii*) in the floodway
