# FORESHORE AND CHANNEL ASSESSMENT OF THE TOODYAY BROOK

WATER AND RIVERS COMMISSION REPORT WRM 22

WATER AND RIVERS COMMISSION  
REPORT NO WRM 22  
FEBRUARY 2001

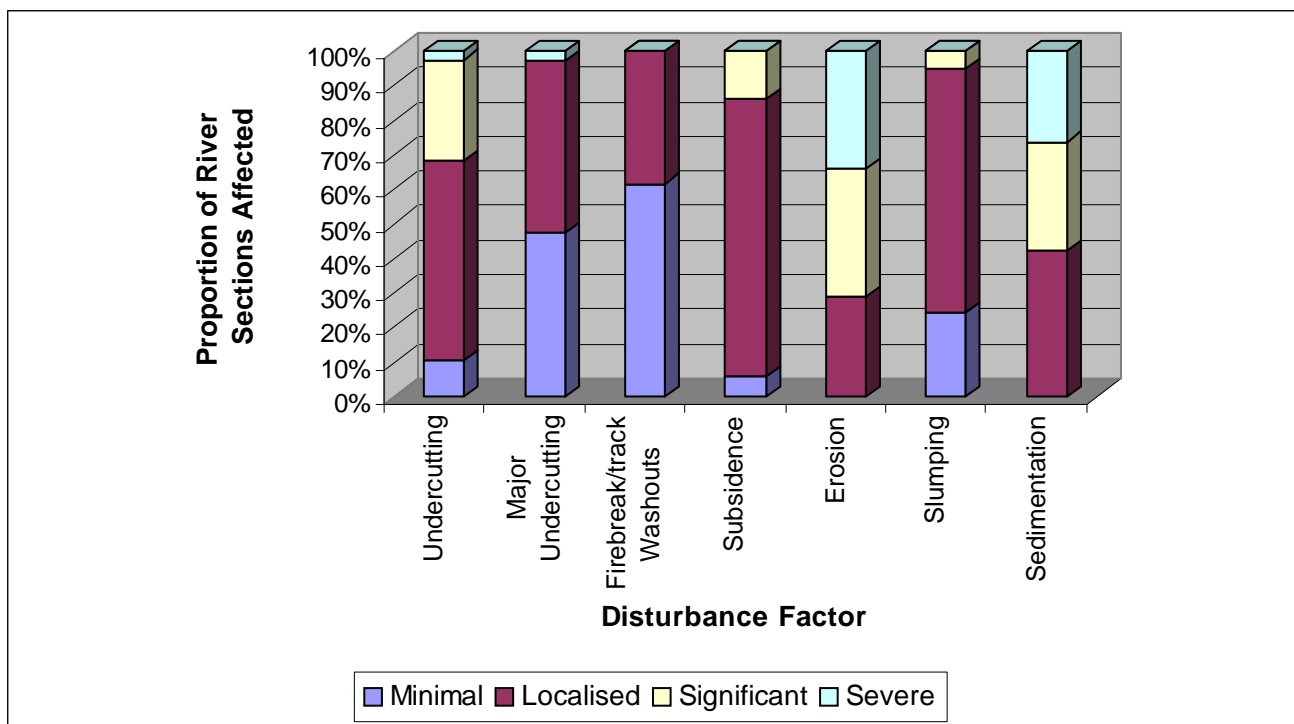
Figure 6. Proportion of channel disturbance along Toodyay Brook

Figure 6 shows the percentage of occurrence of all components relating to channel disturbance. The results show that the worst disturbance factors along the Toodyay Brook are erosion and sedimentation. Erosion was recorded as severe in 34% (13 of the 38 sections surveyed) and significant in 37% (14 sections). No sections surveyed along the Brook were rated as having minimal erosion.

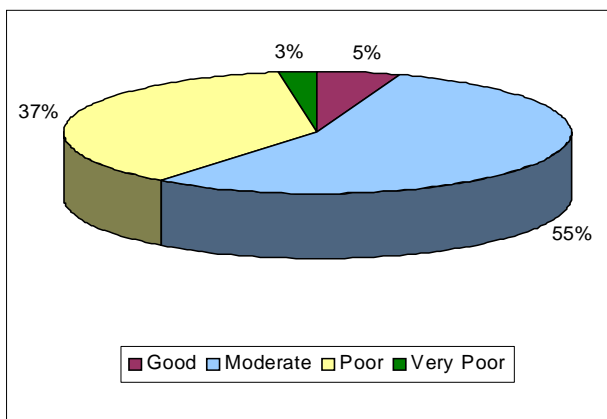
**Figure 7. Bank stability and sedimentation ratings for Toodyay Brook**

Figure 7 shows that 55% of surveyed sections were rated as having moderate bank stability and erosion. This means that vegetation cover was good, but might have been sparse along verges, while there were areas of localised erosion, bank collapse and sediment slugs (Pen and Scott, 1995). 37% of sites were recorded as having poor bank stability and erosion, defined by severe active erosion and sediment heaps with collapsing banks, with bare banks and verges common. Only 5% of the sections were classified as good, 3% as very poor and 0% as being in excellent condition.

Results indicated that the majority of sections were recorded as being either moderate or poor in regards to bank stability and sedimentation when rated in terms of Overall Stream Environmental Health.

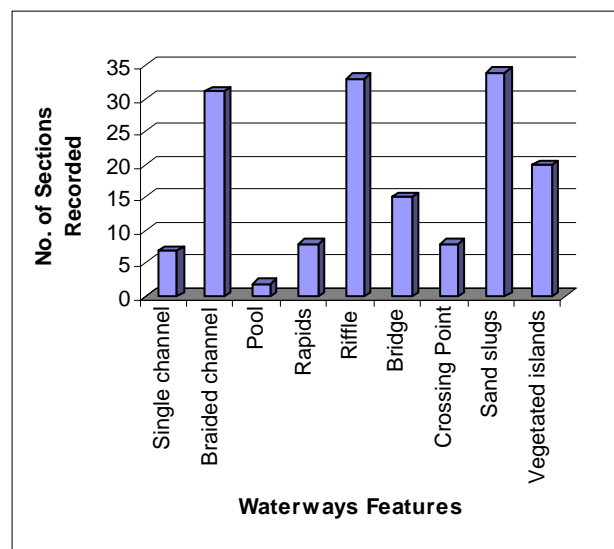
**Figure 8. Waterways features recorded along Toodyay Brook**

Figure 8 shows that the most common features recorded during field observations of Toodyay Brook were sand slugs (occurring at 89% of sections) and riffles (at 87% of the sites).

Bridges were present in 39% of the surveyed sections. Some were road bridges and some were points at which landholders could cross their own properties. A few of the bridges were run down and are not in use. 21% of survey sections have man-made crossing points across the waterway where there has been obvious construction work undertaken to create the crossing.

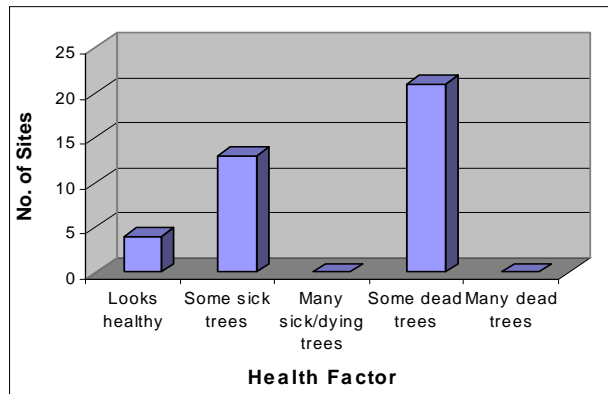
Figure 10. Vegetation health

Figure 10 shows that the majority of sections surveyed along the Toodyay Brook had some dead trees. Of the surveyed sections 55% were recorded as having some dead trees, 34% as having some sick trees, and 11% as looking healthy.

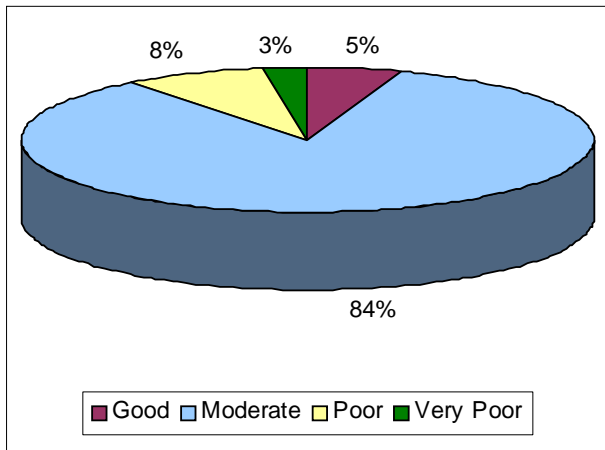
**Figure 11. Vegetation cover along Toodyay Brook**

Figure 11 depicts results collated for stream cover during a survey to determine the Overall Stream Environmental Rating. 84% of the sections were rated as having a moderate stream cover, meaning that there is some permanent shade and overhanging vegetation with some instream cover (Pen and Scott, 1995). 8% were rated as poor, 5% as good and 3% as having very poor stream cover. No sites were recorded as having an excellent stream cover.

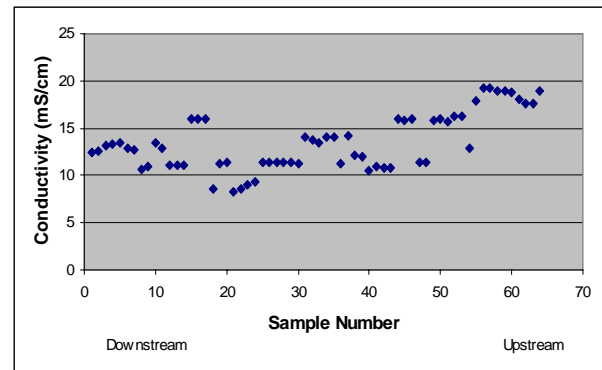
**Figure 14. Electrical conductivity along Toodyay Brook – May 2000**

Figure 14 depicts the electrical conductivity (EC) that was recorded along the Brook. The highest conductivity recording was 19.3mS/cm, sample 56, which occurred in the upstream survey sections along the Brook, while the lowest recorded conductivity was 8.3 mS/cm, (sample number 21), which occurred midway along the waterway. The average electrical conductivity (as a result of averaging all conductivity recordings along the Toodyay Brook) was 13.52mS/cm.

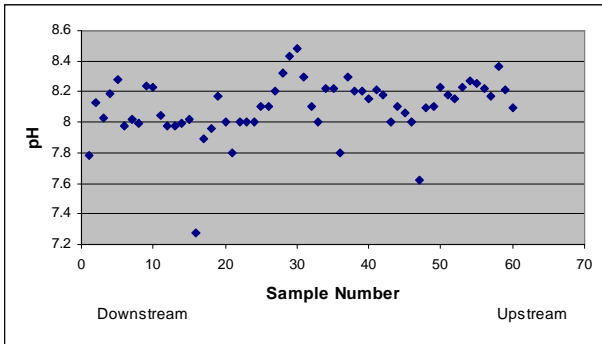
**Figure 15. pH Levels along Toodyay Brook – May 2000**

Figure 15 shows the variation in pH levels recorded during field assessments of watercourse. The lowest pH recorded was 7.28, (sample number 16), while the highest was 8.48 (sample number 30). Both were recorded in sections located approximately mid-way along the length of the tributary. The average pH for all samples taken from the Brook was 8.10.

The average pH (8.10) recorded for the length of the Toodyay Brook was within the Australian Water Quality Guidelines recommended for drinking purposes (between 6.5 and 8.5). It was also within the acceptable level for freshwater aquatic biota protection (between 6.5 and 9.0) (ANZECC, 1992). The highest and lowest pH values (8.48 and 7.28 respectively) show that the range of values recorded was not high.

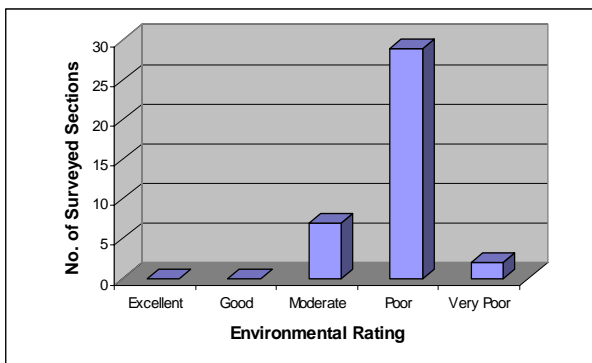
**Figure 16. Overall stream environmental health ratings for Toodyay Brook**

Figure 16 depicts that 18% of the surveyed sections were classified as having moderate stream health, 76% as having poor stream health, and 5% as having a very poor stream health. No section was rated as excellent or good. This was mainly due to lower ratings in the verge vegetation, surrounding landuse and floodway and bank vegetation categories.

Survey results show that the Toodyay Brook has been classified as having a poor Overall Stream Environmental Health rating. When looking at the points scored by each section, the majority of sections that were rated as “poor” were close to being rated as moderate. Map 9 provides a visual representation of the ratings recorded along the Brook.
