# HUTT RIVER FORESHORE ASSESSMENT

Prepared by  
Regional Operations  
Department of Environment

DEPARTMENT OF ENVIRONMENT  
WATER RESOURCE MANAGEMENT SERIES  
REPORT NO WRM 45  
FEBRUARY 2005

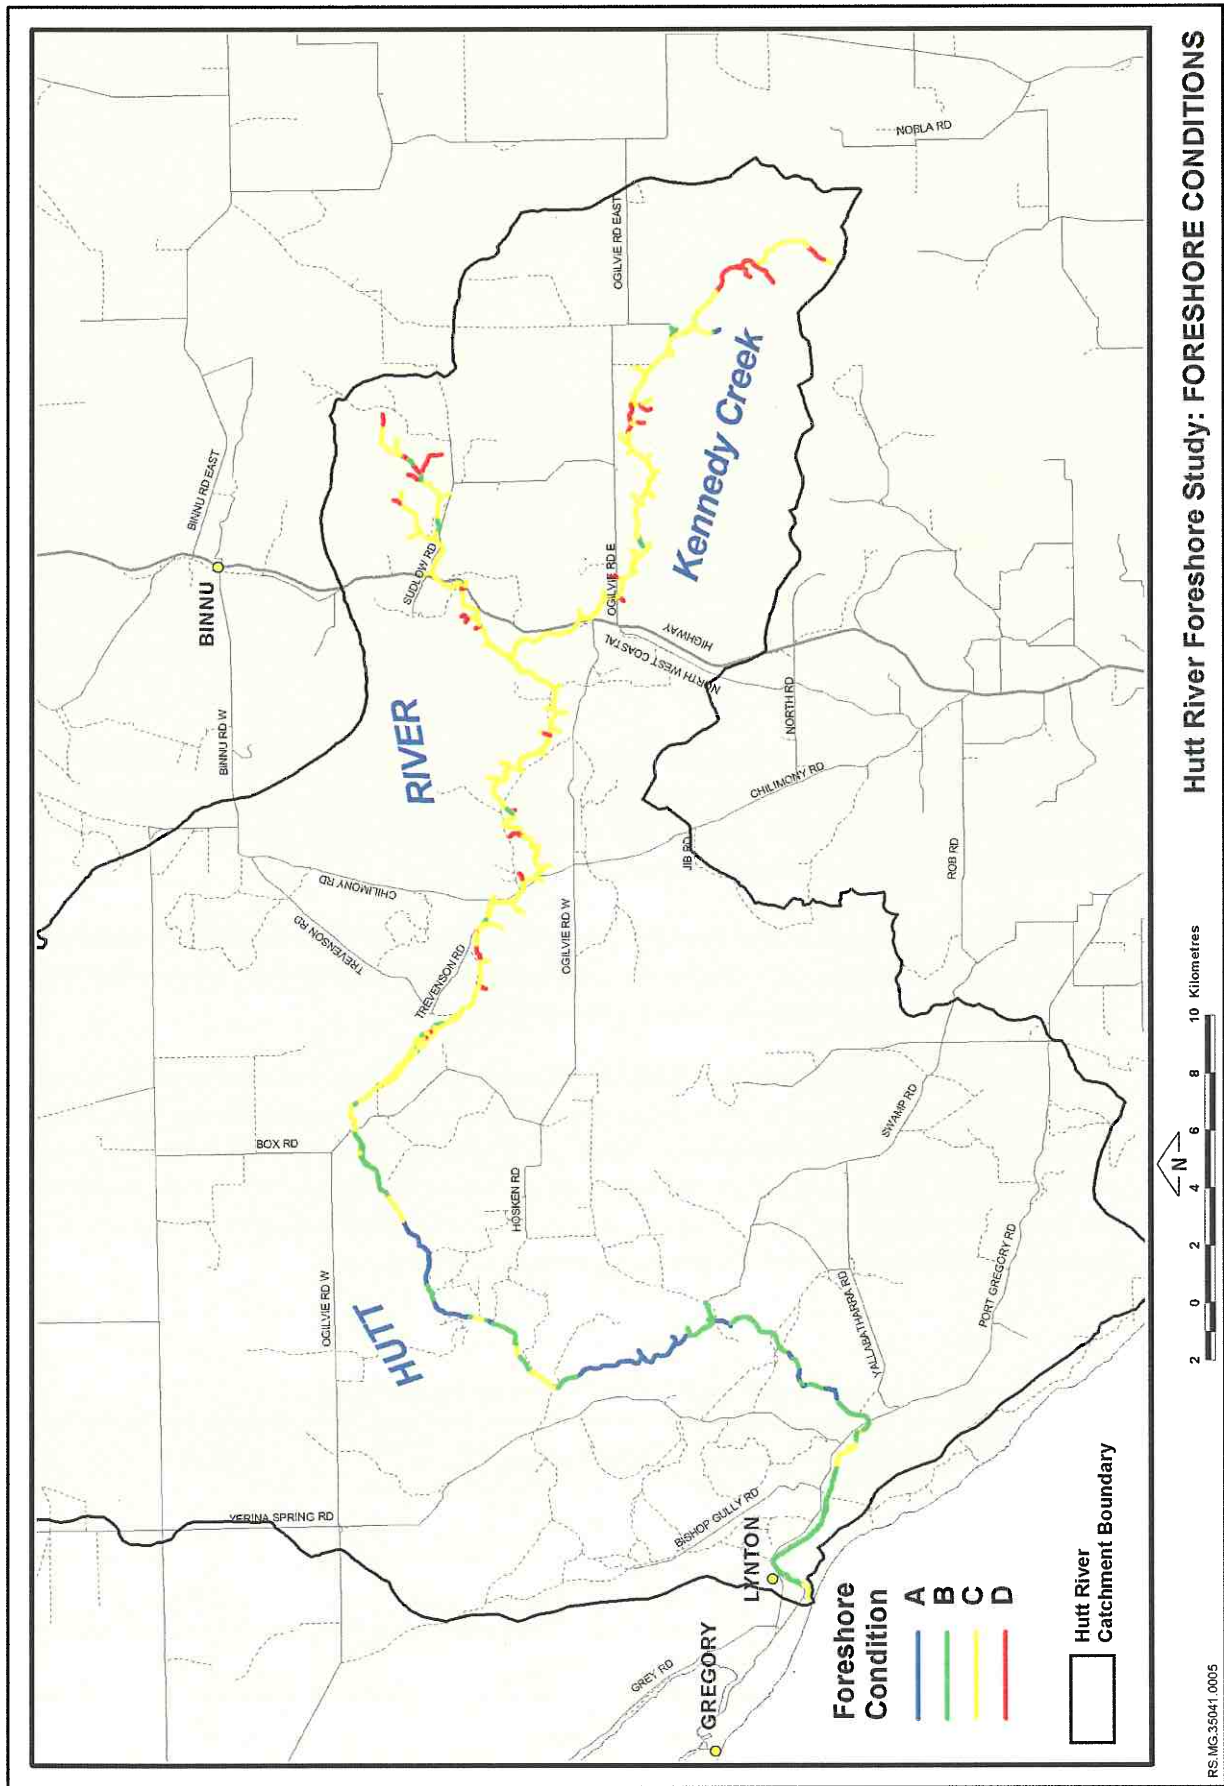
Figure 2: Summary of Foreshore Condition

Condition Rating	Total Length	Total %
A (Very Good)	10.7km	11%
B (Good)	22.7km	23%
C (Moderate)	57.9km	60%
D (Poor)	5.8km	6%
<b>Total</b>	<b>97.1km</b>	<b>100%</b>

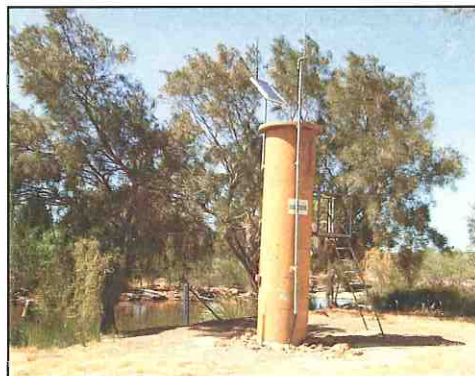
*Photograph 1: Department of Environment Stream Gauging Station*

The Department of Environment Hutt River Gauging Station (Photograph 1) records rainfall, river flow, conductivity and water temperature data. The Gauging Station is located approximately 10km upstream of the mouth of the river (see map 3) and records data for most of the flow from the catchment.

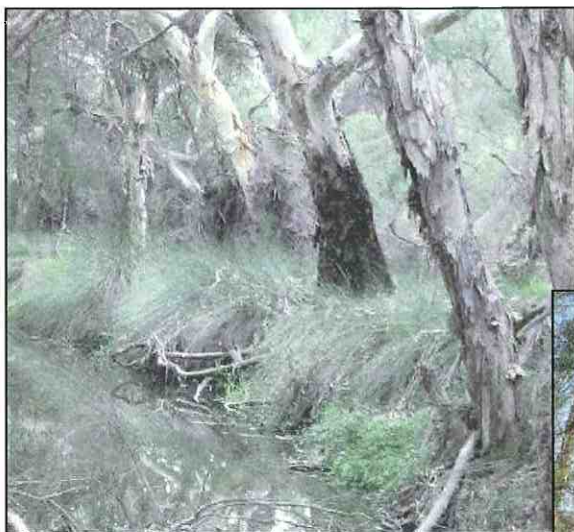
**A grade foreshore:** Fringing vegetation provides habitat, shade and leaf litter, important elements of a healthy river system.

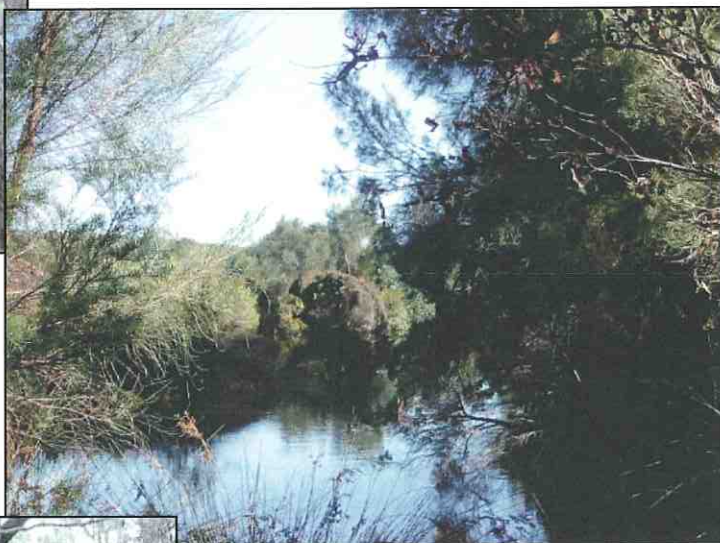
**A grade foreshore:** Native fringing vegetation protects the banks from erosion, as well as trapping sediment and organic matter before it reaches the river.

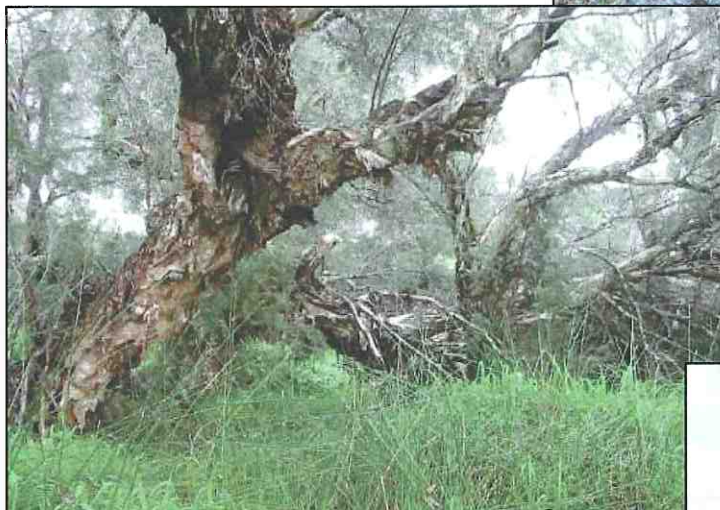
**B grade foreshore:** Although sedges are abundant, weeds have become a significant component of the understorey vegetation.

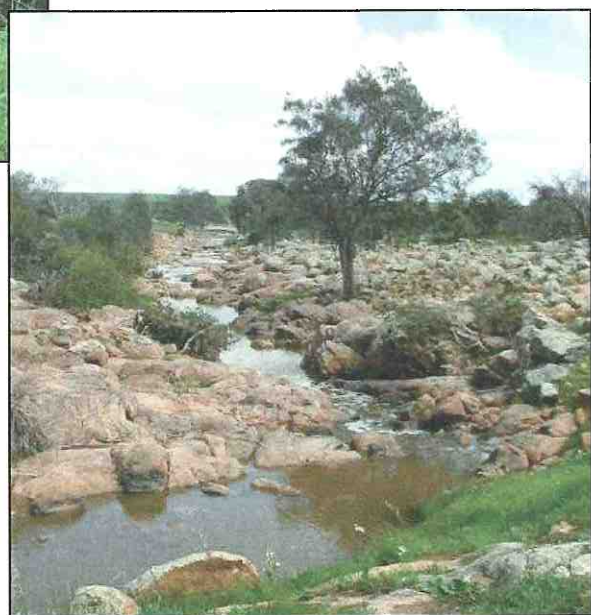
**B grade foreshore:** Rocky areas exhibit excellent bank stability.

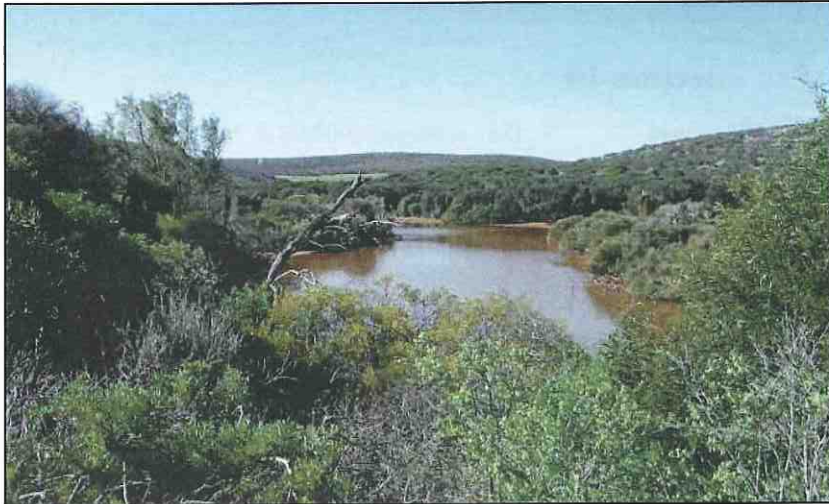
Bank stability at the mouth of the river is moderate. Large flows appear to have caused significant erosion along the banks and sand dunes and there is little vegetation stabilising the dunes. The river, previously meandering to the north just before reaching the ocean, has changed course recently during a large flow event. Much of the flow now bypasses its original path and flows straight to the ocean.

*Photograph 5: Hutt River Estuary*

Main Issues	Suggested Actions
Estuary management requires full integration of catchment and marine management. Pressures include catchment development, increased terrestrial runoff and nutrient supply, sediment deposition, habitat loss and resource exploitation.	<i>Encourage good land and waterway management within the catchment to minimise adverse impacts on the estuary. Prevent onsite degradation of the estuary and coastal environment.</i>
Although evidence of pigs and rabbits was not observed along this section they are present and disturbing the bed and banks on nearby properties. In order for feral animal control to be effective it is imperative that all landholders in the region participate in a regional approach.	<i>Initiate and participate in a Co-ordinated Community Control Program. Contact the Department of Agriculture in Geraldton for information.</i>
The estuarine and coastal areas of the Hutt River are located on Unallocated Crown Land. This area requires management to prevent further degradation and to enhance the area for environmental and recreational value.	<i>Establish vesting and management responsibility of the Hutt River estuarine and coastal areas. Develop an estuarine and coastal management plan for the area.</i>

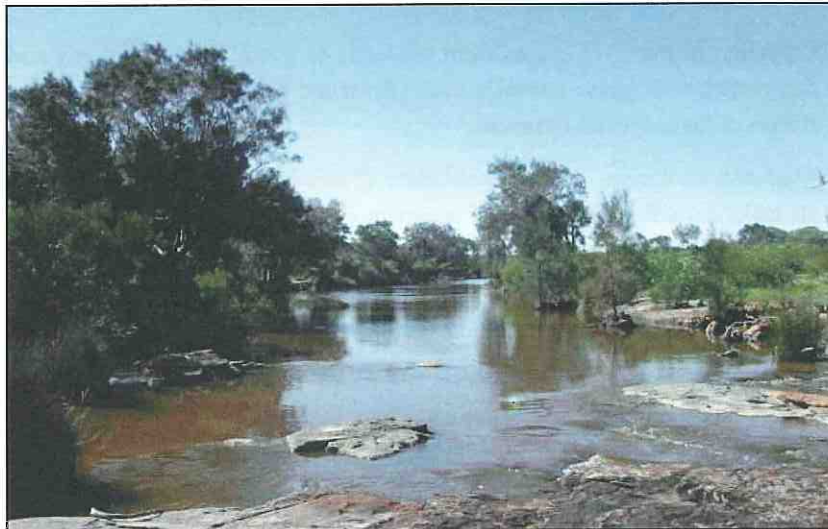
*Photograph 6: Much of the Hutt River has a stable rock bed*
