Department of Mines, Industry Regulation and Safety

Wheal Ellen Mine Shafts and Open Pits Geotechnical Assessment and Remediation Methodology (DMIRS750620) Geotechnical Report

September 2020

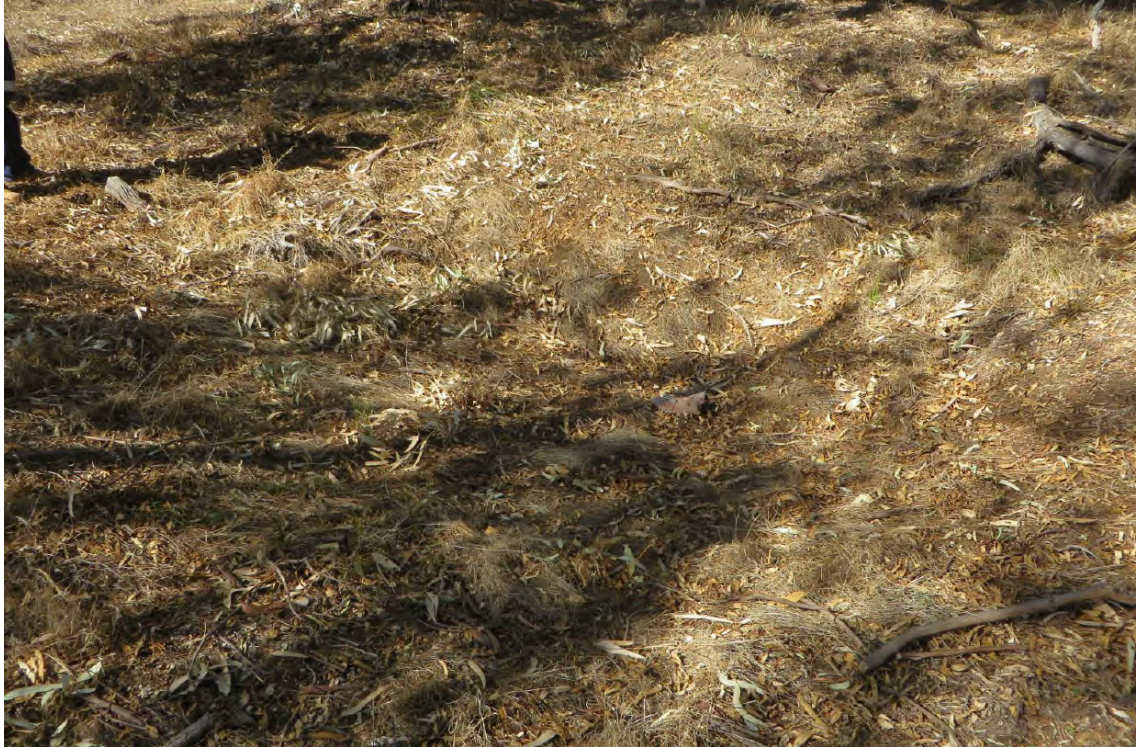
Image 9 Old Workings Pass: 2020 photo (DMIRS)

Both appear to have been backfilled and that fill subsided to form depressions. The Old Working Pass depression is shallow, not steep sided and well vegetated with grass. In comparison, the Old Workings Shaft has steeper un-vegetated sides indicating erosion and subsidence processes are continuing. Given the location of the shaft, surface water flows during heavy rainfall events are likely to be the primary trigger for instability.

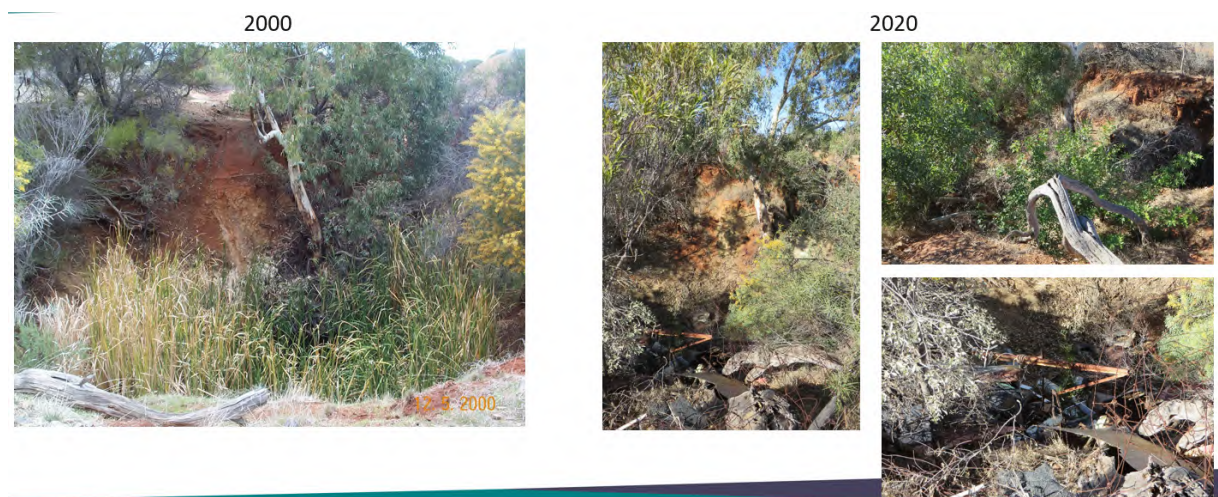
Image 17 S0113097: 2000 and 2020 comparison photos (DMIRS)

As shown in Image 14, feature S0113149 is thought to be associated with a pass which extended to the No. 1 level at 38 m. Feature S0113097 is thought to be associated with another pass immediately to the southwest.

The base of S0113149 is about 2.1 m higher than the water in the base of S0113097 which is obscuring its base. The slopes of the pit suggest it has been open cut but it is distinct from the pit associated with an unnamed pass to the immediate southwest.

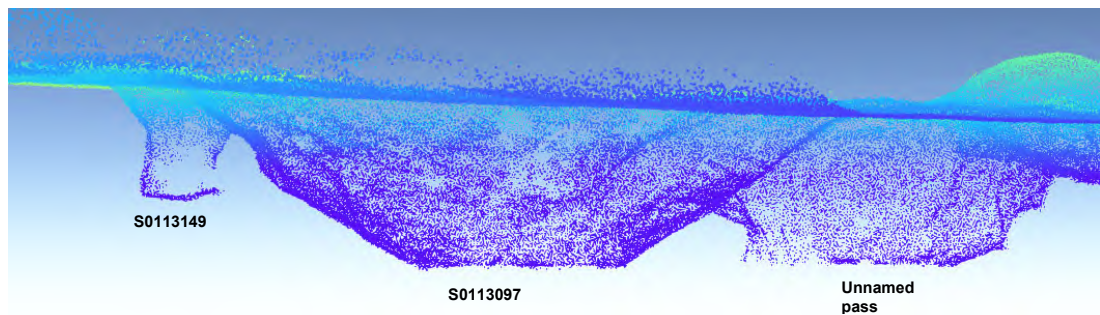
Image 18 S0113149 and S0113097: Point cloud elevation view

Although now part of the same pit, it is clear in the below point cloud image that feature S0113149 is separate and more likely a backfilled pass which has subsided.

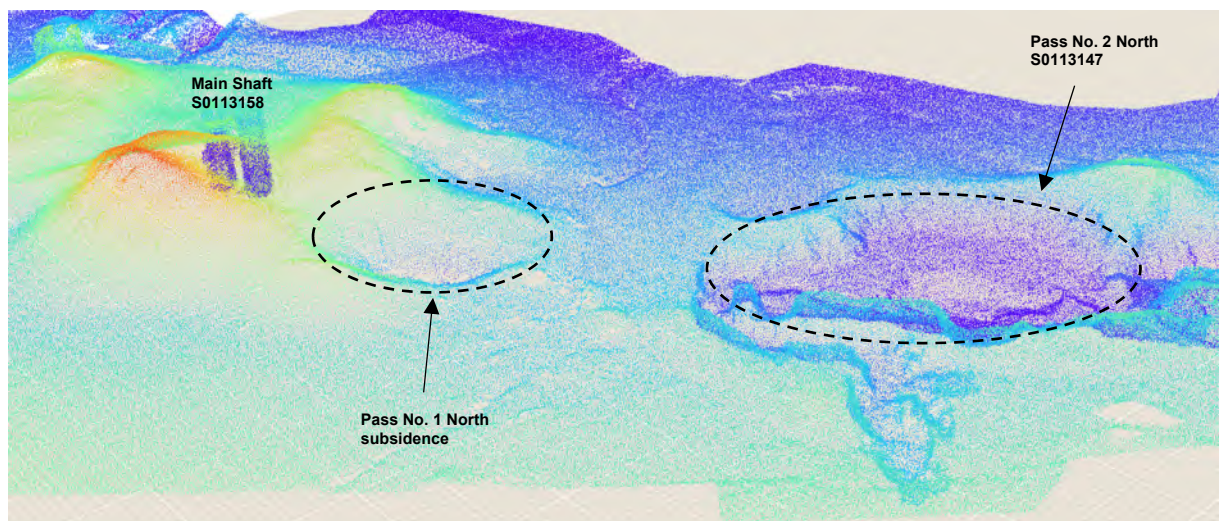
Image 19 S0113147 and Pass No. 1 North: Point cloud elevation view

Pass No. 2 North is the southwestern extension of the “barbell” shaped open cut. It extended to “old workings” at about 29 m depth with stoping below this as is the case of the adjacent workings. It is currently about 3 m deep, shallower than the adjacent pits to the northeast. This is because it has been filled with fines (soil). The original depth is expected to have been similar to the adjacent pit at about 6.7 m.

The interpreted relationship between Pass No. 1 North, Pass No. 2 North and the Main Shaft (S0113158) is shown in the below point cloud image.

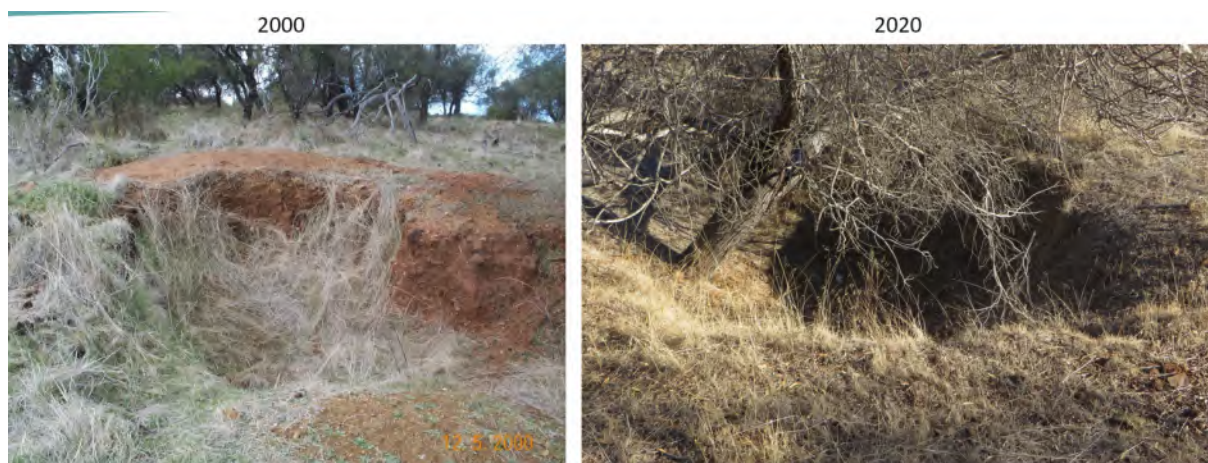
Image 25 S0113127: 2000 and 2020 comparison photos (DMIRS)

These features form part of a chain of bowl shaped depressions not exceeding 1.9 m depth. Neither feature contained ponded water although they are both expected to collect surface water runoff from the slope to the southeast during periods of rainfall.

Comparison of the below 2000 and 2020 images show little change in the past 20 years other than vegetation.

These features are not associated with any known shafts or passes and probably represent subsidence resulting from movement of soil into stopes below under the action of water flows.

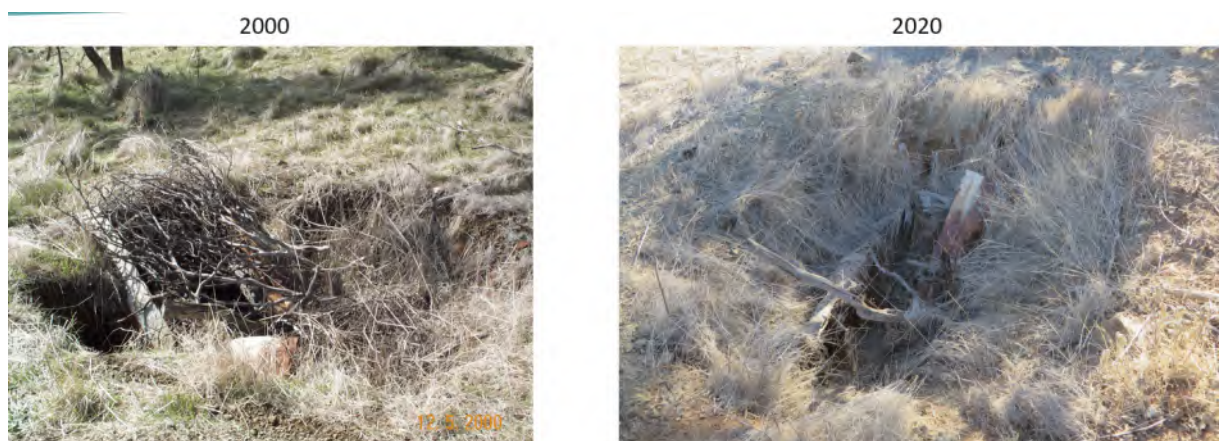
Image 27 S0113114: 2000 and 2020 comparison photos (DMIRS)

The feature did not contain ponded water although it is expected to collect surface water runoff from the slope to the southeast during periods of rainfall.

Comparison of the below 2000 and 2020 images show some removal of sticks, changes to vegetation and also a flattening of the pit sides since 2000. This is attributed to erosion from surface water during periods of heavy rain.

The origin of this feature is difficult to ascertain. Possibilities are a shaft or subsidence resulting from movement of soil into a stope below under the action of water flows.

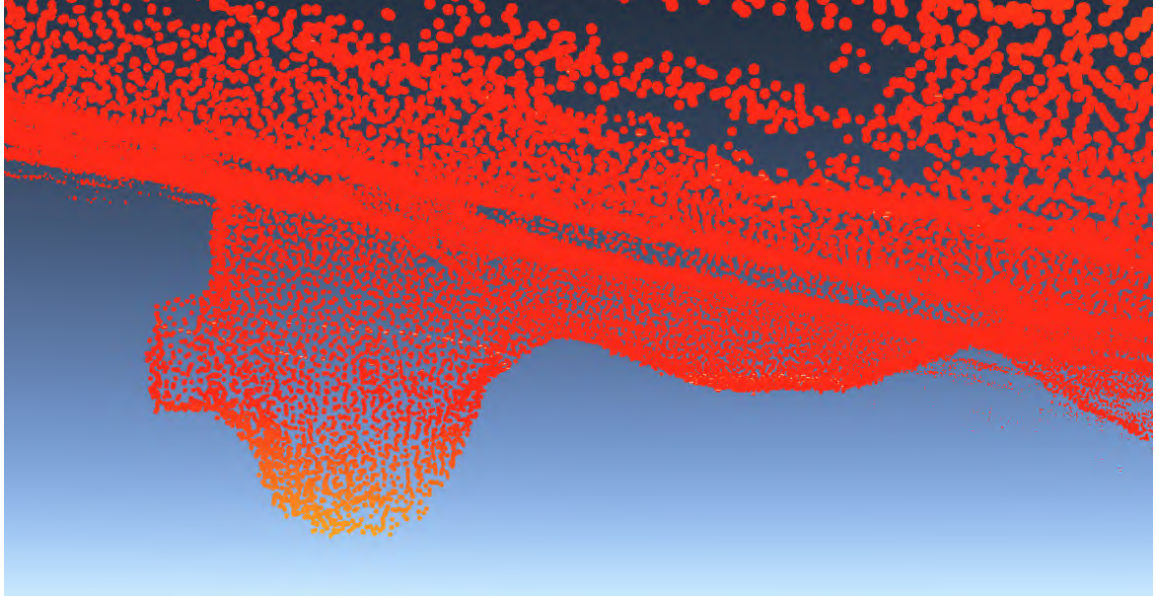
Image 28 S0113122 point cloud

The feature is about 3.6 m deep and did not contain ponded water although it is likely to collect surface water runoff from the adjacent slope during heavy rain.

The shape of the feature is similar to Pass No. 5 North with the western face noticeably steeper and the base sloping down to the northwest in the same direction as the lode dip. However, S0113122 is elongated along the lode sub-crop with a secondary and shallower depression on the southern end and a narrow undercut section on the northern end. This undercut section is visible in the 2000 photo as well as the below point cloud image.

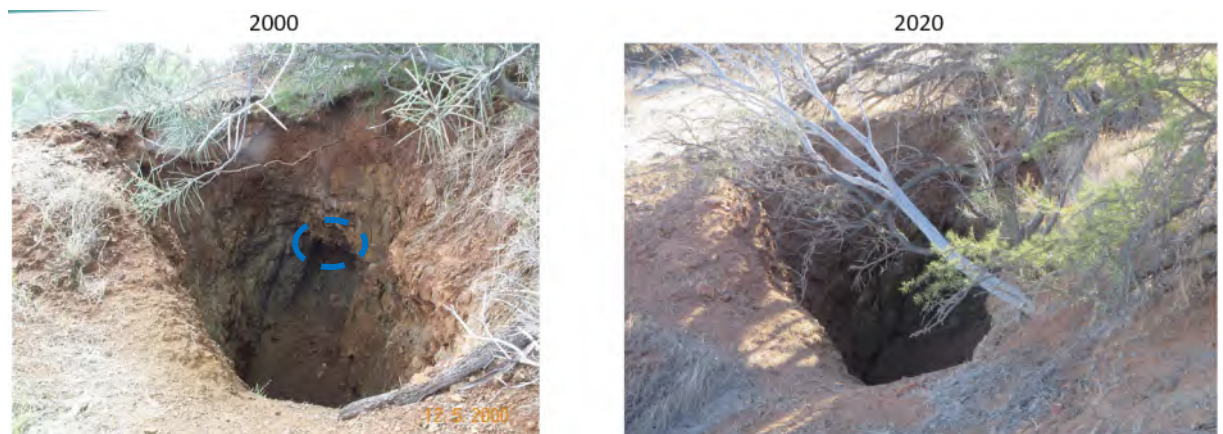
Image 29 S0113122: 2000 and 2020 comparison photos (DMIRS)

Comparison of 2000 and 2020 photos below show little change in the past 20 years. Some collapse of the undercut section has occurred with the loss of a group of swallow nests that are visible in the 2000 photo but not the 2020 photo.

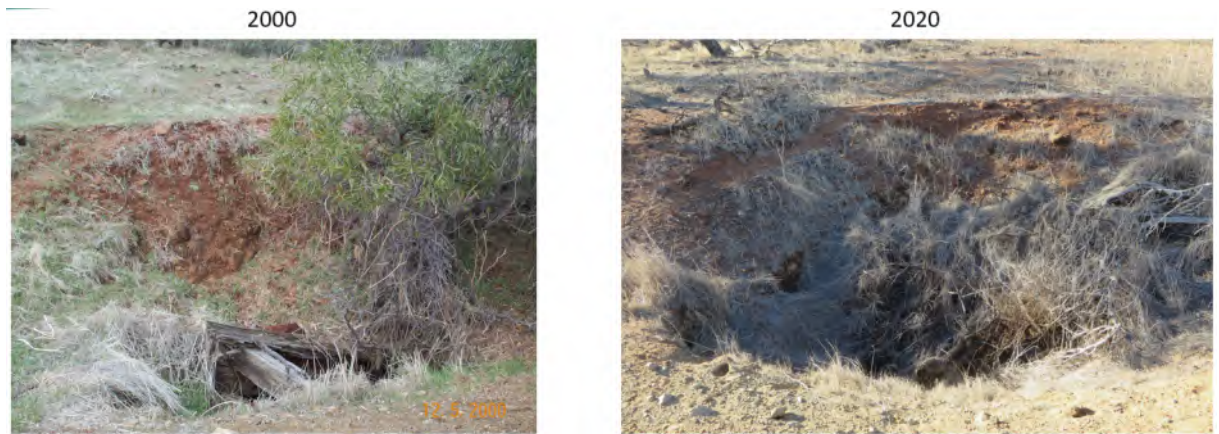
Image 31 S0113111: 2000 and 2020 comparison photos (DMIRS)

The feature is about 3.6 m deep and roughly circular in plan. It did not contain ponded water although it is expected to collect surface water runoff from the slope to the southeast during periods of rainfall.

Comparison of the below 2000 and 2020 images show removal of some timber, changes to vegetation and possible erosion of material from the base of the feature since 2000, deepening it although this may be from removal of the timber.

The likely origin is a subsidence feature resulting from movement of soil into a stope under the action of water flows.

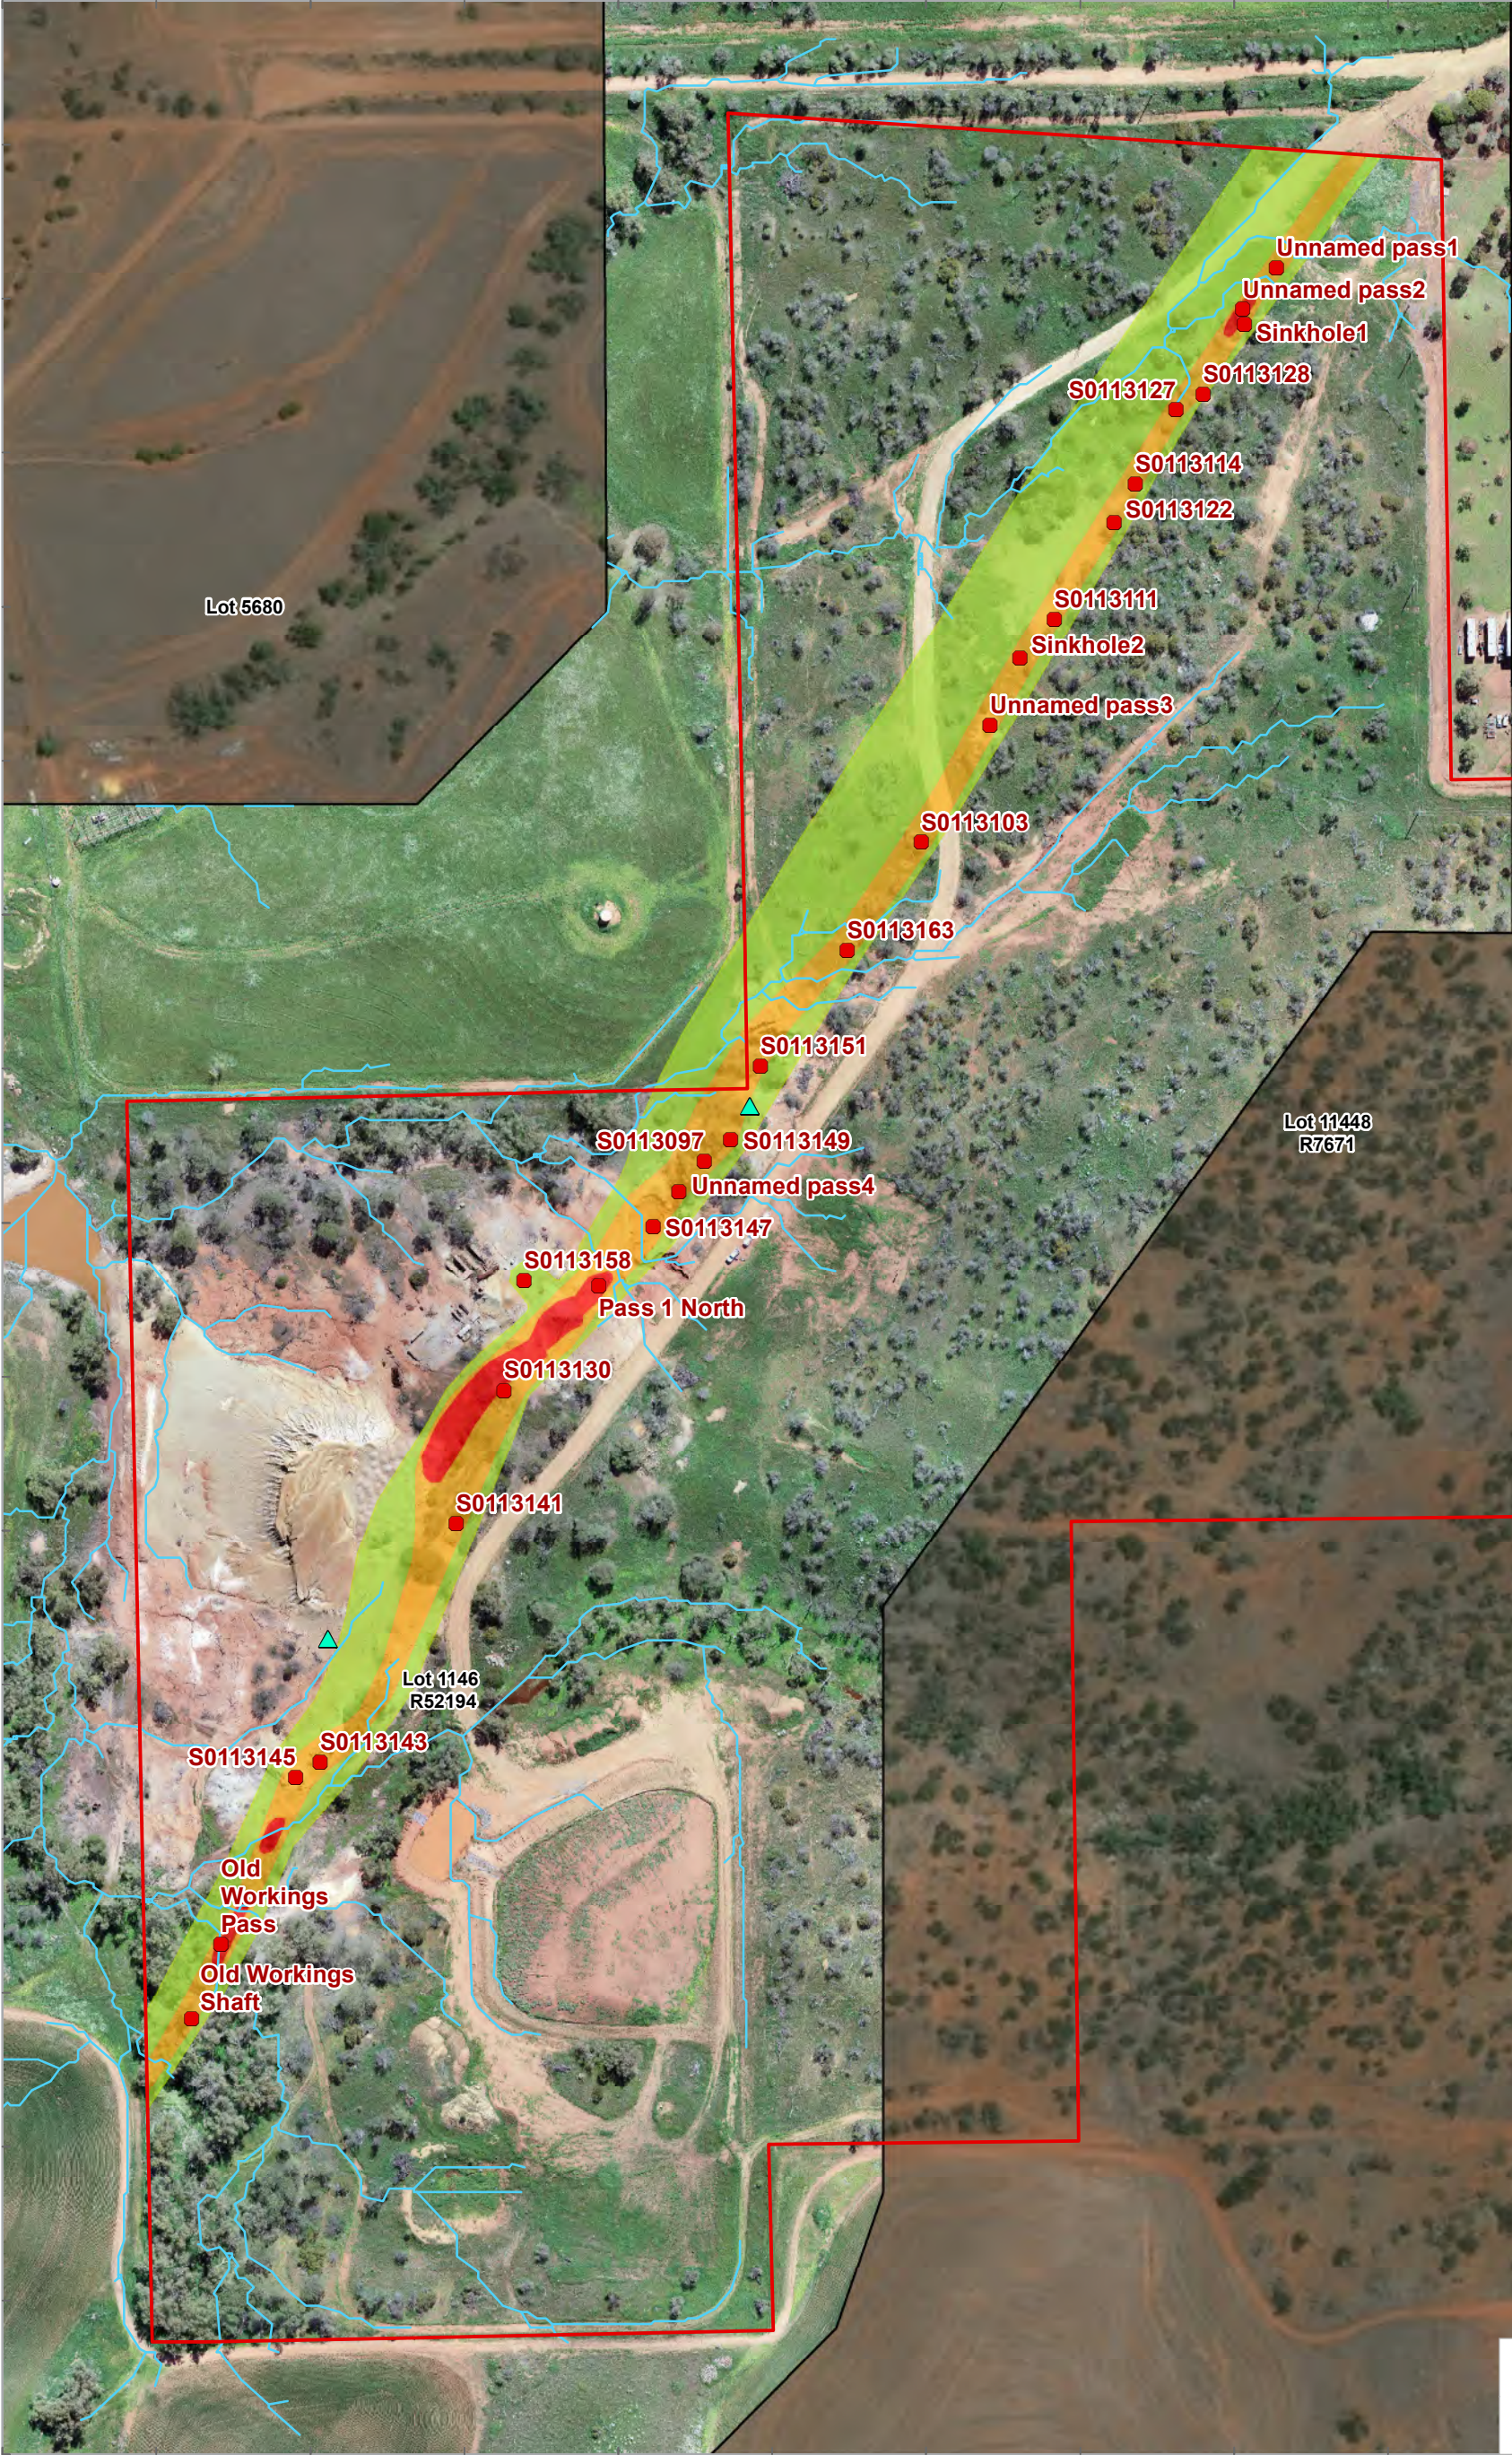
FIGURE 6

Potential Asbestos Containing Material (ACM) in the form of cemented sheeting was observed at two locations shown in Figure 6. The suspected ACM will need to be taken into consideration during remediation to manage risk to human health.

Zones of Low, Moderate and High sinkhole hazards are shown on Figure 6 in Appendix B.
