Report on  
Geotechnical Investigation

Donnybrook Mine Shaft Condition  
Lot F27 Goodwood Road, Upper Capel

Prepared for  
Department of Mines, Industry Regulation & Safety

Project 96721.00  
June 2021

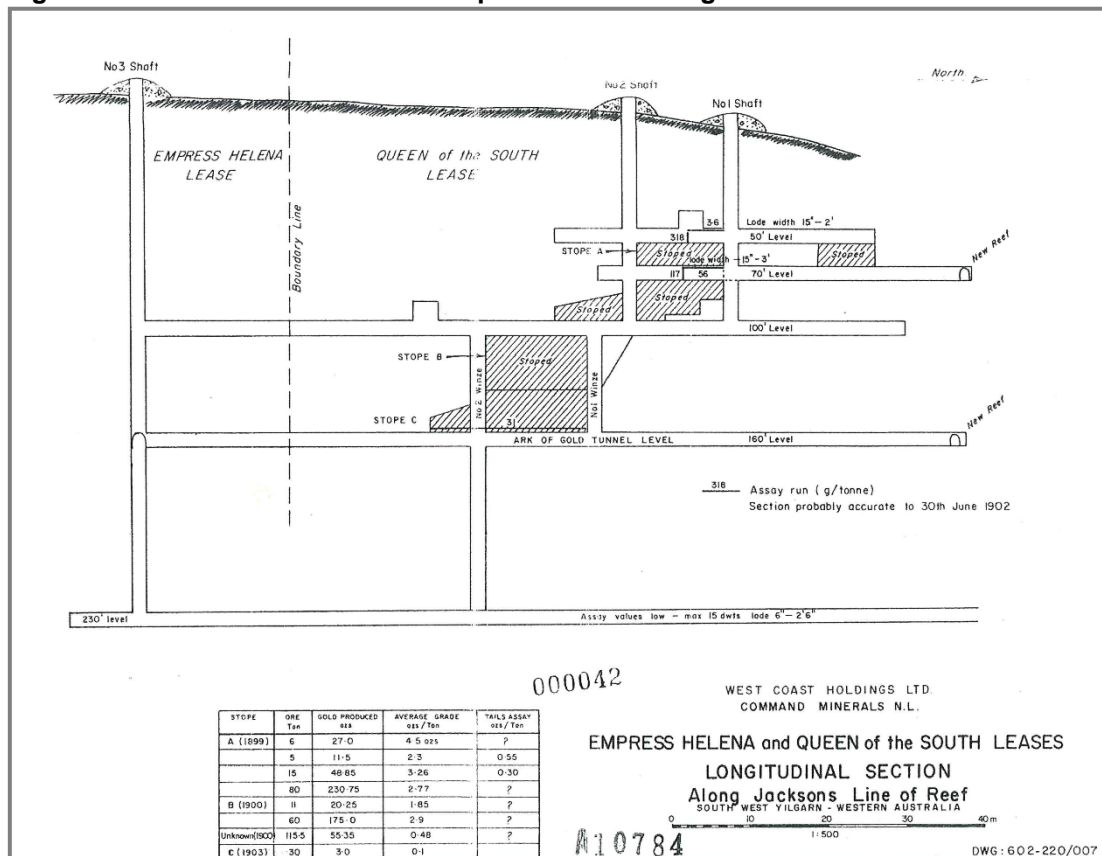
**Figure 1: Queen of the South and Empress Helena Longitudinal Cross Section**

Georeferencing a plan of the Queen of the South with records of mining tenement boundaries sourced from DMIRS online data and the database of abandoned mine features suggests that some of the features chosen for assessment as part of this study (Feature 7 and 8) may be associated with the main shafts of the mine targeting Jackson's Reef, as shown in Figures 1 and 2 below.

- Ground conditions comprise weathered sandstone, likely to increase in strength with depth.
- Ore targeted by mining began from relatively shallow depths, such as 9 m.
- Typical depths of shafts in the area was approximately 15 m however nearby mines were worked to 60 m.
- The reefs targeted by mining activities were relatively narrow, generally not greater than 1.5 m in width, indicating that large underground stopes would be unlikely. Information within Figure 1 indicates widths up to 0.9 m within areas in the vicinity of the ten features for investigation, Furthermore, no historical documents provide any indication of large open workings below ground.
- Figure 1 suggests mining activities in the vicinity of the ten features began from 50 feet (15 m) deep.

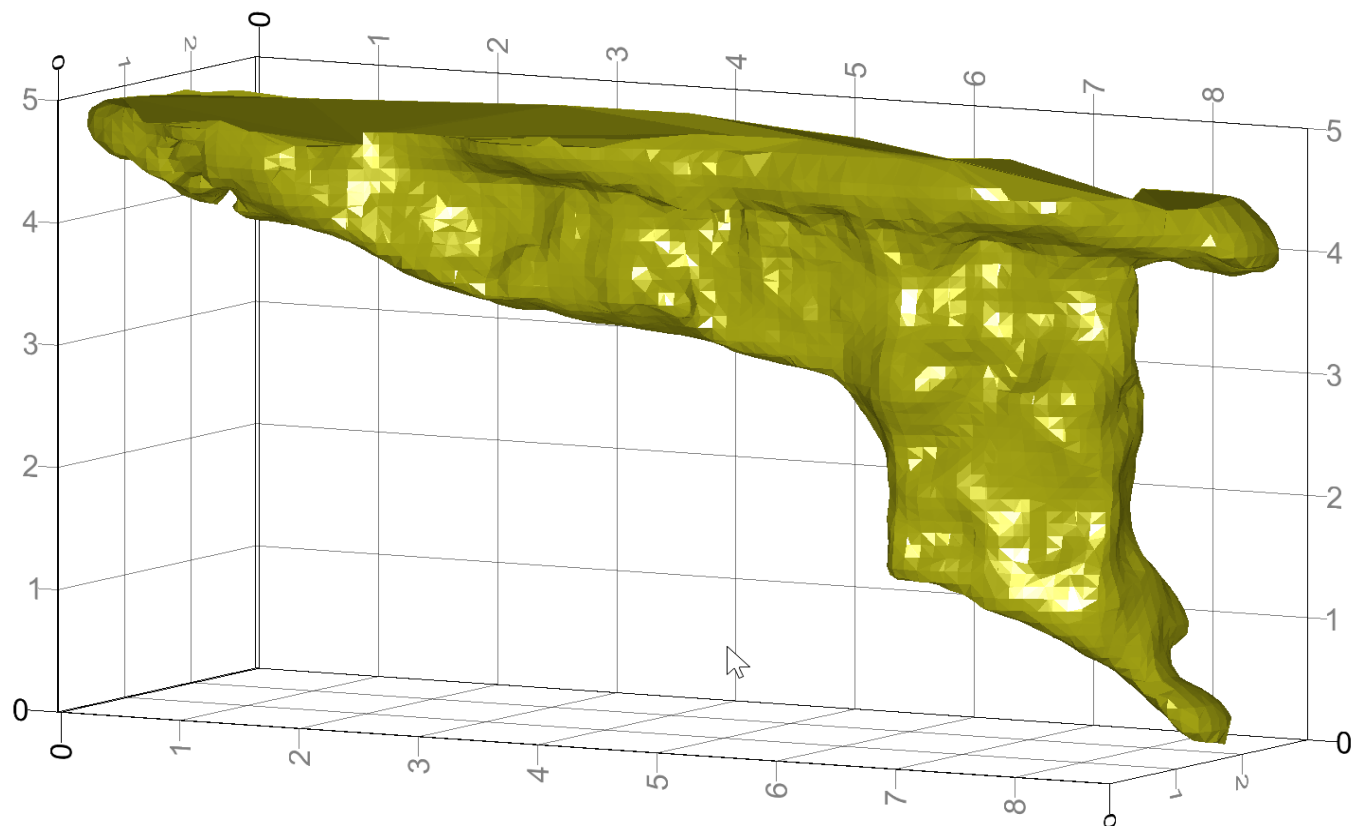
**Mesh 3: Feature 4**

4	A trench excavation, approximately 7 m long with two depths: 1.5 m deep in the shallow western half and increasing to 3.3 m at the eastern extremity of the feature. A short horizontal continuation approximately 0.3 m to 0.5 m in length extends from the base of the 3.3 m deep section towards the track (to the east). Water was observed ponding in this continuation during a previous site inspection, suggesting no further continuation. The base appears natural and can support the weight of the 8 tonne excavator when bearing down on its bucket placed at the base of the feature. The side walls are near vertical and show no evidence of collapse.
5	A relatively square vertical shaft extending to 3.6 m depth. From the base of the shaft, an opening angles downwards in an easterly direction (bearing 110°). LiDAR captured data up to 4.6 m inside the angled opening, to a depth of approximately 10 m below ground surface. The lateral opening is on average 1 m wide. LiDAR data indicated a separation of approximately 7.5 m between the roof of the opening and the ground surface beneath the track. The side walls are near vertical and show no evidence of collapse.

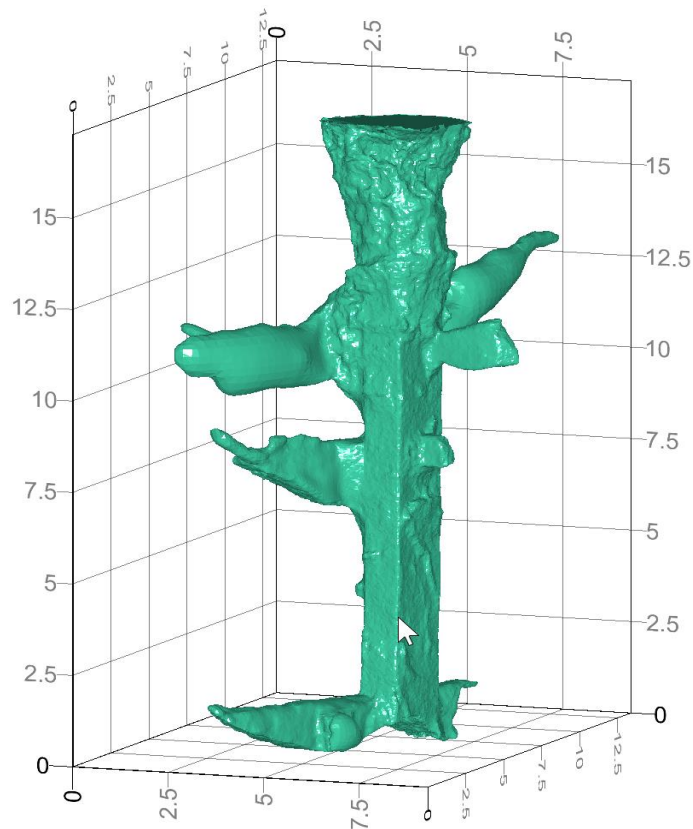
**Mesh 6: Feature 8**

Feature 8 is possibly No. 2 Shaft of the Queen of the South mine, however historical data suggests that the historical No. 2 Shaft extends to 30 m depth, whereas the measured depth of Feature 8 was 16 m (which generally agrees with the 50 foot (15 m) deep mine level shown in Figure 1, page 3). Imagery produced by the LiDAR scanning and video footage indicate that the base of Feature 8 is unlikely to be a plug created from material collapse from above and appears to be the base of a shaft providing access to the horizontal level at 15 m depth.
