# ABANDONED MINE FEATURES ASSESSMENT

## WHEAL ELLEN GEOTECHNICAL REPORT

11953-G-R-001 Public Document

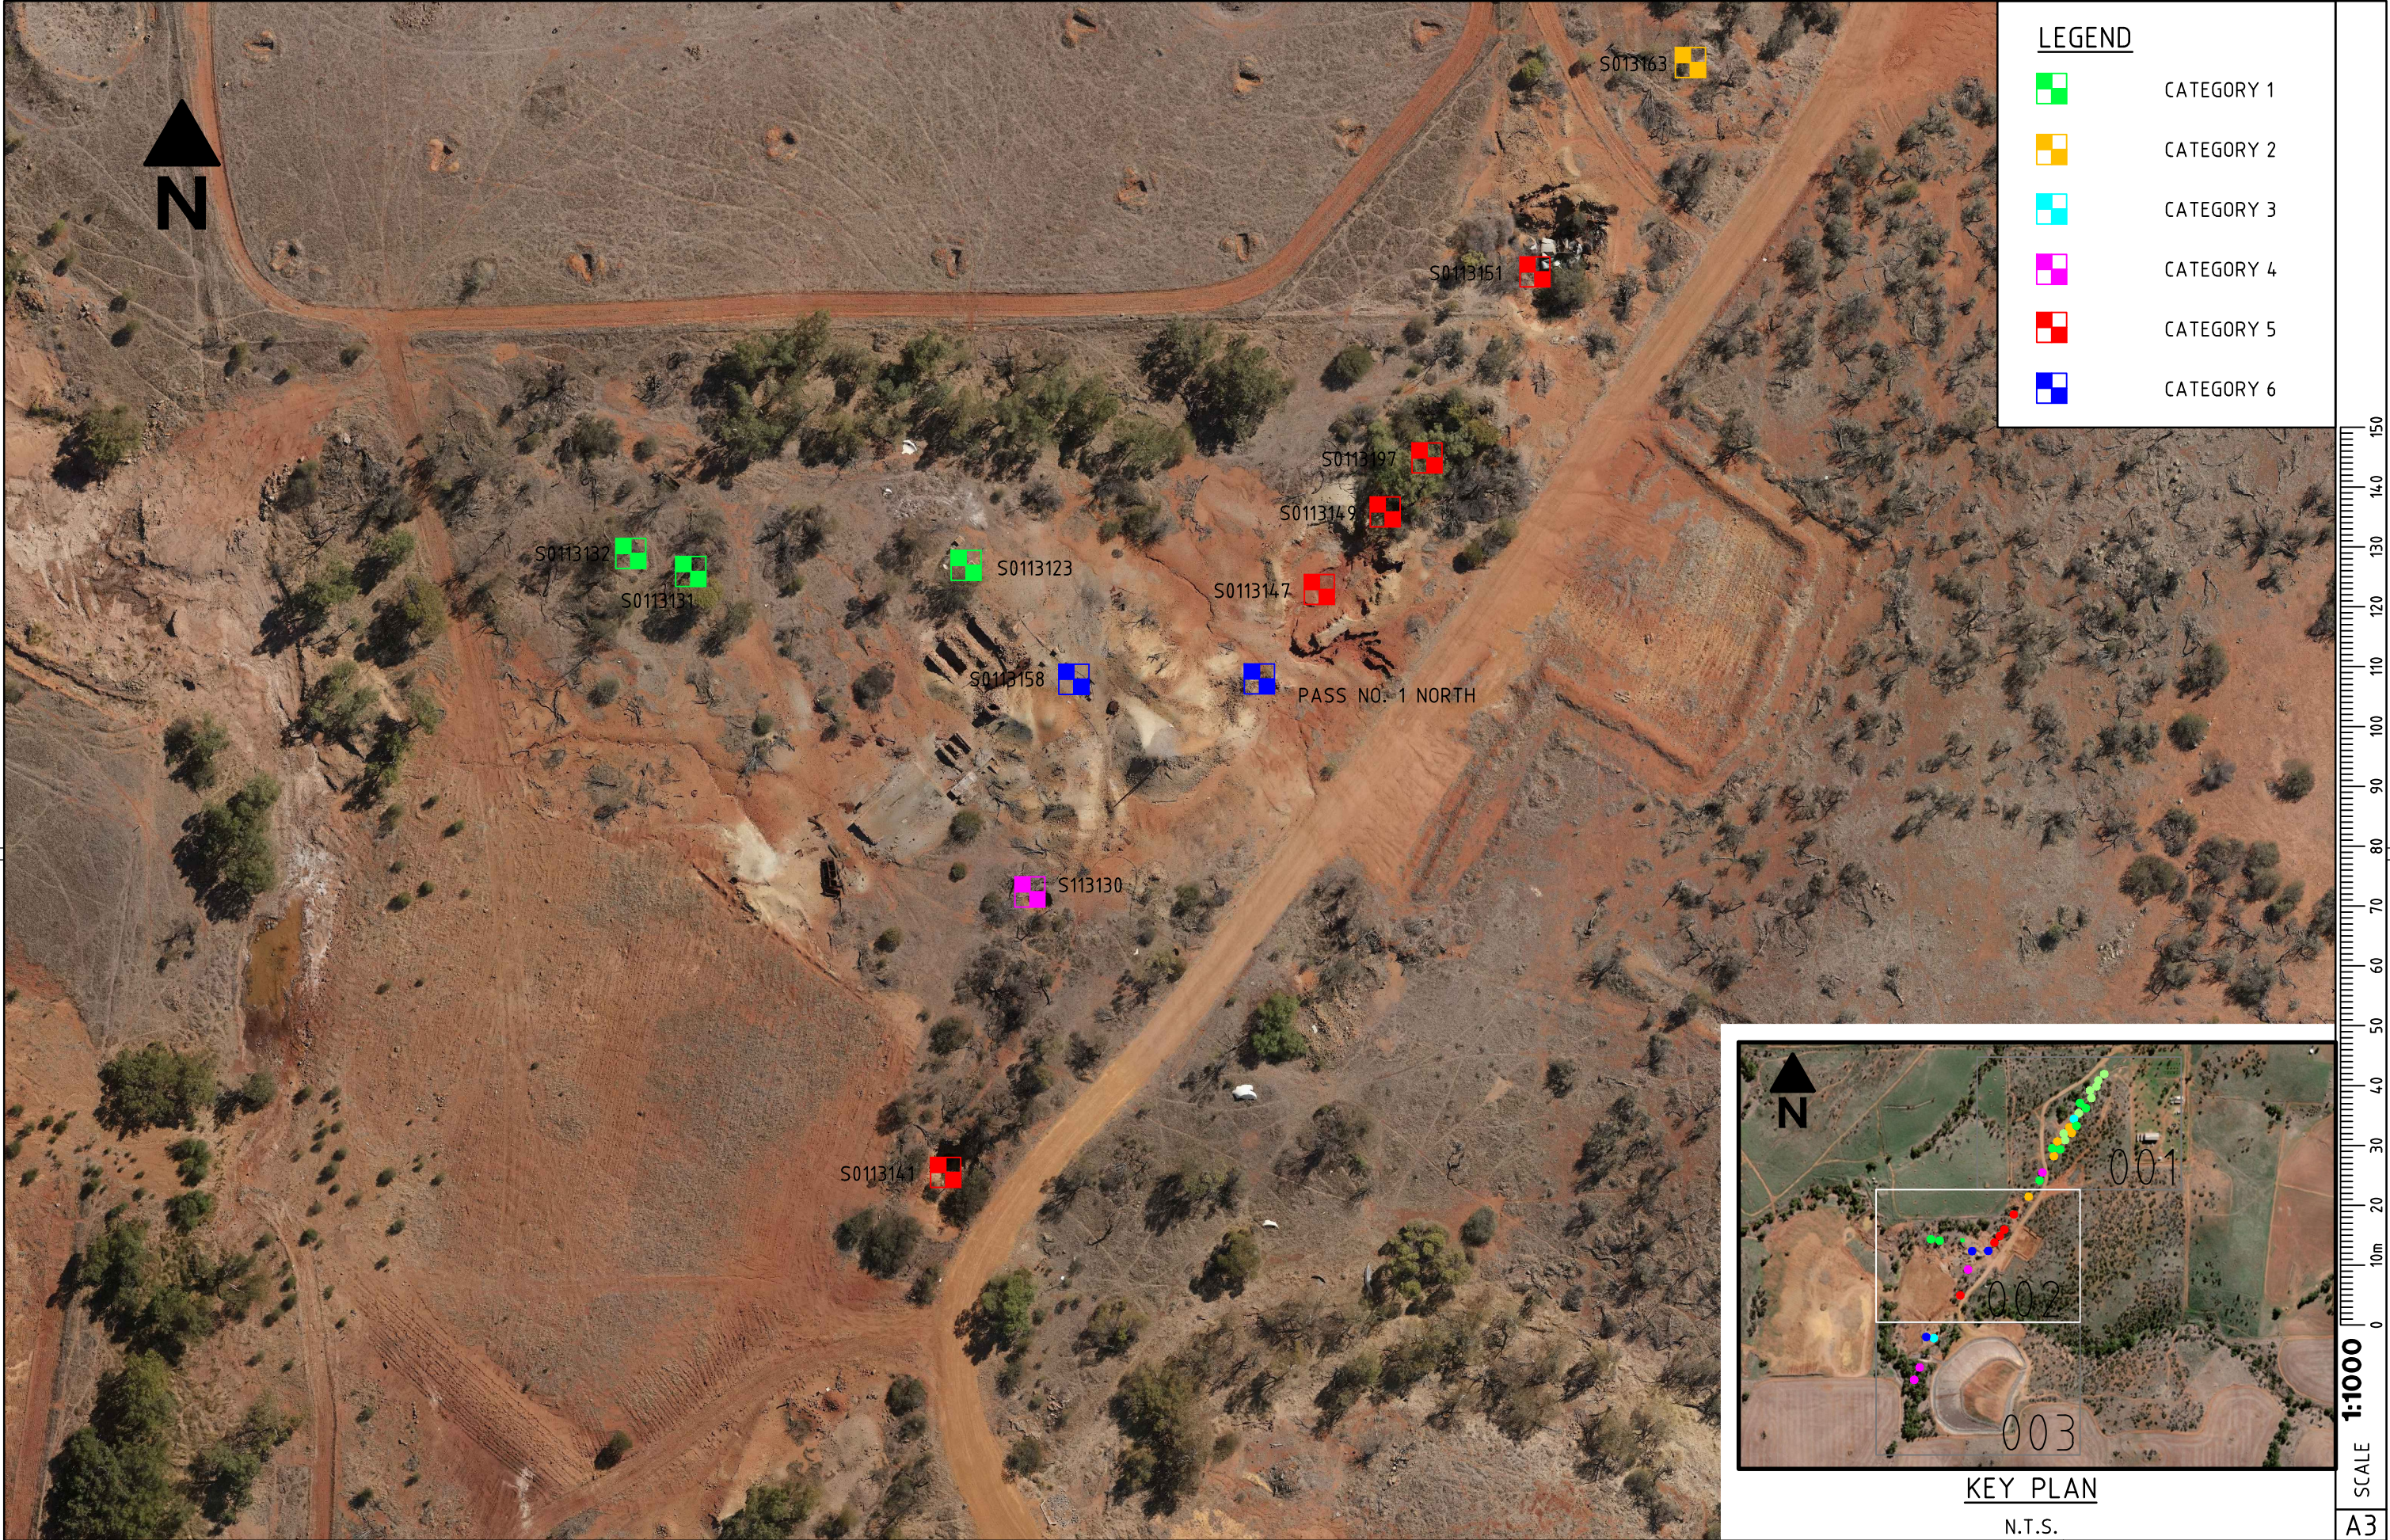
DRAWING TITLE	WHEEL ELLEN MINE REHABILITATION FEATURE CATEGORY MAP AREA - SHEET 2
---------------	---

CONSULTANT DRAWING NUMBER	11953-G-D-002
11953-G-D-002	B

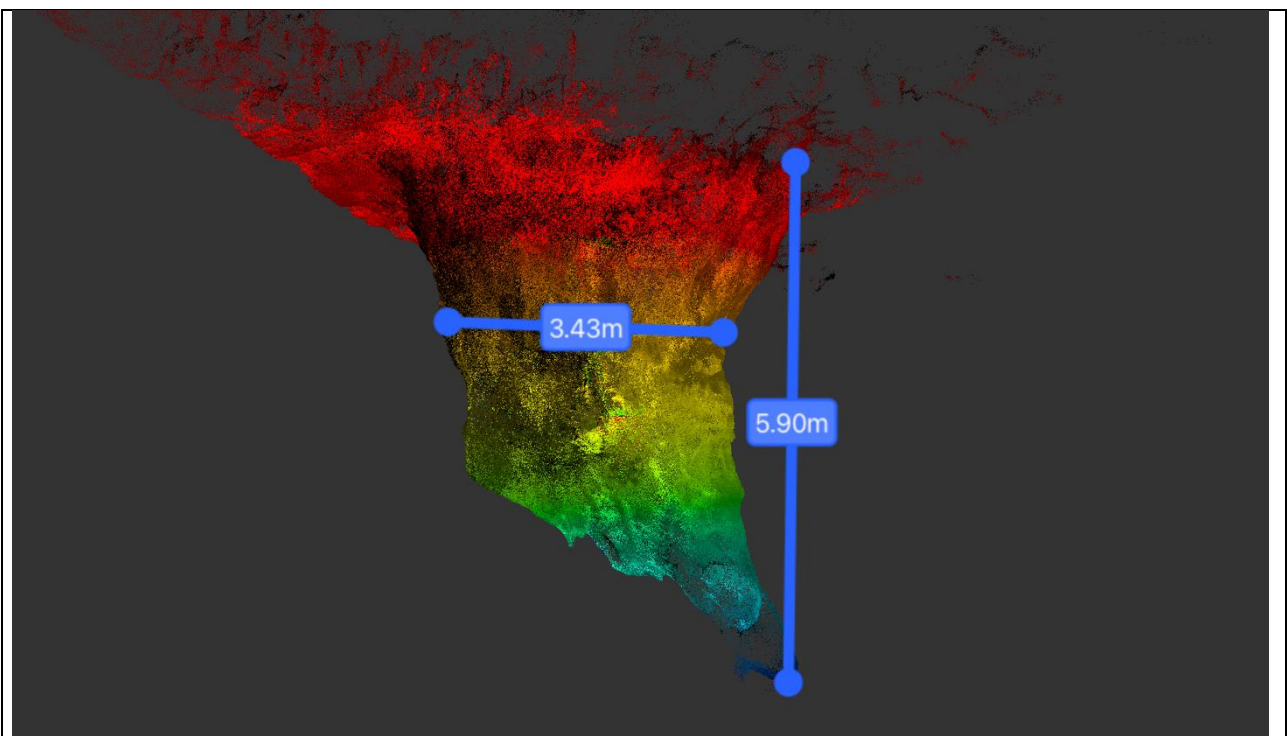
Figure 1

Feature S0113103	Project No:	11953
	Client: Department of Energy, Mines, Industry Regulation and Safety (DEMIRS)	Date:	19/11/24

3D LIDAR SCAN

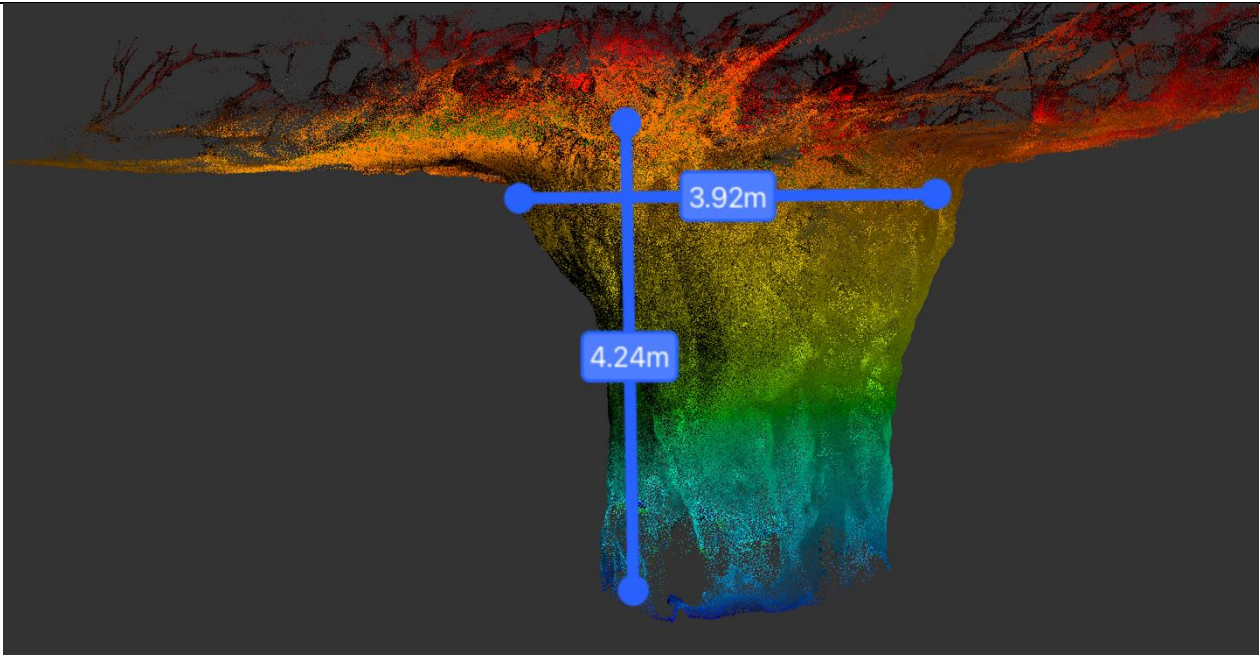
Figure 1

Feature S0113130	Project No:	11953
	Client: Department of Energy, Mines, Industry Regulation and Safety (DEMIRS)	Date:	18/11/24

3D LIDAR SCAN

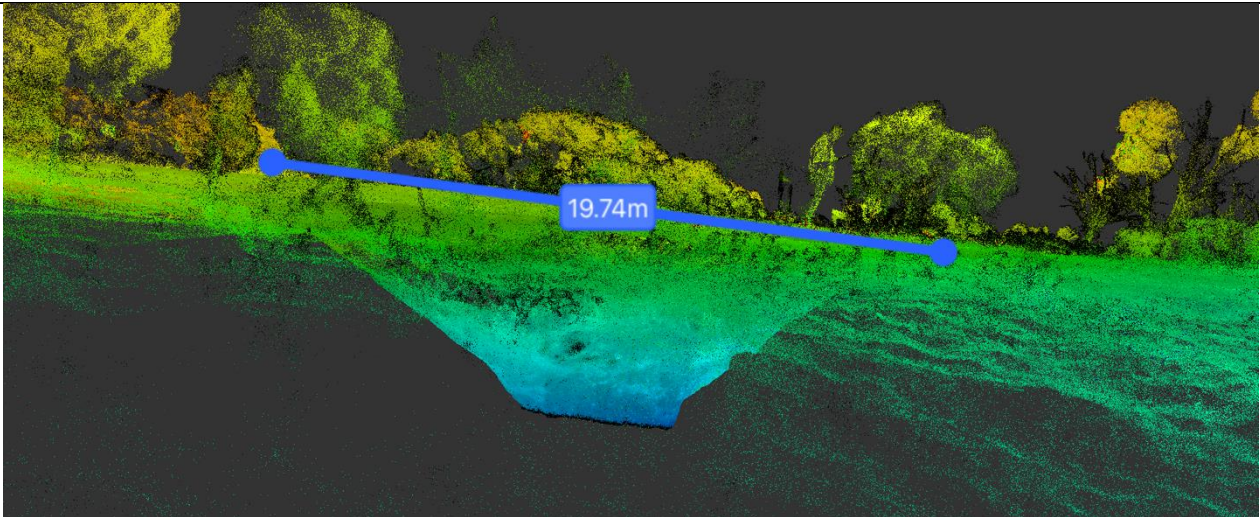
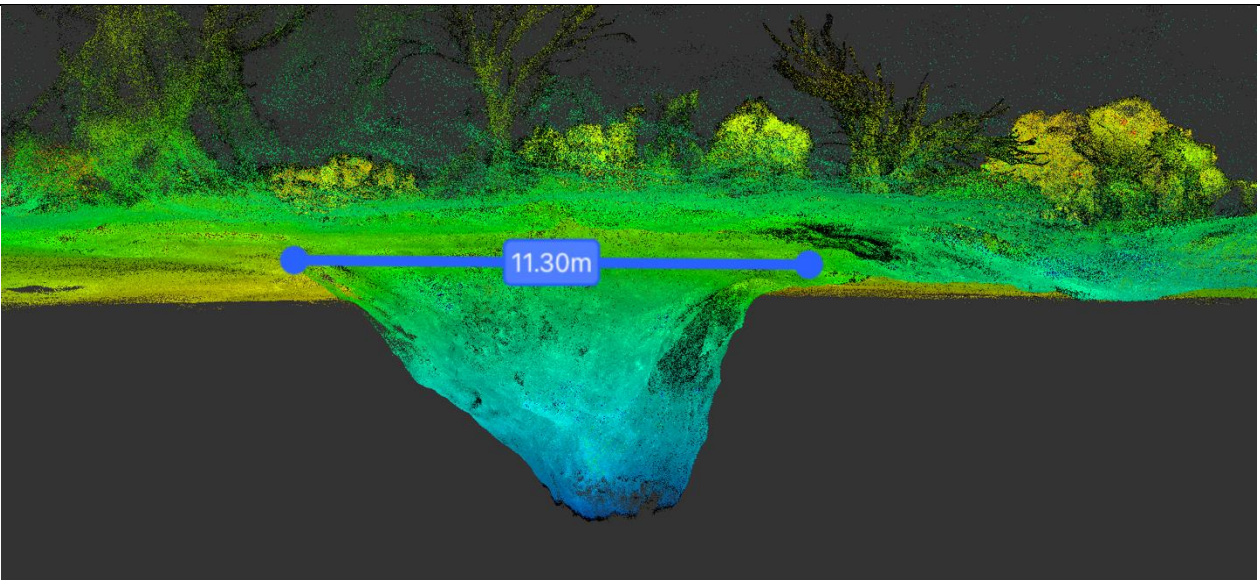
Feature S0113141	Project No:	11953
	Client: Department of Energy, Mines, Industry Regulation and Safety (DEMIRS)	Date:	18/11/24

3D LIDAR SCAN

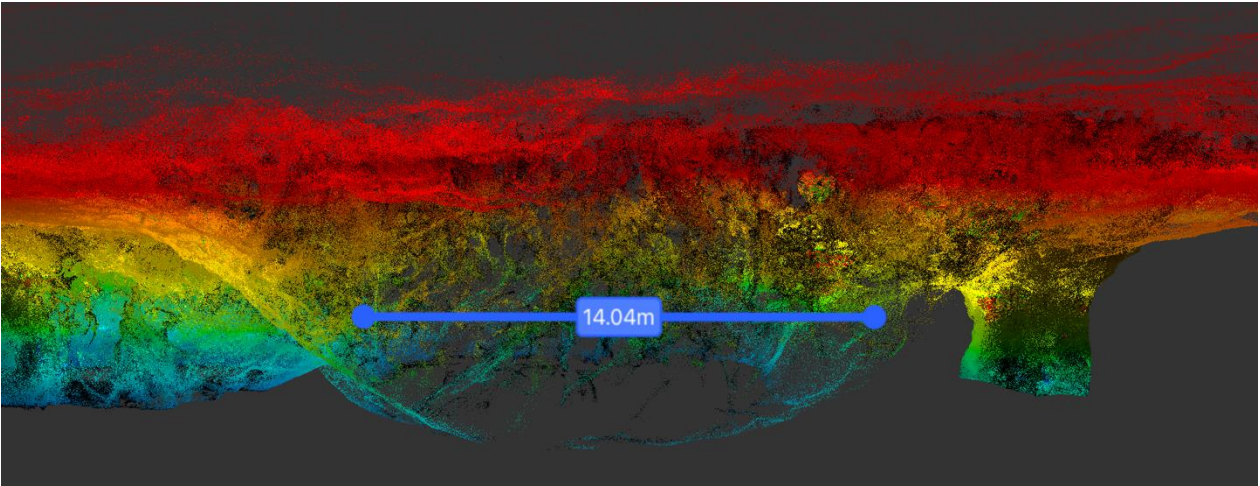
Figure 1

Feature S0113097	Project No:	11953
	Client: Department of Energy, Mines, Industry Regulation and Safety (DEMIRS)	Date:	18/11/24

3D LIDAR SCAN

<b>3</b>	<p>Shallow shafts and excavations with soft / unknown base conditions. The base of these features may also be filled with loose soils, vegetation, rocky backfill material, etc.</p> <p>The investigation methods suggest the base conditions of these features are potentially unstable.</p>	<p>S0113122</p> <p>S0113143</p>	
<b>4</b>	<p>Backfilled or waterlogged deep shafts. The available historical information suggests these are shafts / passes which extend to significant depths beneath the ground surface (&gt; 15 m) and are potentially interconnected at depth.</p> <p>These features are likely to extend to significant depths below what is visible (i.e. scannable) and are likely to comprise false floors. The base conditions of the shafts are unknown and are potentially unstable.</p>	<p>Old Workings Shaft</p> <p>Old Workings Pass</p> <p>S0113103</p> <p>S0113130</p>	
<b>5</b>	<p>Open pits and deep shafts that have been excavated to form open pits. These features are waterlogged and at the time of the investigation, the exact dimensions and location of the shafts were unknown. The available historical information suggests these are shafts / passes which extend to significant depths beneath the ground surface (&gt; 15 m) and are potentially interconnected at depth.</p> <p>These features are likely to extend to significant depths below what is visible (i.e. scannable) and are likely to comprise false floors. The base conditions of the shafts are unknown and potentially unstable.</p> <p><i>*S0113147: this feature is a backfilled shaft that is situated within a drainage gully. The rehabilitation for this feature is likely to be similar to the other features in this category.</i></p>	<p>S0113147*</p> <p>S0113151</p> <p>S0113149</p> <p>S0113097</p>

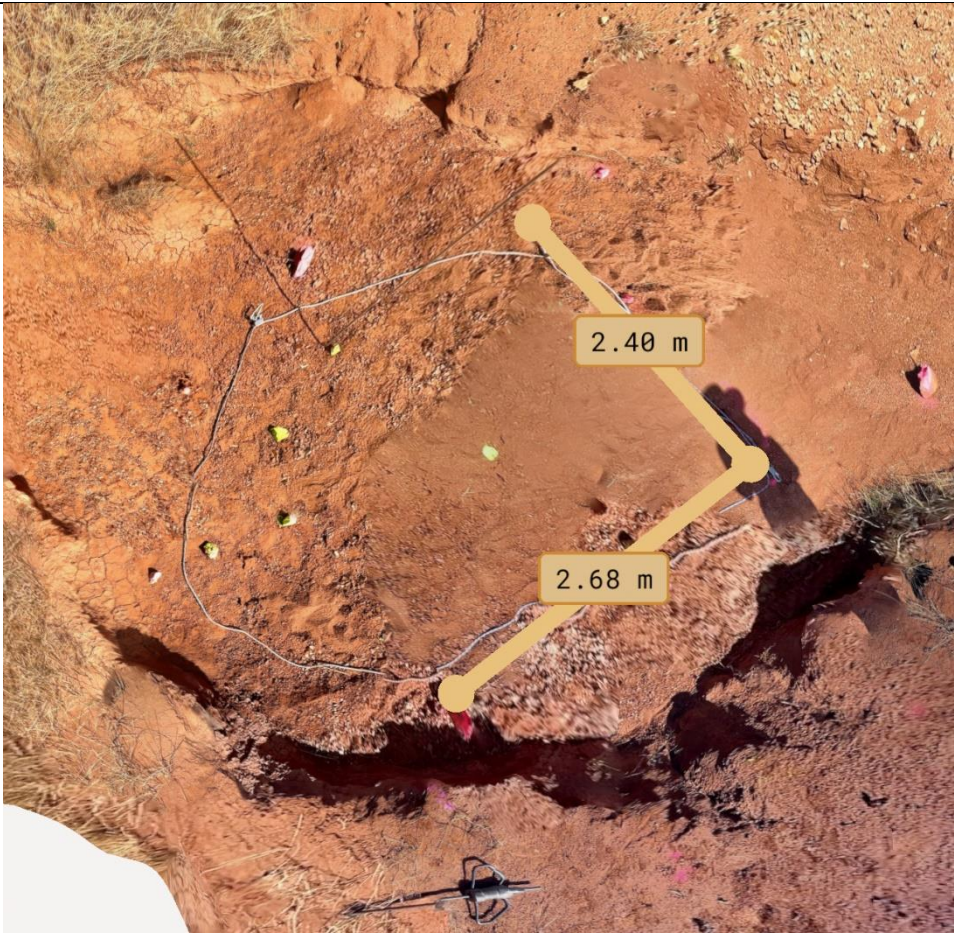
Figure 1

Feature S0113147	Project No:	11953
	Client: Department of Energy, Mines, Industry Regulation and Safety (DEMIRS)	Date:	18/11/24

3D LIDAR SCAN

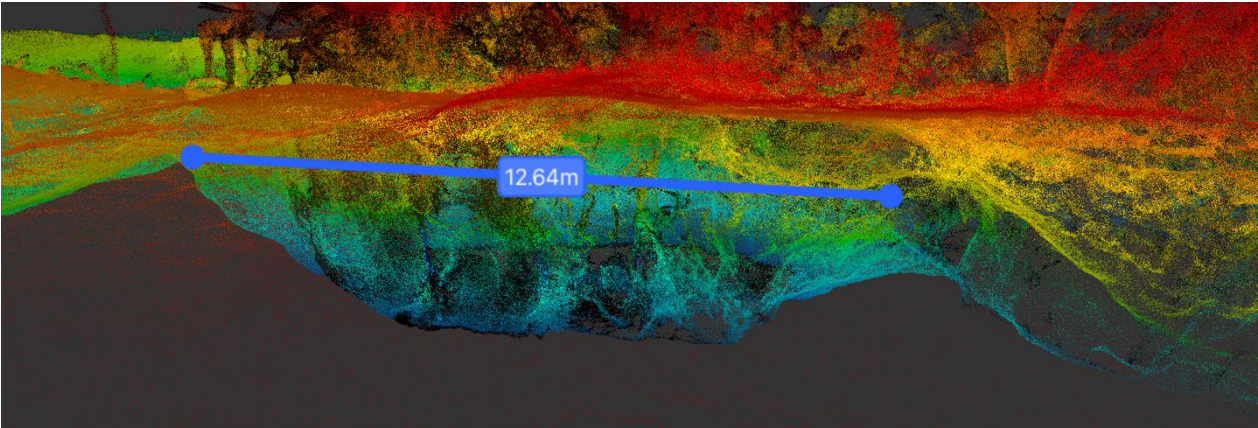
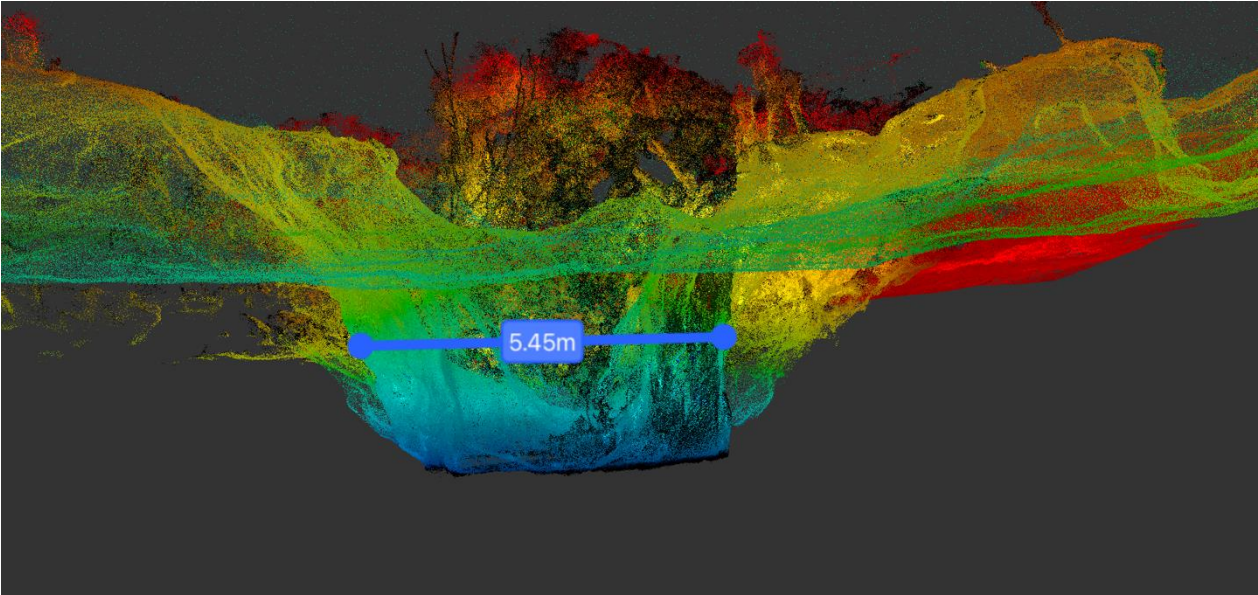
Feature S0113149	Project No:	11953
	Client: Department of Energy, Mines, Industry Regulation and Safety (DEMIRS)	Date:	18/11/24

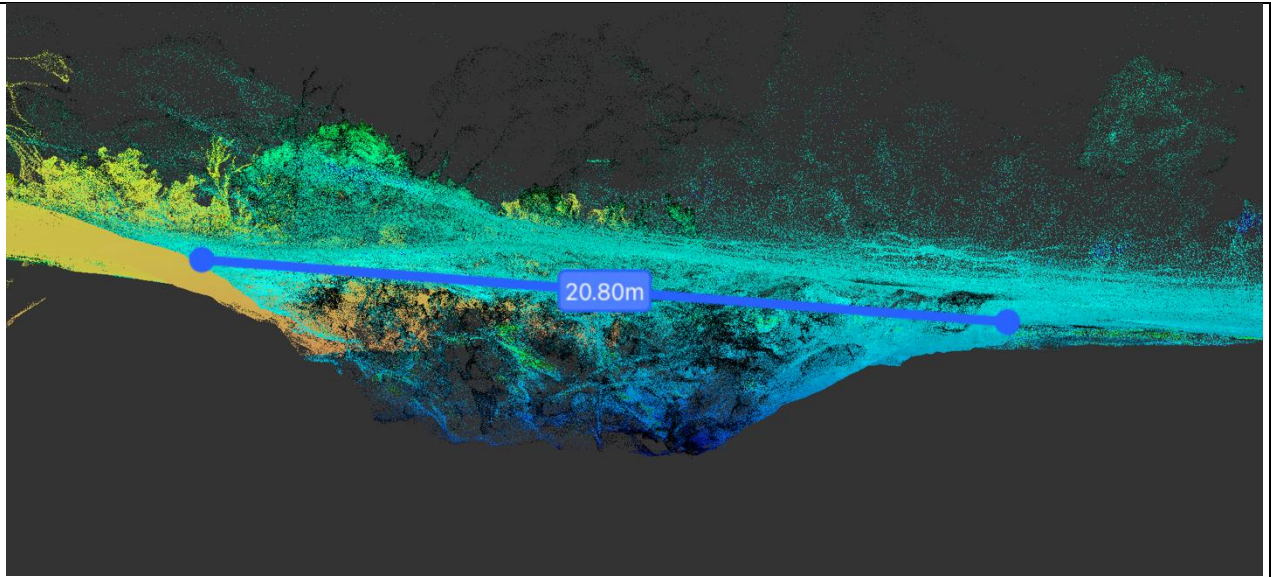
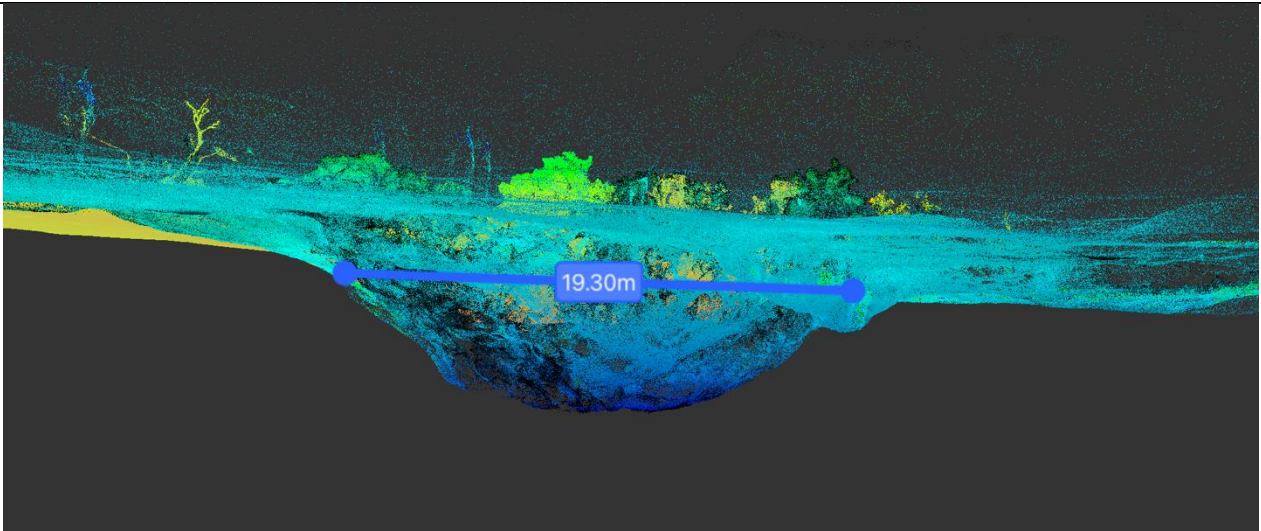
Feature S0113151	Project No:	11953
	Client: Department of Energy, Mines, Industry Regulation and Safety (DEMIRS)	Date:	18/11/24
