Water notes for rivers management

ADVISORY NOTES FOR LAND MANAGERS ON RIVER AND WETLAND RESTORATION

Demonstration sites of waterways restoration in WA

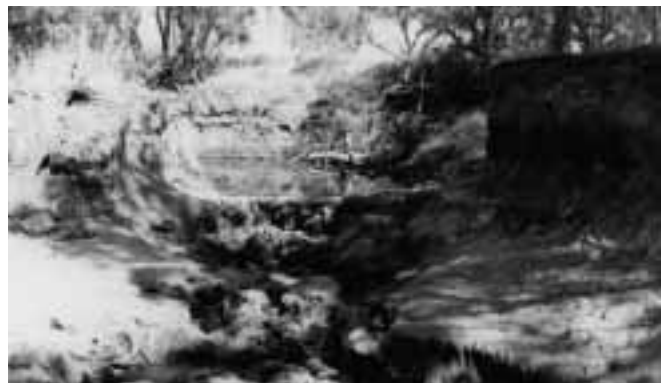
Figure 1. Spencers Brook prior to restoration works. The base of the brook is severely eroded and the headcut is actively advancing upstream.

Spencers Brook was selected as a site for restoration works as it was undergoing severe bed scouring and head-cutting back up the brook, as shown in Figure 1. Near total clearing of the catchment and little supportive vegetation on the banks of the brook resulted in steep banks that were consequently prone to undercutting and collapse. The stream bed had eroded to about one metre lower than its pre-Training Scheme level due to hydrological changes, lowering of the Avon River channel and the lack of supporting vegetation.

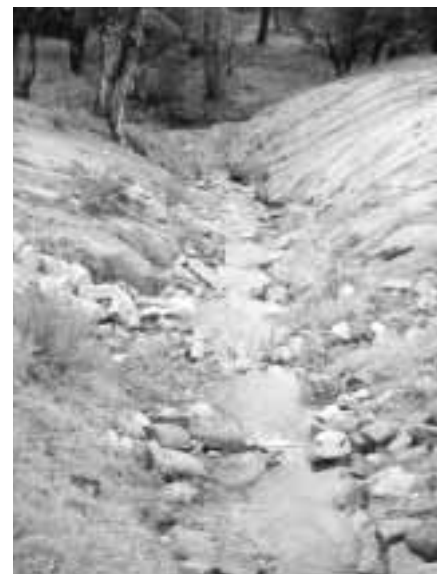
Figure 4. Rock riffles and matting installed on Southernwood Creek.

A series of riffles was constructed in the channel using broken cement curbing and stone. The riffles were installed to control erosion by gradually stepping the creek down to the river. The riffles were spaced at short intervals to reduce flow velocity along the artificially steep slope of the creek to its confluence with the Southern River (Figure 4). The site was further enhanced through revegetation, weed control and re-contouring the steep banks to control drainage (Figure 5).

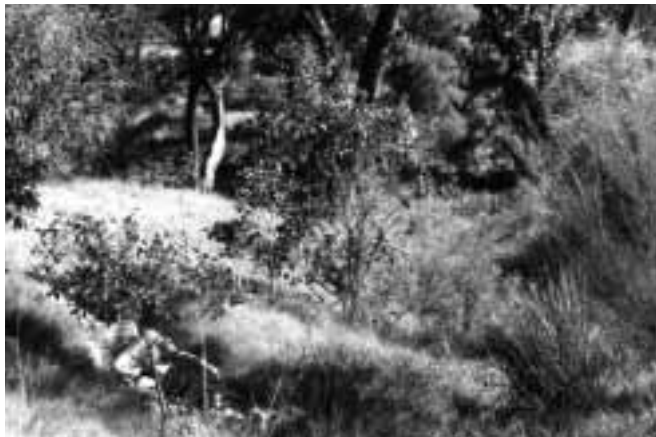
Figure 5. Southernwood Creek, four years later. The riffles have stabilised the bed and revegetation has stabilised the banks.

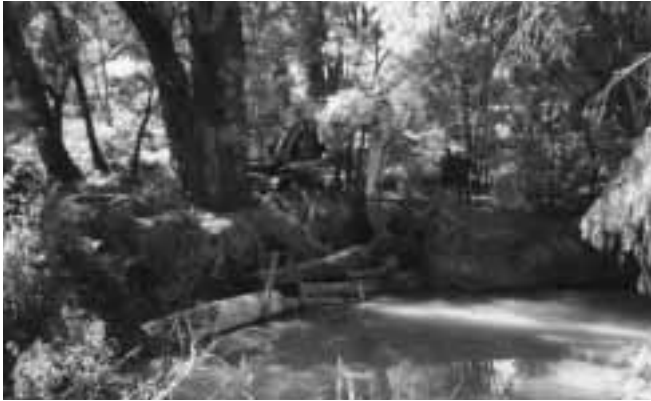
Figure 13. Placement of large logs to protect the bank.

The demonstration reach is located on the Capel River, near the railway overpass in Capel. A tight bend in the river was severely eroding and threatening existing large trees on the bank. In March 2000, large logs were placed by an excavator around the erosion zone to stabilise the bank (Figure 13). The logs were held in place by driving three metre pine posts into the riverbed and wiring the logs to the posts.

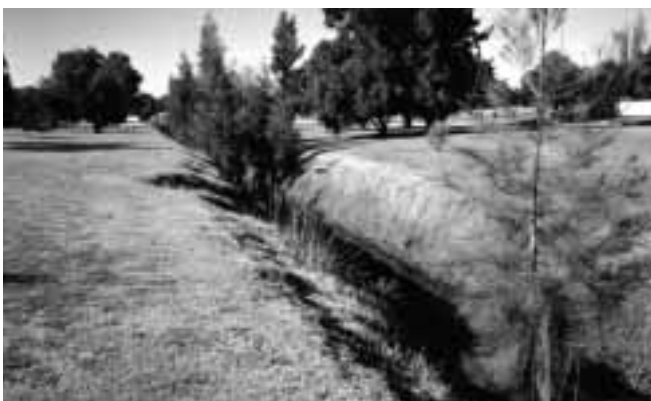
Figure 14. Bannister Creek prior to restoration works.

This site is located on Bannister Creek, adjacent to Bywood Way in Lynwood, Perth (southern metropolitan region). The creek was originally a series of wetlands, but has been used as a main drain since 1979. The aim of the project was to transform a straight section of the drain (Figure 14) into a living stream. The function of the waterway to convey stormwater from the urban and industrial catchment into the Canning River needed to be maintained. As the creek is within a recreational reserve, enhancement of the creek aesthetics was also an objective.
