ONGOING SITE MANAGEMENT PLAN SUMMARY

Erindale Grove Estate
North Beach Road, Gwelup

Report No: [CI0144:10](#)

Version/Date: [Rev 0, December 2011](#)

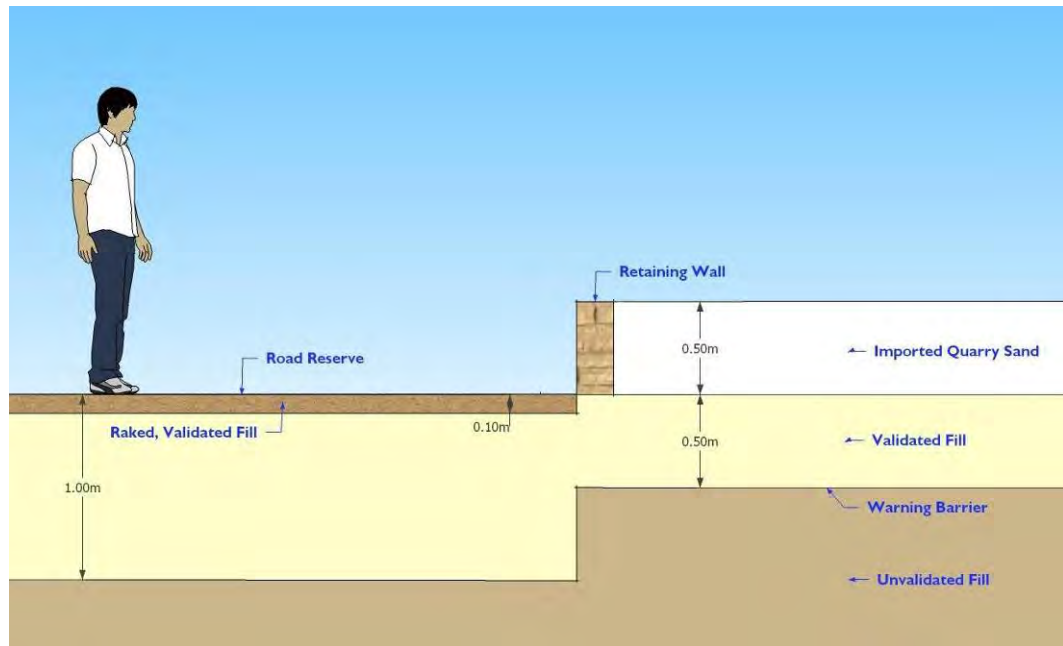
Figure A: Schematic of the Installed Geotextile Barrier over Lots

To remediate these lots the surface 0.6 metres of recycled soil was removed and validated (by manually sifting samples of the soil through a sieve to check for any ACM fragments) as not ACM impacted (defined as being above the DoH guidelines) before being reused. A geotextile warning barrier layer was then placed across the lots and a minimum of 0.5 metres of this validated soil (i.e. soil which is not ACM impacted) was replaced on top of the geotextile warning barrier. The thickness of the soil cover over the warning barrier was then tested at 66 points; the mean thickness was 0.72 m and the minimum thickness measured was 0.6 m. Subsequently a further 0.5 m of clean, virgin sand was added to the surface of all these lots. This provides a total thickness of 1.1 m of clean or validated soil above the warning barrier, with the surface 0.5 m of soil containing no fragments of ACM. Refer to Figure A for a schematic representation of the final configuration.

The geotextile warning barrier placed across the lots is an A14 bidim cloth; which is a non-woven, needle punched, continuous filament, polyester geotextile. This material is strong and stretchable, to resist tearing during earthworks, and provides excellent drainage. The material lies above the water table and will therefore not be affected by potentially acid sulfate soil impacted groundwater. The product is engineered specifically to remain in soil and is not expected to suffer any significant deterioration over a period of decades while buried in the ground.

The thickness of the protective barrier of clean and validated soil exceeds the requirements of Section 5.2 of the DoH 2009 guidelines by approximately 0.5 m. The clean soil contains no ACM, the validated soil below 0.5 m is not ACM impacted but is recycled and may contain fragments of ACM, bricks, masonry, gravel, etc. This means that the probability of identifying ACM above the adopted 2009 DoH guideline level (0.01%w/w) within soil above the warning barrier on these lots is very small, and the risk to human health is considered negligible.

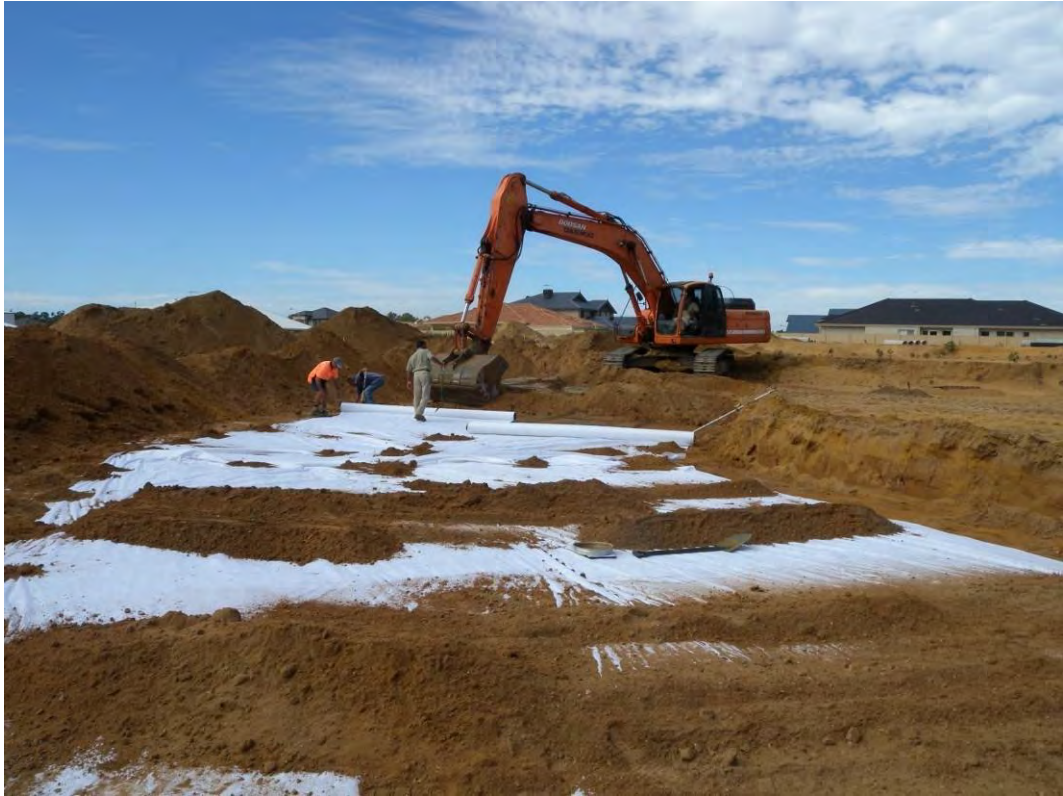
Plate A: Installation of Geotextile Barrier

The warning barrier acts as a passive control measure between the clean soil cover and the underlying soil which may be ACM impacted. The warning barrier (refer Plate A) has been installed to identify to site users that appropriate management measures must be implemented when subsurface works extend past this depth. The warning barrier is designed to alert rather than prevent access to the impacted soil.

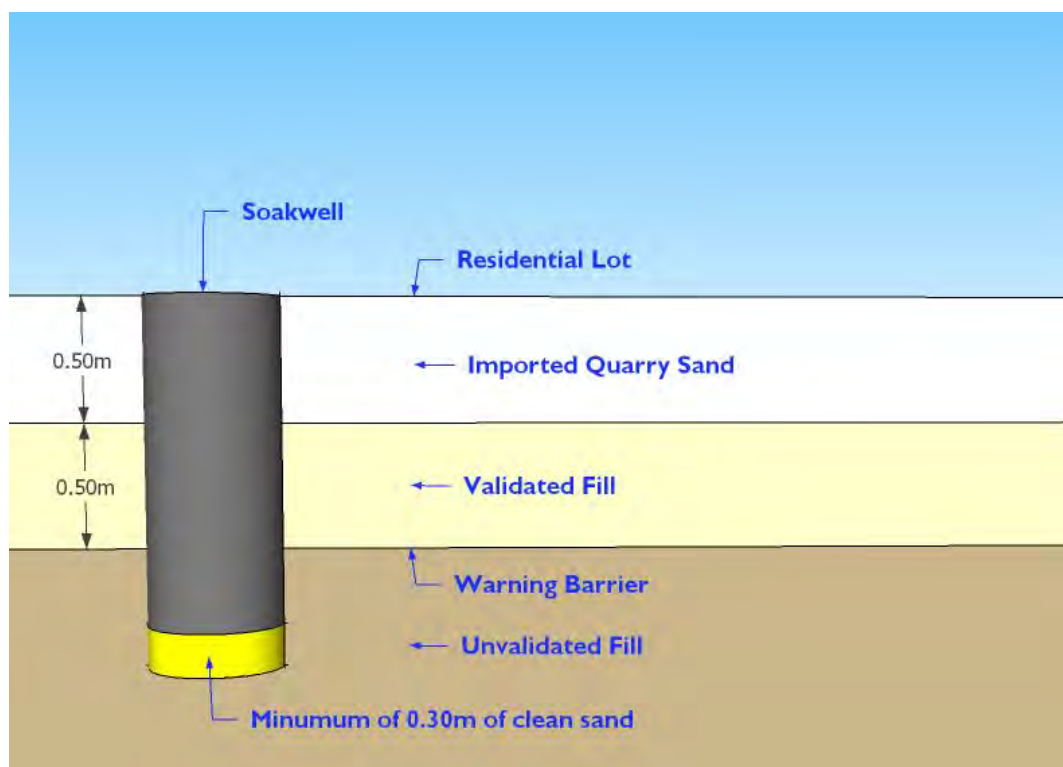
Figure B: Soakwell Penetrating the Warning Barrier

Following subsurface activities the warning barrier must be replaced where it has been disturbed and all appropriate measures undertaken to ensure that the warning barrier abuts any structures that progress through the barrier (e.g. soakwells). Large soakwells which penetrate the barrier should have at least 30cm of clean sand placed at the bottom of the soakwell, see Figure B. All services such as power or sewer which may be accessed in the future for maintenance purposes should be excavated to 0.1 m below the required service base depth, where the warning barrier should be replaced and 0.1 m of clean soil backfilled prior to re-installation of the service. No soil other than the top 1.0 m cover should be used as backfill above the warning barrier. Clean soil should be added to account for any soil that cannot be reused, and the top 0.1 m of soil should be free of visible fragments of ACM.

- The geotextile warning barrier within impacted residential lots must be repaired with like or similar material. Where services penetrate through the barrier they must be surrounded (walls and base) with a minimum 10 cm thickness of clean soil backfill consistent with the DoH (2009) advice that ACM fragments should not be visible within the first 10 cm of the soil profile. The warning barrier should be first installed into the excavation prior to placement of clean soil and infrastructure item.

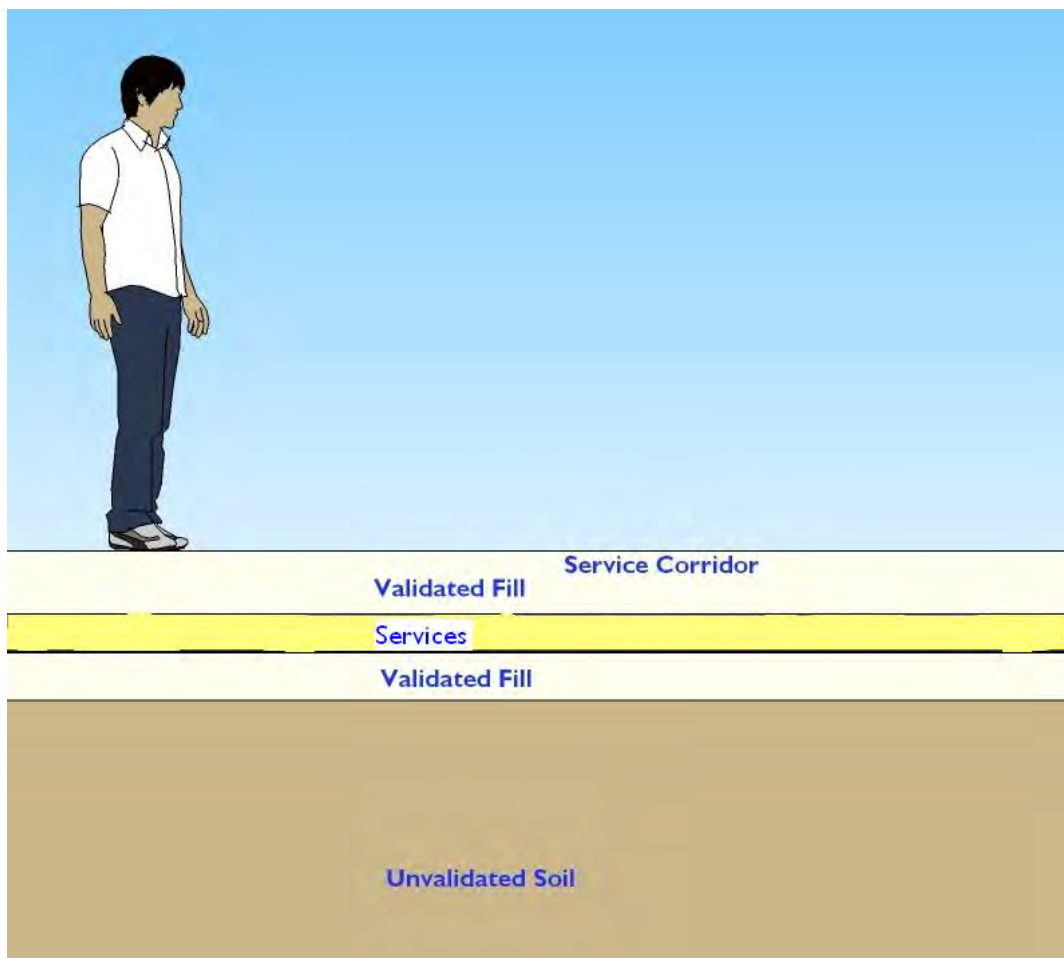
Figure C: Schematic of a Typical Remediated Service Trench

The service trenches have been tested as free of ACM impact above the DoH guideline value of 0.01% w/w.

During the installation of services, soil within the trenches was inspected and validated as acceptable prior to backfilling.

The material within all service trenches is considered to present no hazard to people undertaking future works within the service trenches. However, any services work undertaken outside the existing service trench (i.e. installing a new services corridor) may encounter ACM impacted soil. It will be clearly visible where the soil profile changes from clean backfill; which is brown, orange or yellow in colour; to the ACM impacted fill which is dark grey to black in colour, with extensive amounts of construction and demolition material.

If ACM impacted soil (i.e. outside the original backfilled material) is encountered during works within service trenches the material should be removed and replaced with clean soil. It will be apparent as such soils contain large amounts of construction and demolition materials and are dark grey to black in colour. The ACM impacted soil should be disposed of at a suitable landfill licensed to accept asbestos impacted soil. All ACM impacted soil should be managed in accordance with Section 3.0.

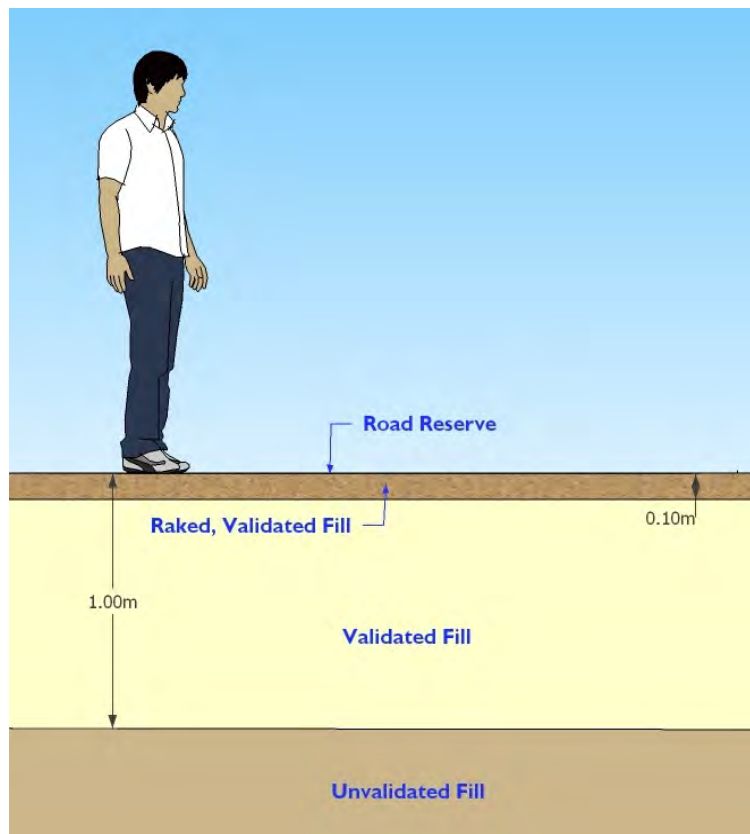
Figure D: Schematic showing a Typical On-site Validated Unsealed Verge

The unsealed areas of the road reserve are predominantly comprised of areas where service corridors have been installed. The soil within the service trenches has been validated to the full extent of the services and there is a very low probability that ACM will be identified (in excess of acceptable levels) within these areas. Refer to Figure D for a schematic representation.

There are several small areas of unsealed verge which were not collocated with service corridors. These areas have been individually validated as not ACM impacted, to a depth of 1.0 m. Given they are located in the road reserve, are not readily accessible by the public (for the purposes of excavations), and are not utilised for services, a warning barrier is not in place below the validated clean soil cover. There may be shallow excavations required for irrigation pipes, but there is no reasonable expectation of them penetrating to, or below, 1.0 m.

If ACM impacted soil is encountered during works within unsealed verges the material should be removed and replaced with clean soil. It will be apparent as such soils contain large amounts of construction and demolition materials and are dark grey to black in colour. The ACM impacted soil should be disposed of at a suitable landfill licensed to accept asbestos impacted soil. All ACM impacted soil should be managed in accordance with Section 3.0.

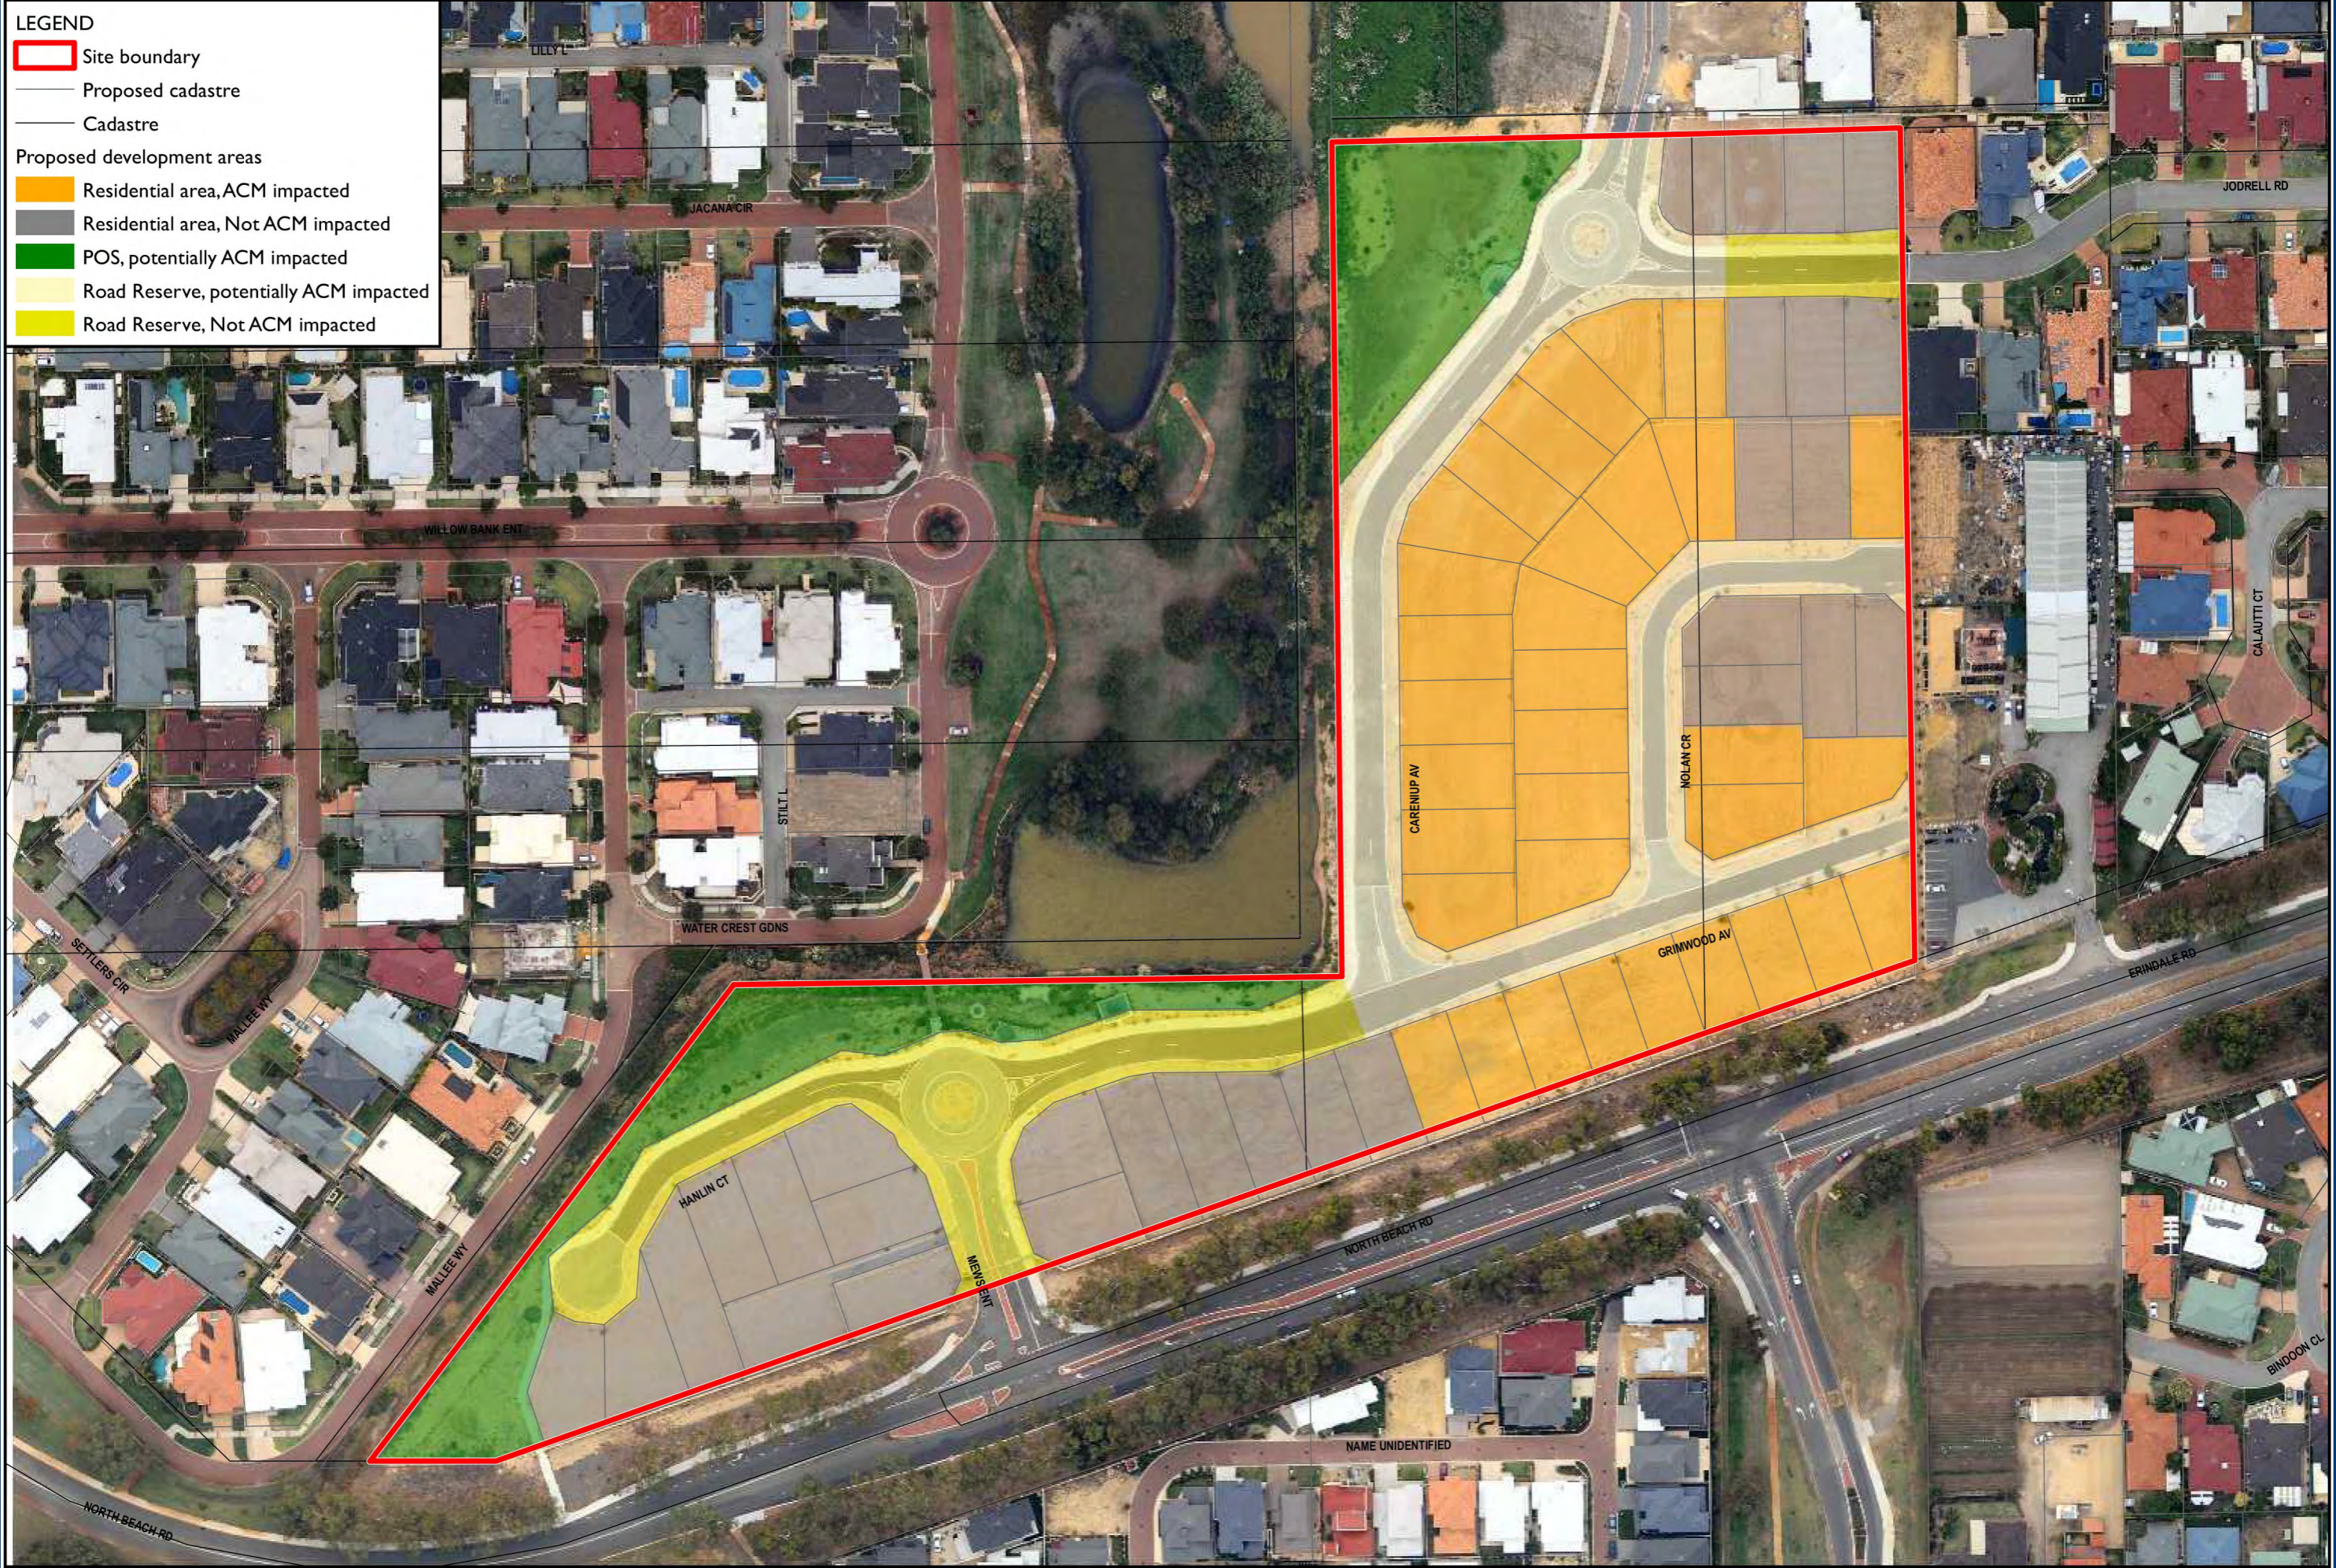
Proposed development areas

- Residential area, ACM impacted
- Residential area, Not ACM impacted
- POS, potentially ACM impacted
- Road Reserve, potentially ACM impacted
- Road Reserve, Not ACM impacted
