Suspended Plaster Tile Ceilings in Schools

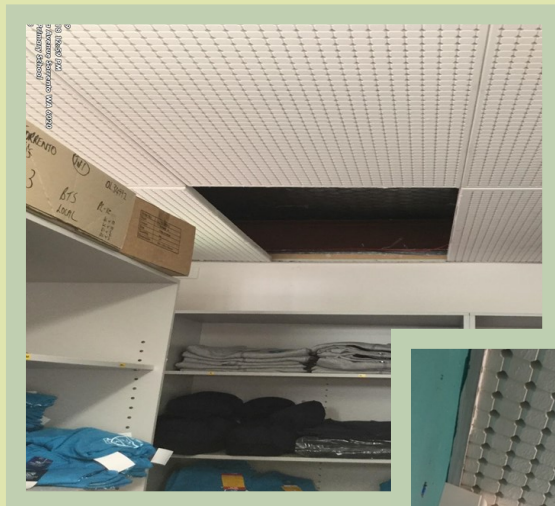
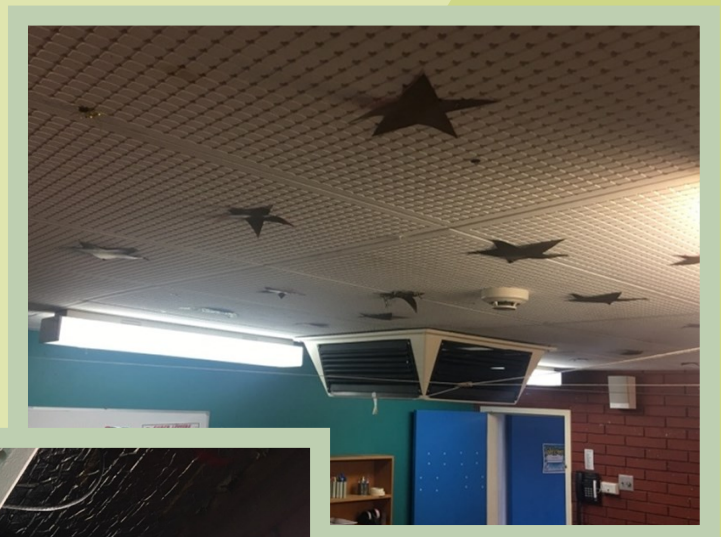
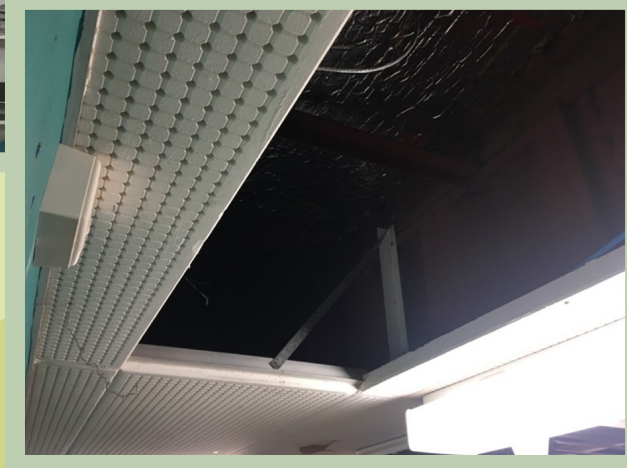
A number of older school buildings have **suspended plaster tile ceilings** (refer to photos below). These ceilings were mainly installed in schools constructed in the 1970's. In recent months, a number of tiles at different schools have **fallen down**. Investigations showed that the tiles may have been disturbed by tradespersons installing services within the ceiling cavities. The consequences of these tiles falling can be **catastrophic** as each plaster tile typically weighs around 12 kilograms.

In **2016**, BMW arranged for all suspended plaster tile ceilings at schools to be resecured. This included the **application of a sealant** between adjoining tiles to **minimise lateral movement**. **Subsequent work** by other tradespersons has resulted in the **sealant being removed** in places and not reinstated. This can **compromise the safety** of the entire ceiling system. In addition, tiles have been found to be **incorrectly re-fitted** after cabling contractors have installed services within the ceiling cavities.

Contractors accessing these ceiling cavities **must reinstate** the ceiling tiles to the same condition as before. If there is **any doubt**, the contractor **must engage a competent ceiling installer** to validate that the ceilings have been **properly and safely reinstated**.
