## INTRODUCTION

This information sheet deals with the care and conservation of metals used in building, including cast and wrought iron as fencing and decorative panels, steel-framed windows and roof plumbing. For further information refer to the references at the end of the sheet, and to the separate information sheets on Corrugated Roofing, and Slating, Tiling and Roof Plumbing.

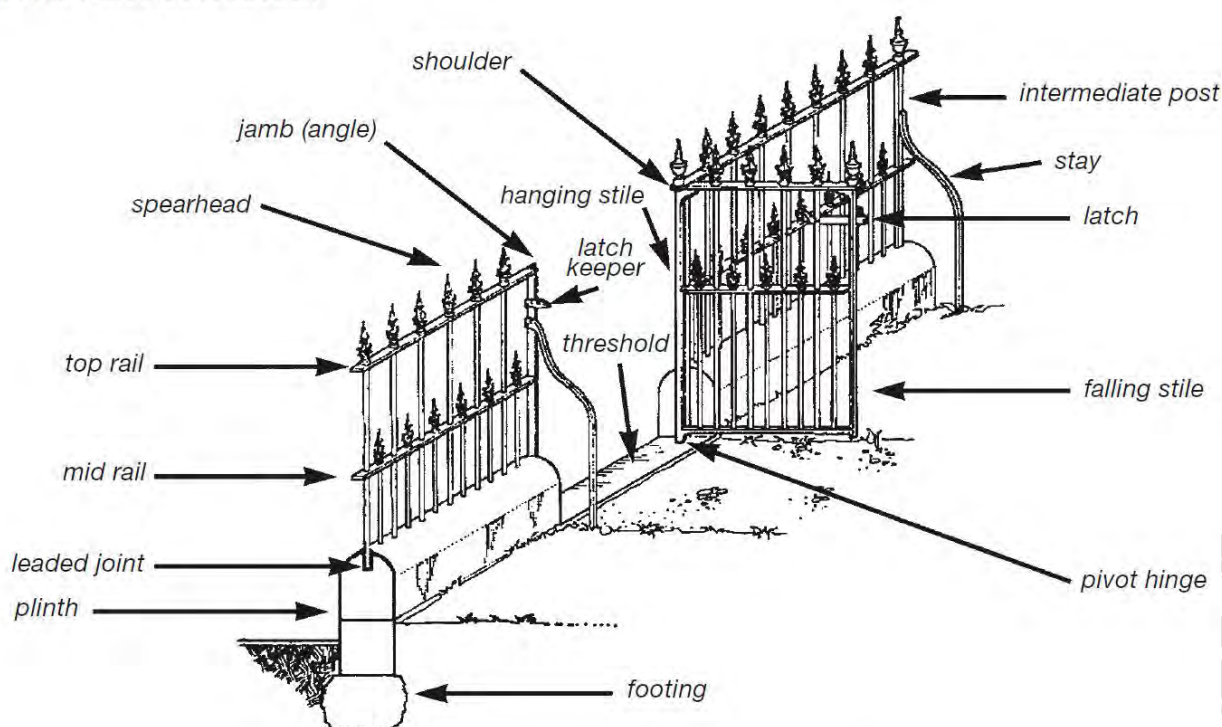
### Iron Palisade Fence Construction

Palisade fences typically have a low stone or rendered brick plinth surmounted by a palisade of wrought iron or mild steel shafts. The shafts penetrate flat wrought iron or mild steel rails and carry ornamental spearheads or tops of cast iron. The iron palisade is supported along its length by posts of cast or wrought iron or masonry.

Illustration from Ian Stapleton, *How to Restore the Old Aussie House*, Flannel Flower Press, 1991

Crevice corrosion can occur where the shafts penetrate the rails, and also between the spearheads and the top rail. Careful filling and painting of these areas is required to eliminate crevices where corrosion may occur.

The traditional practice was to set the iron shafts in a leaded joint by pouring molten lead into an oversize hole around the base of the shaft and tamping it down as it cooled. The lead insulates the iron from damp stone and, because it is soft, allows a certain amount of movement due to thermal expansion and contraction of the iron.
