# Bennett Brook

## Bennett Brook – facts and figures

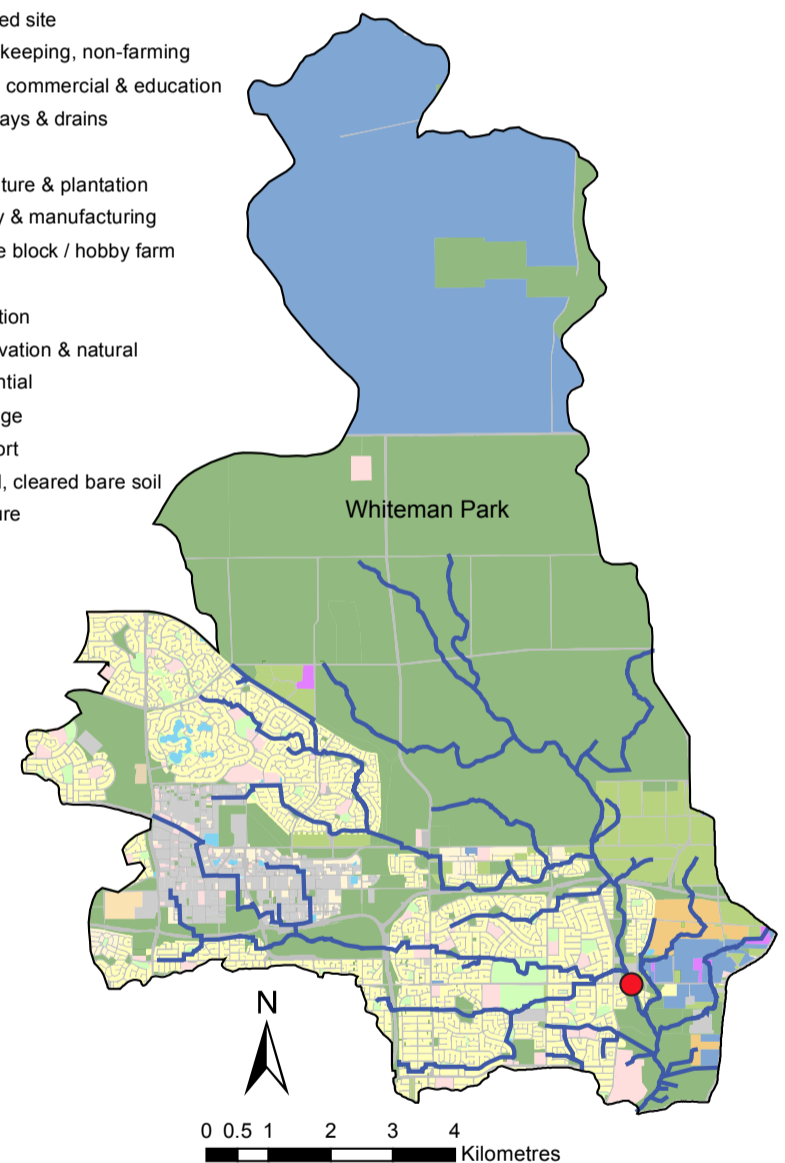
### Legend

- Monitored site
- Animal keeping, non-farming
- Offices, commercial & education
- Waterways & drains
- Farm
- Horticulture & plantation
- Industry & manufacturing
- Lifestyle block / hobby farm
- Quarry
- Recreation
- Conservation & natural
- Residential
- Sewerage
- Transport
- Unused, cleared bare soil
- Viticulture

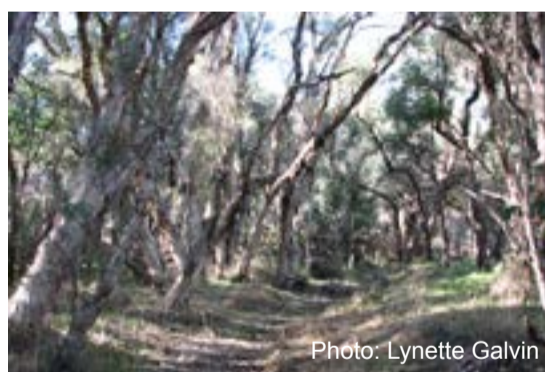
Bennett Brook is ephemeral near its headwaters, drying in summer.
