River Action Plan for the Brunswick River

2006

Leschenault
Catchment
Council

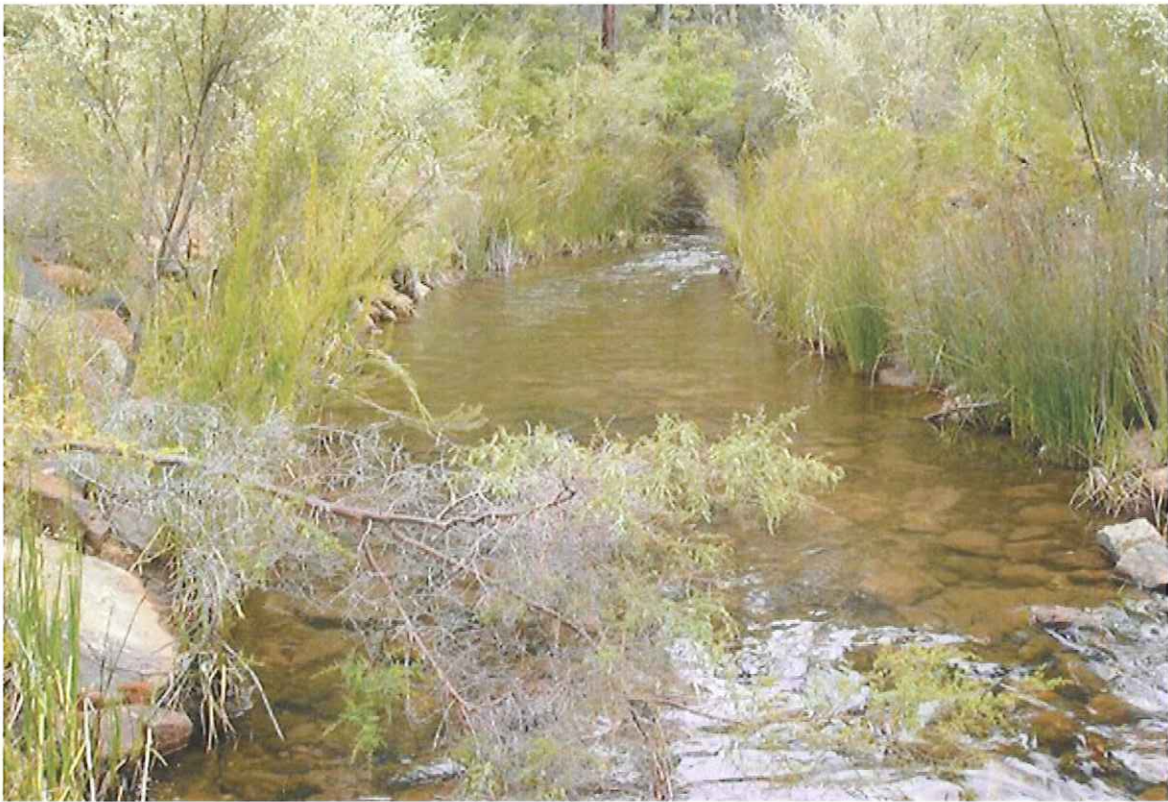
A Grade foreshore: Note complete vegetation cover which is essential to the health of the waterway.

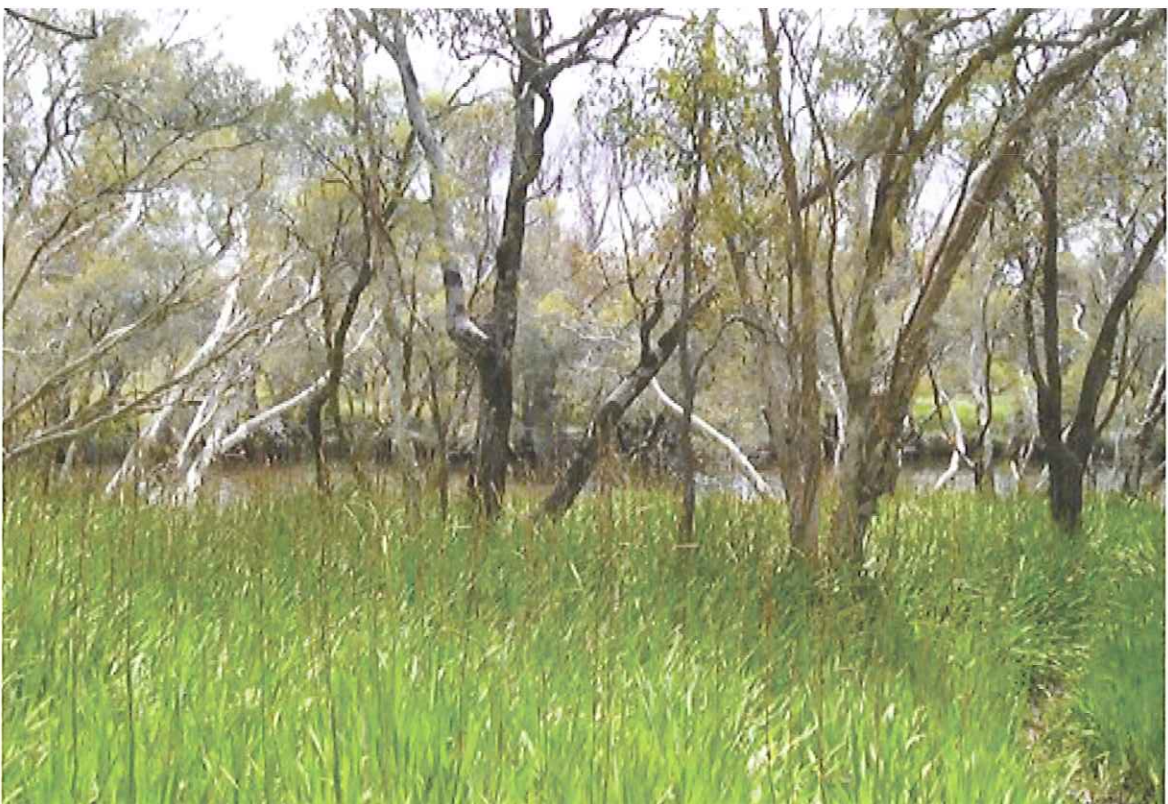
B3 Grade Foreshore: The understory is entirely dominated by weeds (mainly watsonia), but many native trees still remain.

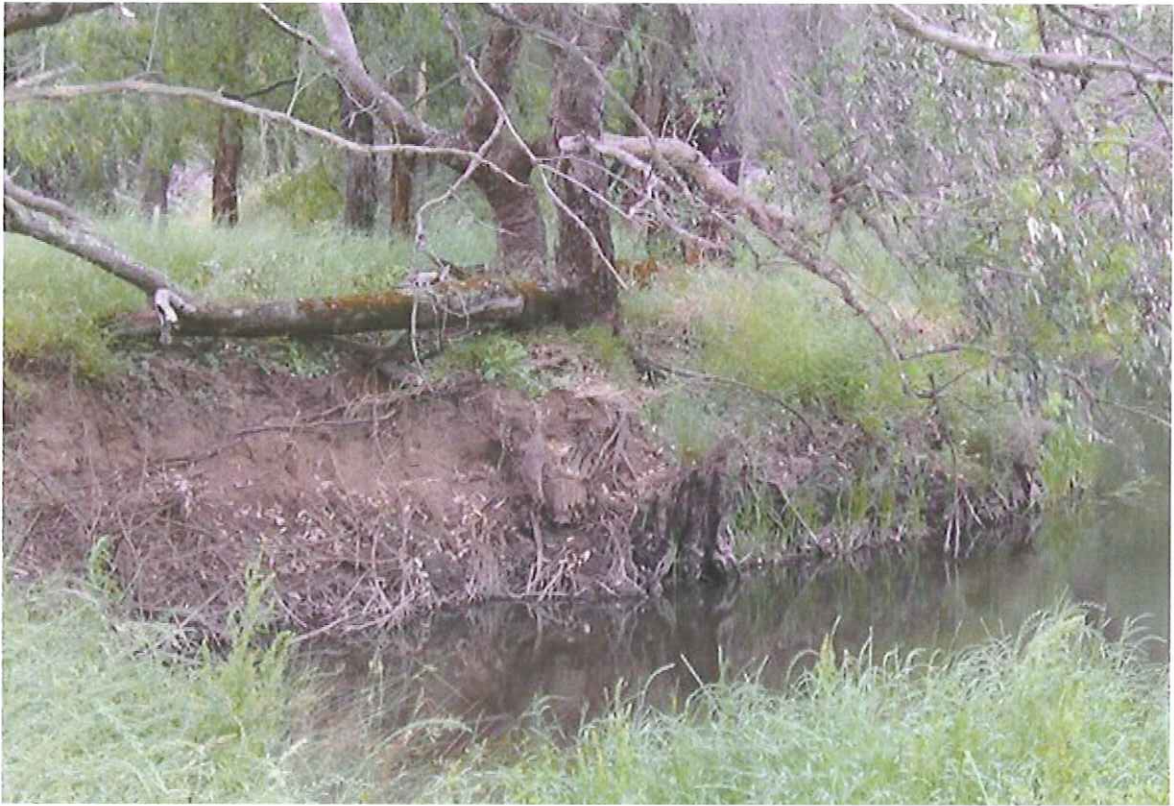
C3 Foreshore. Note the extensive bank erosion and the understorey consists entirely of annual weeds.

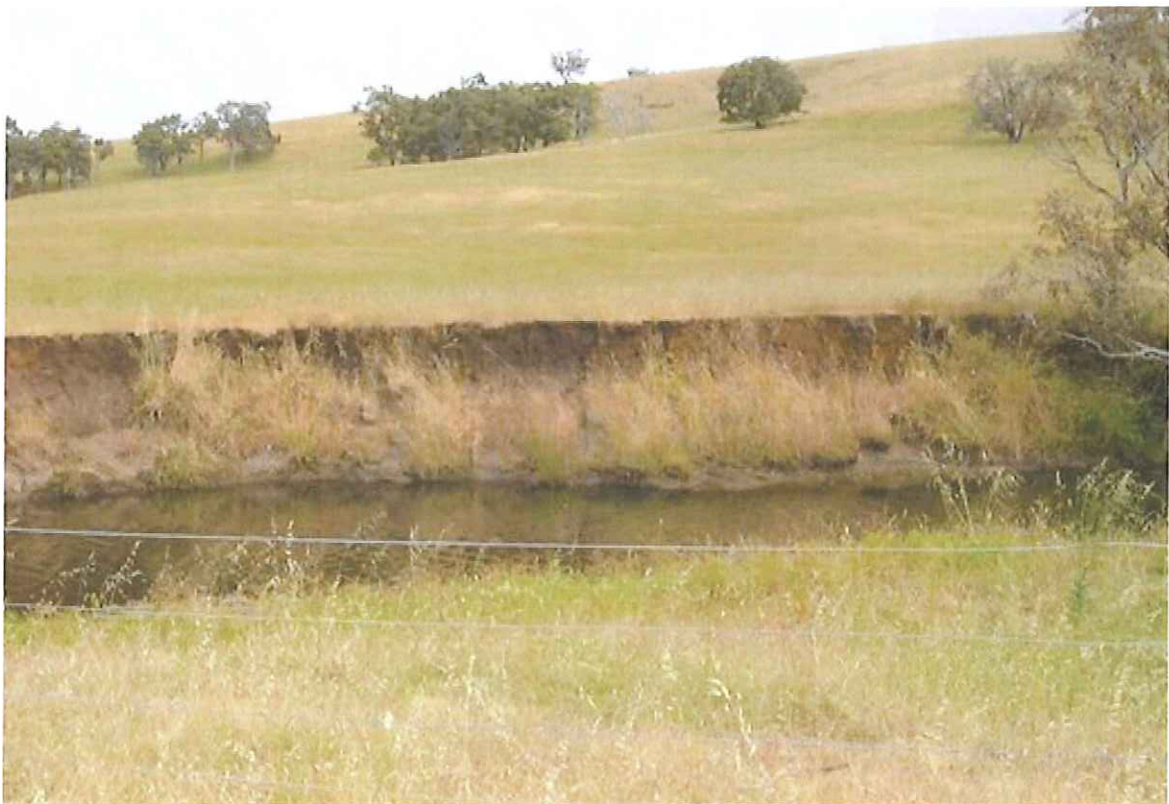
D2 Grade Foreshore: The channel has eroded away over time, leaving a weed (mainly annual grasses) infested drain. No native vegetation occurs at all on these banks.
