Spontaneous ceiling collapse

The following is a guide for home owners who may have concerns about the stability of the plasterboard ceilings within their home.

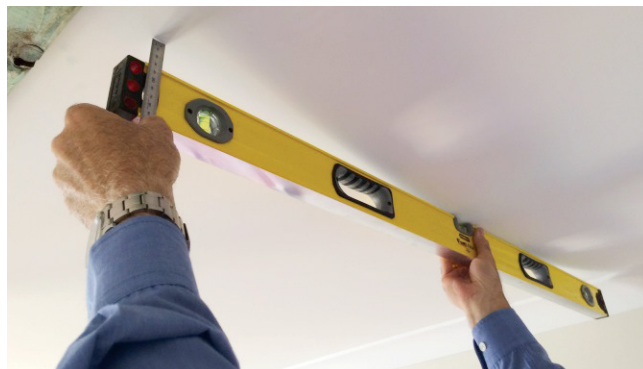
- Place a straightedge or spirit level over an area of ceiling sheeting and see if there is unevenness anywhere in your ceiling.

Use a spirit level to check the flatness of ceiling sheeting.
