ABANDONED MINE FEATURES ASSESSMENT

NORTHAMPTON – COMMONAGE & WANERENOOKA REHABILITATION OPTIONS STUDY

11126-G-R-002 Public Document

11126-G-R-001 Public Document

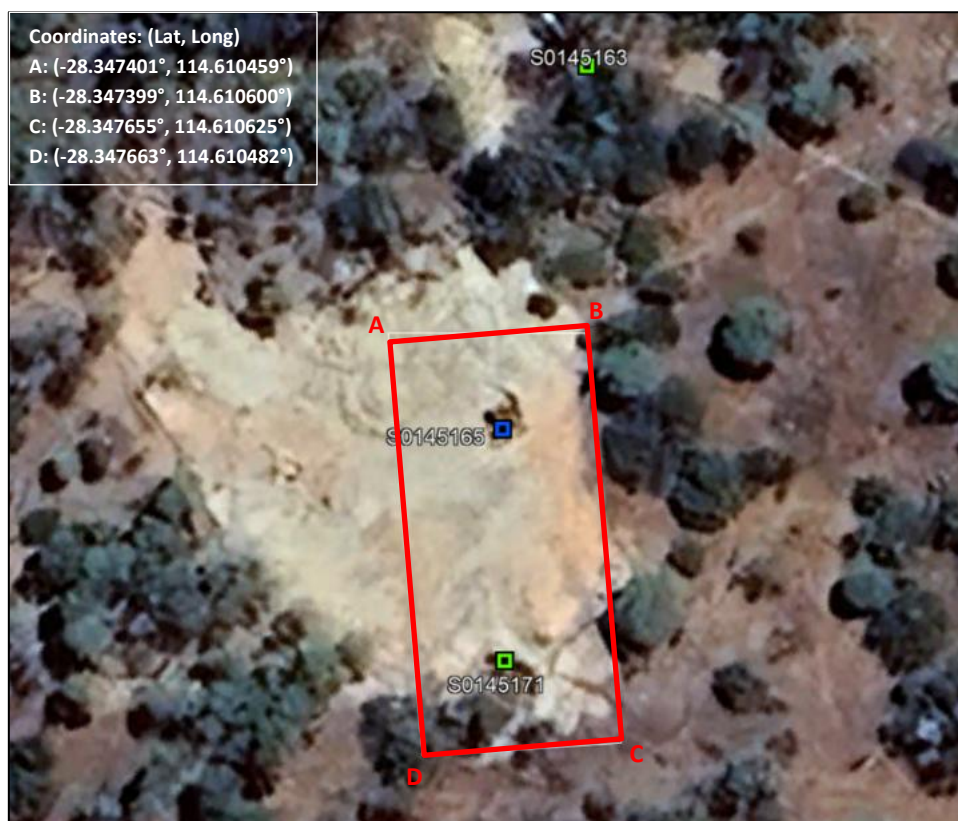
Figure 2: Reinforced earth area Commonage (Area 2)

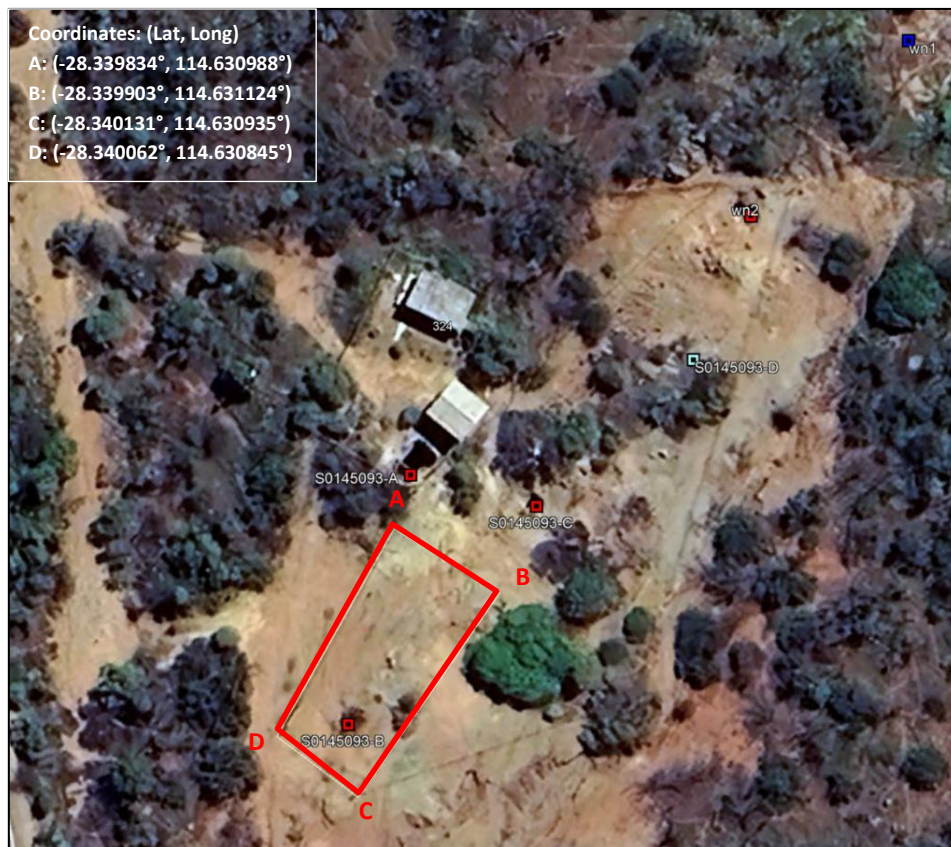
Figure 3: Reinforced earth area Wanerenooka

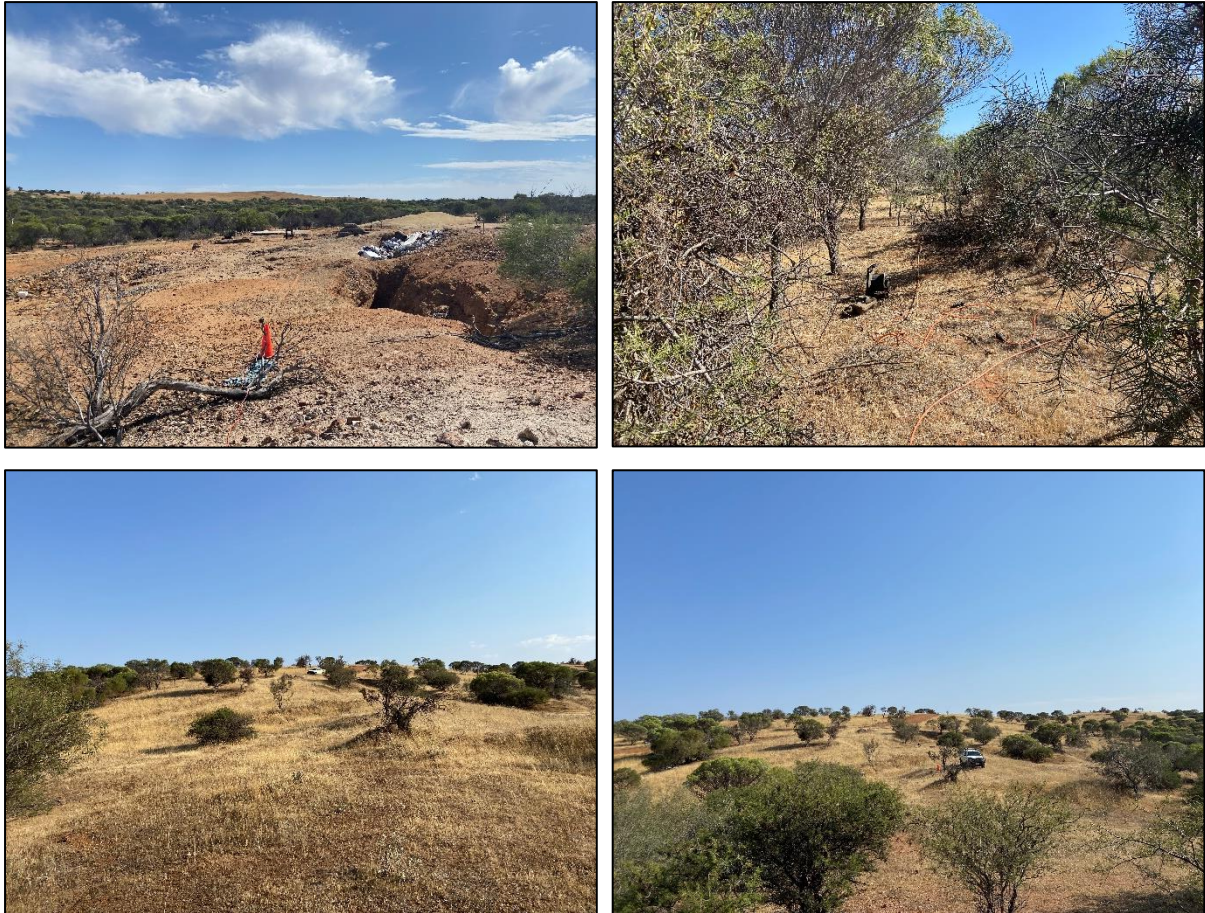
Figure 2: Typical ground surface conditions at Commonage.

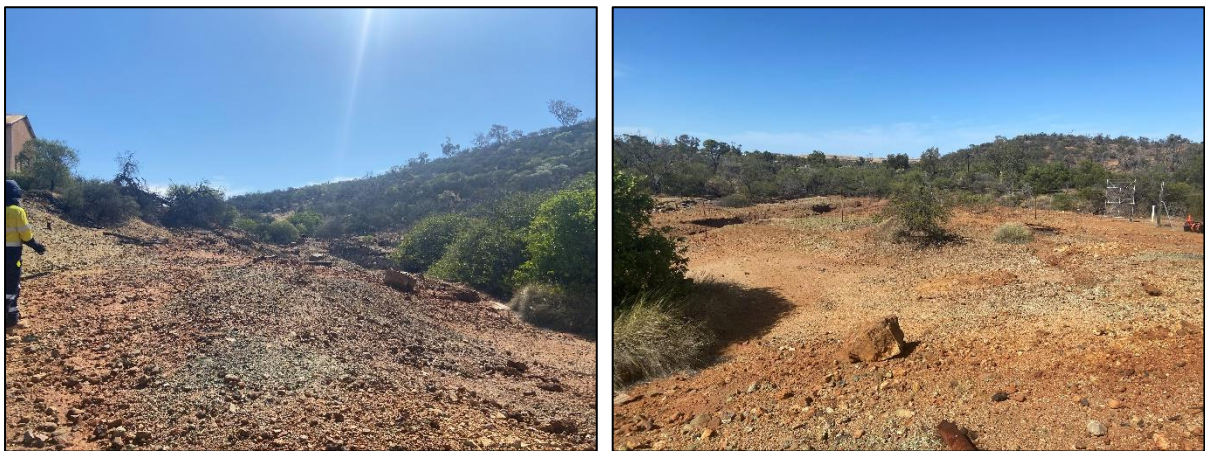
Figure 3: Typical ground surface conditions at Wannerenooka.

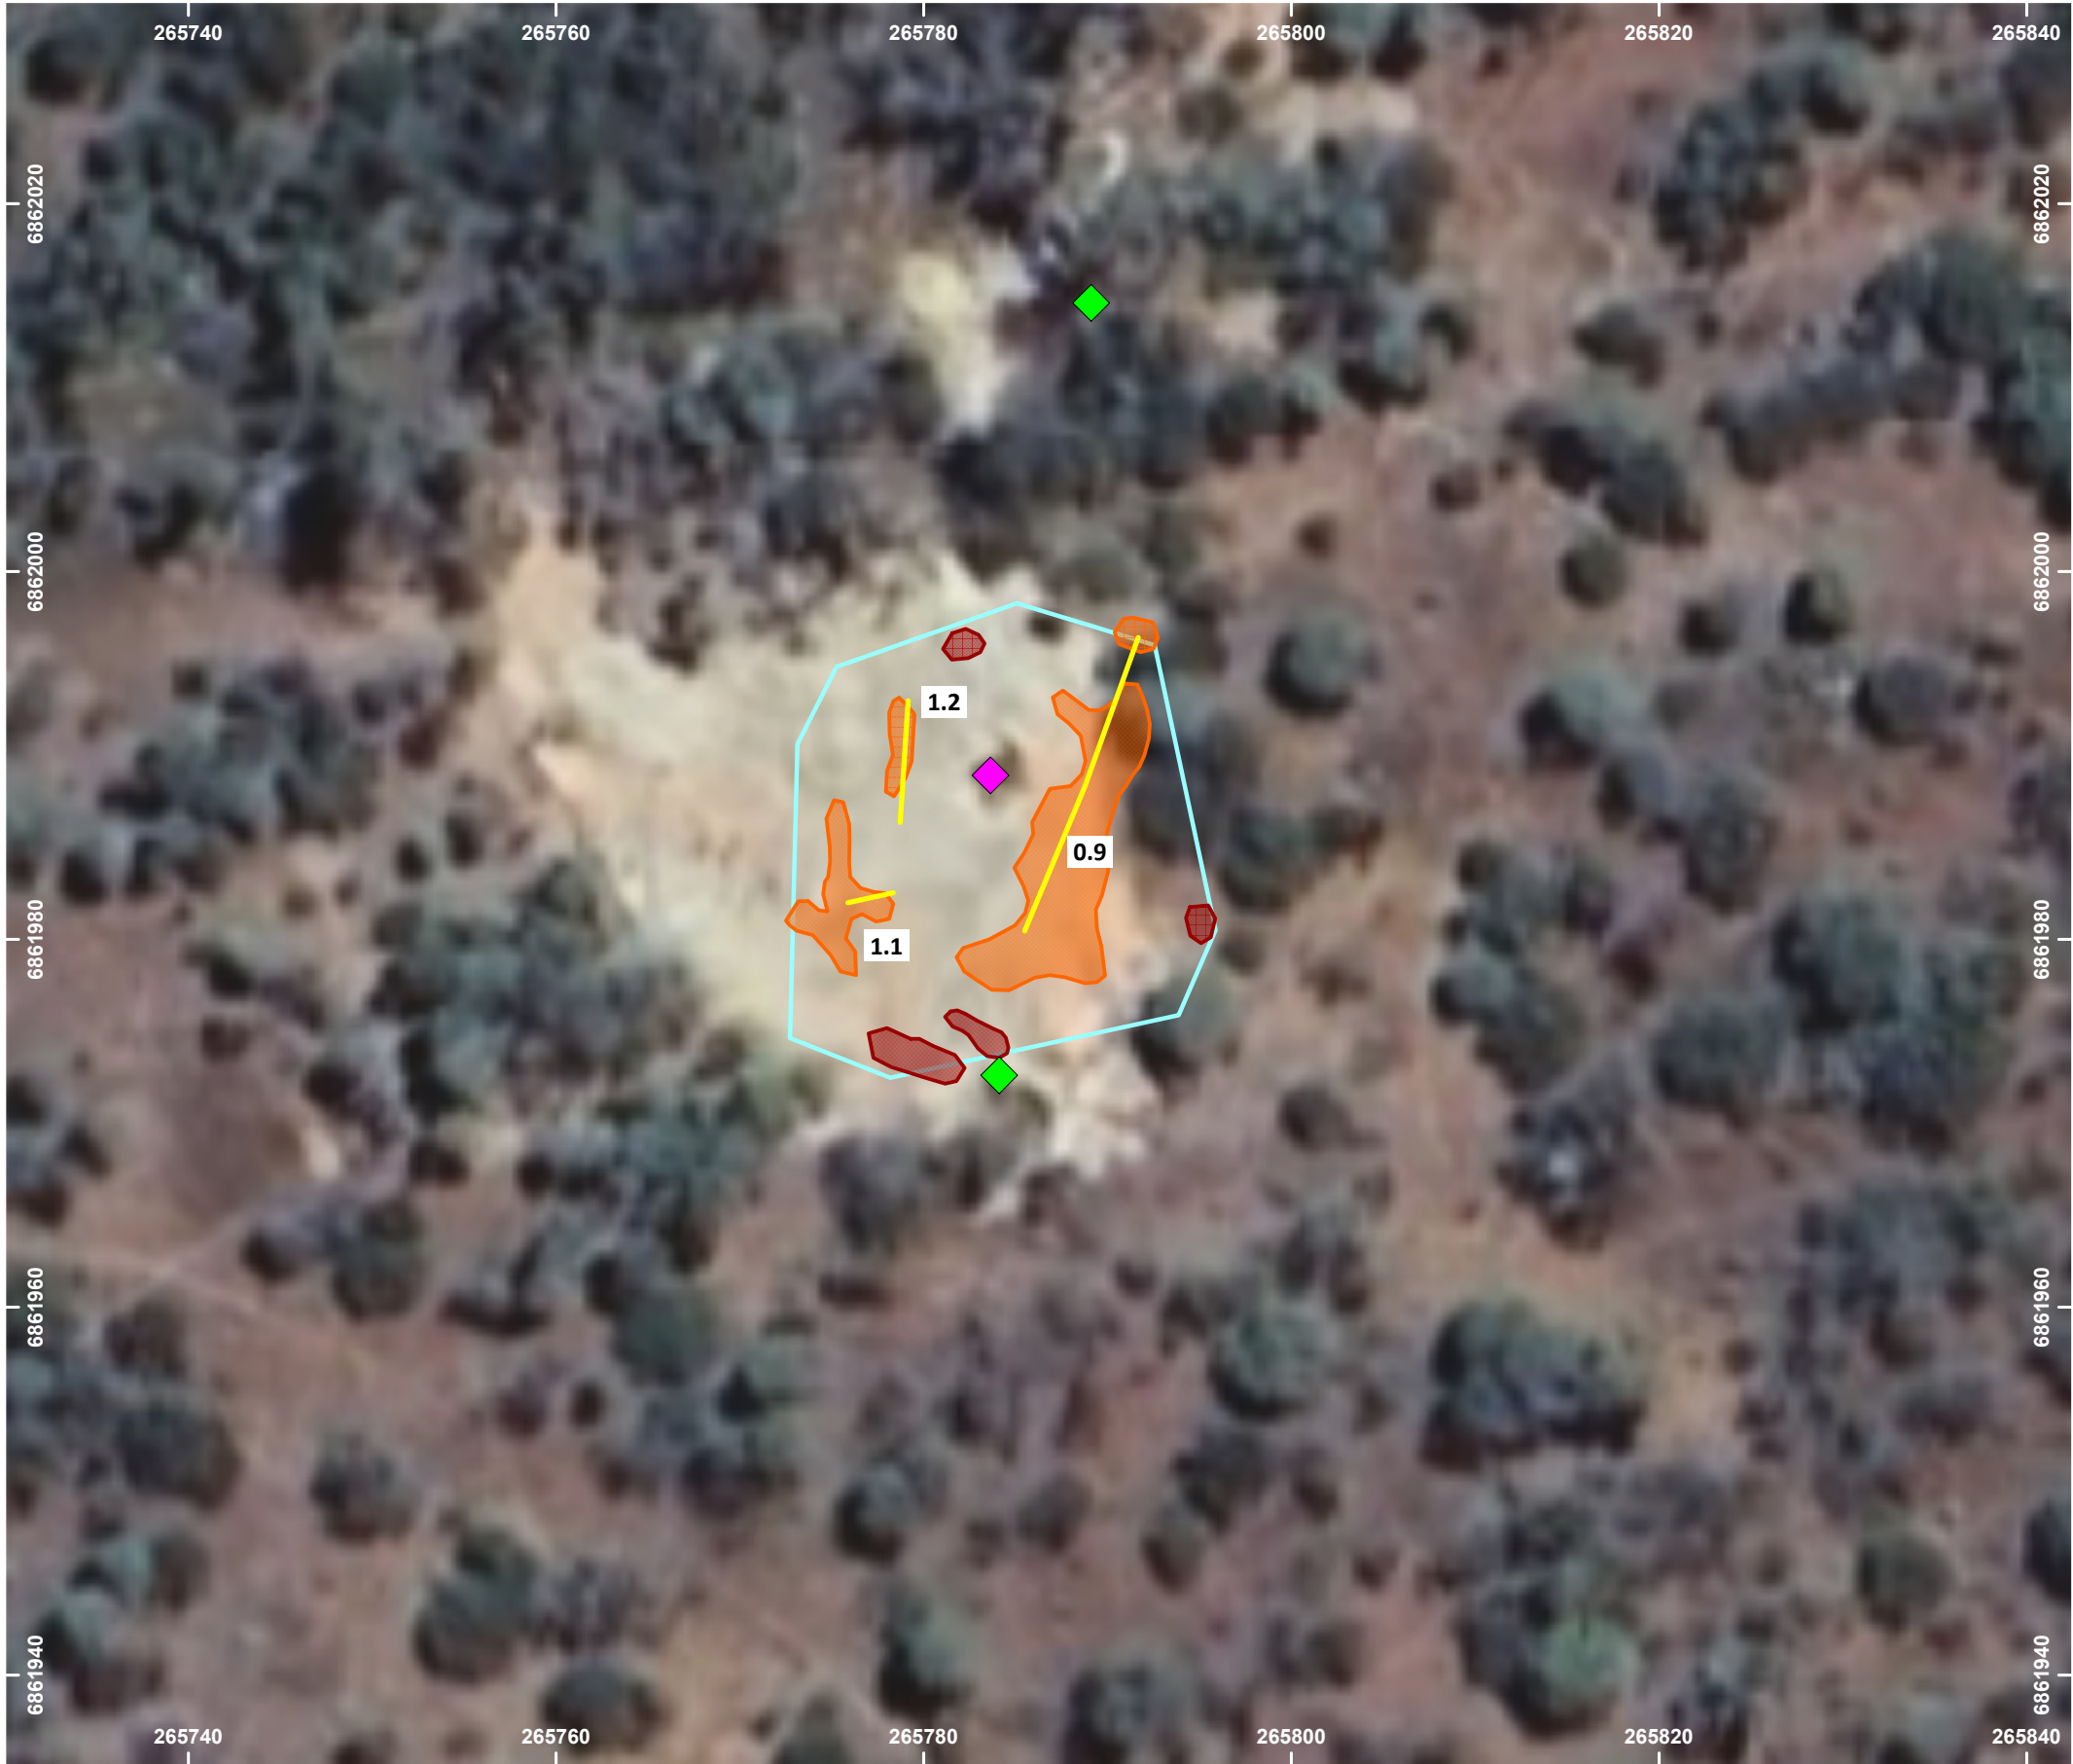
COMMONAGE SOUTH GPR INTERPRETATION

-   Potential shallow mine workings
-

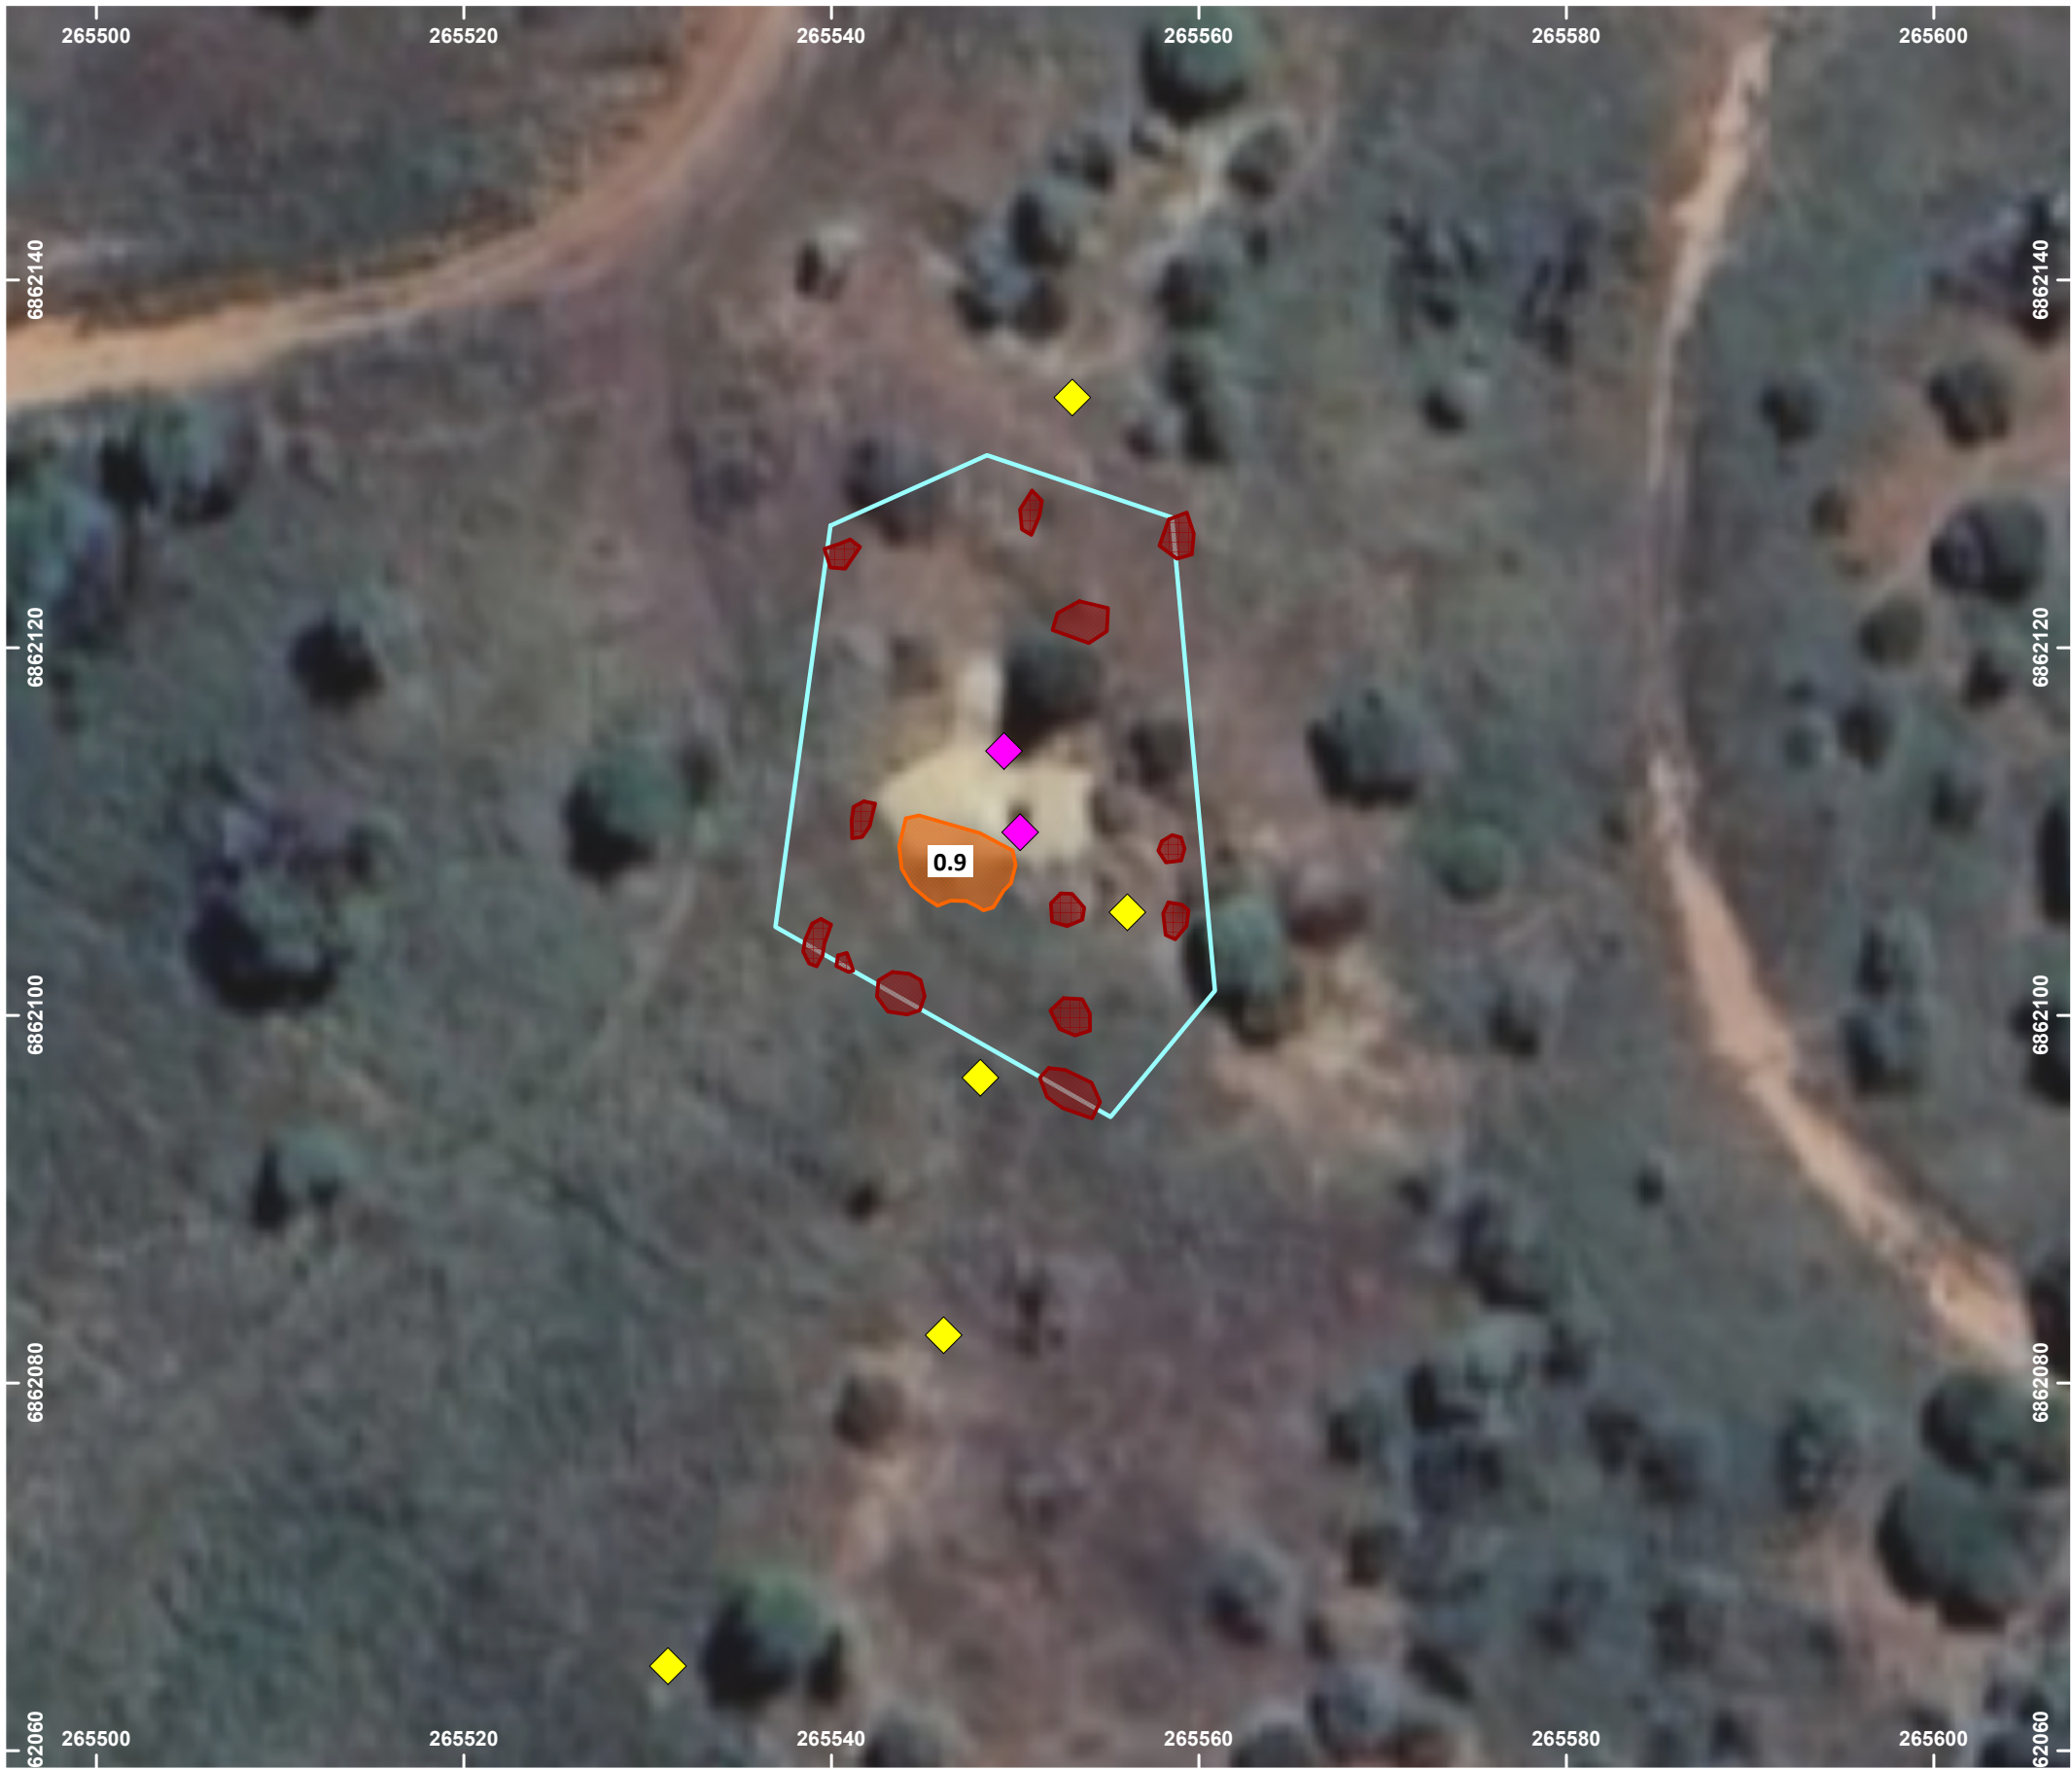
COMMONAGE WEST GPR INTERPRETATION

-   Potential shallow mine workings
-   Worked ground with low potential for voiding of subsurface material
-   Worked ground with high potential for voiding of subsurface material
- 0.5** Depth to feature (mBGL)
-
