Report on Shaft Condition Assessment

**Reids Ridge Abandoned Mine Site
(Commodore and Reids North)**

Yalgoo-Ninghan Road, Paynes Find WA

Project 224768.00

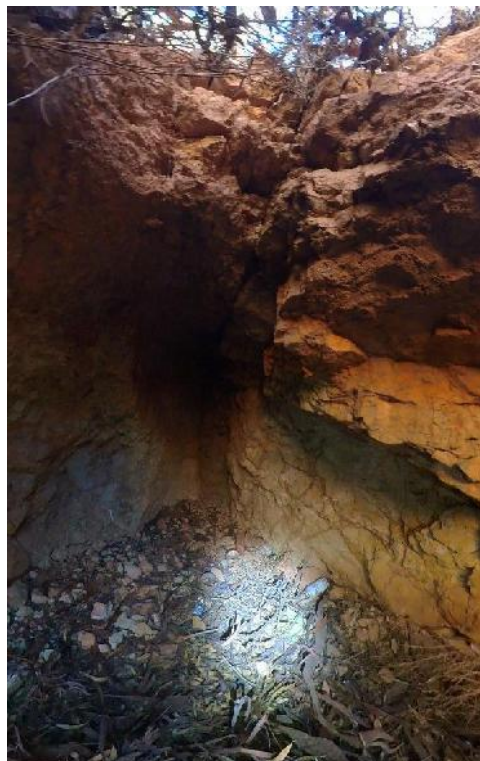
Photograph 2: Feature 1 looking south, showing no lateral continuation

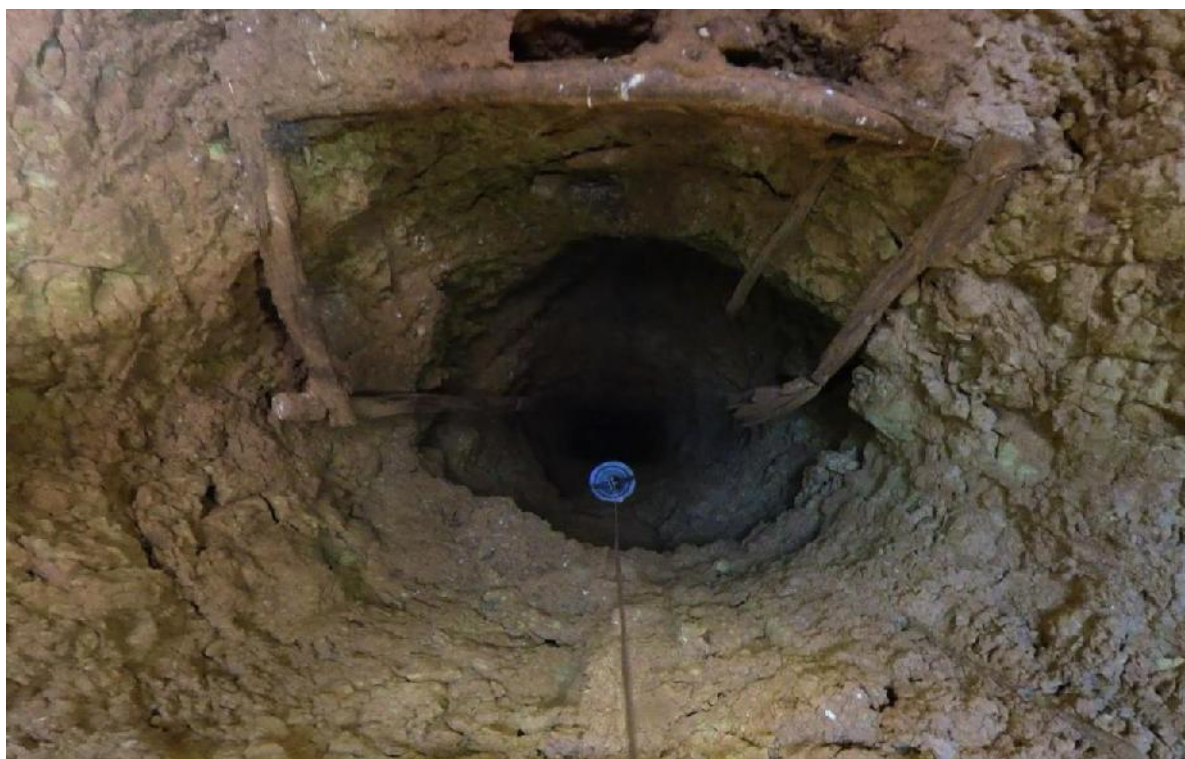
Photograph 4: Feature 2 looking down, 2 m deep

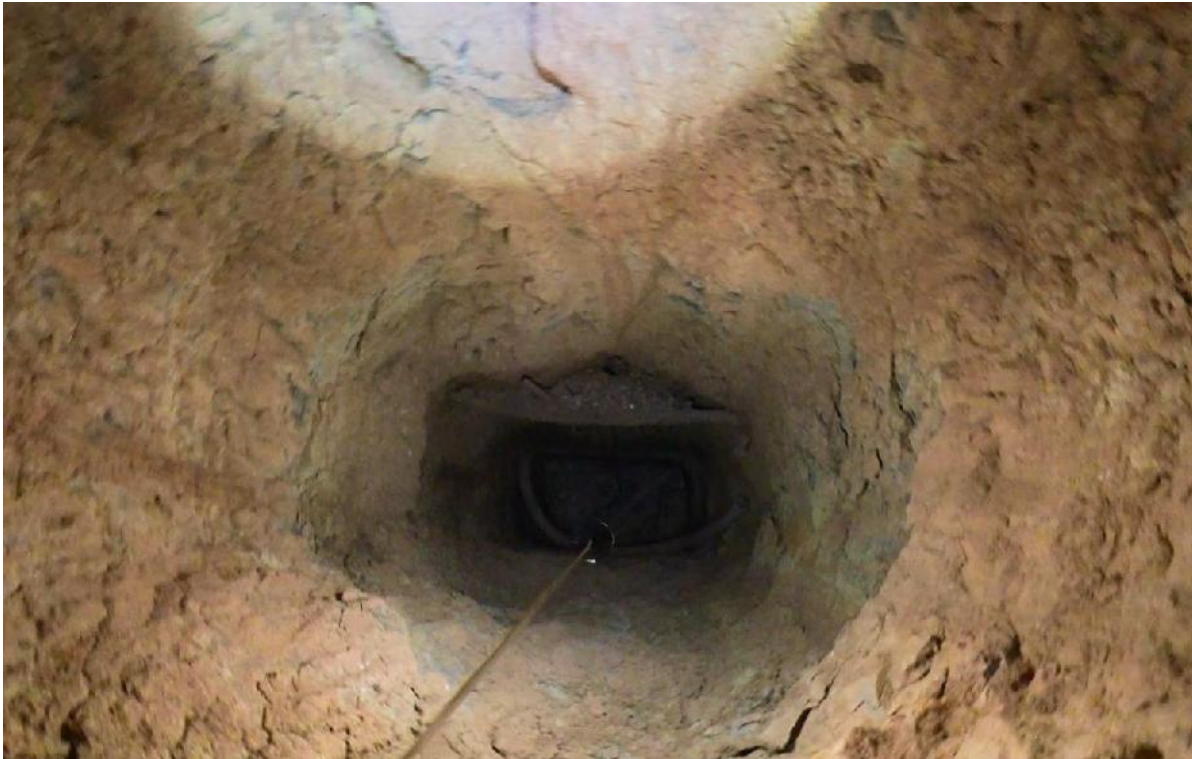
Photograph 5: Feature 2, looking down, 8 m deep

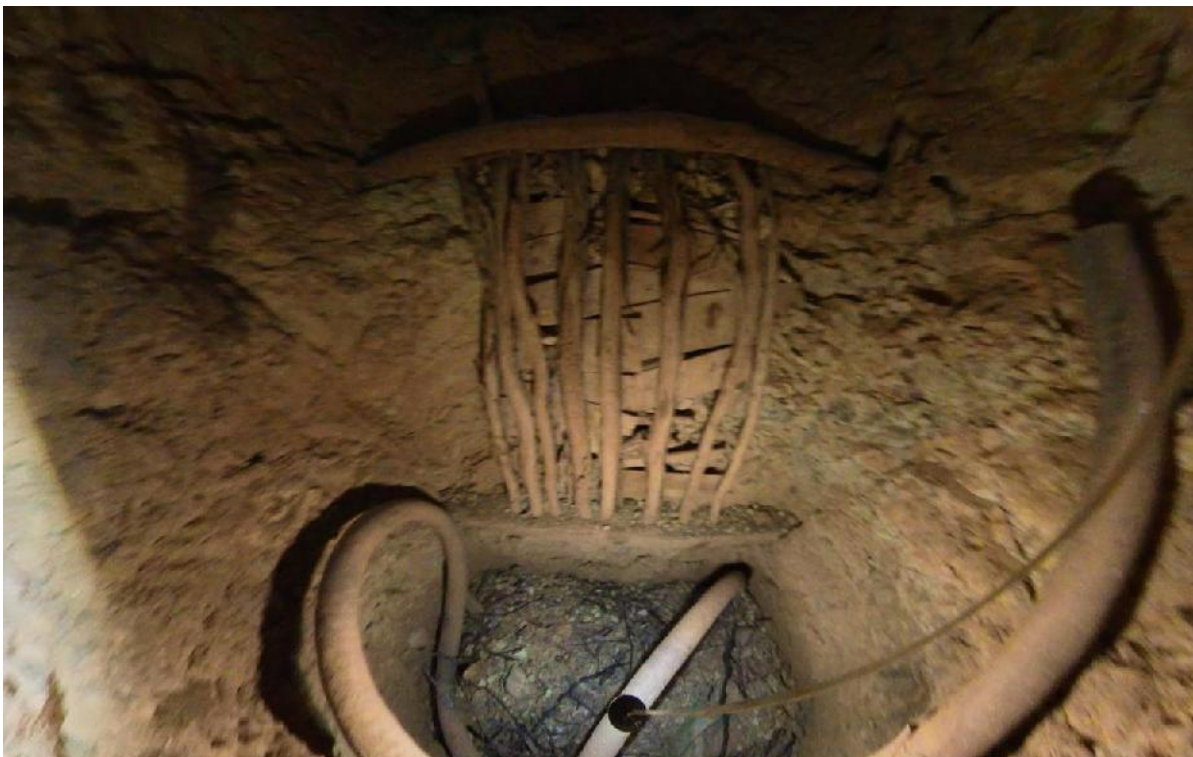
Photograph 6: Feature 2 base of shaft

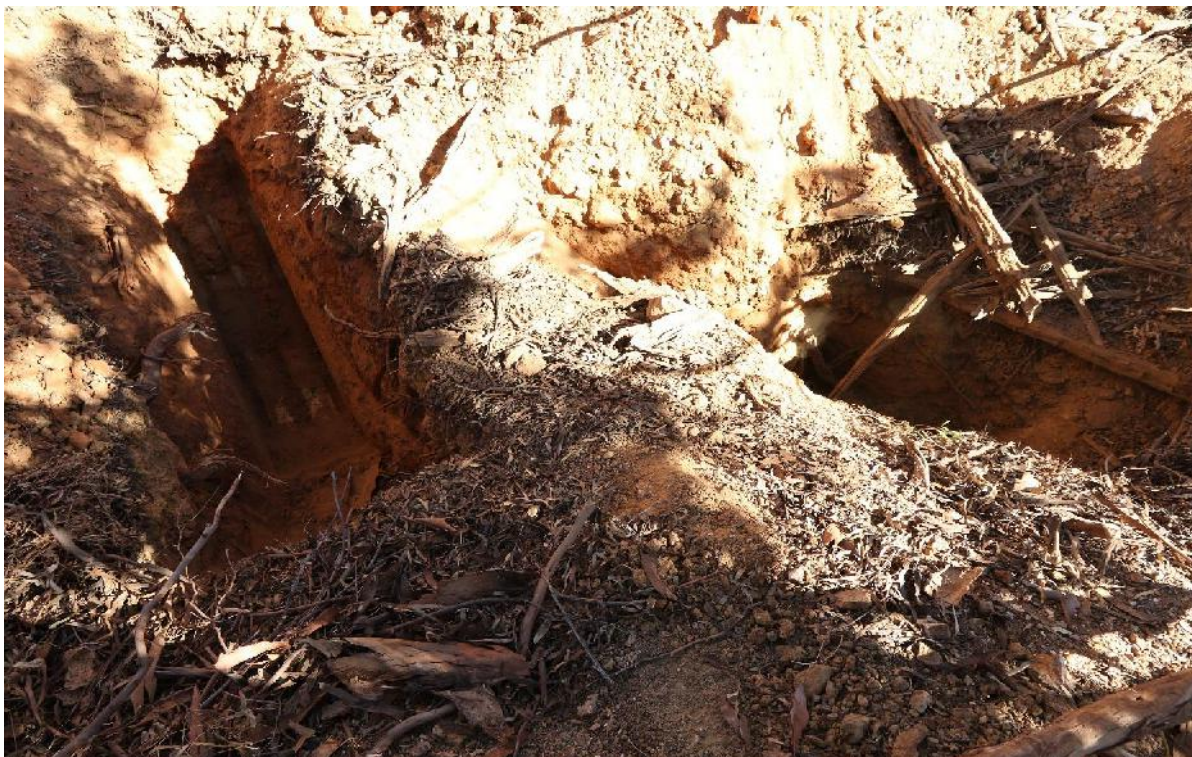
Photograph 8: Feature 3 looking south, following excavation and eastern excavation

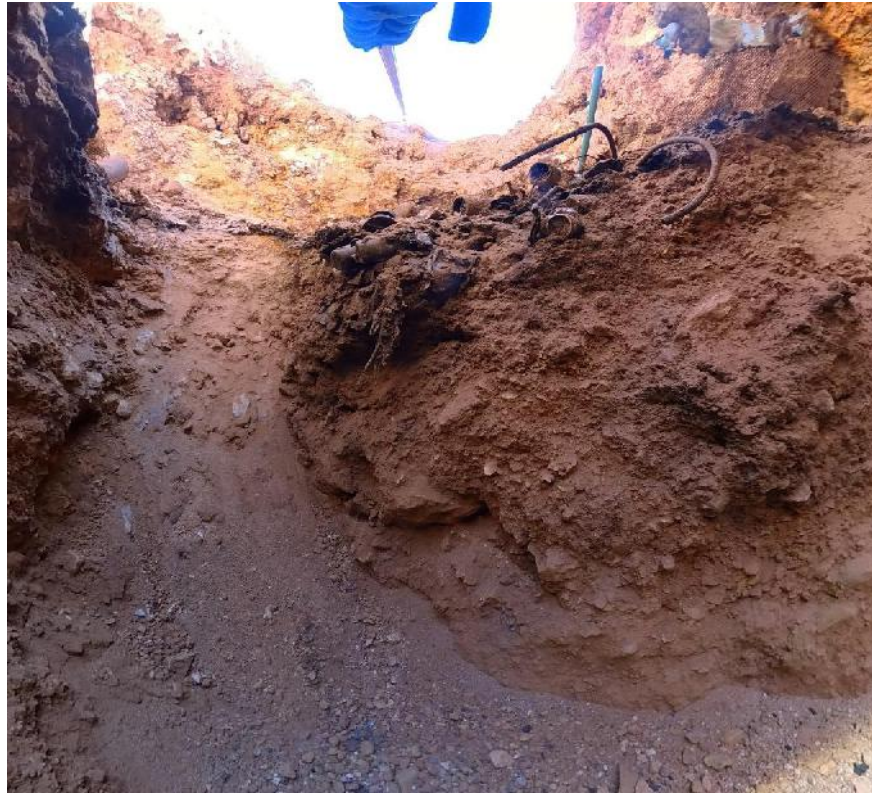
Photograph 13: Feature 5a, post excavation through refuse backfill

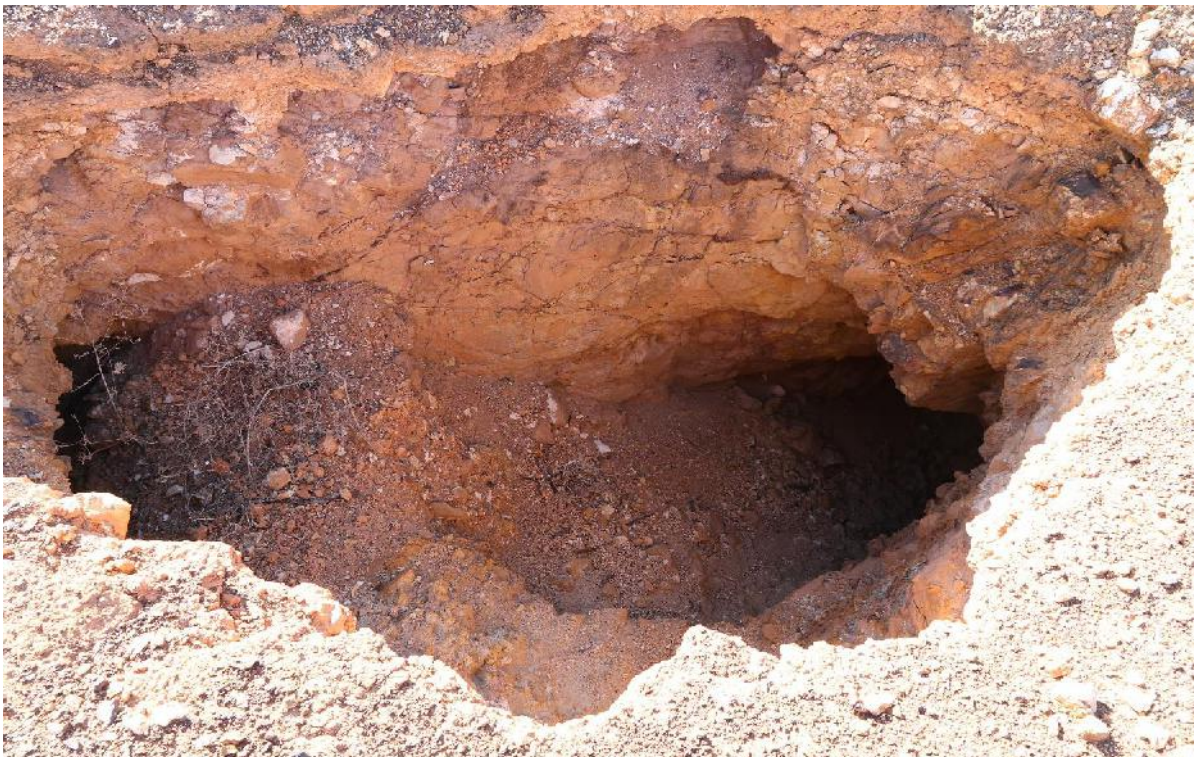
Photograph 14: Feature 5, looking north showing link to Feature 5

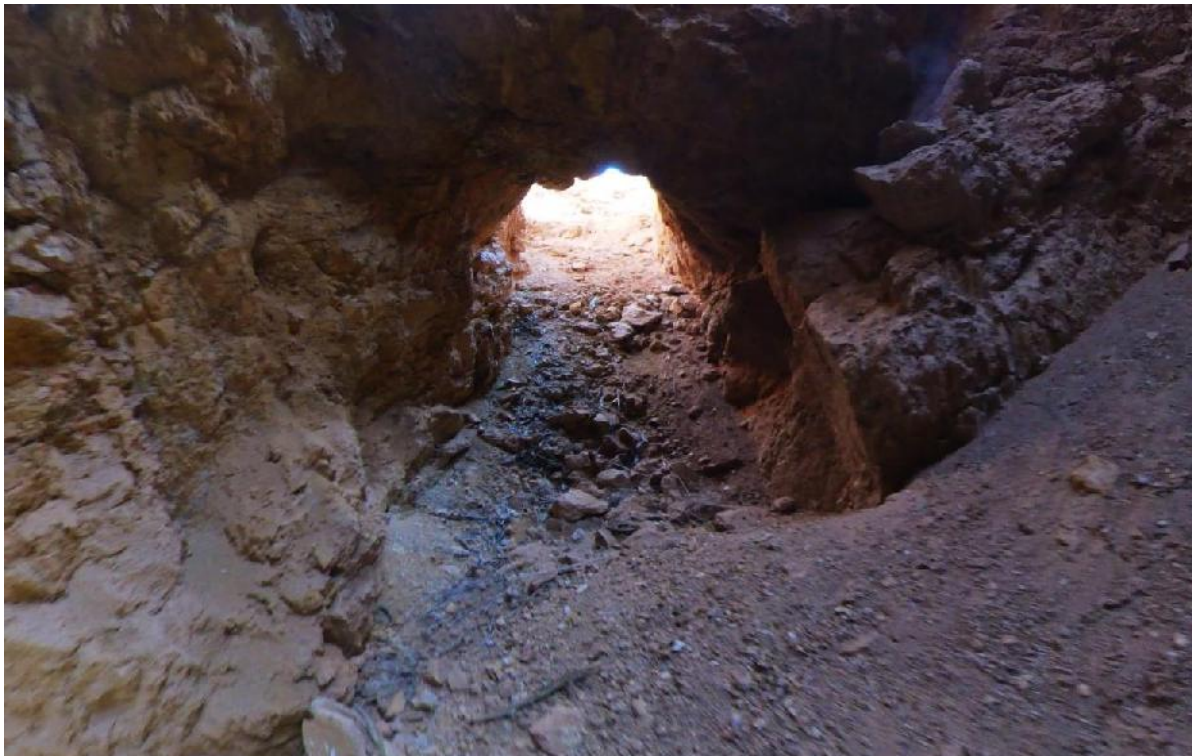
Photograph 16: Feature 6, looking south, showing link to Feature 5

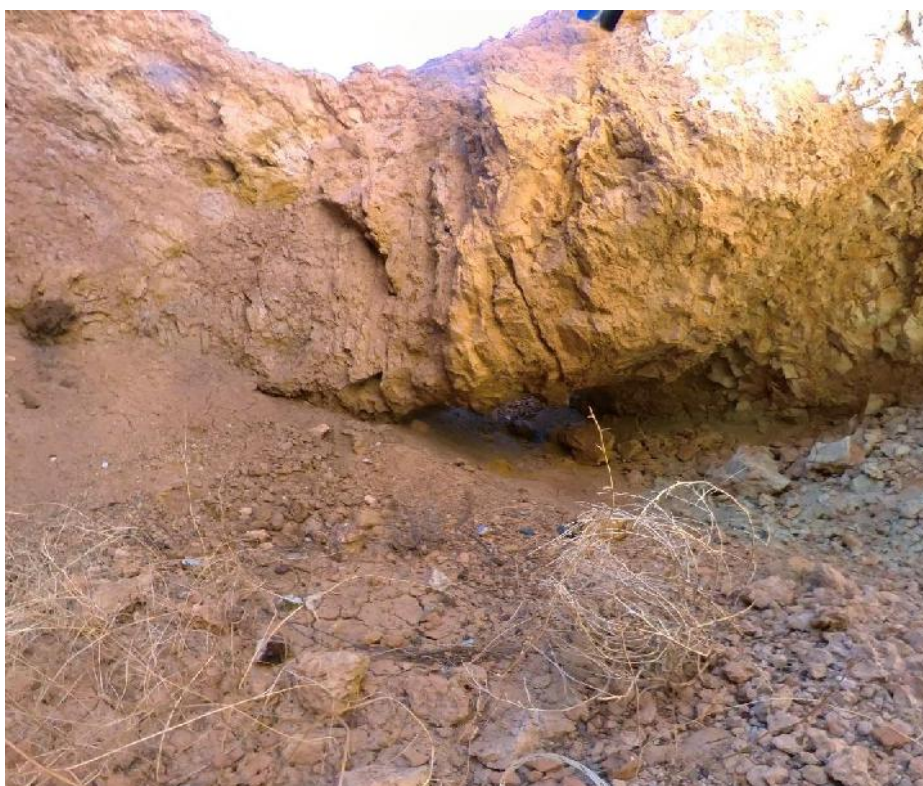
Photograph 18: Feature 7, looking north, showing link to Feature 8

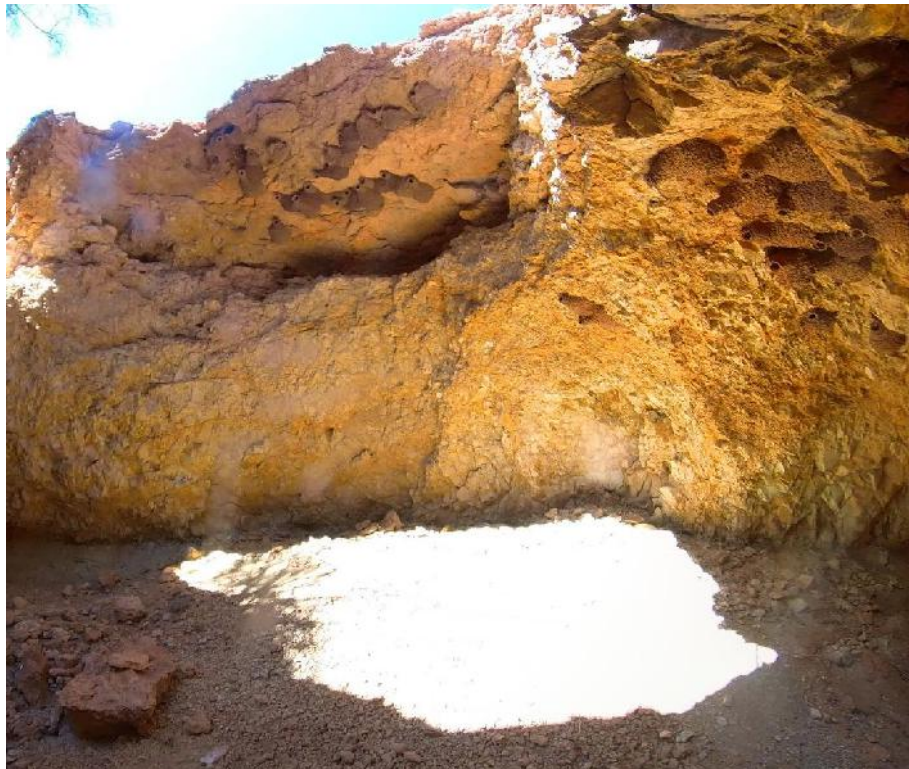
A 1.8 m x 2.5 m at surface, 4.1 m deep excavation, widening to 5.0 m x 6.1 m at the base (resulting in an overhang of up to 2.7 m). A 1.2 m wide lateral working links to Feature 8. Bird nests were observed on the underside of the overhang on the eastern side of the feature (photo 22 in Appendix C). No excavation was undertaken in this feature owing to the base being beyond the reach of the backhoe.

Bird nests were observed on the underside of overhanging ground in Features 9 and 11c via camera lowered into the features (photos 22, 33 and 34 in Appendix C). No other evidence, such as smell, guano or other excrements, were noted during the field work by Douglas.

Photograph 22: Feature 9, facing east. Birds nests on overhang visible.

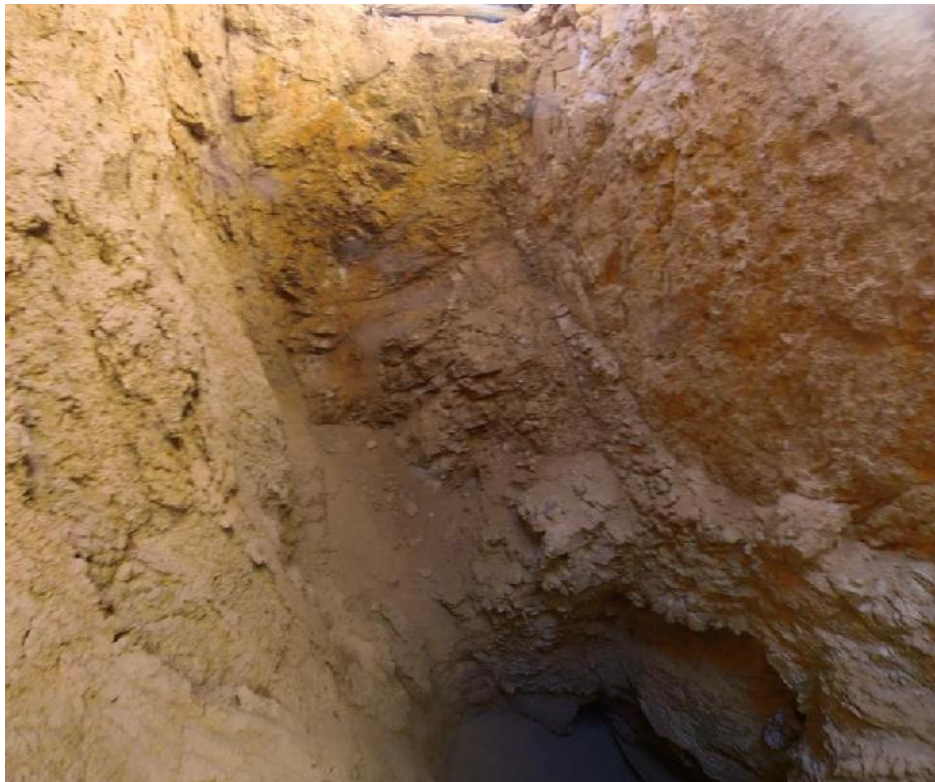
Photograph 24: Feature 10, approximately 1.5 m deep, facing north.

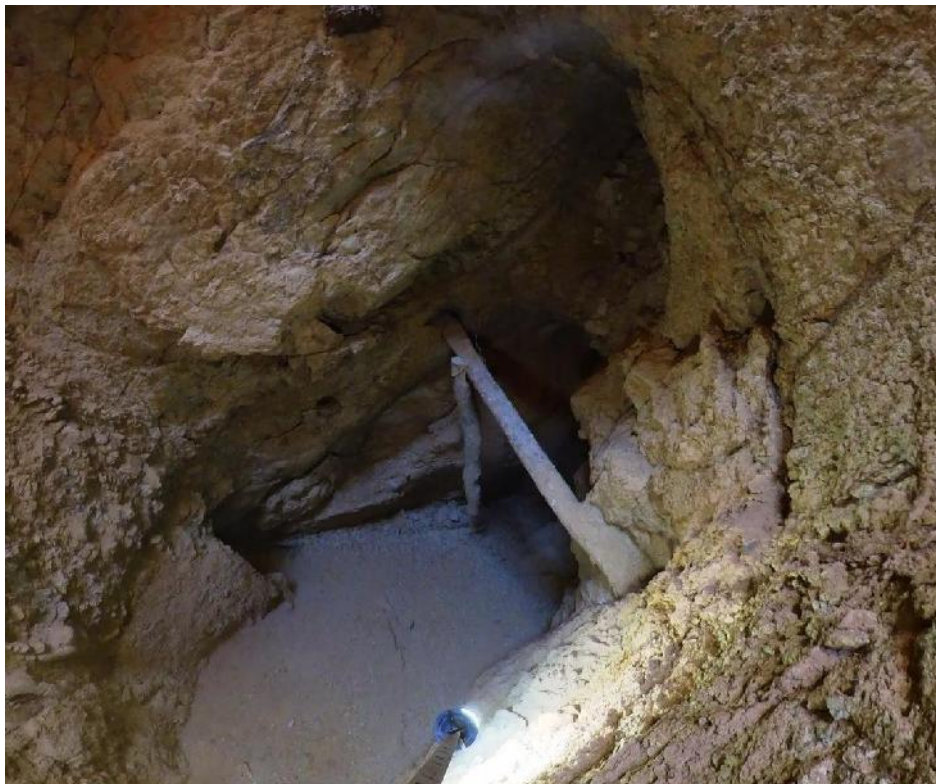
Photograph 26: Feature 10, base

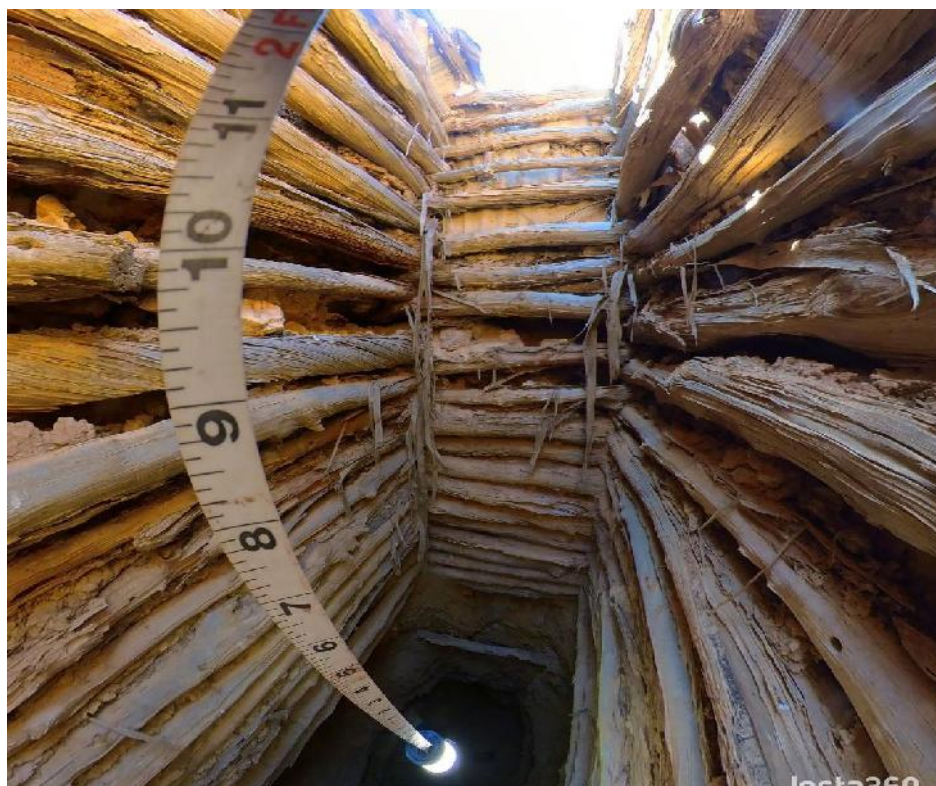
Photograph 28: Feature 11, 1 m deep

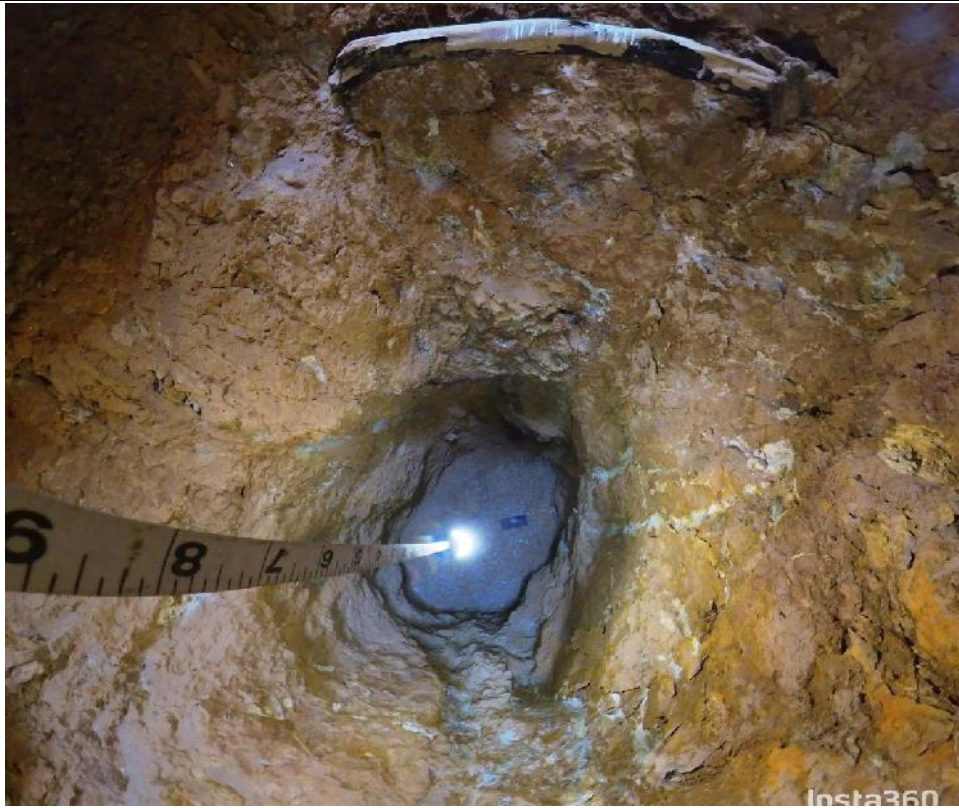
Photograph 29: Feature 11, 3 m deep, facing down

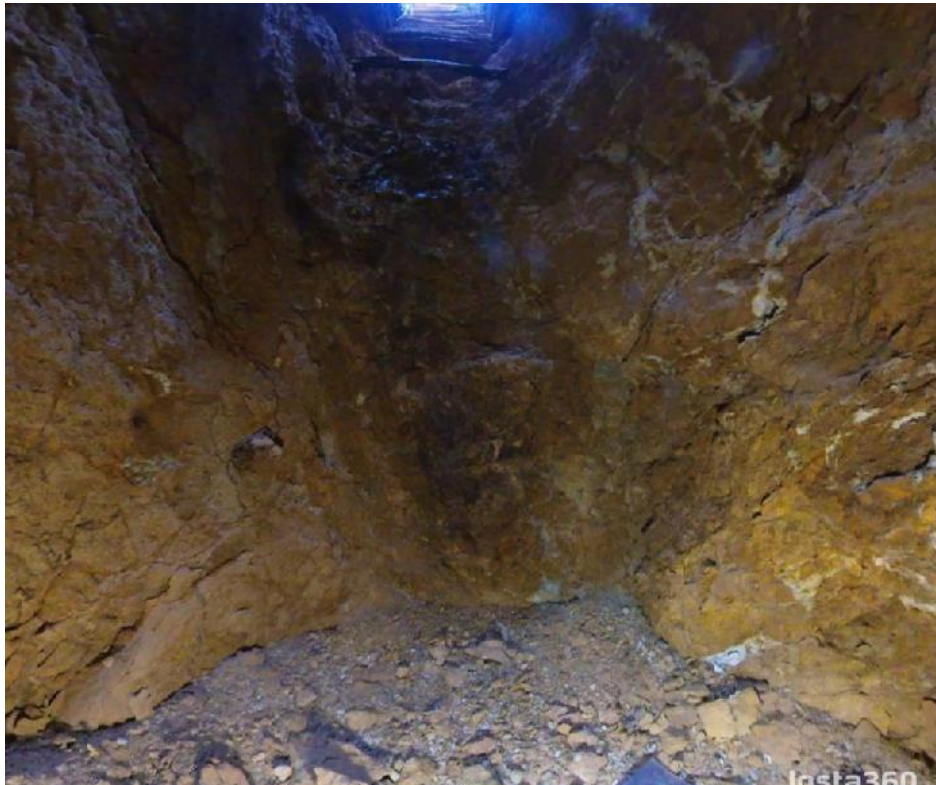
Photograph 30: Feature 11, base

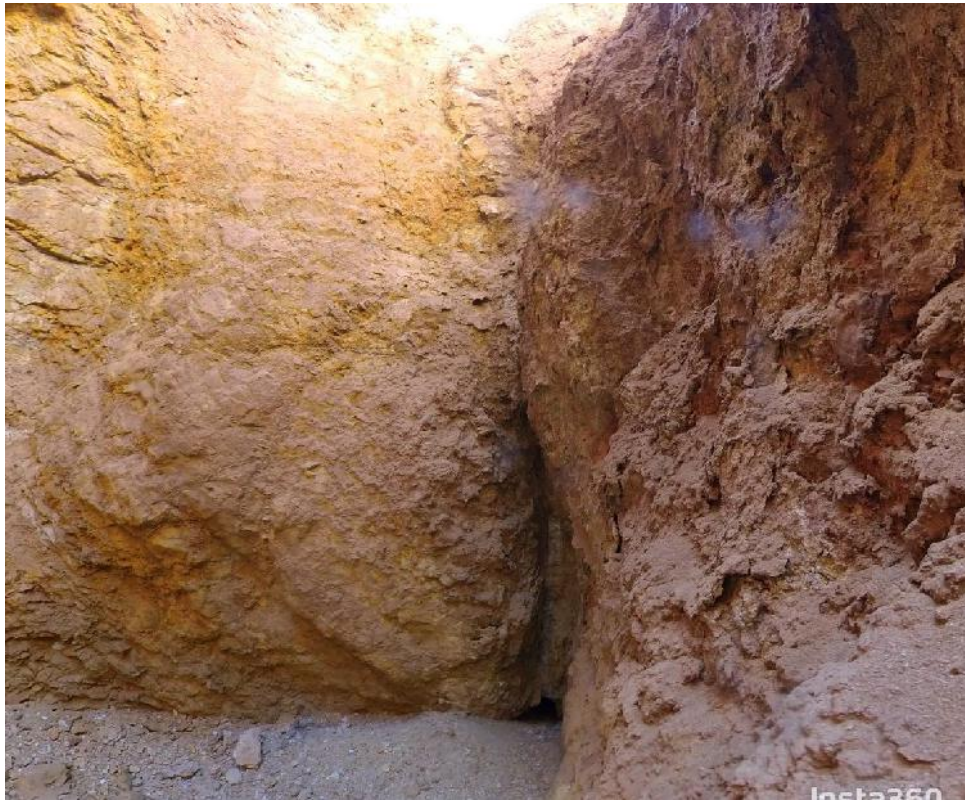
Photograph 35: Feature 11c, base, facing northwest

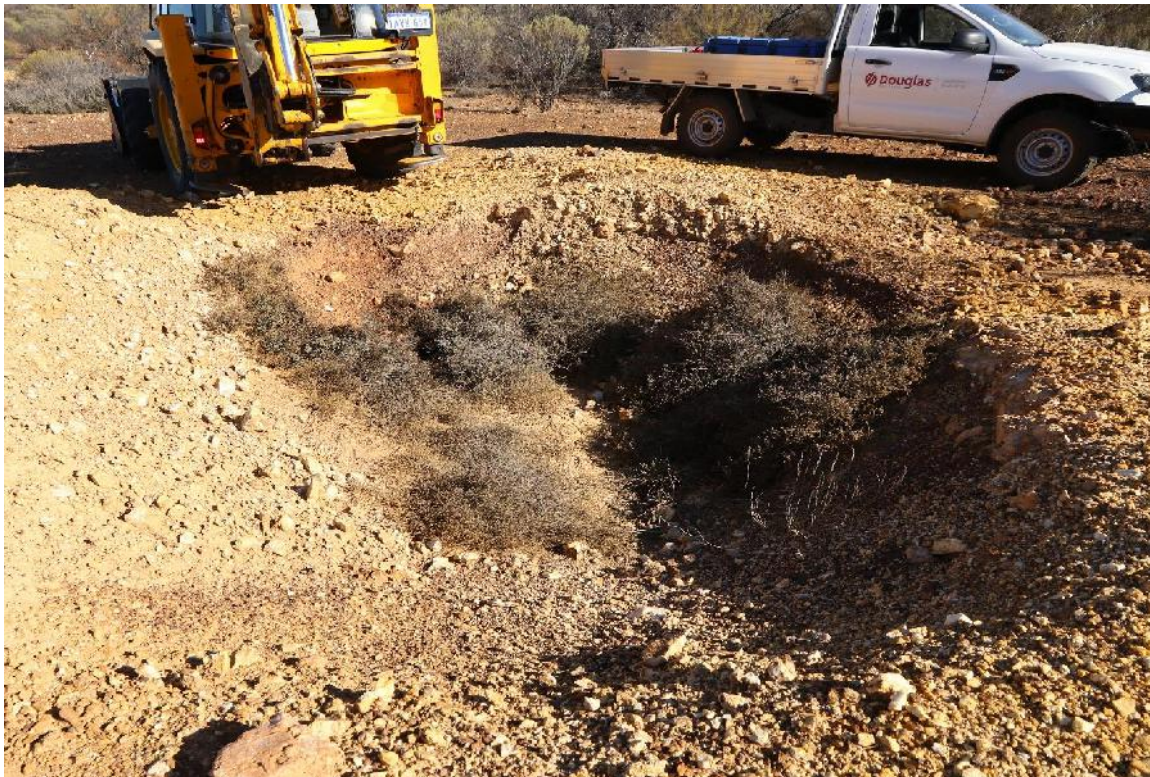
Photograph 36: Feature 12a

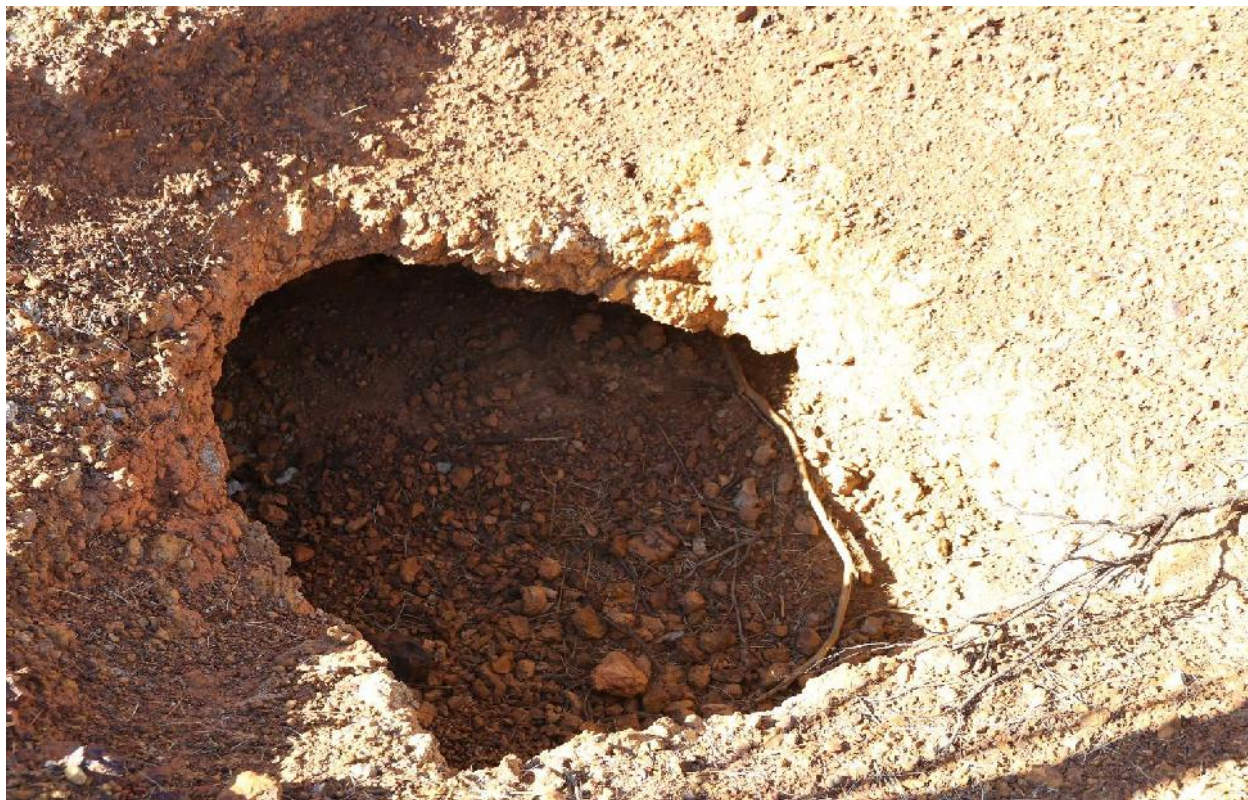
Photograph 37: Feature 12

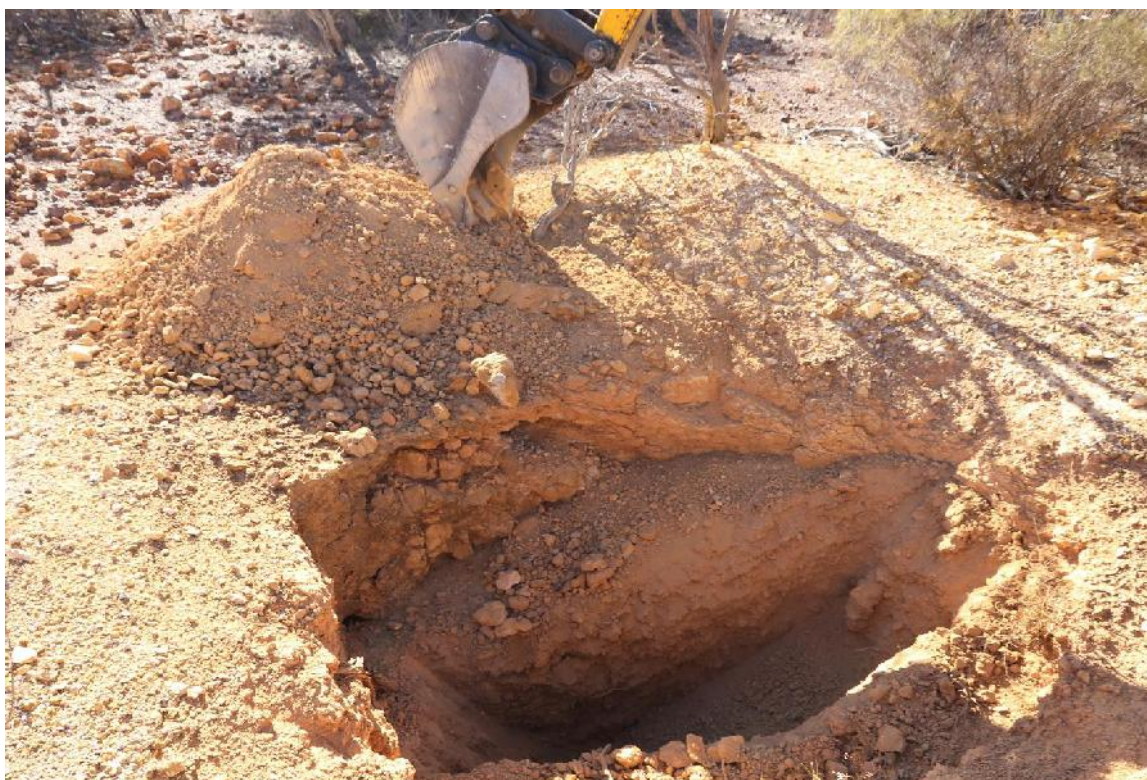
Photograph 38: Feature 13. During excavation of base.

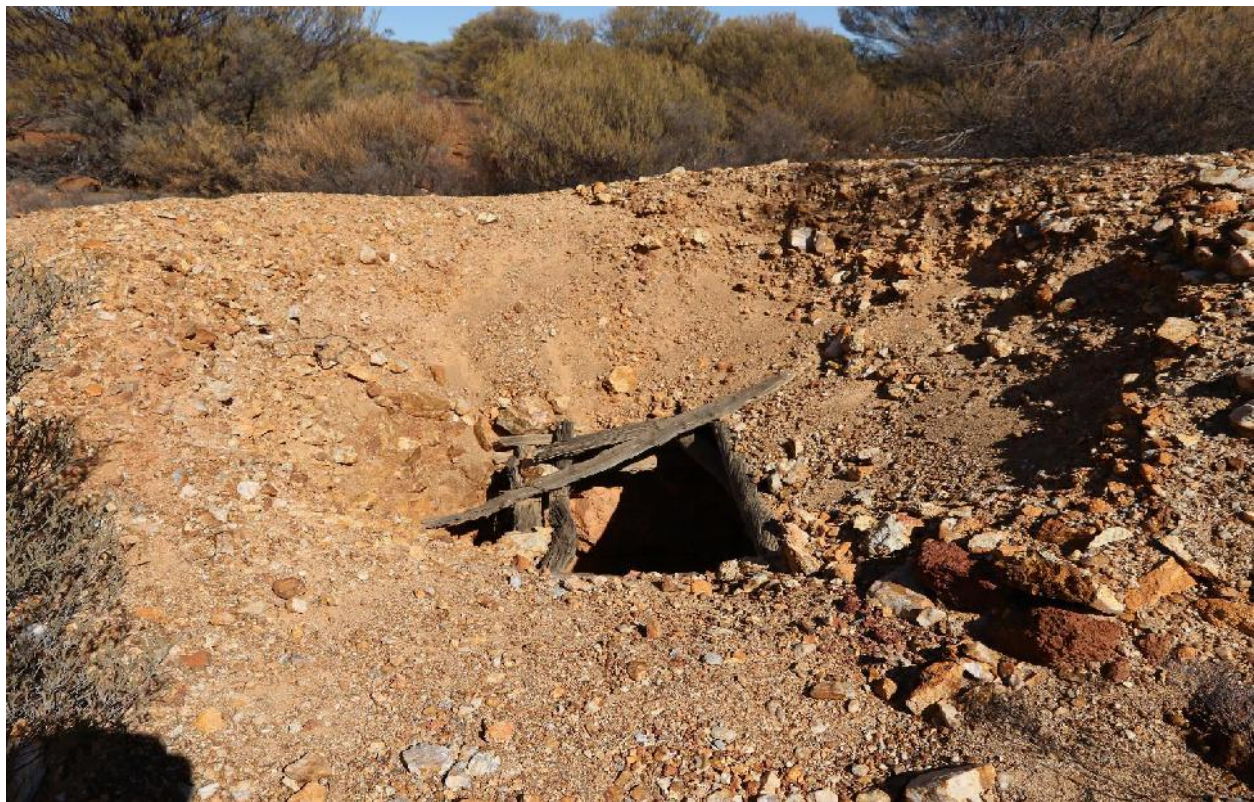
Photograph 39: Feature 14, facing west

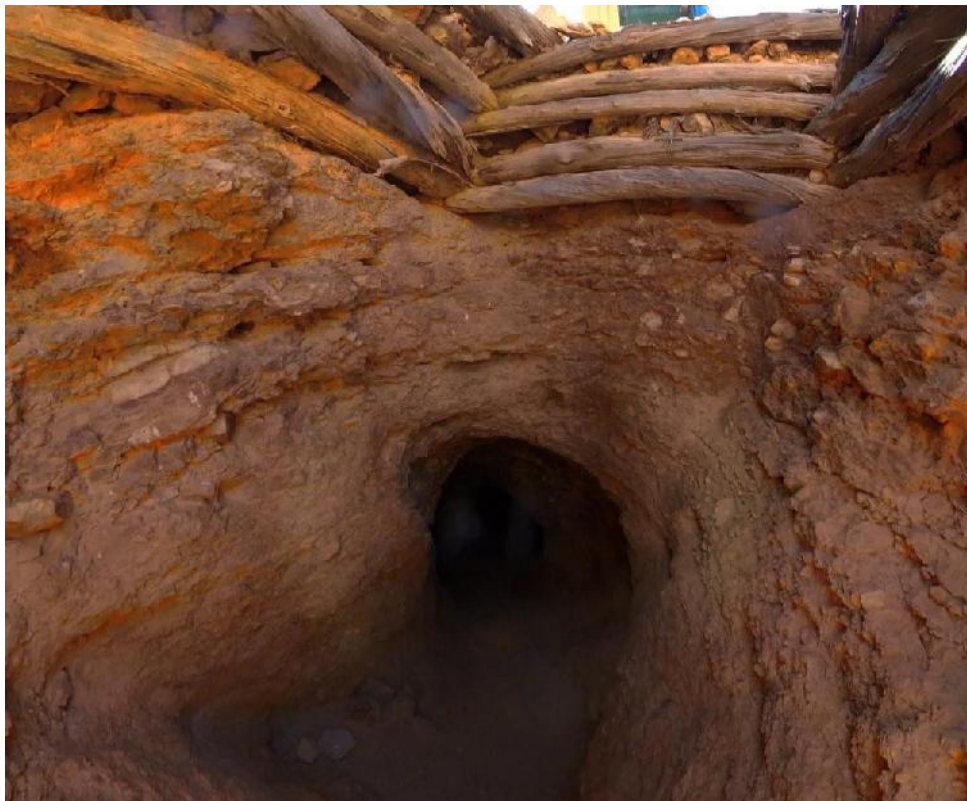
Photograph 40: Feature 14, 1 m deep, facing northeast

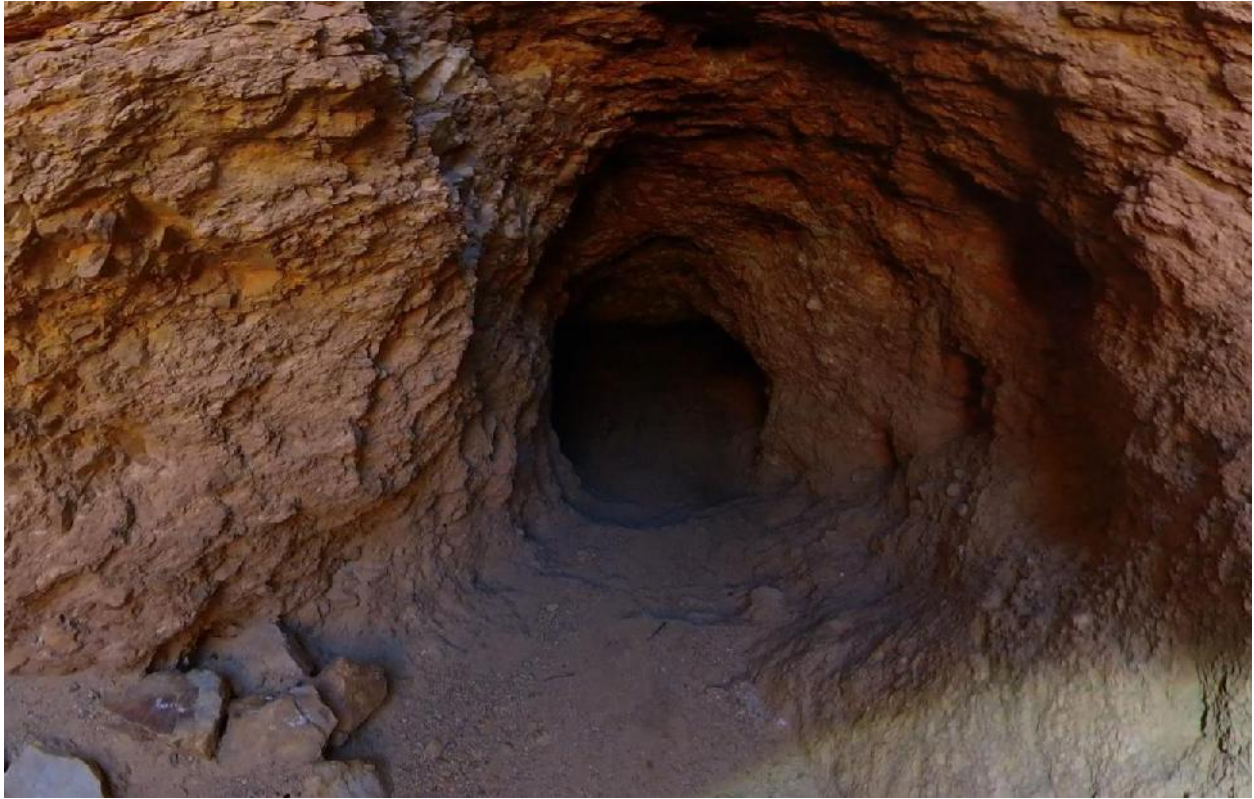
Photograph 41: Feature 14, 3 m deep, facing northeast

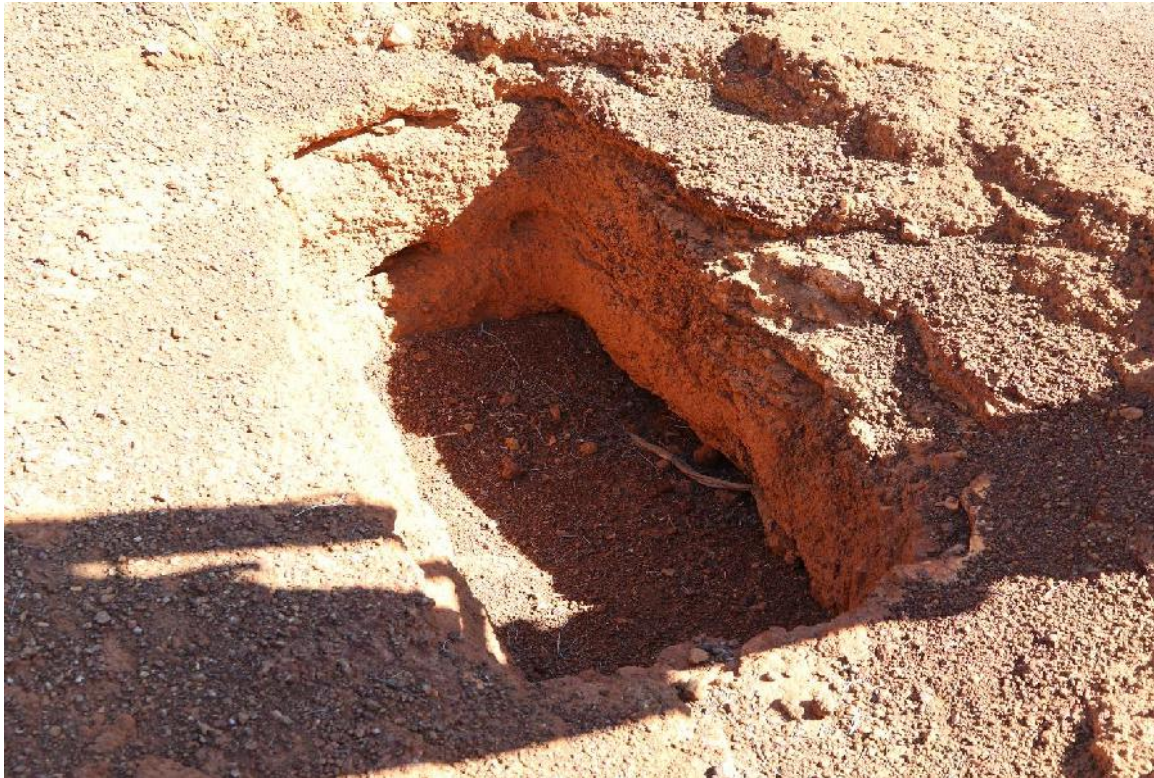
Photograph 42: Feature 15

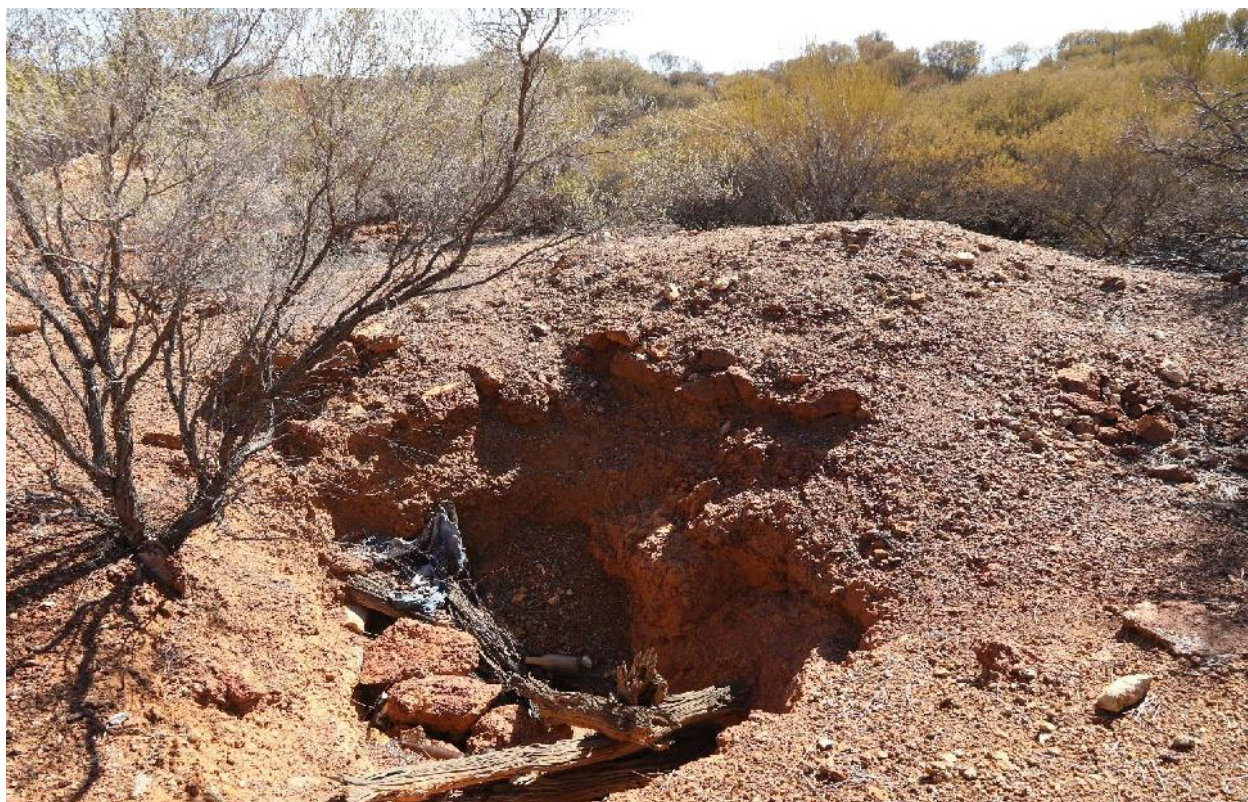
Photograph 43: Feature 16, facing north

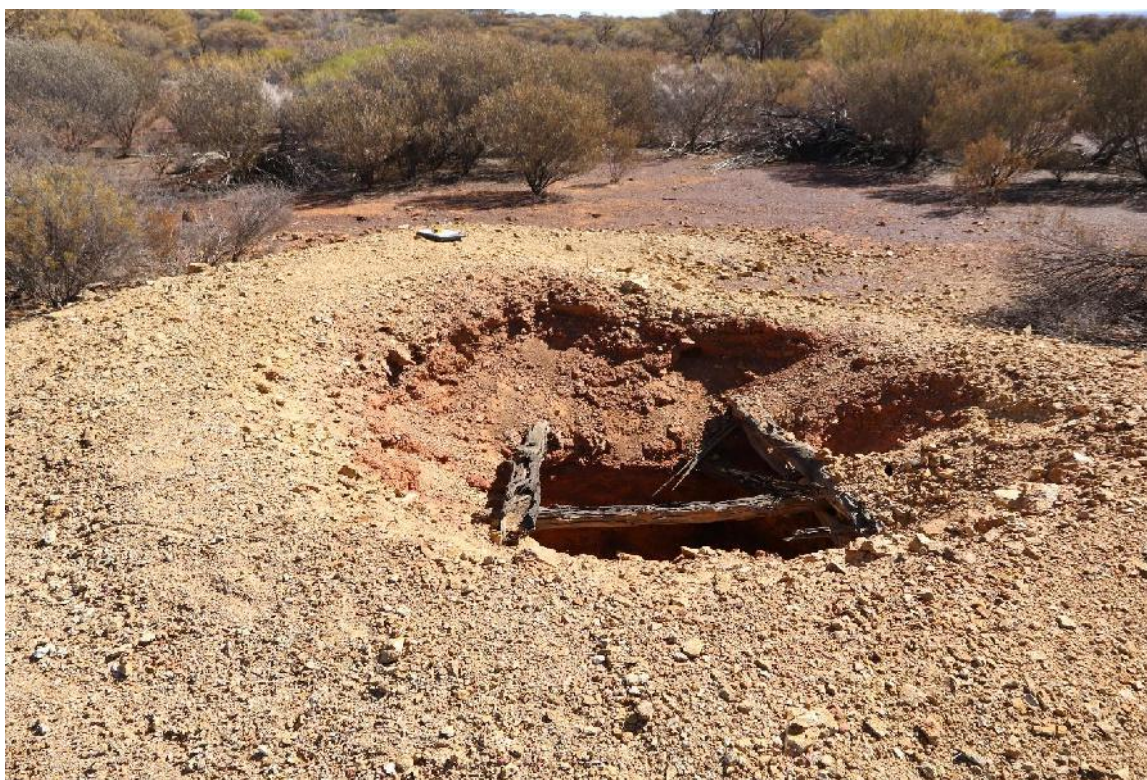
Photograph 44: Feature 17, facing north

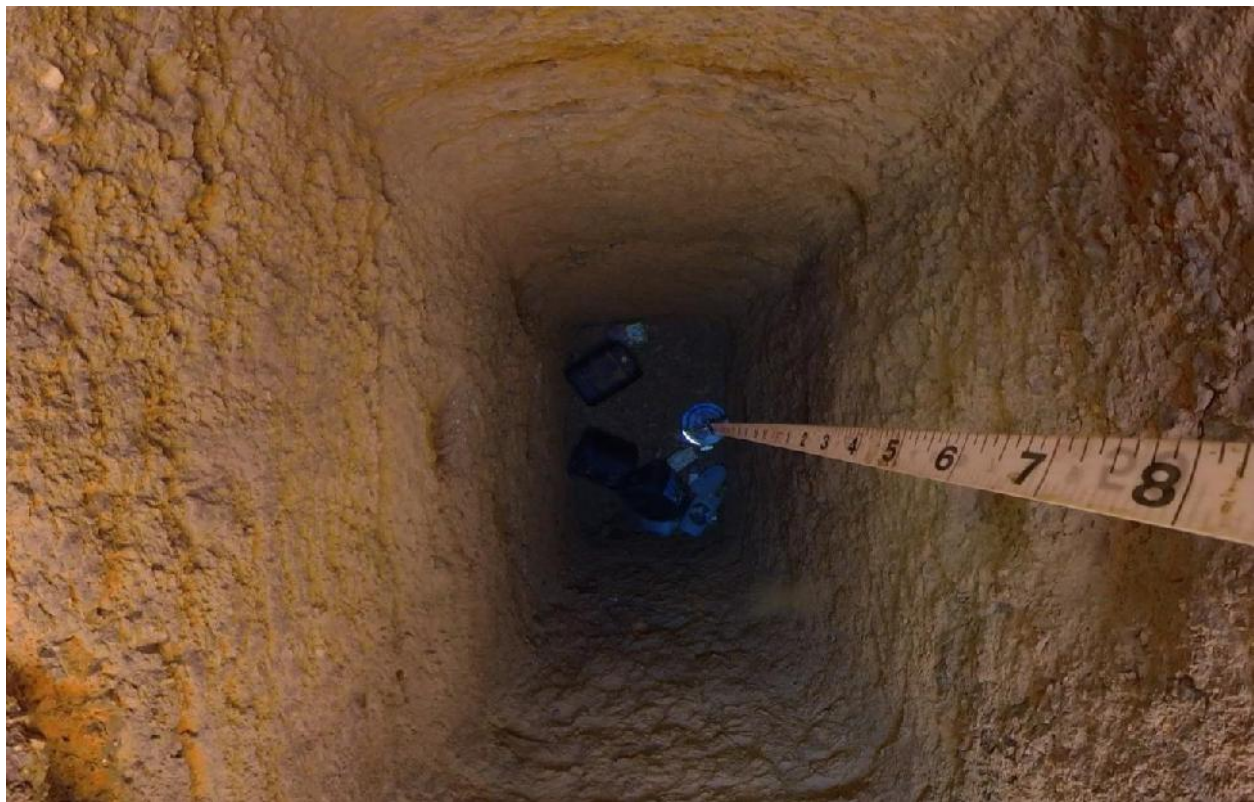
Photograph 45: Feature 17, 1 m deep, facing down

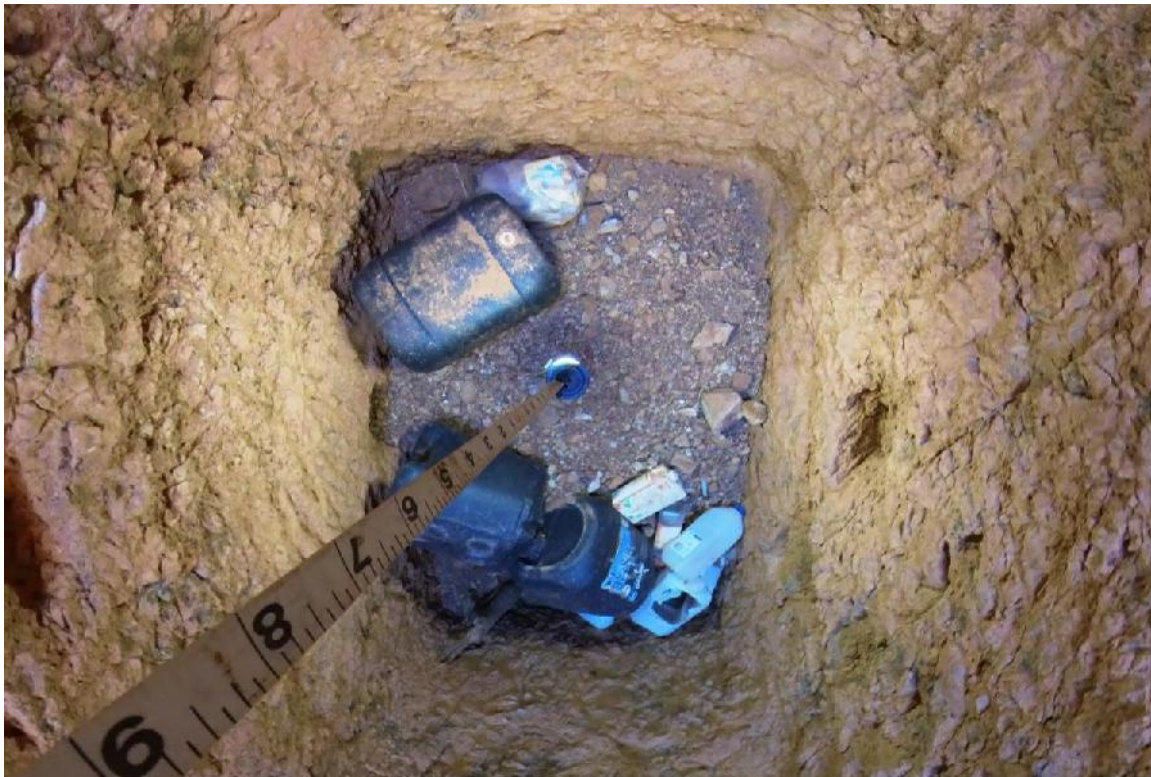
Photograph 46: Feature 17, base
