Report on Shaft Condition Assessment

**Reids Ridge Abandoned Mine Site
(Commodore and Reids North)**

Yalgoo-Ninghan Road, Paynes Find WA

Project 224768.00

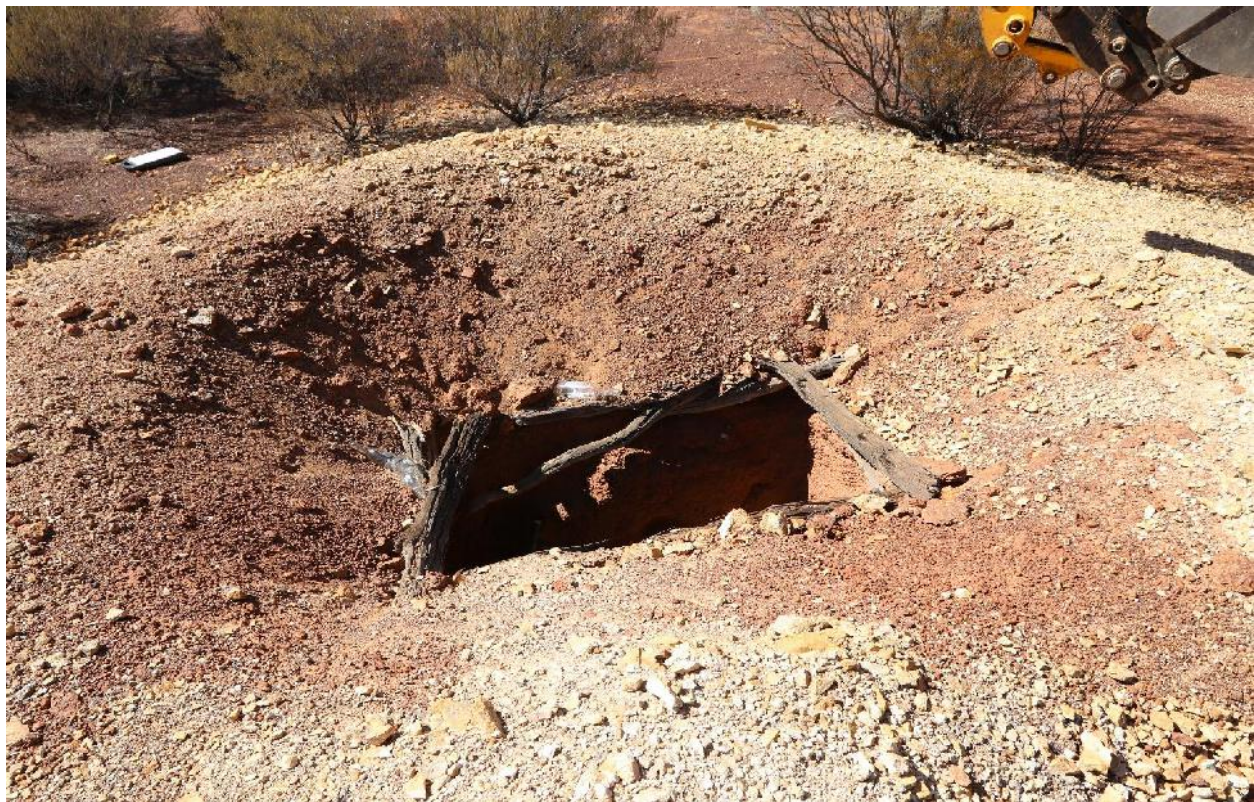
Photograph 47: Feature 18, facing east

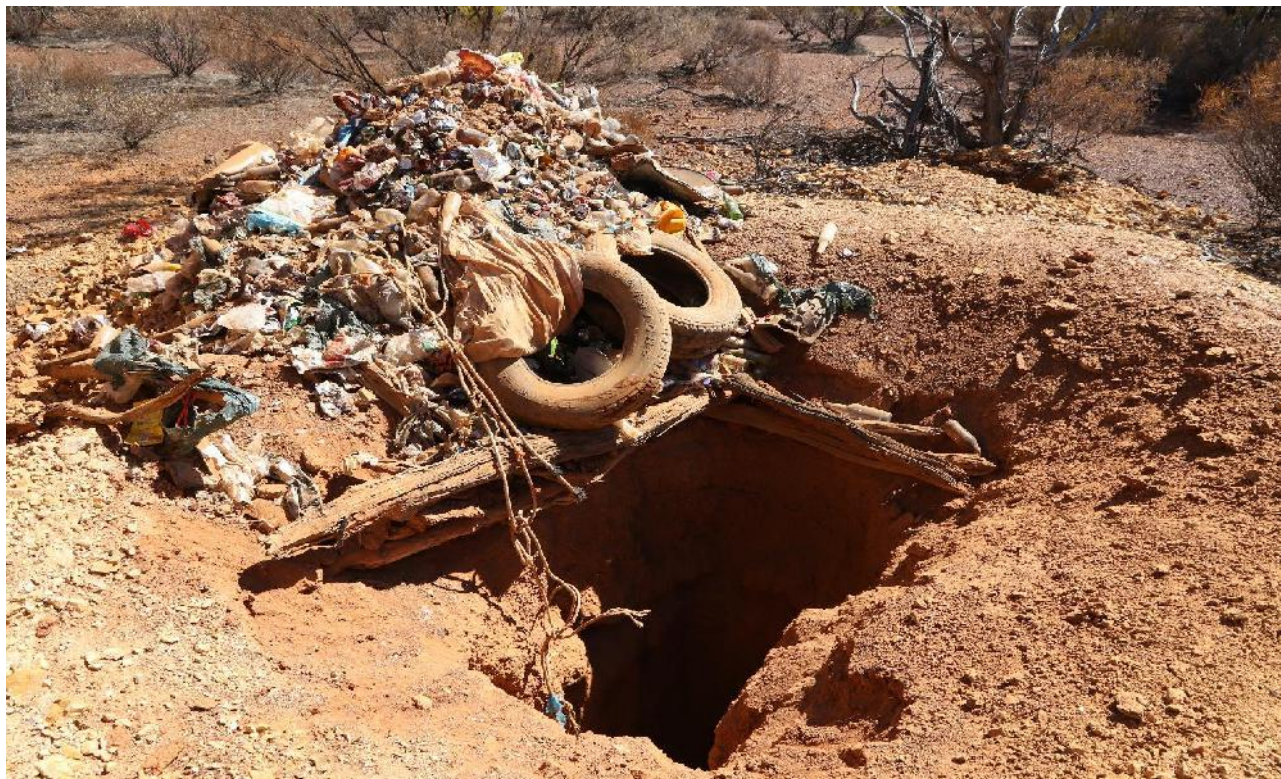
Photograph 48: Feature 18, excavated refuse, facing north

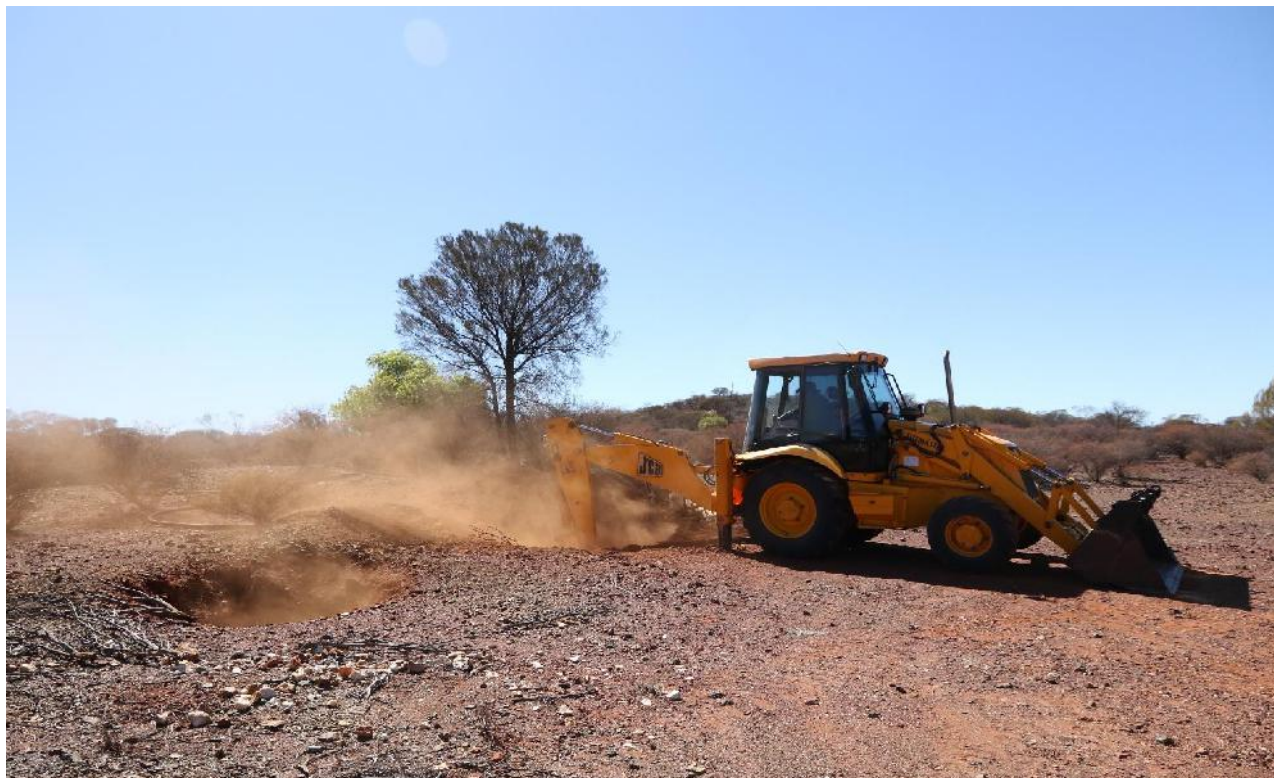
Photograph 49: Features 20 and 21, facing north

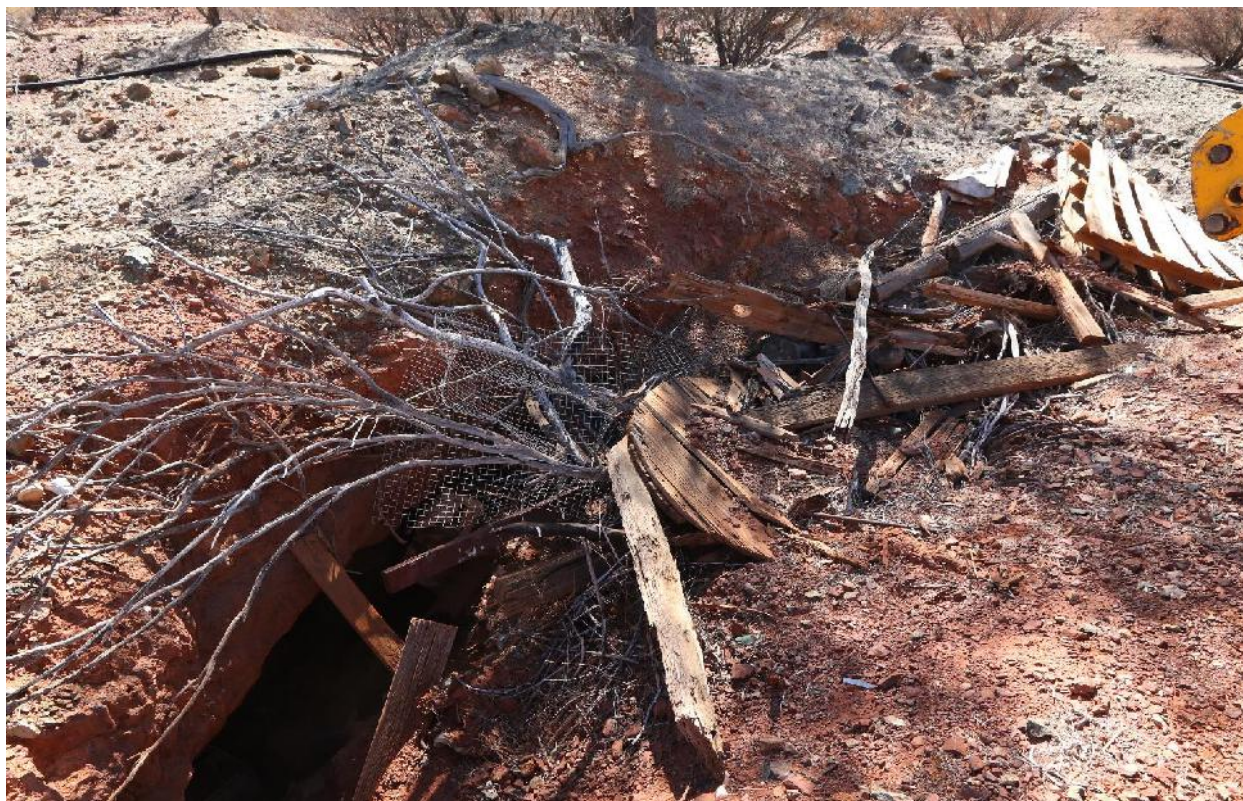
Photograph 50: Feature 21, facing northwest

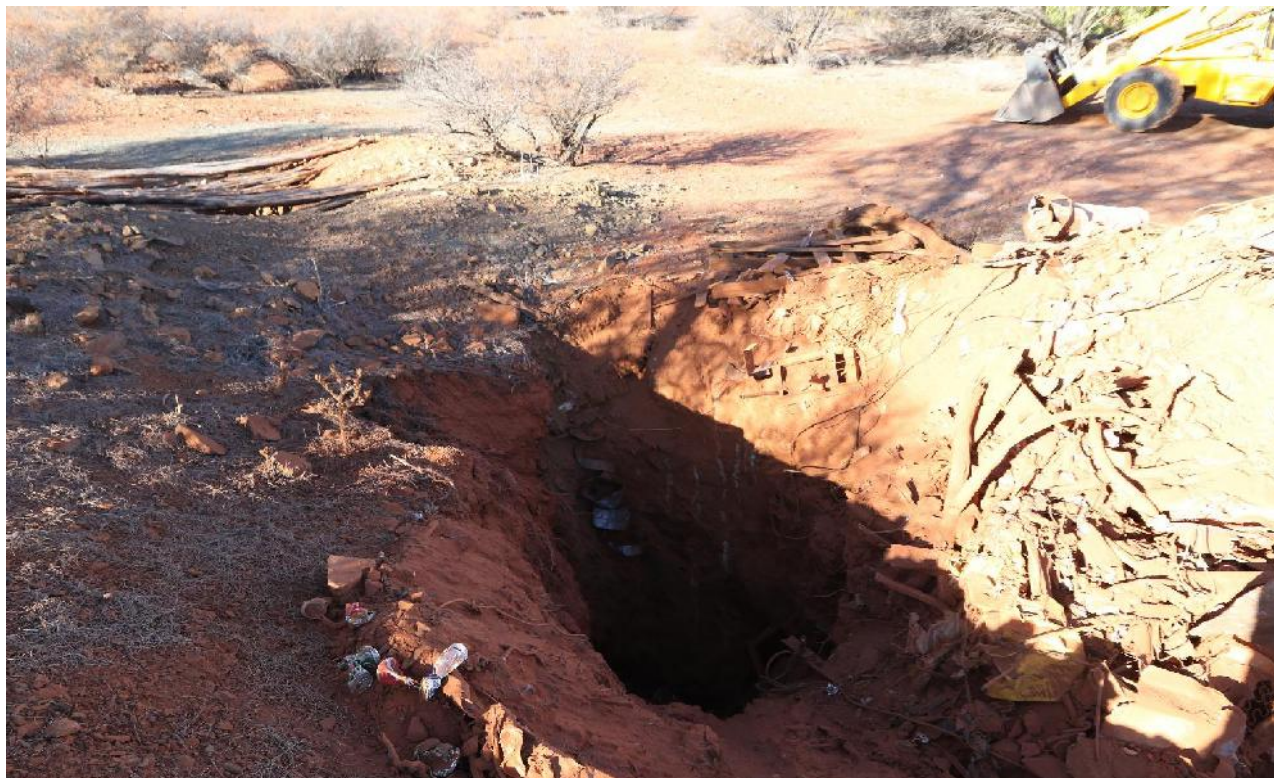
Photograph 51: Features 21 and 22, facing northeast, following some excavation

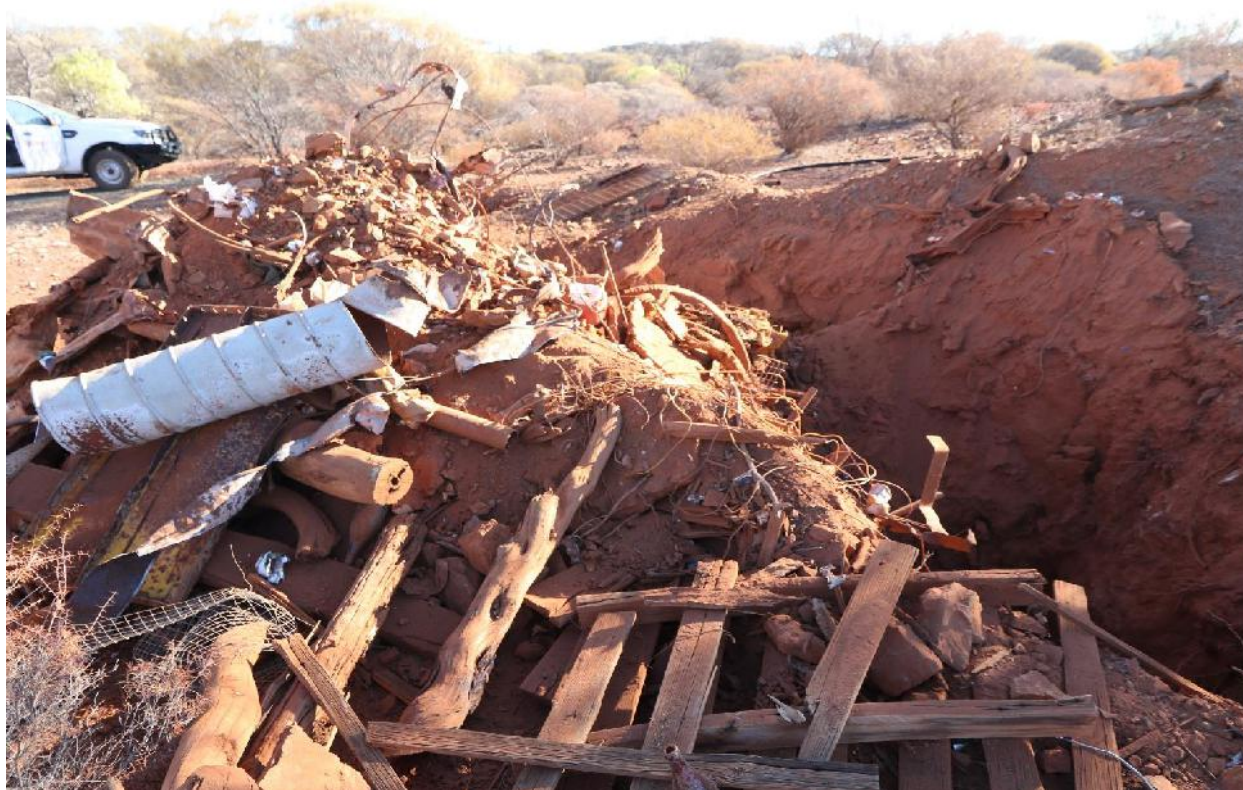
Photograph 52: Feature 21, excavated refuse

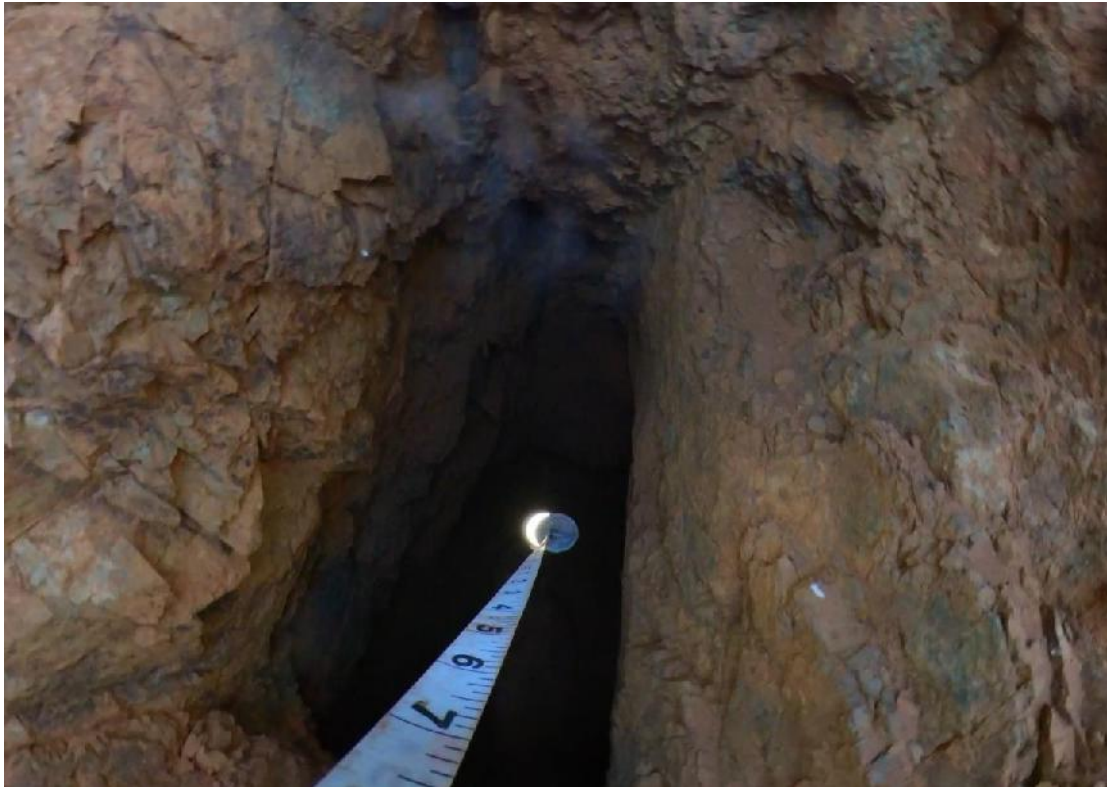
Photograph 53: Feature 22, approximately 1 m deep, facing down

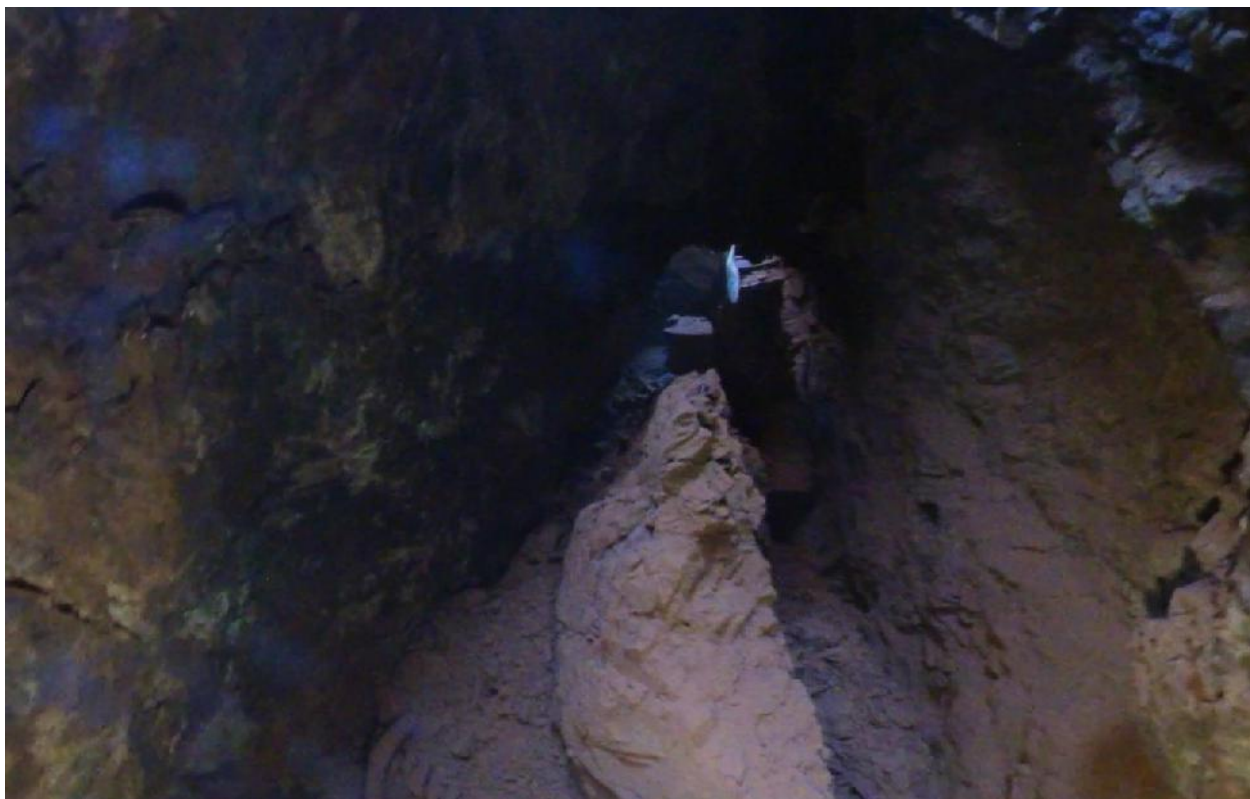
Photograph 54: Feature 22, near base, facing south to Feature 21
